## MASTER'S THESIS

Study program/ Specialization: <b>MSc Petroleum Engineering/Drilling Technology</b>	Spring semester, 2014 Open / Restricted access
Writer:  <b>GOKULAKRISHNAN THIYAGARAJAN</b>	..... (Writer's signature)
Faculty supervisor: <b>Mesfin Belayneh, UiS</b>	
Title of thesis:  <b>GAP Analysis of Macondo Blowout incident with their prescribed Standards &amp; Codes</b>	
Credits (ECTS): <b>30</b>	
<b>Key words:</b> GAP Analysis, Macondo Blowout, Deepwater Horizon, Standards and Codes	Pages: 77 + enclosure: 14  <b>Stavanger, June 2014</b>

Macondo blowout also known as the Deep Water Horizon incident has been one of the biggest oil field disaster in history. It has also become an effective case study for the Health Safety and Environmental aspects of the Petroleum Industry.

This thesis deals by exhaustively comparing the GAP between the Macondo blowout with the regulations, recommended practices, guidelines, Industry standards and codes that existed prior to the blowout (Pre-Macondo) and what was actually implemented in case of deep water horizon as well as analyzing it with the current Norwegian / International Standards and codes (Post-Macondo).

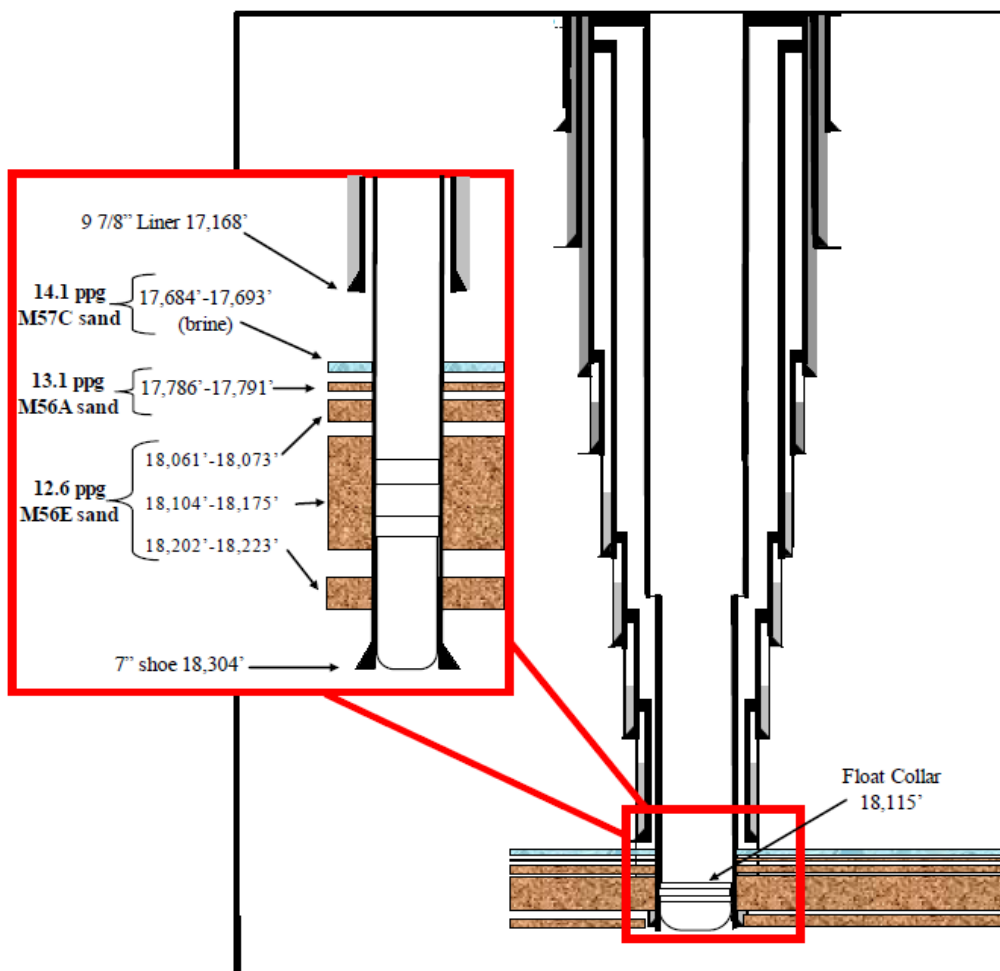
Figure 13-Macondo Well Shoe Track and Hydrocarbon Intervals<sup>16</sup>

Following the lost circulation events described above, BP and Transocean controlled the mud loss by LCM pills and decided to install the 9 7/8" casing at 17168' from the original 19650', see figure 14. BP continued to drill the open hole section for the production casing and faced difficulties with the drilling margin (see figure 10), from 17168' (9 7/8" casing shoe) to 18223' where the pore pressure kept reducing from 14.1 ppg to 12.6ppg,

Therefore the drilling mud equivalent circulating density (usually 14.1+ 0.2 ppg above pore pressure) was fracturing at the bottom of open hole interval (12.6 ppg pore pressure) while overbalancing the top of the open hole interval (14.1 ppg pore pressure). Figuratively

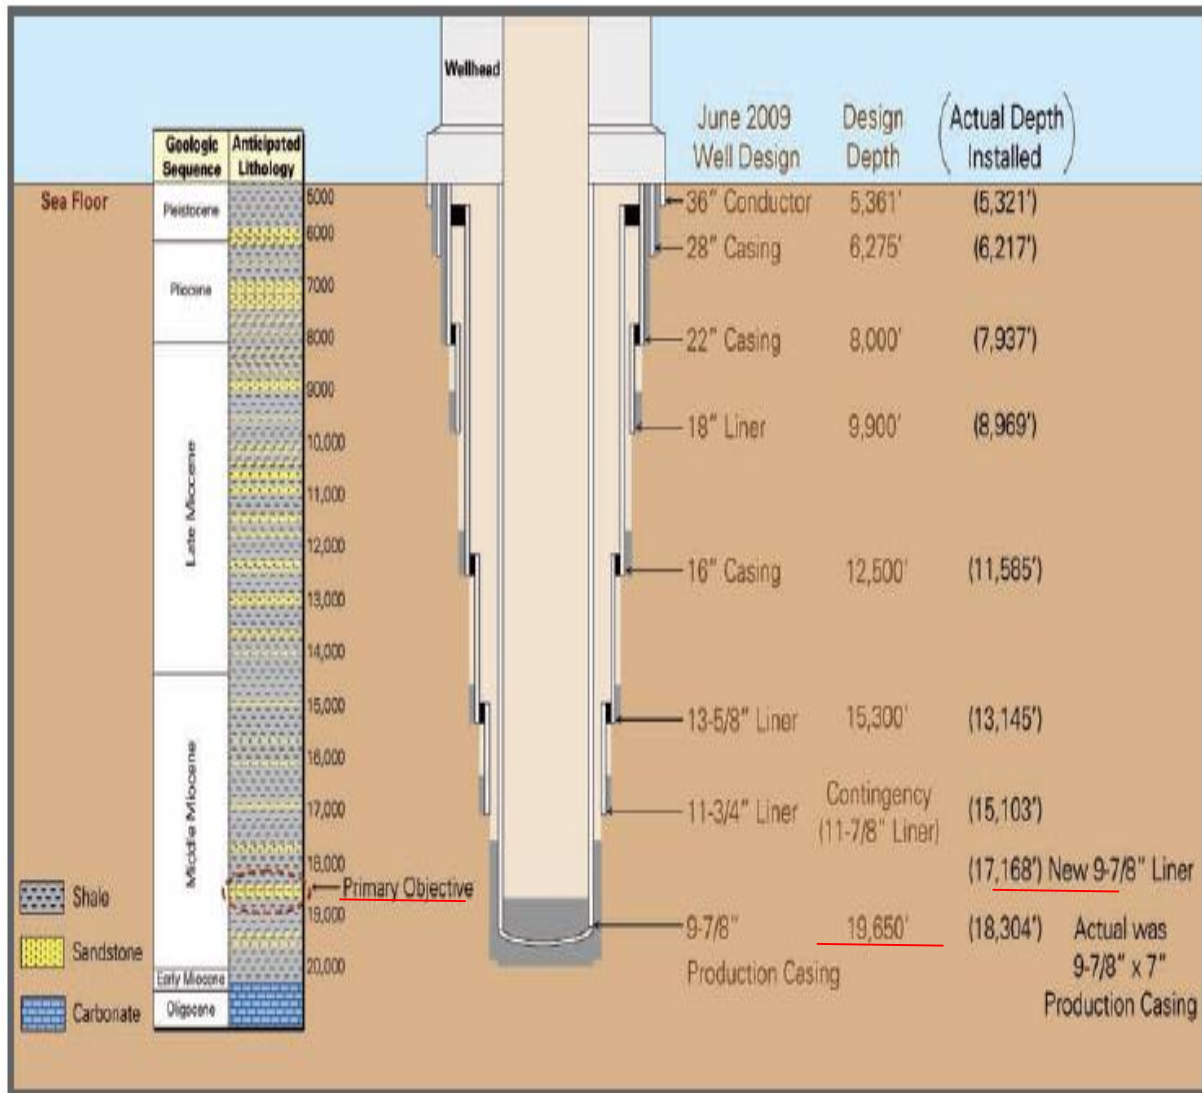
Figure 14-Geology, Original Well Design and Installed Depth<sup>17</sup>

BP and the service companies ran out of drilling margin, so decided to revise the total well depth at 18360' from the original well total depth of 20200'.

At 18360' the wellbore was still inside the primary sandstone reservoir see figure 14, which forced BP to reconsider their original long casing string design (" a "long string" production casing—a single continuous wall of steel between the wellhead on the seafloor, and the oil and gas zone at the bottom of the well"[1]). They had two options, see figure 15, one was to go with the originally planned long string production casing and the other a shorter string called a liner tie back production casing string (" a "liner"—a shorter string of casing hung lower in the well and anchored to the next higher string"[1] ).

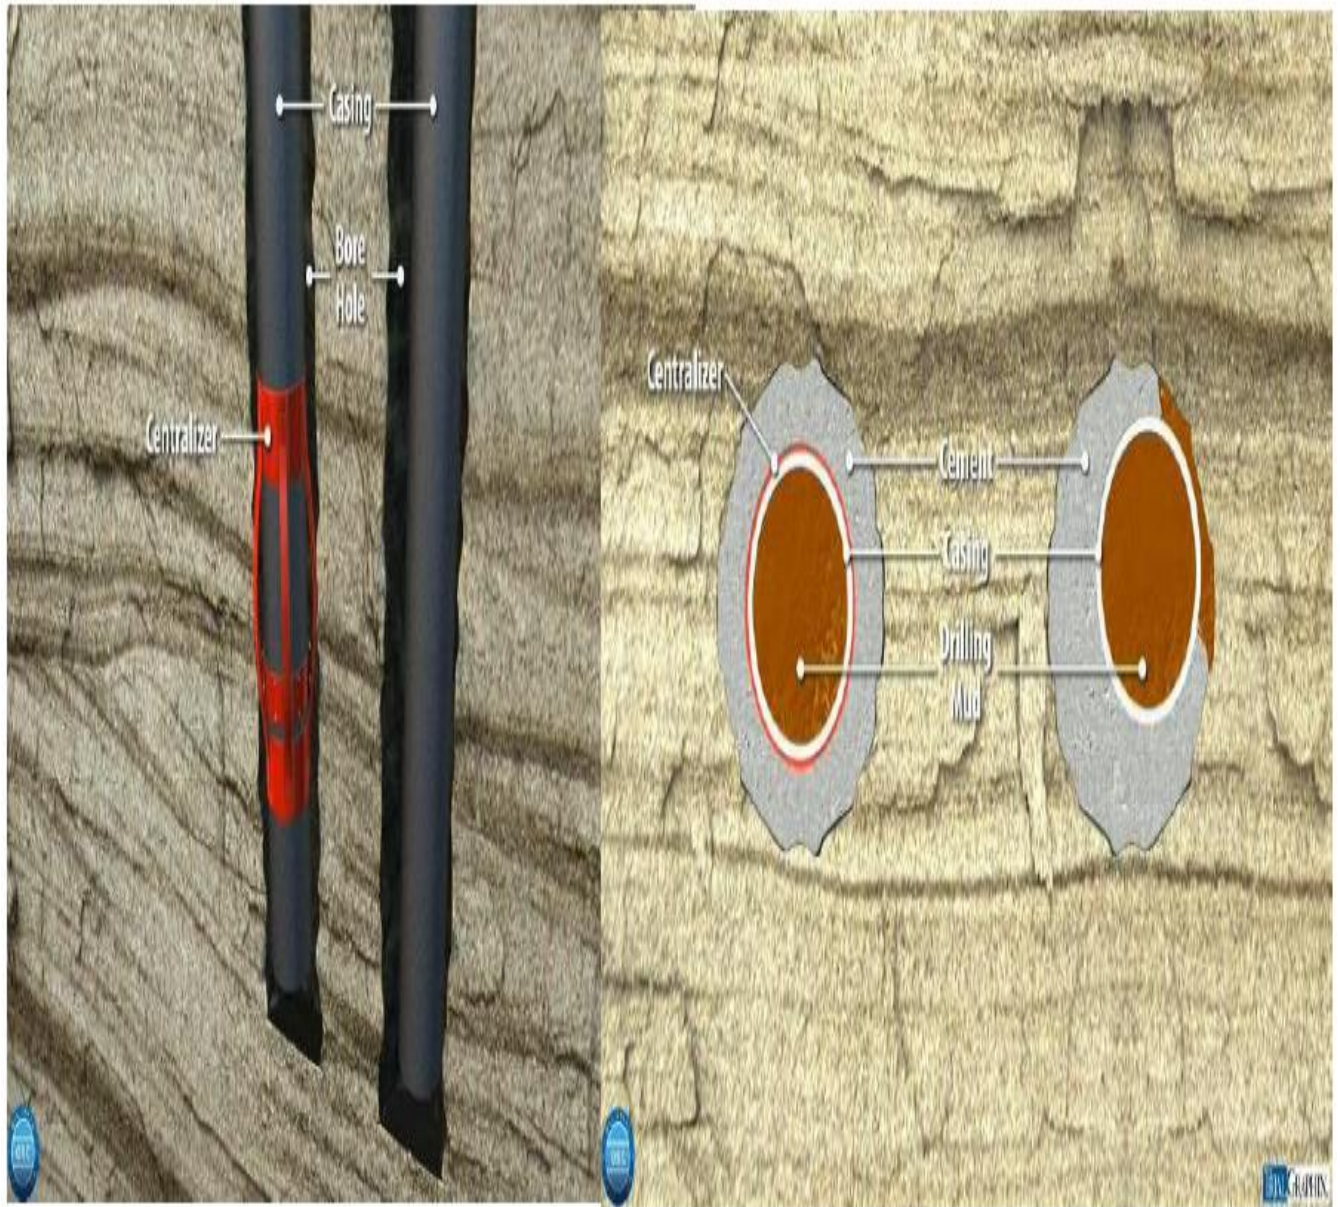
Figure 16-Centralizers<sup>23</sup>

BP received the fifteen centralizers and found that they were of the wrong type with separate stop collars and decided to go ahead with just using the six that were available on the rig. Before receiving the analysis report from Halliburton, BP installed the long casing string with six centralizers, the report ( BP received the final report after the blowout) concluded that severe gas flow problems were likely to occur, the report also contained vital compressive strength analysis of the cement[1, 4] .

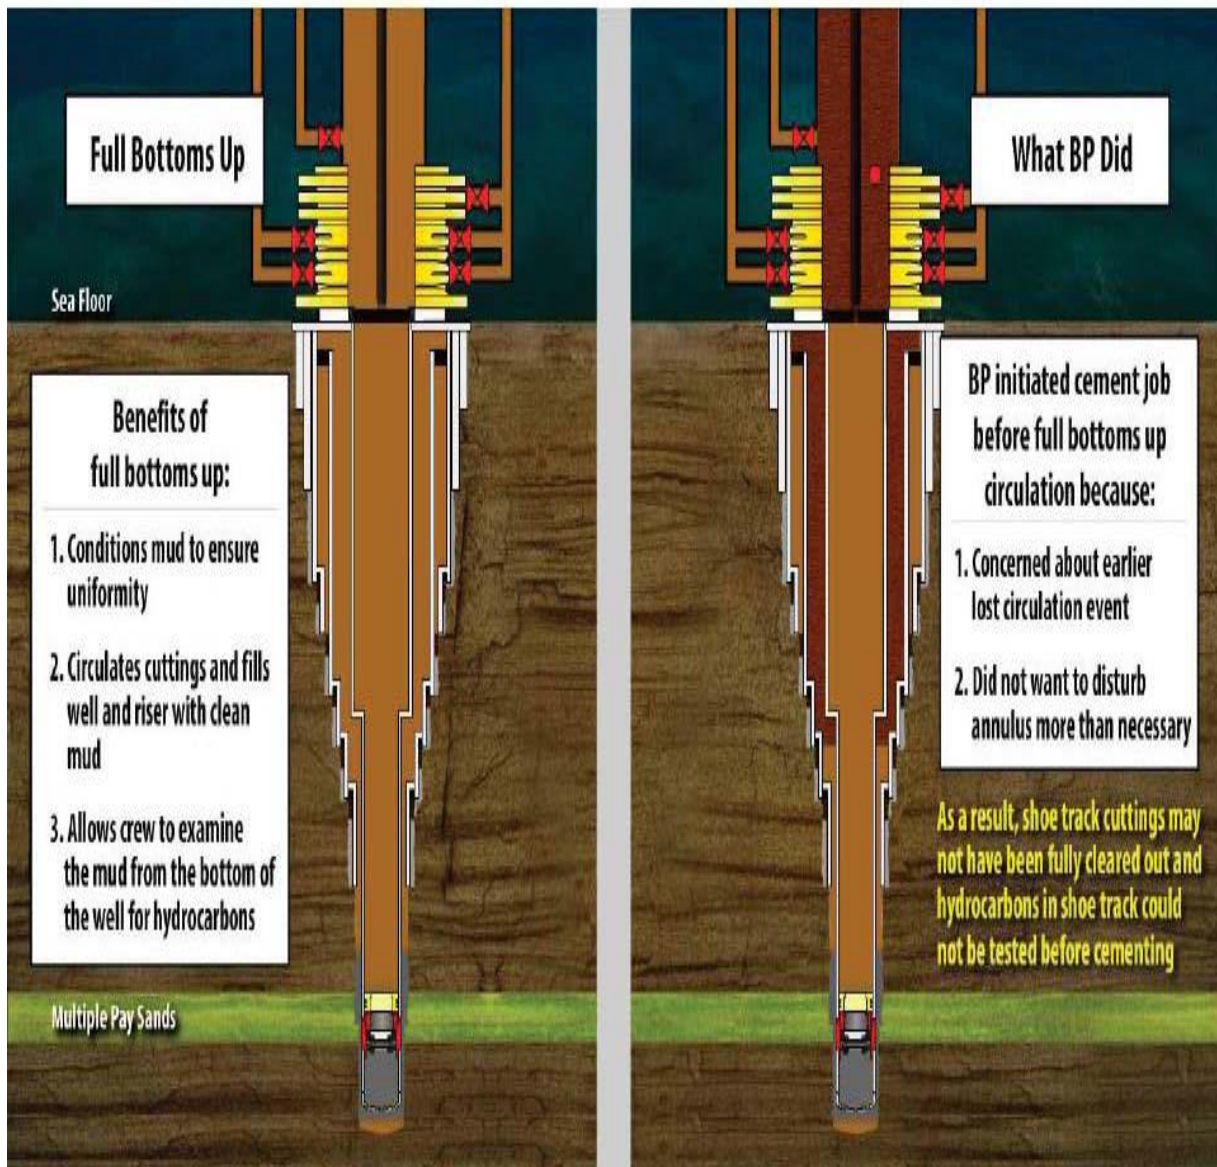
Figure 17-Illustration of conventional Bottoms up VS what BP did<sup>24</sup>

It is widely accepted in the industry to perform a full bottoms up of the well bore prior to primary cementing. Full bottoms up circulation of the wellbore would clean the annulus from any drilling cut debris and stops contamination of the cement see figure 17. It is done by pumping base oil, spacer and cement mix into the well, to displace the existing drilling mud all the way to the trip tank on the rig see figure 18. The mud-logger can perform useful tests to examine the drilling mud for any residual hydrocarbons in case the formation was flowing

already in the wellbore. But BP, given the fact of the previous washout and the lost circulation materials used to plug the formation, were concerned and decided to only perform a partial displacement of the drilling mud. “BP circulated approximately 350 barrels of mud before cementing, rather than the 2,760 barrels needed to do a full bottoms up circulation.[1]”

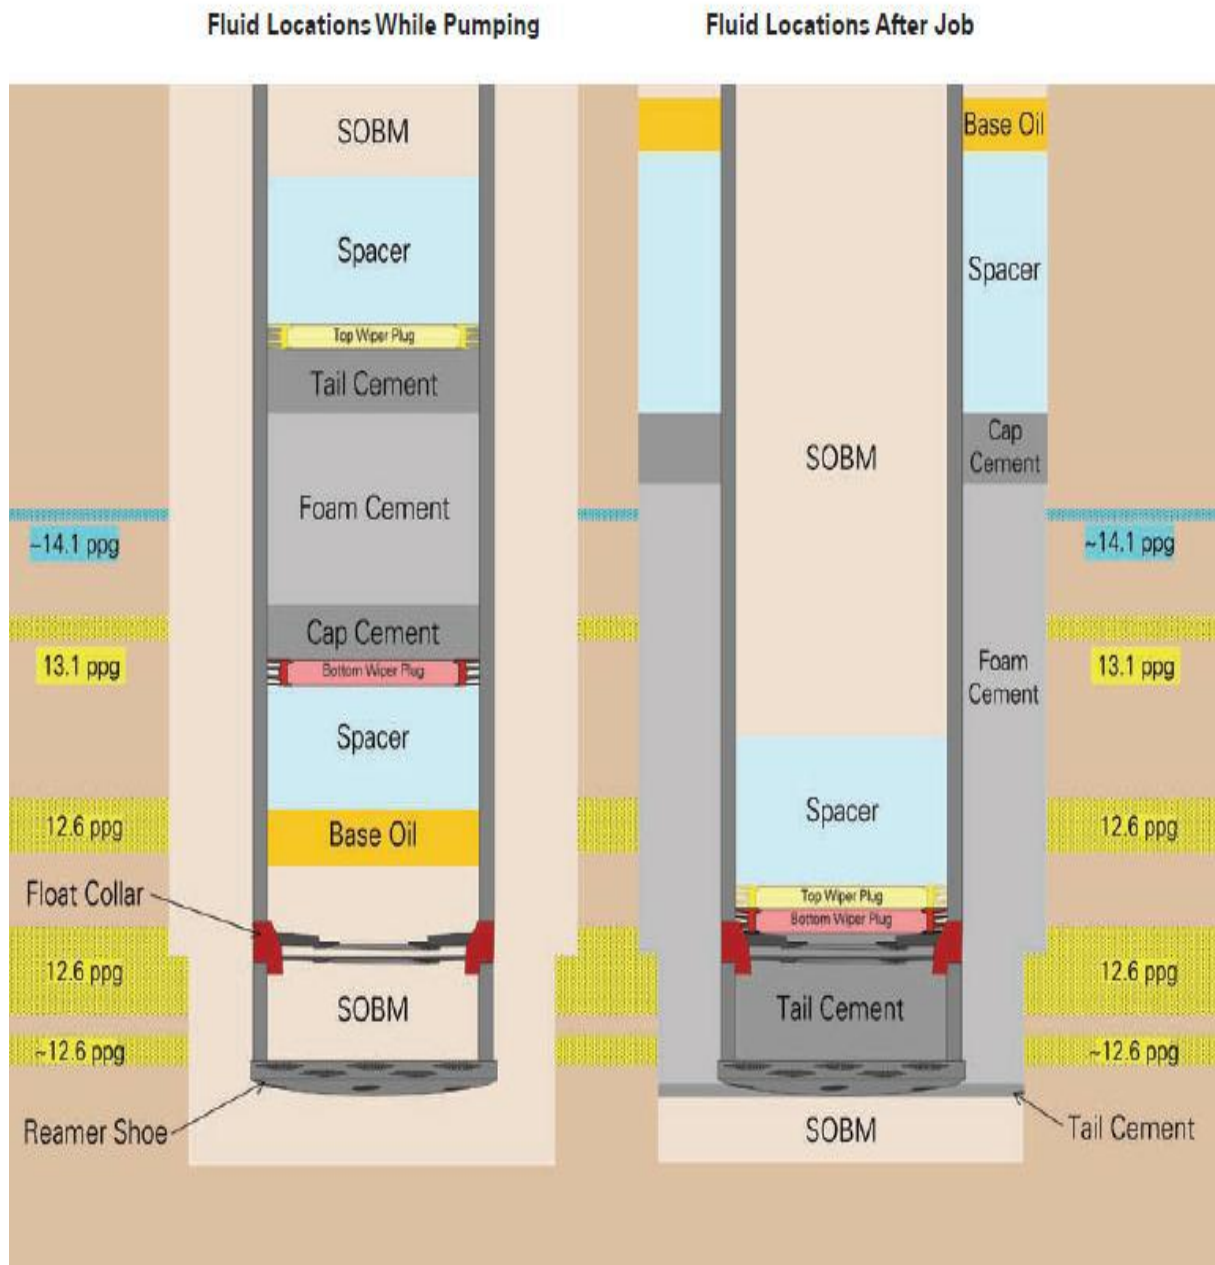
Figure 18-Cement Fluid Locations<sup>25</sup>

Additionally, BP used only 60 barrels of cement mix to cement 500ft above the uppermost hydrocarbon bearing zone and 800ft for the principal hydrocarbon zone. This is considered as a relatively low volume to give a good cement placement (that more cement volume means less contamination and an increased efficiency). But BP chose to use only the bare minimum volume of cement with a slight margin for error. Increased cement volume causes higher PPG exerted on the annulus of the liner/casing shoe, potentially causing damage to the formation[1]. Therefore BP decided to do only a partial displacement 500ft above the payzone. A comparison of partial displacement vs full displacement is shown in figure 17.

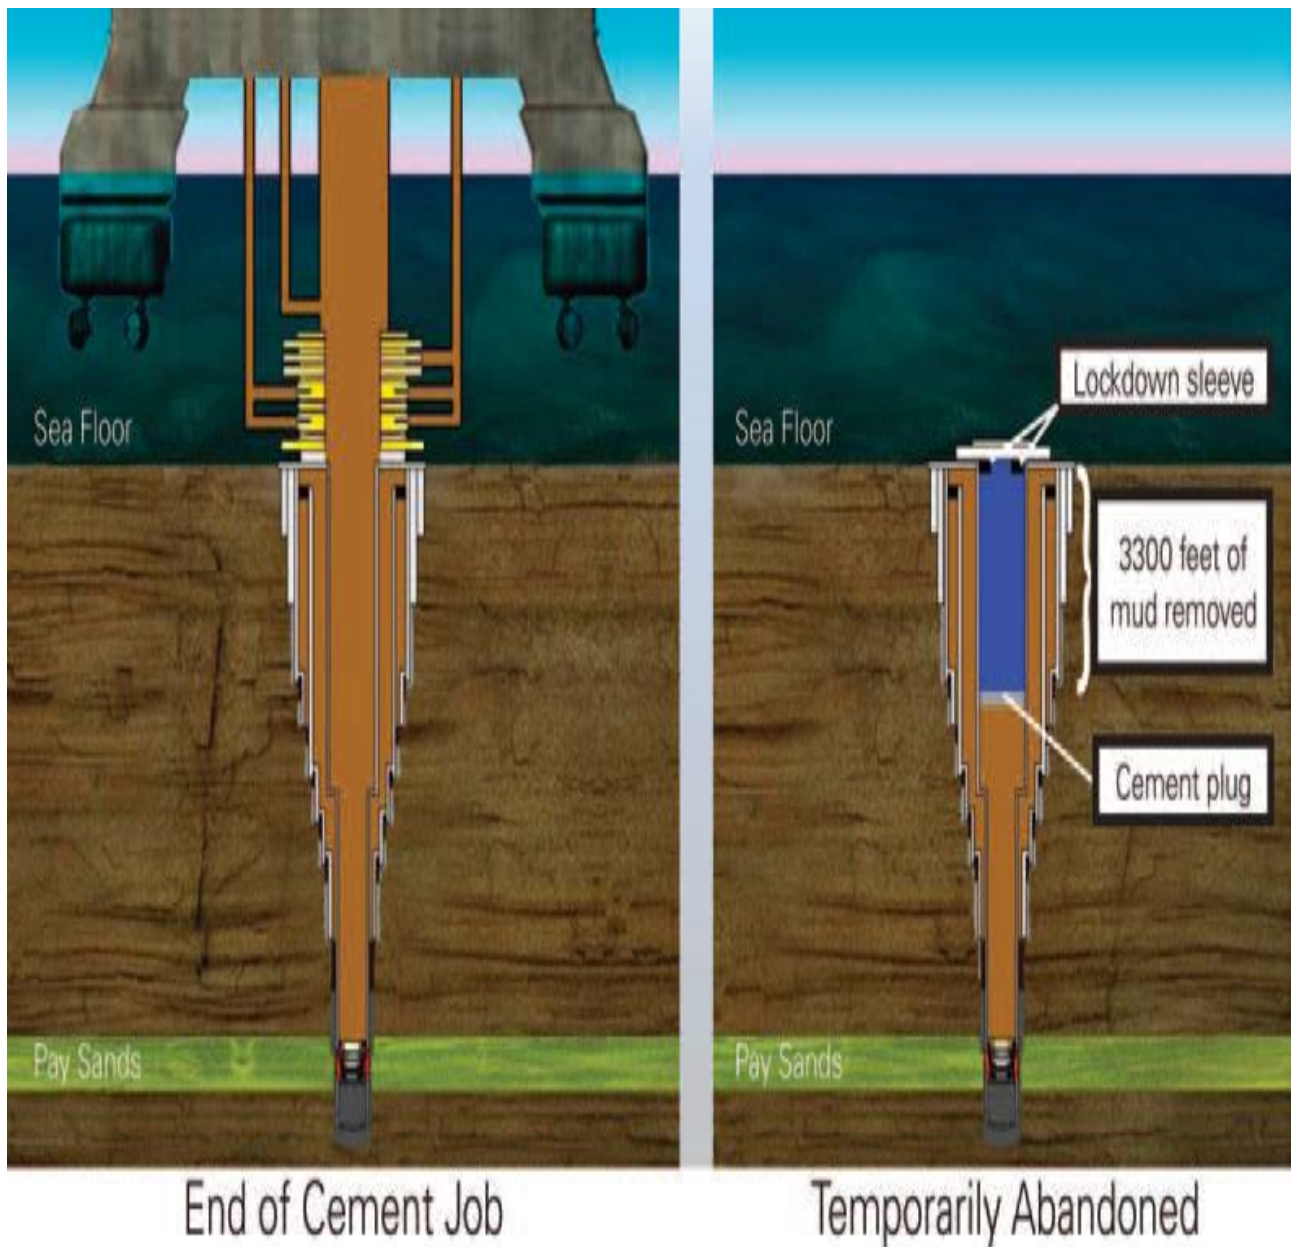
Figure 20-Status of the well before (left) and after temporary abandonment (right) with the cement plug<sup>29</sup>

After the cementing operations, the well was due for temporary abandonment<sup>28</sup>. In order to do this, the Deepwater Horizon had to a) remove the BOP and the riser from the wellbore b) set a cement plug well below the seabed and c) put in a lock down sleeve on the well head. Lock down sleeve is used to keep the existing casing hanger and the seal assembly from moving out of place, the movement can be caused when high pressure fluids are flowing upwards in turn lifting the casing. Figure 20 shows the Status of the well before and after temporary abandonment.

BP decided to put the cement plug at 3300ft below the sea floor (8367ft from the rig) on contrary to 6000ft originally planned. they also decided to put the lock down sleeve after the surface cement plug is set and not vice versa as originally planned[1].

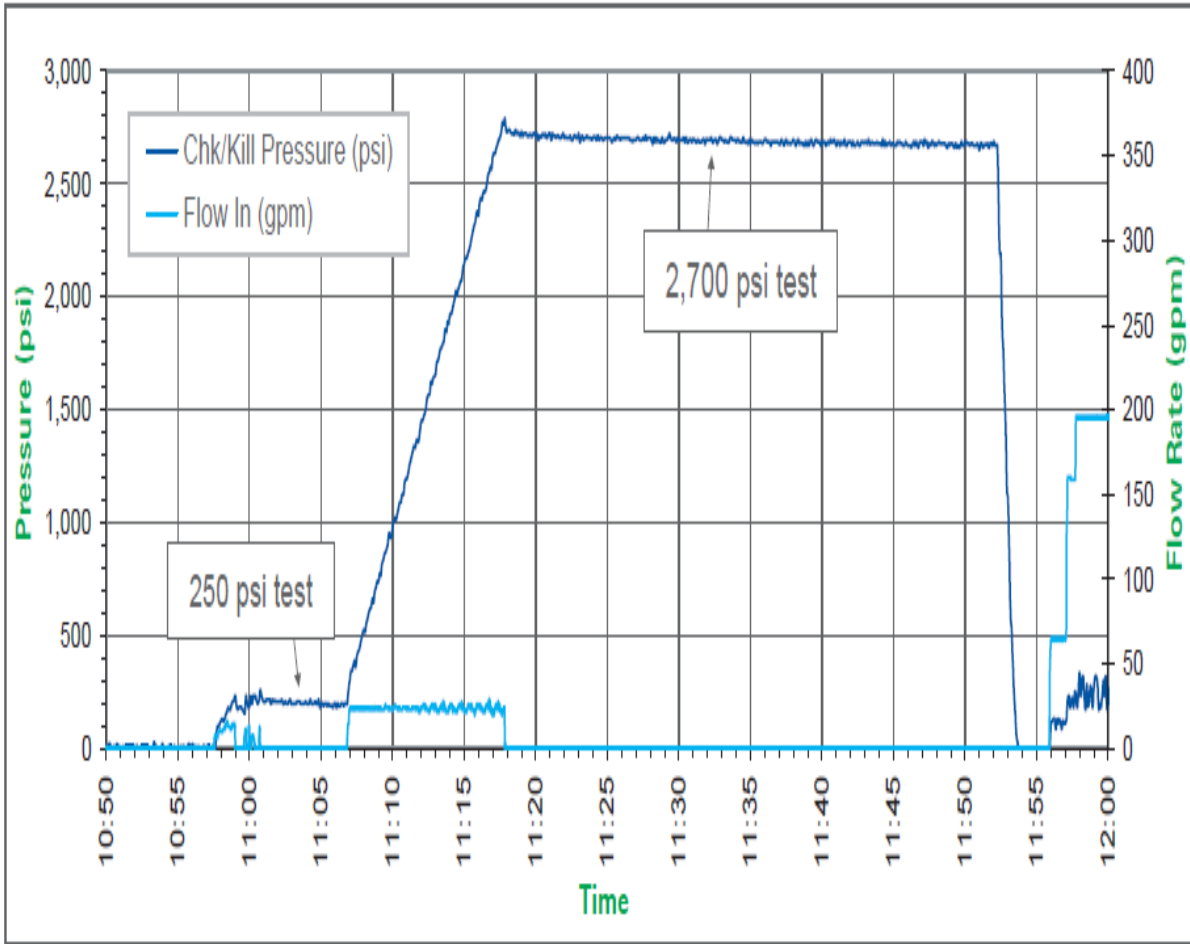
Figure 22-Positive Pressure Test<sup>31</sup> (Macondo Real time data)

In a positive pressure test, pressure is built up in the well by pumping additional fluids, to check if the pressure is sustained over a period of time. In case there is a leak in the barrier envelope, the pressure will not stay constant over time. BP pumped the well to 250 psi and waited for 5 minutes and then pressured again up to 2500psi and watched for 30 minutes, see figure 22.

The pressure inside the pipe was stable and constant. The positive pressure testing was considered adequate and conclusive.

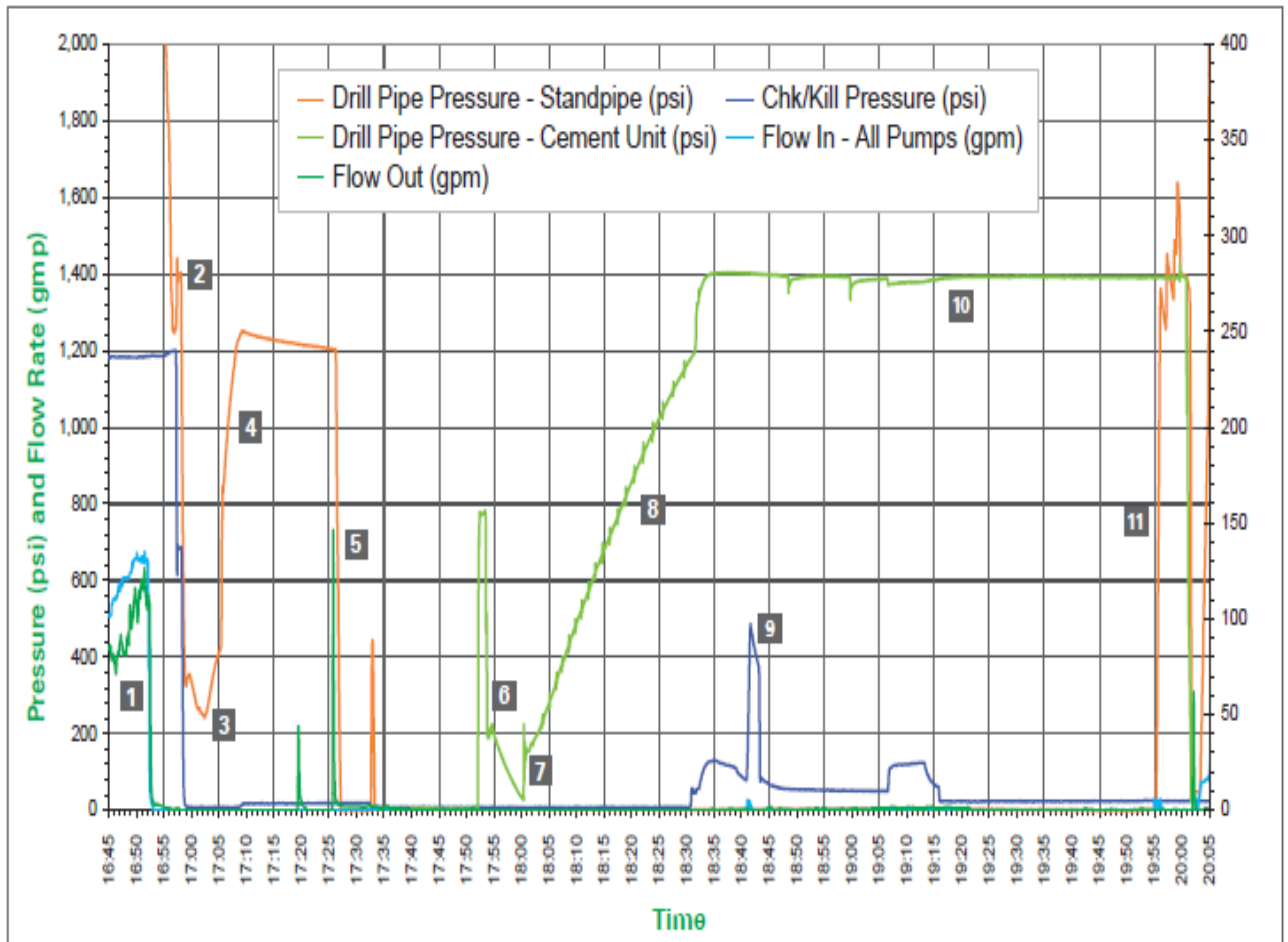
The first negative pressure test in Macondo showed a sign of problem, after initial bleed off, the pressure in the well could never be brought towards zero i.e. the drill pipe pressure stayed at 260psi and also returned water to the rig. Following this, the rig crew shut the drill pipe valve and observed 1262psi, first negative test failed[5]. See figure 25.

Meanwhile, the rig crew noticed falling spacer level in the riser so dedicated to close the annular preventer tight and perform the second negative test, during the second test the drill pipe pressure was bled to 0psi but the drill pipe returned around 15 barrels of fluid, unusually large volume, following the bleed-off the drill pipe was shut in again only to see the pressure shot up to 773psi, the second negative pressure testing failed[5].

| <p><b>1</b> Spacer displacement complete; mud pumps stopped.</p> <p><b>2</b> Annular preventer closed; attempt to bleed drill pipe pressure to zero.</p> <p><b>3</b> Drill pipe pressure decreases to only 273 psi; annular preventer leaking.</p> <p><b>4</b> Drill pipe pressure increases as annular preventer leaks; hydraulic closing pressure increased to seal annulus.</p> <p><b>5</b> Drill pipe pressure bled to zero for negative-pressure test.</p> <p><b>6</b> Decision made to conduct negative-pressure test via kill line; kill line opened; 3 bbls to 15 bbls bled to cement unit.</p> | <p><b>7</b> Shut in kill line at cement unit, drill pipe pressure starts to increase.</p> <p><b>8</b> Drill pipe pressure slowly increases to 1,400 psi.</p> <p><b>9</b> Fluid pumped into kill line to confirm full; kill line opened to mini trip tank for monitoring.</p> <p><b>10</b> Discussion ongoing about 'annular compression' and 'bladder effect' while monitoring kill line; drill pipe pressure static at 1,400 psi.</p> <p><b>11</b> Negative-pressure test concluded, declared a success; preparation made to continue displacement.</p> |
