MASTER'S THESIS

Study program/ Specialization: Mechanical and Structural Engineering and Materials Science	Autumn semester, 2014 Open
Writer: Martin Ask

(Writer's signature)
Faculty supervisor: Gerhard Ersdal (UiS) External supervisor(s): Narve Oma (Ptil), Kai Heine Sirevaag (Solvang)	
Thesis title: Ageing of ships, LPG tankers	
Credits (ECTS): 30	
Key words: Ageing, ship, LPG, tanker, corrosion, fatigue, buckling, coating, maintenance, ballast tank	Pages: 14 + 141 + enclosure: 37 Stavanger, 15.01.2015 Date/year

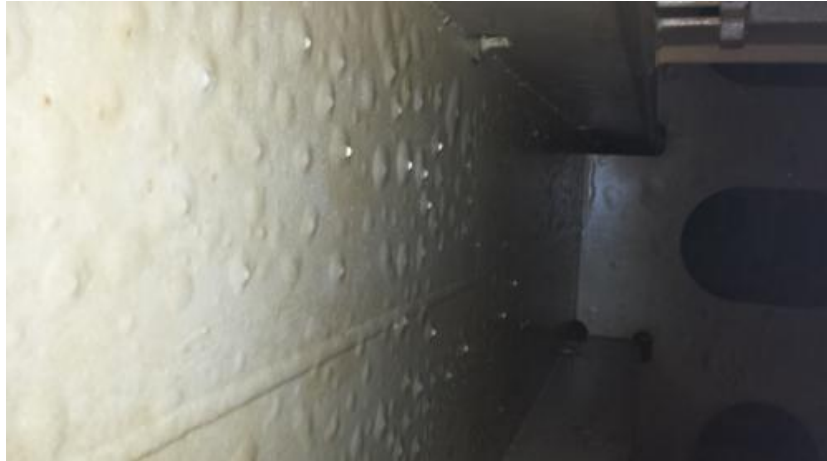
If there are grease or oil left on the surface the paint will not stick to the surface, with poor quality as result. If there are any salt left under the paint, it will be blisters in the paint. See picture 26.

Picture 26 Blisters in the ballast tank in Clipper Skagen (Solvang 2012)

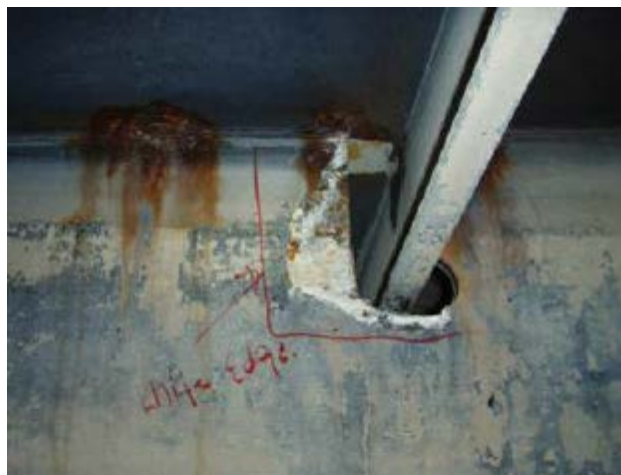
Web frames cut outs for deck longitudinals and side longitudinals were found with edge corrosion. See picture 45.

Picture 45 Marked area needs renewal. (Clipper Skagen 2009)

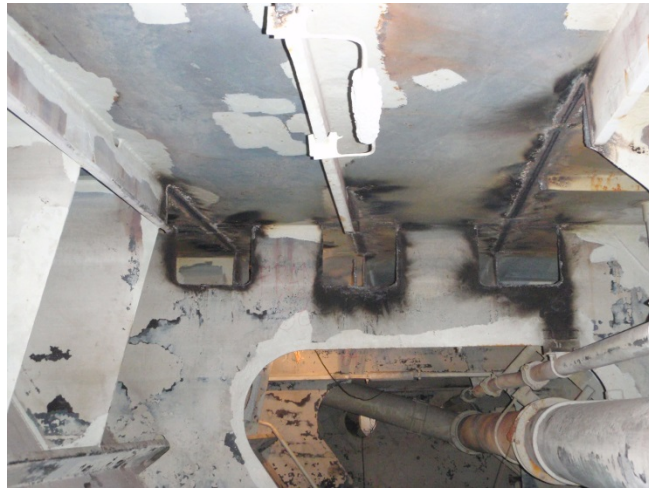
Picture 46 Corroded part cut out (Clipper Skagen 2009)

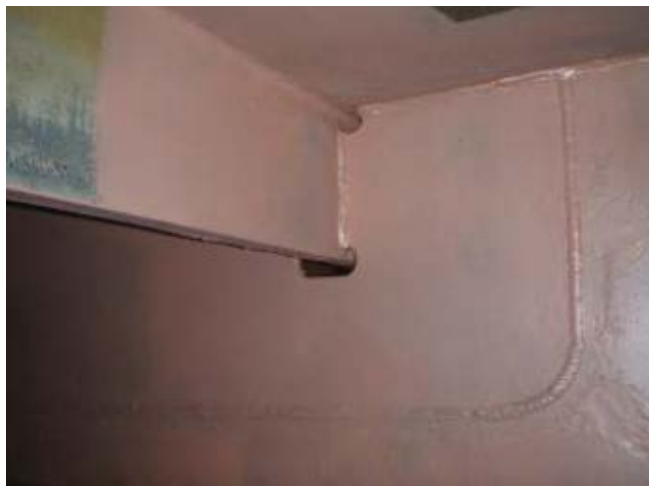
Renewed with inserts and coated. See picture 47. Coating application here also looks to be too thin.

Picture 47 New insert welded in place and coated (Clipper Skagen 2009)

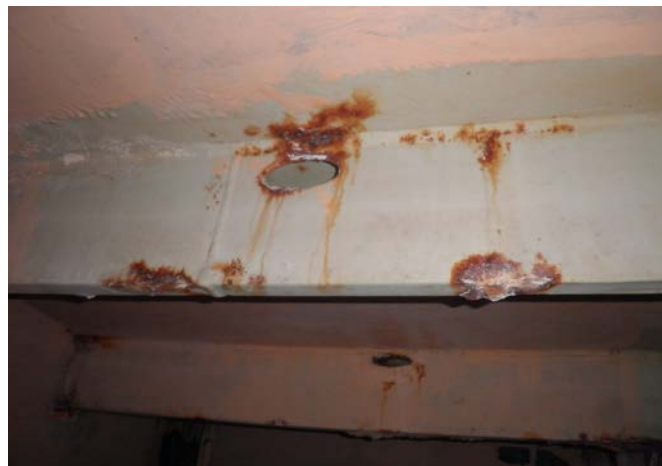
When inspected in Gibraltar, it was five years since most of the steel replacement carried out in 2009. During the inspection it was found substantial corrosion on and around the repaired areas. Corrosion on welds and around the drain hole. See picture 49 and 50.

Picture 49 Corrosion on renewed steel (Ask 2014a)

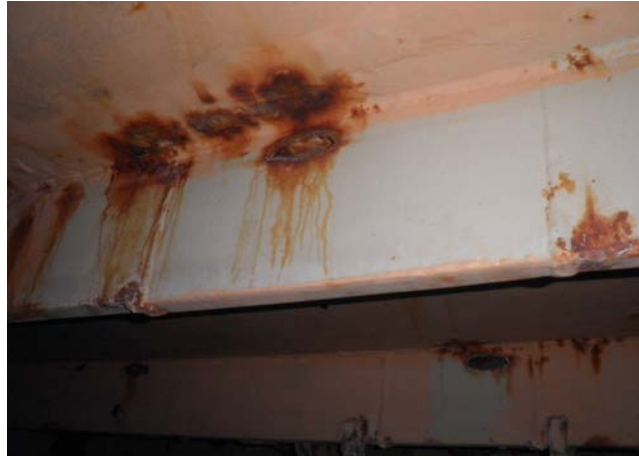
The corrosion on the weld seams and near them normally occurs when it is poor surface preparation before coating. The corrosion near a weld seam can also appear due to coating breakdown when welding. After welding all the coating nearby, which has been affected by the heat of the welding should be grit blasted and recoated.

Picture 50 Corrosion on renewed steel (Ask 2014a)

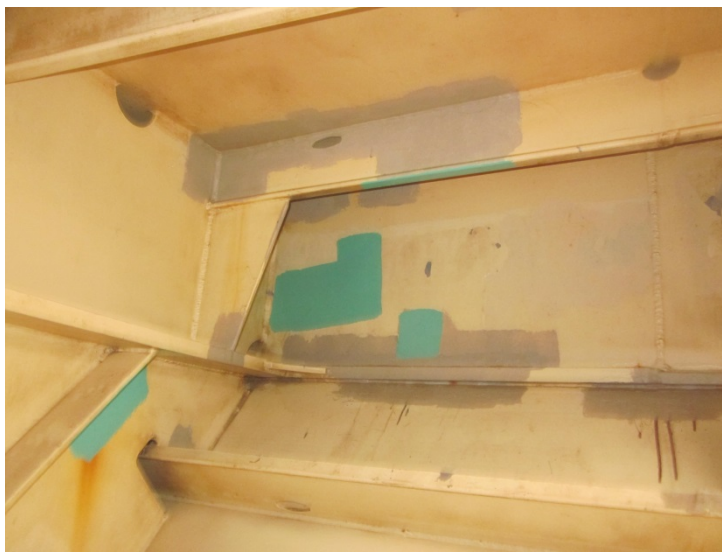
Corrosion spots found and painted. See pictures 63 and 64.

Picture 63 Sloping plate (Clipper Harald 2012b)

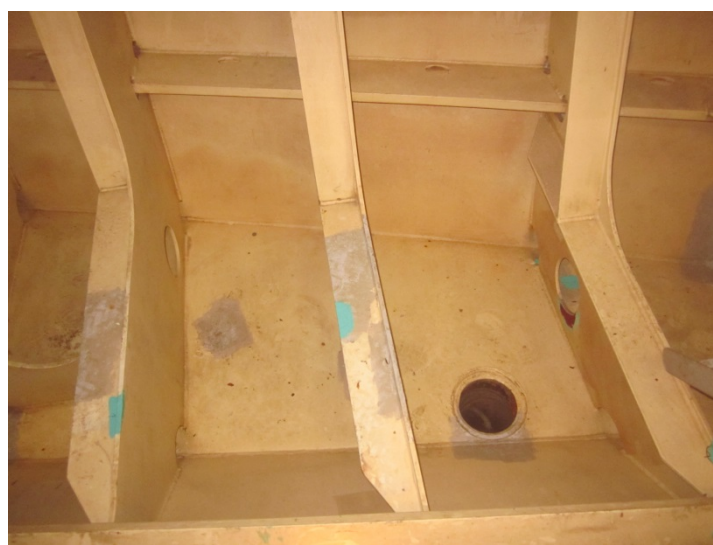
Picture 64 Bottom (Clipper Harald 2012b)

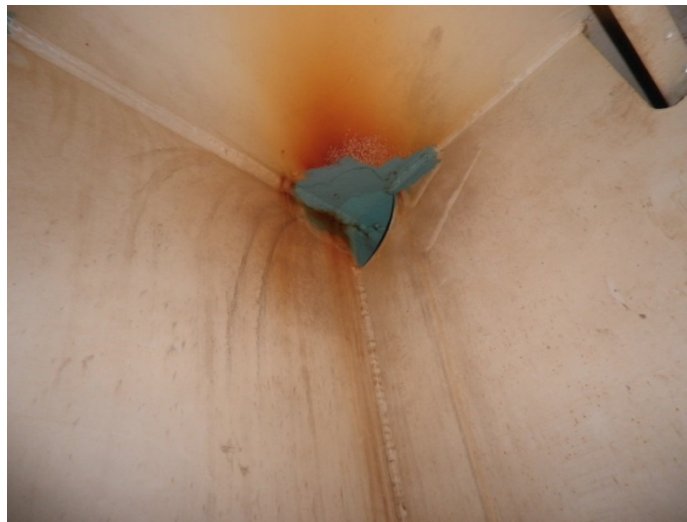
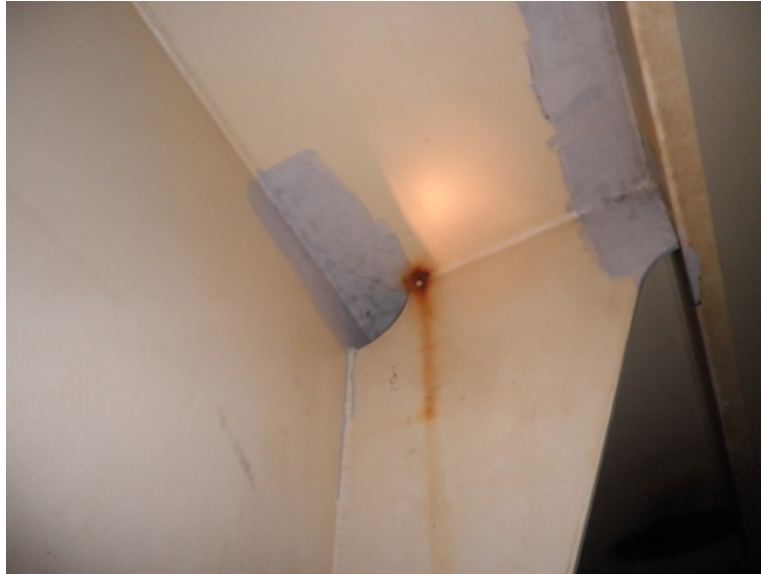
All the tanks were in general good condition with minor rust spots. Corrosion on earlier maintained areas was found. See picture 65, 66 and 67.

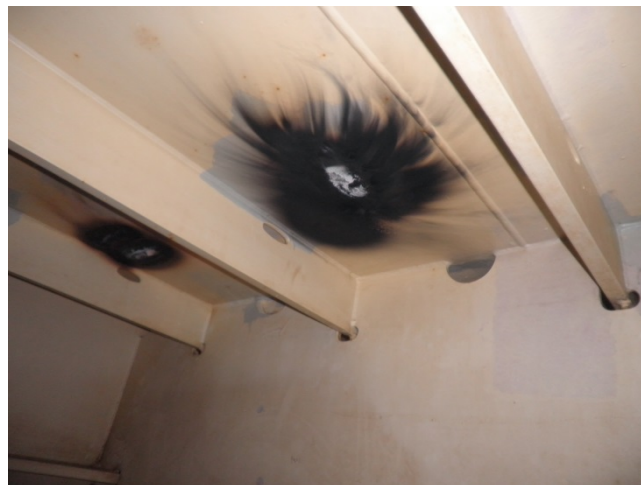
Welding on deck has been carried out, and caused coating breakdown in the ballast tank. See picture 68 and 69. All the heat damaged coating need to be grit blasted and recoated.

Picture 68 Deckhead after welding on deck (Ask 2014b)

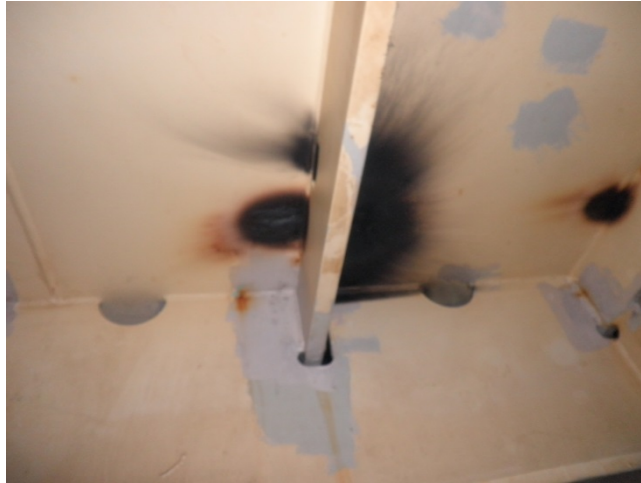
Picture 69 Deckhead after welding on deck (Ask 2014b)

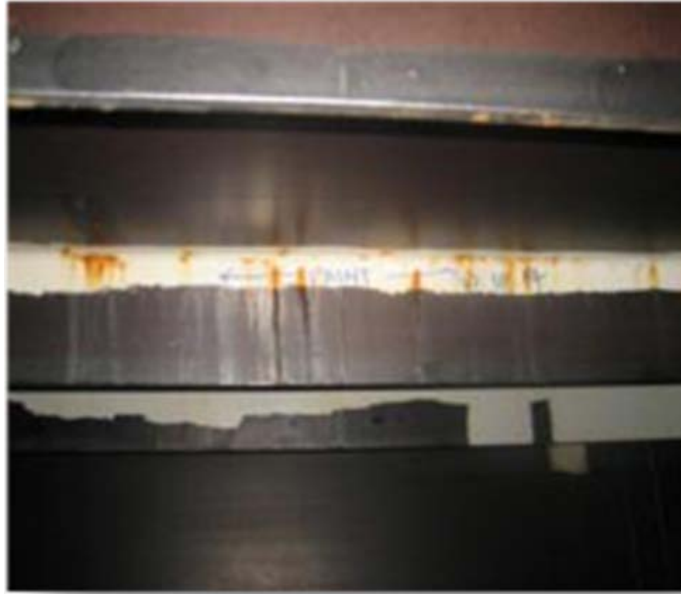
Corrosion spots found on previously maintained areas around drain holes and weld seams in the deckhead. See picture 71 and 72.

Picture 71 Corrosion on weld seams in deckhead (Clipper Star 2014)

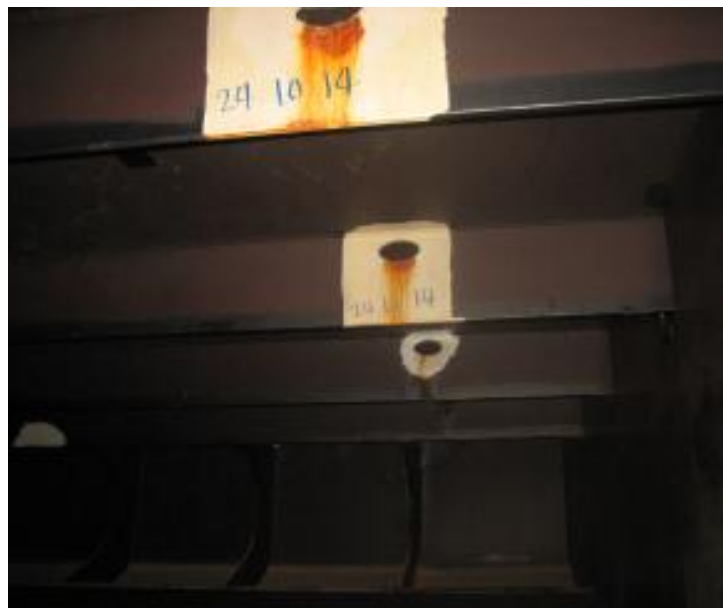
Picture 72 Corrosion in drainholes in deckhead (Clipper Star 2014)

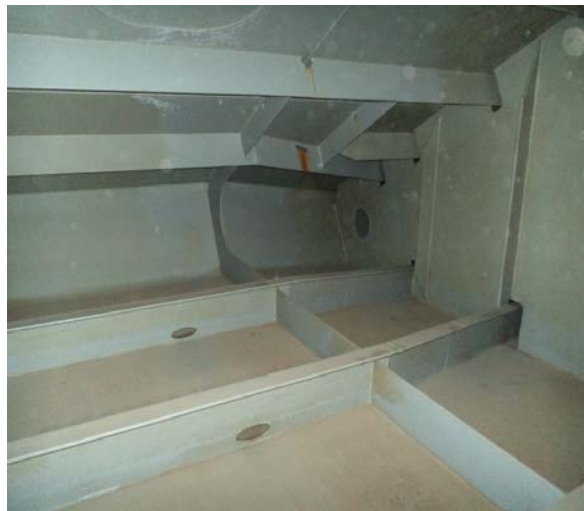
Overall condition of the tank was good, with some corrosion in the drain holes in the top of the tank. See picture 75.

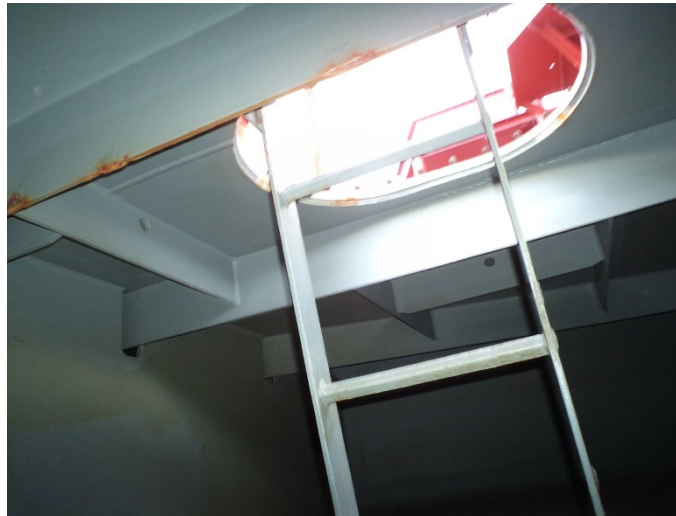
Corrosion found among other things on a longitudinal (see picture 73) and in drain holes (see picture 77). No coating maintenance carried out at inspection.

Picture 76 Corrosion on longitudinal near manhole (Clipper Mars 2013)

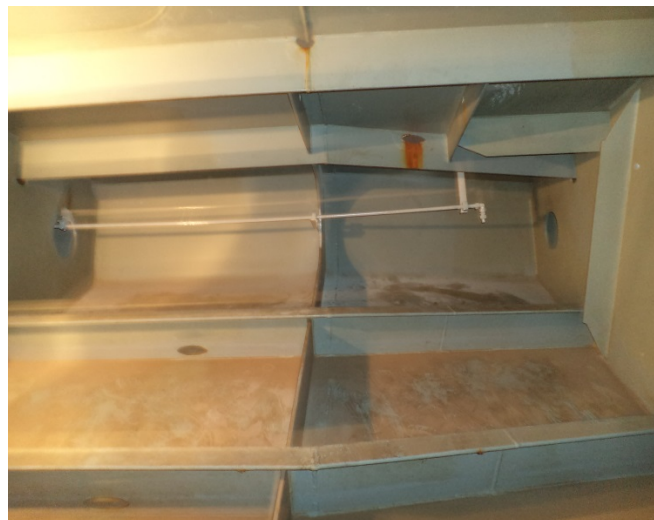
Picture 77 Corrosion in drain holes under deckhead (Clipper Mars 2013)

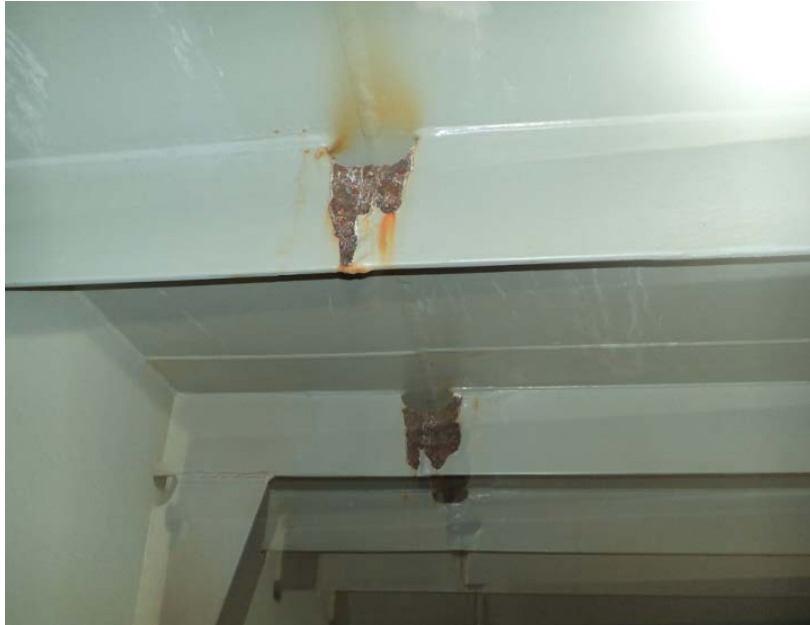
The tank are in generally good condition , but with corrosion around drain holes in longitudinal. See picture 78 and 79.

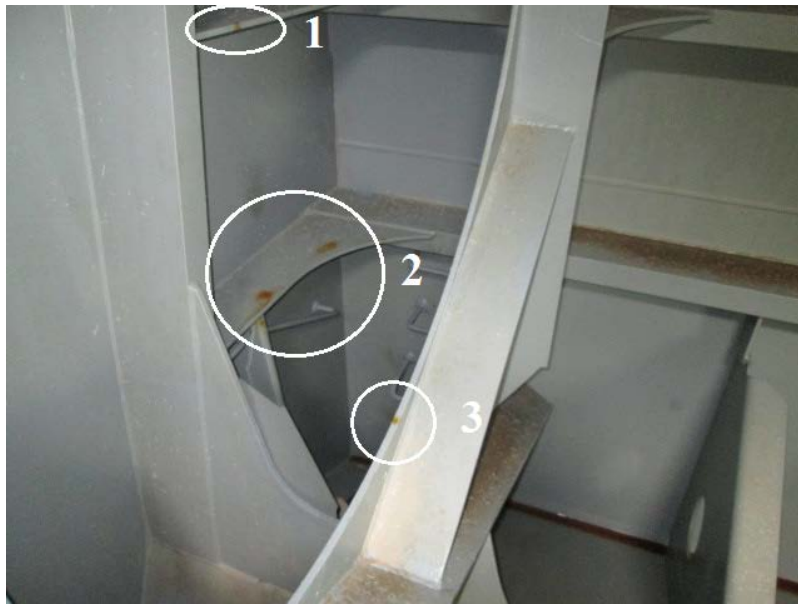
Picture 82 Transverse bulkhead (Clipper Posh 2014)

1. Edge corrosion
2. Localized corrosion – grooving or pitting corrosion
3. Edge corrosion

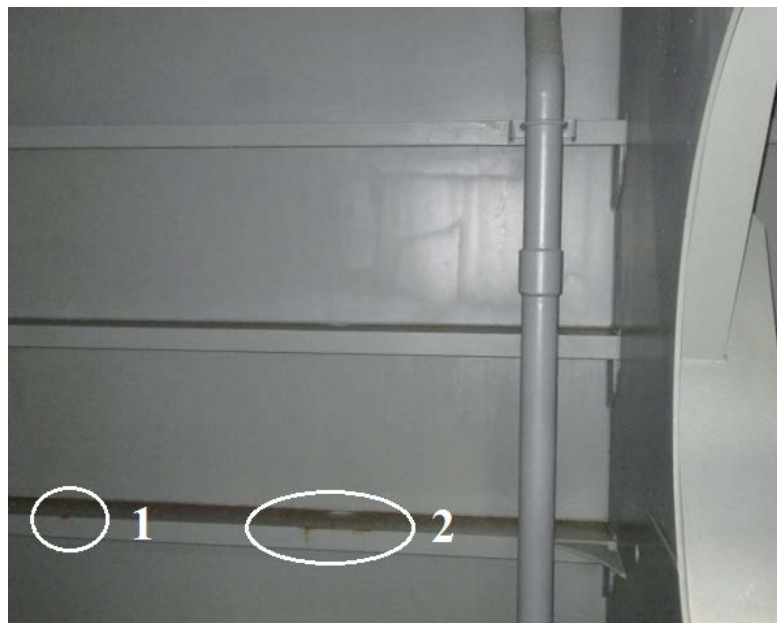
Picture 83 Side shell (Clipper Posh 2014)

1. Edge corrosion
2. Edge corrosion

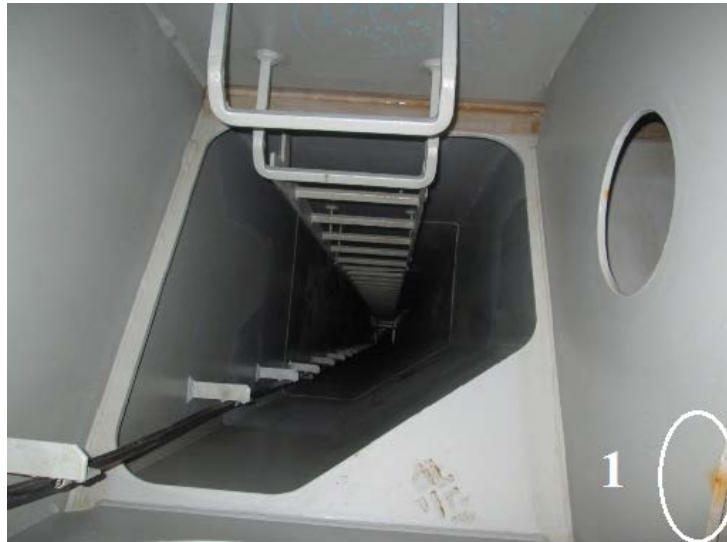
Picture 84 Trunk to double bottom tank (Clipper Posh 2014)

1. Edge corrosion

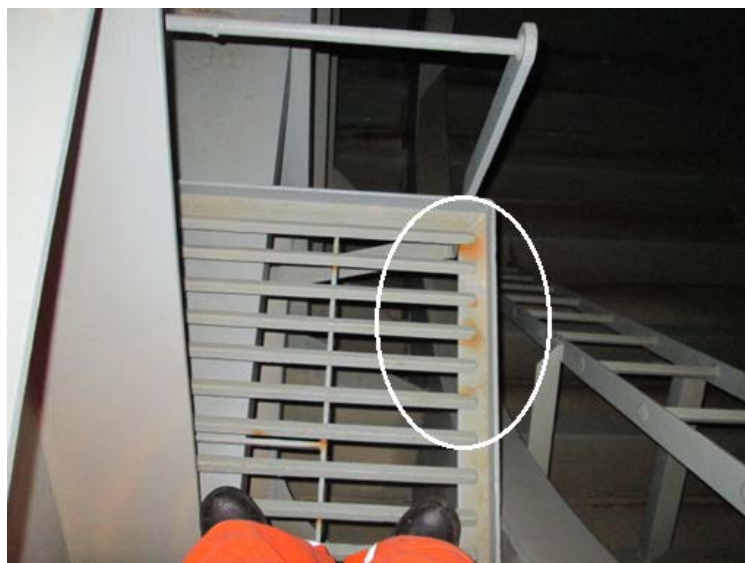
Picture 85 Double bottom tank (Clipper Posh 2014)

Crevice corrosion found on the access platform for ladder to double bottom. See picture 85.

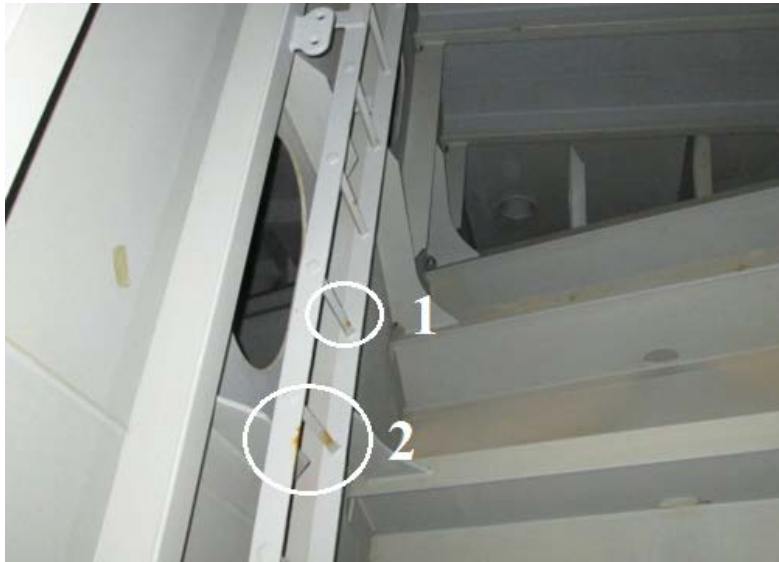
Picture 86 Ladder in fore peak tank (Clipper Posh 2014)

1. Edge corrosion
2. Edge corrosion

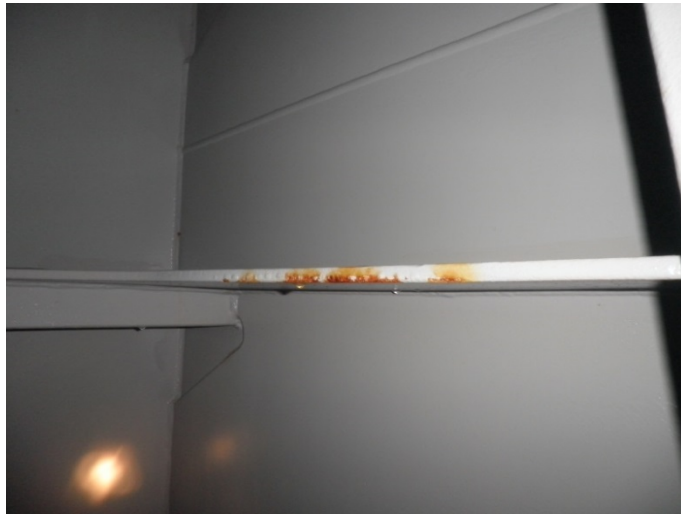
Edge corrosion was found on a sharp edge on the transverse bulkhead. See picture 88. Probably caused by too sharp edge and/or too thin coating.

Picture 88 Edge corrosion on transverse bulkhead (Ask 2014c)

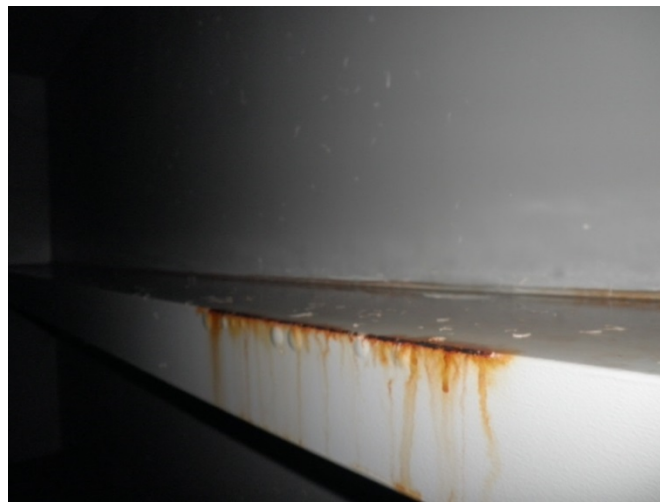
Edge corrosion was found on a sharp edge on a longitudinal on the side shell. See picture 89. Probably caused by too sharp edge and/or too thin coating.

Picture 89 Longitudinal on side shell (Ask 2014c)

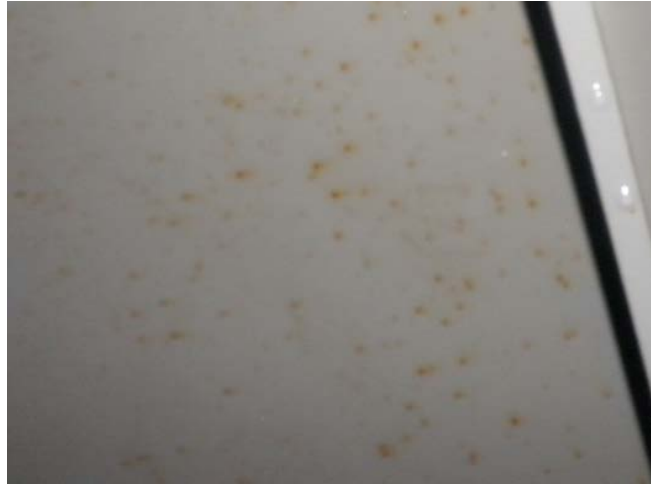
Pitting corrosion or abrasive dust from grinding was found in the deck-head. See picture 90 and 91. Some of the areas with what looks to be pitting corrosion may just be abrasive dust after grinding during new build.

Picture 90 Pitting/abrasive dust in the deckhead (Ask 2014c)

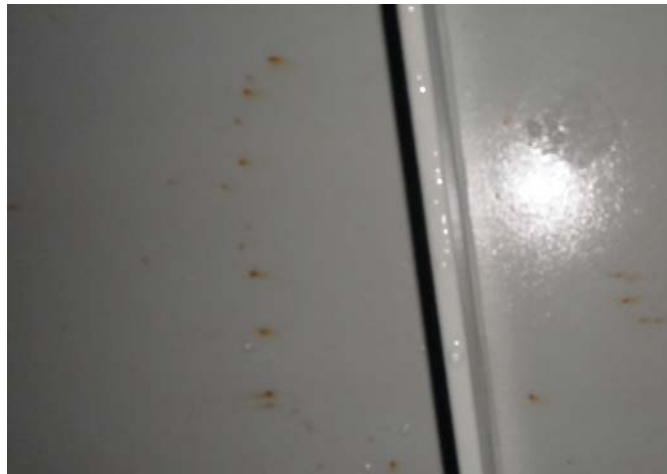
Picture 91 Pitting in the deckhead (Ask 2014c)
