Universitetet
i Stavanger

MASTER'S THESIS

Study program / Specialization: Offshore Technology: Marine & Subsea	Spring semester, 2016 <input type="checkbox"/> Open / Restricted Access
Writer: Jon Henrik S. Johnsen
Faculty supervisor: Jonas Odland External supervisor:	
Thesis title: Loss of Integrity on Mooring Systems – Causes and Consequences	
Credits (ECTS): 30	
Key words: Station Keeping Offshore Mooring System Mooring System Incidents Risks Connected With Mooring Systems	Pages: + enclosure: Stavanger, June 13 th 2016

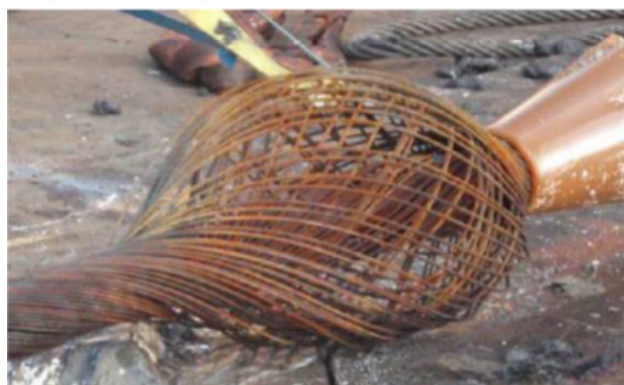
Figure 3-6: Picture showing a steel wire with a phenomenon called bird cage caused by twist in wire in addition to a sudden load change. [16]

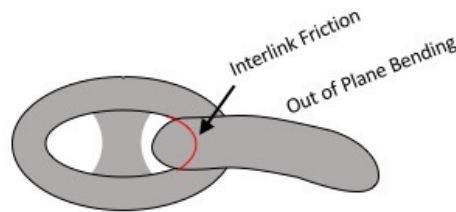
failure occurred still, is because of out of plane bending (OPB). With the locking of the chain links at the exit point of the buoy, interlink friction caused a bending moment in the following link that could freely move. This added bending stress was not accounted for in design, and it lead to larger cyclic stresses in the chain than what was assumed to be caused by the environmental loadings. This increased loading caused a massive reduction in fatigue life of the chain link, and ended up with an early cracking of the metal and thus a reduced stress resistance.

Figure 4-3: Illustration of Out of Plane Bending (OPB).

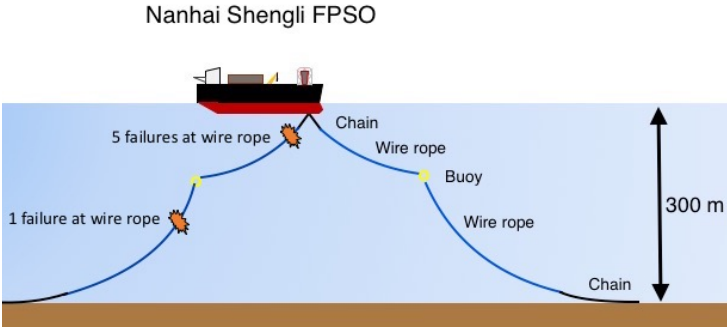
Figure 4-5: Illustration of system failure on Nanhai Shengli FPSO in the Liuhua field.

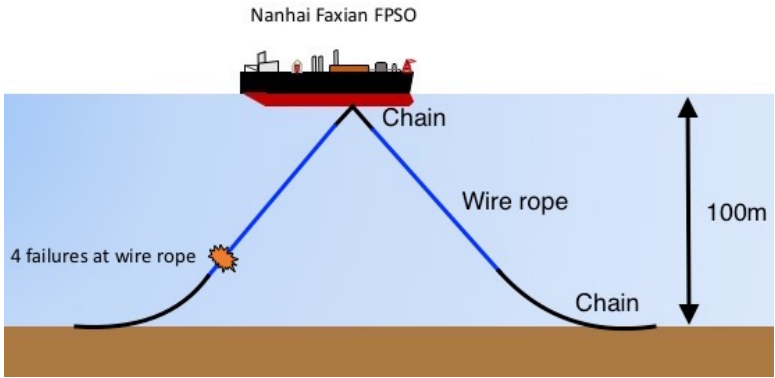
Figure 4-7: Illustration of system failure on Nanhai Faxian FPSO in the Huizhou field.

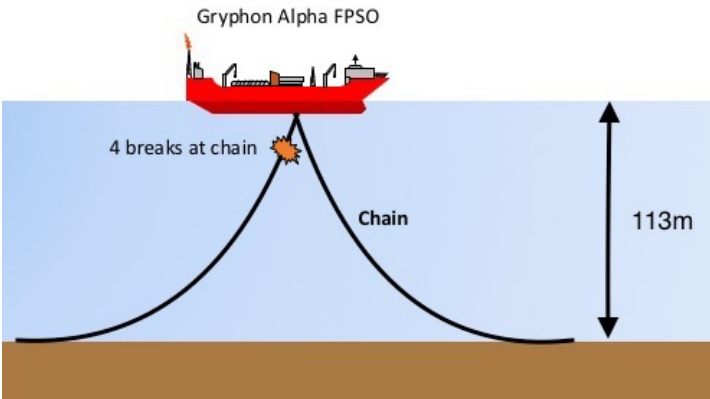
Figure 4-11: Illustration of system failure on Gryphon Alpha in the North Sea.

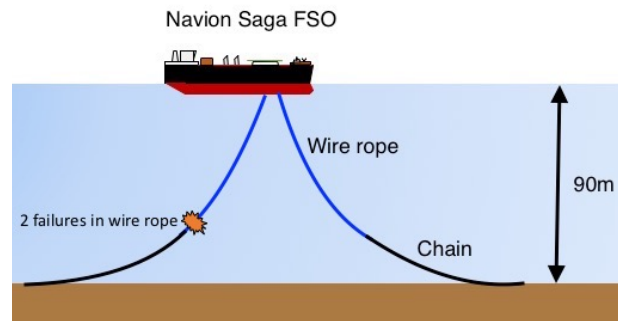
Figure 4-13: Illustration of system failure on Navion Saga in the North Sea at the Volve field.

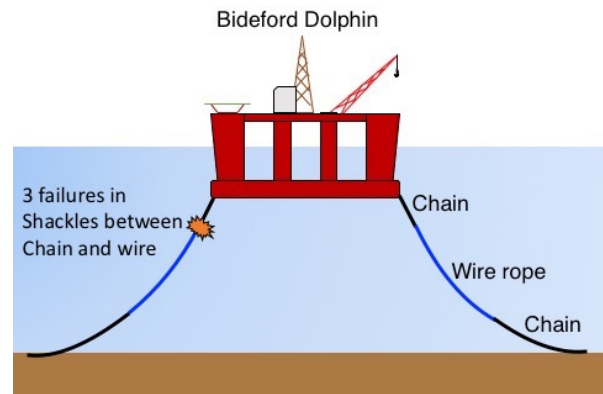
Figure 4-17: Illustration of system failure on Bideford Dolphin in the North Sea close to Snorre.

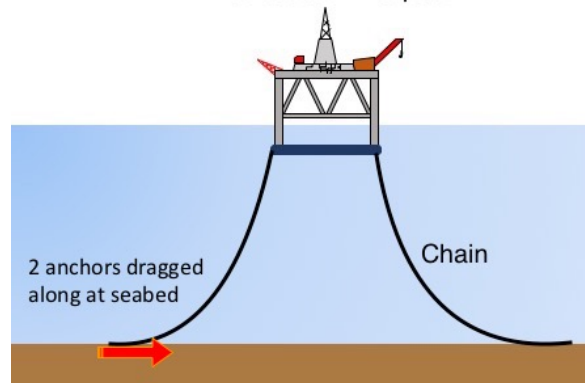
Figure 4-19: Illustration of system failure on Transocean Prospect in the Norwegian Sea at the Heidrun field.

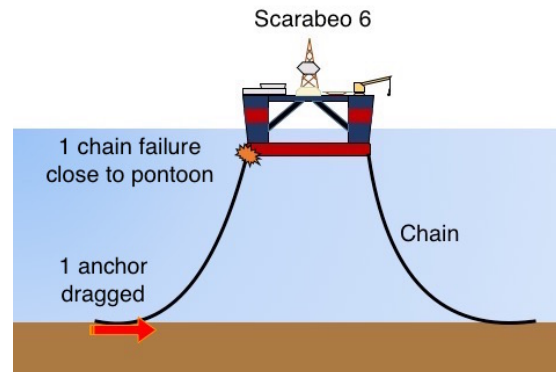
Figure 4-21: Illustration of system failure on Scarabeo 6 in the North Sea at the Grane field.

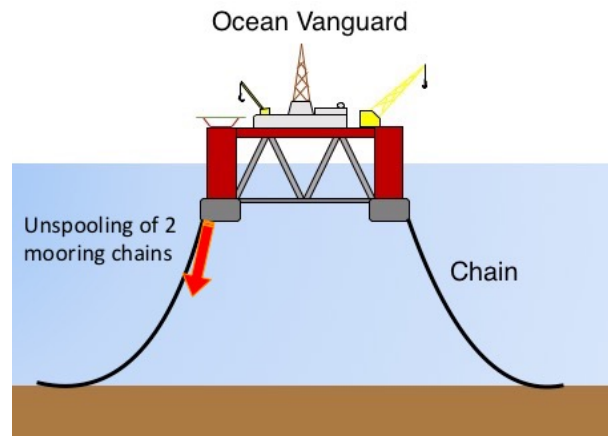
Figure 4-23: Illustration of system failure on Ocean Vanguard in the Norwegian Sea at the Haltenbanken field.

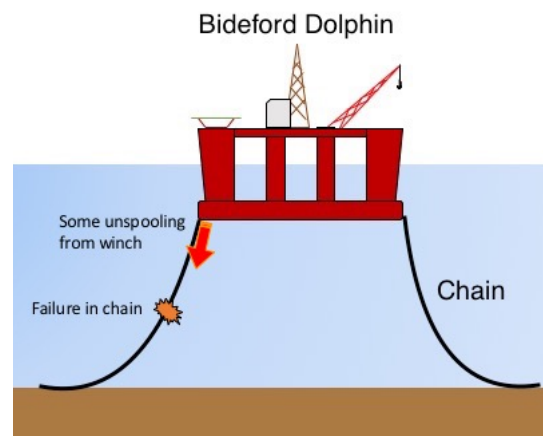
Figure 4-26: Illustration of system failure on Bideford Dolphin in the North Sea at Oseberg Sør.

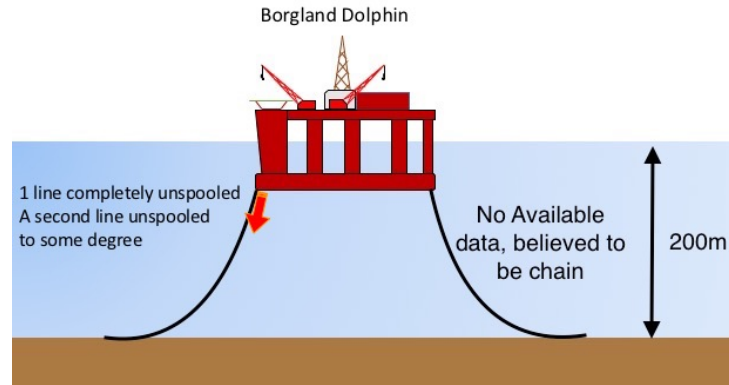
Figure 4-28: Illustration of system failure on Borgland Dolphin in the Norwegian sea at Tordis.

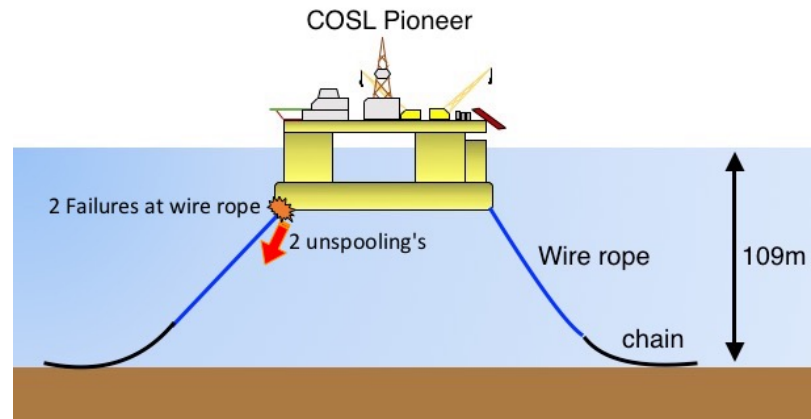
Figure 4-30: Illustration of system failure on COSL Pioneer in the North sea at Oseberg.

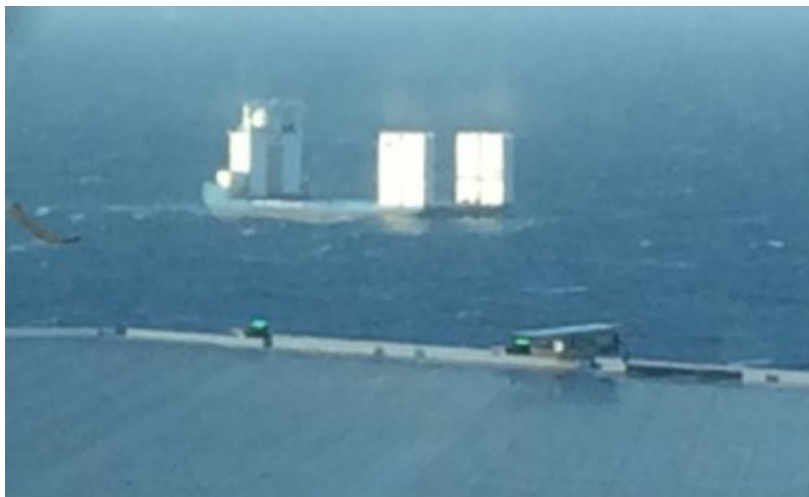
The second incident with an uncontrolled drifting unit has the potential to cause large damage to other structures in close proximity, on either the surface or in the ocean as described above. If this drifting should occur, there are several possible outcomes. If the failed mooring lines failed, or remaining mooring lines fails in the trash zone, or anchors get dragged out of position, heavy chain, wire or anchor would be dragged along the seabed. This event has the potential to cause large damage to the infrastructure placed on the seabed due to possible impacts, and in worst case lead to large spills of hydrocarbons. Another problem with an uncontrolled drifting unit of thousands of tons, is the potential to cause large damage to other structures or vessels in proximity. If it crashes into a platform or ship, the following disaster would be tremendous. Explosions, hydrocarbon spill, considerable damage to both units, are just some of the possible outcomes. This was a possibility just recently in the North Sea, although not by an uncontrolled floating platform. It was motor- and captainless barge that went drifting uncontrolled. The incident occurred in rough weather on new year's eve 2015, where the Eide Barge 33 of approximately a hundred meters (300 ft) had dethatched itself from the tug Eide Wrestler and went uncontrollably adrift into the North Sea. [39] This lead to the evacuation of around 400 persons from two different oil-fields; Ekofisk (ConocoPhillips) and Valhall (BP). [40]

Figure 5-2: The uncontrolled barge Eide Barge 33 passing by the Valhall field. [41]
