University of
Stavanger

BACHELOR'S THESIS

This thesis has looked at and assessed the various challenges with moisture and moisture damage in Norwegian residential buildings.

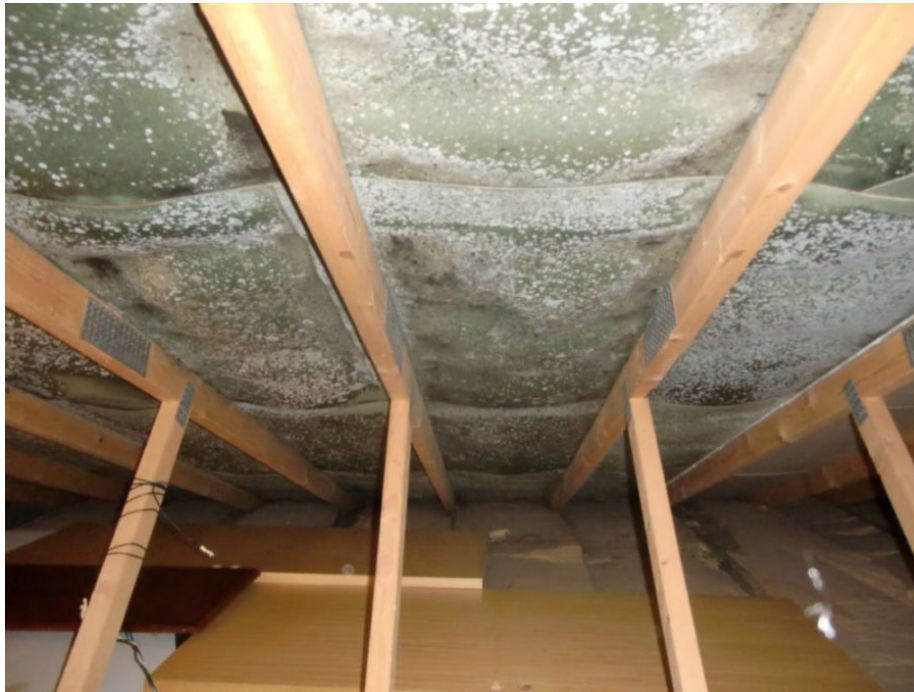
Figure 3: Mold on the inside of roof sarking in cold loft [24].

Figure 3 shows the development of mold, likely caused by a lack of vapor barrier in the joists between the loft and the floor below.

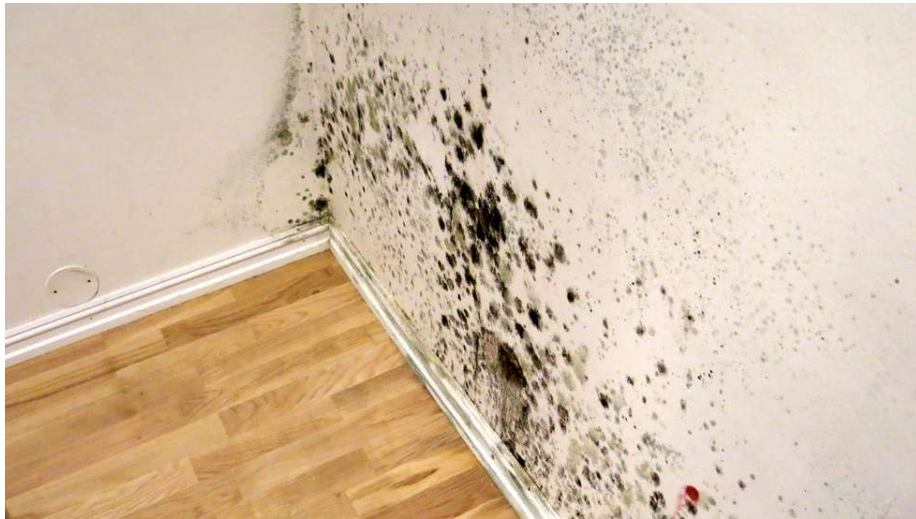
Figure 4: Mold and fungus appearing on interior wall found behind furniture [25].

Figure 4 shows the development of mold on the surface of an interior wall. A likely cause is the surface of the wall being significantly colder than the room temperature, due to lack of or poor insulation. The furniture prevents the surface area of the wall to heat, resulting in a cold surface being exposed to the warm inside air's vapor content.

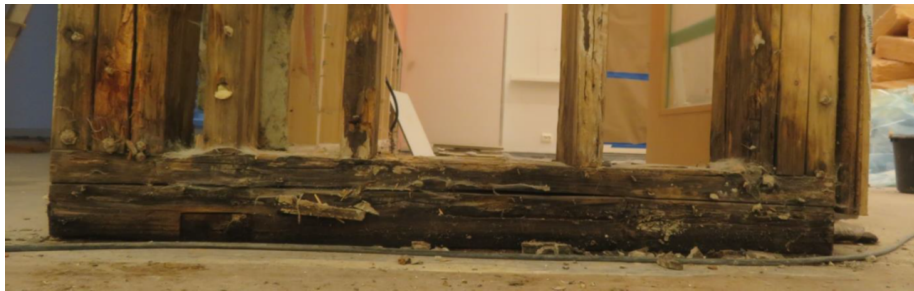
Figure 5: Decaying bottom sill caused by capillary suction [26].

Figure 5 shows how a lack of sill membrane allows the material to absorb moisture from the floor.

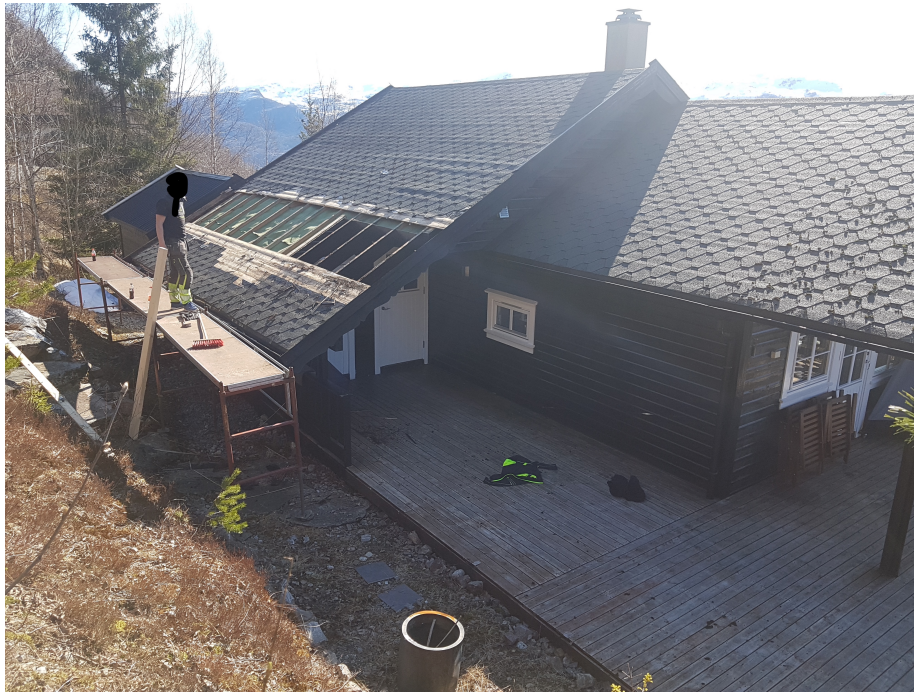
Figure 9: Moisture damage in the roof construction.

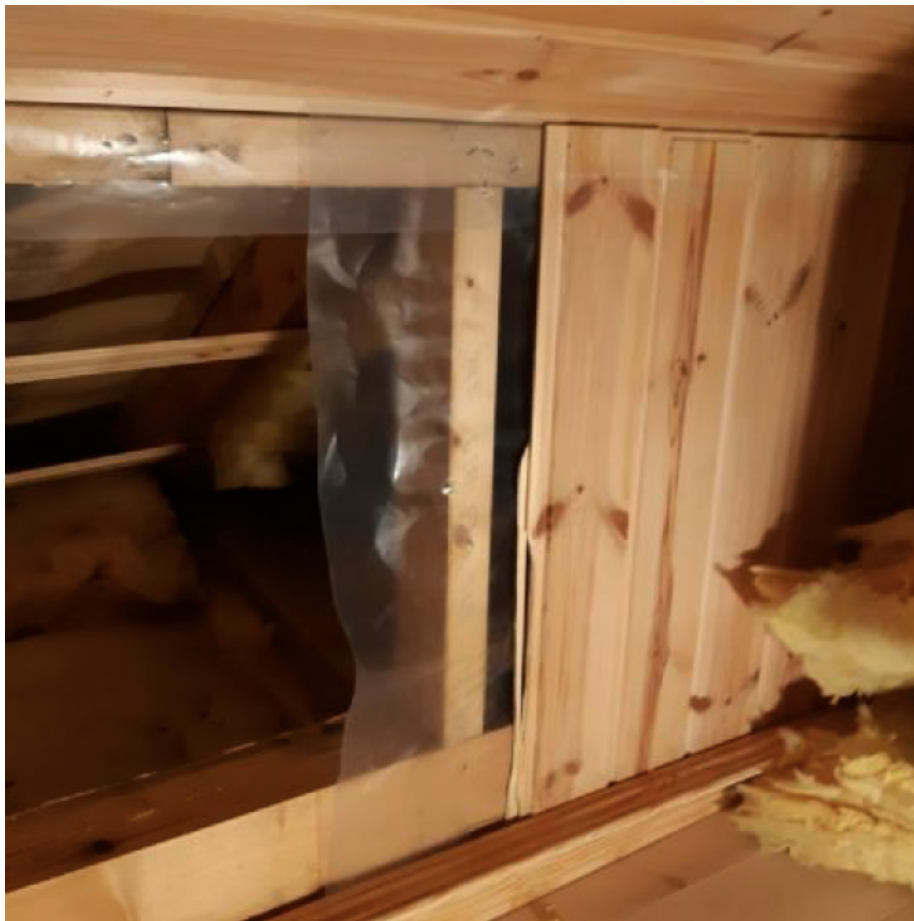
Figure 10: Knee wall located above bathroom and washing room. Visible is the lack of vapor barrier on the ceiling behind the knee wall.

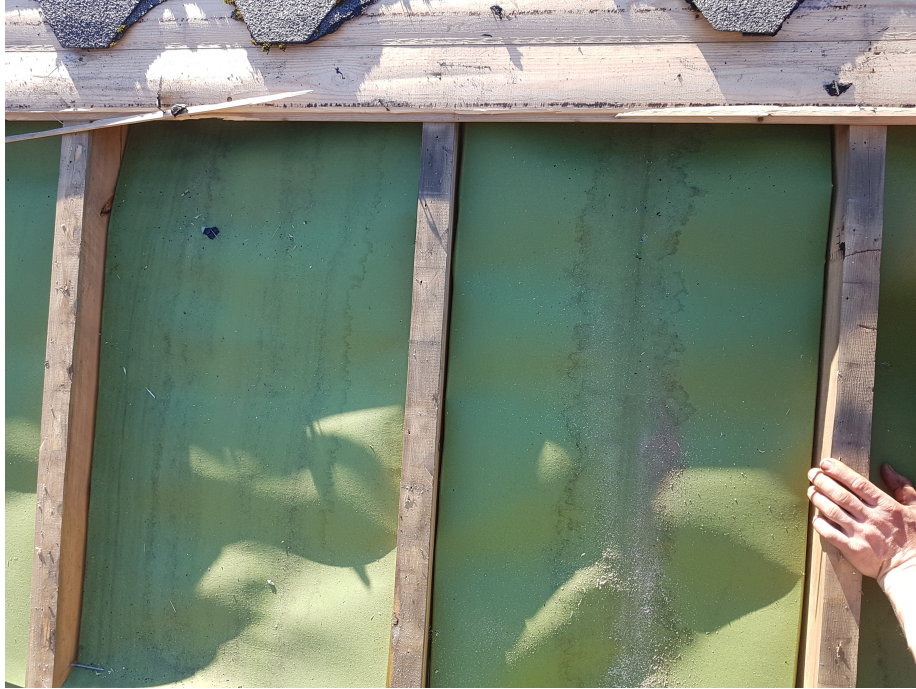
The owner noticed water occasionally dripping from the interior roof of the hall. Opening the knee wall in the area above the hall and removing the roof

insulation within the attic shows significant signs of moisture damages. Large areas of the wood sarking have turned black, with several places showing signs of decomposing (figure 12). There is also a certain amount of fungus visible.

Figure 11: Visible signs of moisture and water on the wind barrier of the roof.

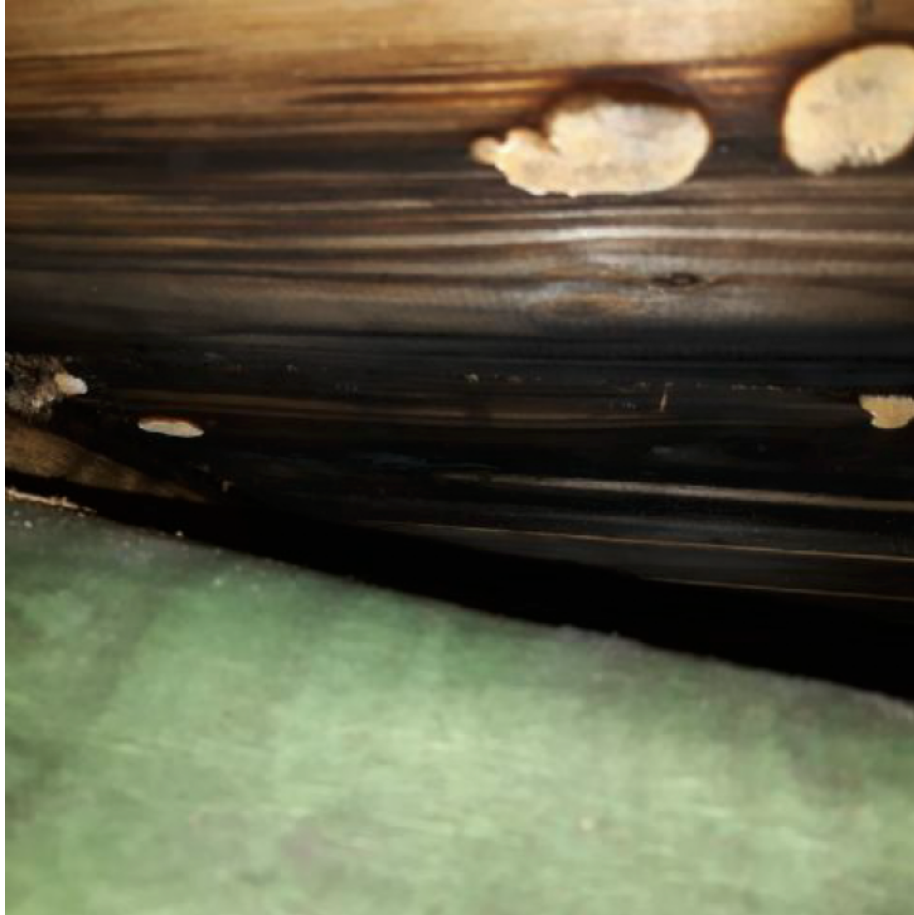
Figure 12: Visible fungus and mold on the inside of the roof sarking, as well as material starting to decay.

Insulation has been installed between the roof beams along the entire length of the beams. The same is done for the floor beams. The roof's vapor barrier, however, has been installed on the spars and down the inside of the uninsulated knee wall (figure 10). There is no vapor barrier within the attic itself, along with no ventilation. This allows the heat from the loft to warm up the attic, and the warm air from the attic to transport through the construction of the roof. This air potentially has a moisture content high enough to cause a RH of above 85 % on the surface of the wooden sarking. In addition, the cardboard wind barriers are squeezed up against the sarking in several places, effectively reducing the air flow within the air space.

Estimated cost include improving damaged areas of the building, and the installation of vapor barrier in the attic where this was missing prior to the damage.

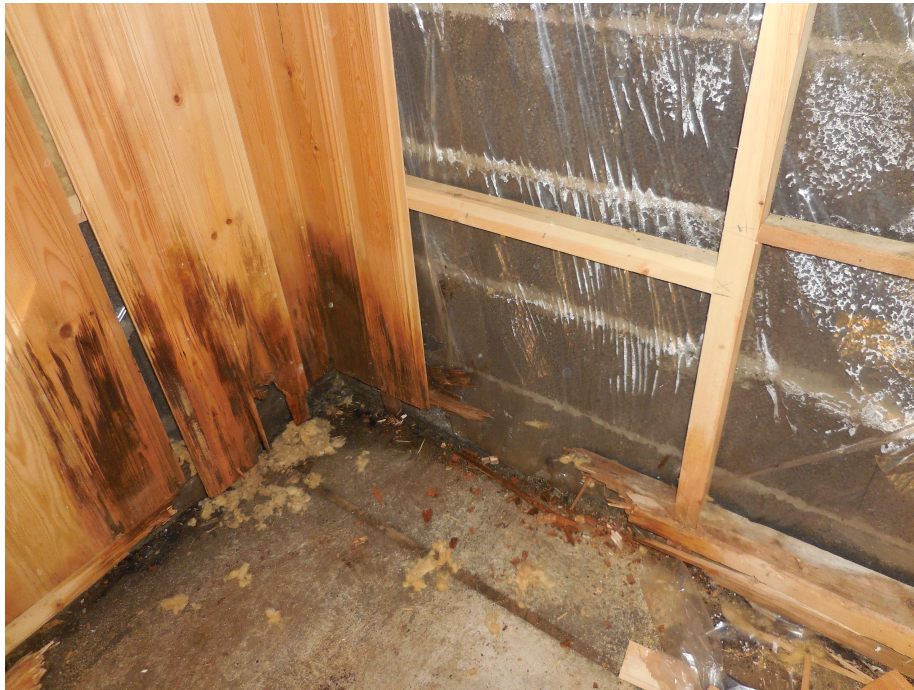
Figure 13: Moisture damage in bedroom.

There are visible moisture damages on the surfaces of the room (figure 13). Due to the room being partly under ground, two of the walls are built in concrete Leca blocks. There is no drainage on the outside of mentioned walls. The remaining walls are wood frames. On the inside of the concrete walls, 48x48 mm sawn timber studs are fixed against the walls, with a thin (likely 0,06 mm) plastic layer in-between. There is 5 cm glass wool insulation within the walls. The interior surfaces of the room consist of wooden panel. The floor of the room consist of laminate flooring on top of a plastic vapor barrier and a concrete floor.

The room has visible moisture damages on the surface of one of the corners of the room (figure 13). The wooden panel has heavy discoloration, and has started to decompose in smaller areas near the floor. Upon opening the wall, several signs of moisture related problems are visible (figure 14). The sill has started to decompose in the corner where the damage was visible on the surface (figure 13), as well as there being several areas of mold, fungus and discoloration (figure 15). The plastic layer between the studs and the concrete blocks are covered in both moisture and mold over the majority of the wall (figure 15).

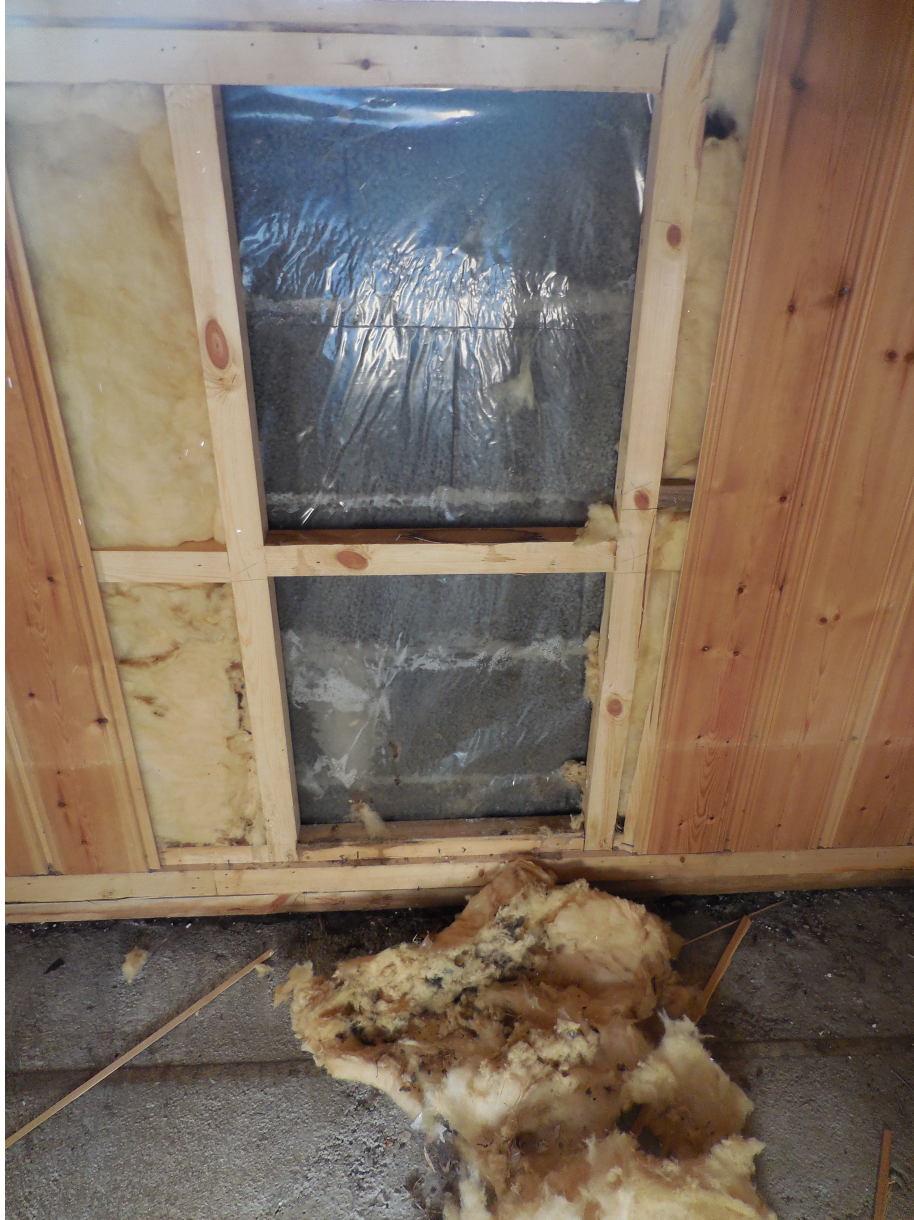
Figure 14: The wall consists of wooden panel, 2×2 studs and sills, 50mm mineral wool insulation, and a vapor barrier installed directly on concrete blocks.

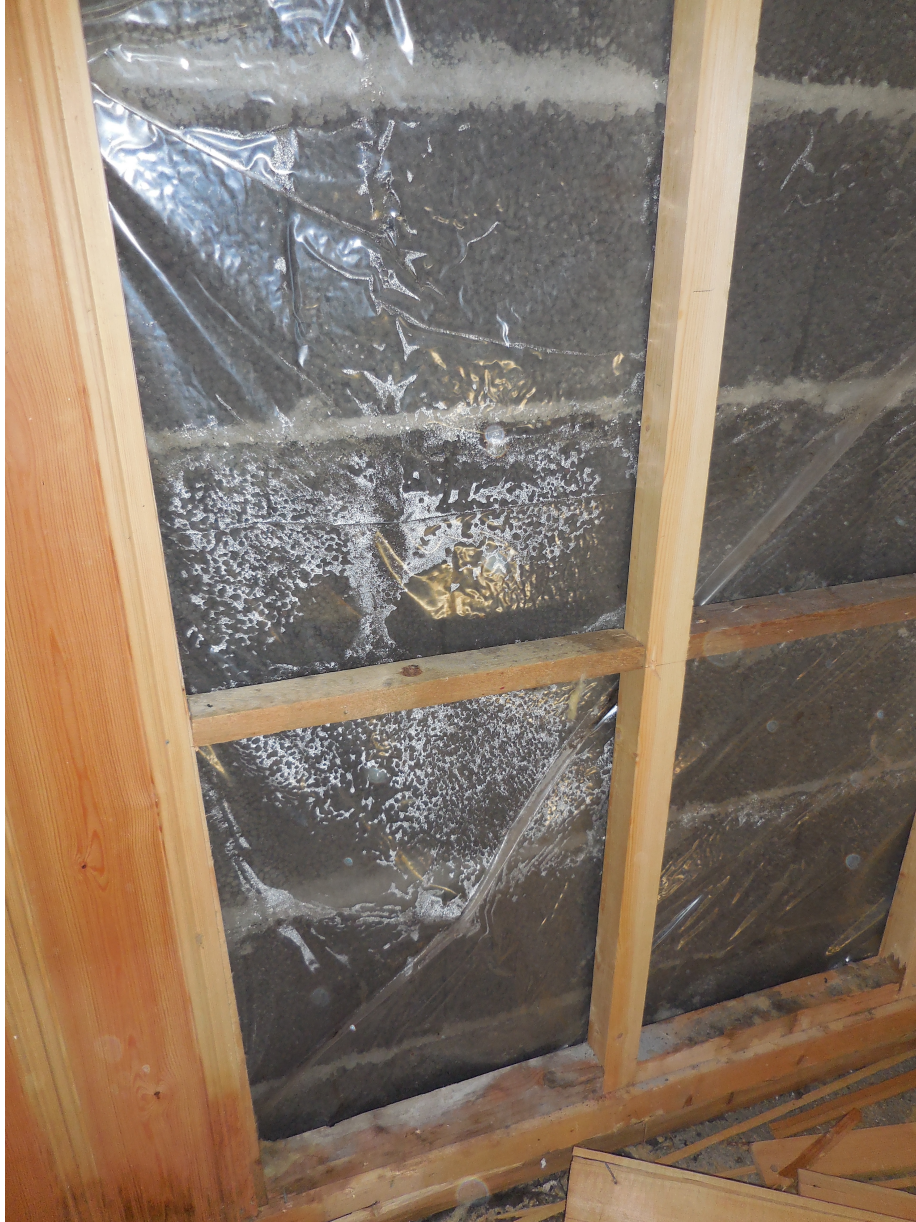
Figure 15: Visible condensation on the vapor barrier when removing the insulation.

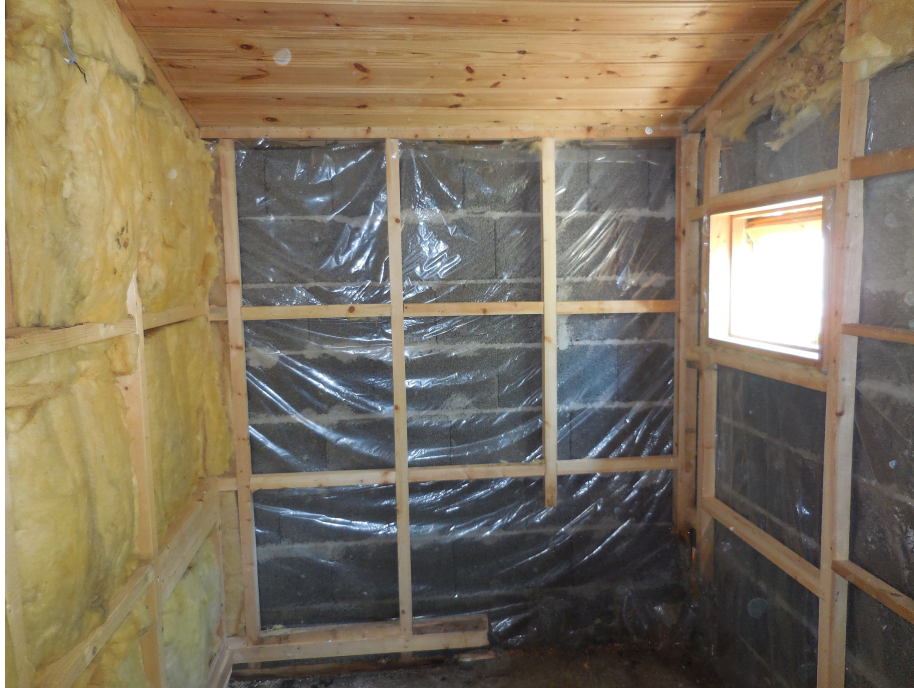
Figure 16: Overview of the room after opening the construction and removing moisture damaged parts of the walls.

In order to stop moisture from reaching the room, it is important to install a drainage system on the outside of the concrete walls [58]. In addition, the outside of the concrete wall should be insulated to reduce the thermal bridge-effect [58], increasing the temperature of the inside of the concrete blocks enough to stop condensation.

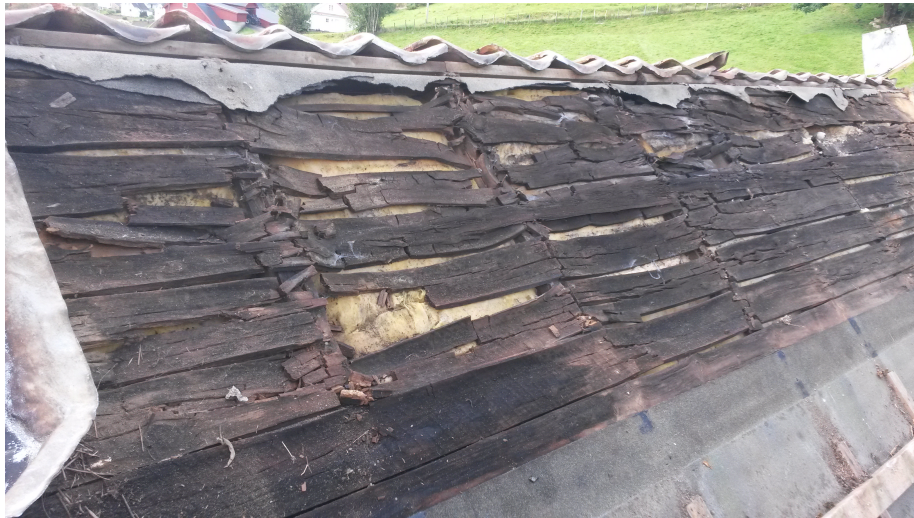
Figure 17: Moisture damage due to condensation in post-insulated roof.

The roof consist of concrete roof tiles over roof battens, and roofing felt installed on top of timber boards. The roof was post-insulated from the inside with 150 mm insulation approximately 2005. Here, the insulation was installed directly towards the timber boards, with no air gap between the two. Further, there was no vapor barrier installed on the inside of the roof during post-insulation.

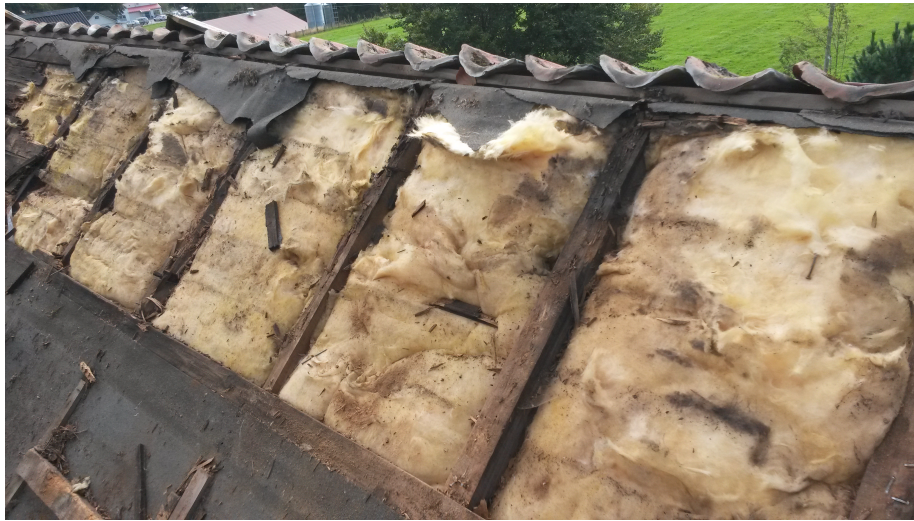
Figure 18: Signs of decaying material on the upper part of the roof beams.

During the laying of new roof tiles, signs of moisture damages became visible. The roof battens and the roofing felt near the ridge of the roof showed significant signs of decaying. Beneath the roofing felt, the timber boards in this part of the roof are rotten. There is no ventilation installed in the loft, mechanical or otherwise.

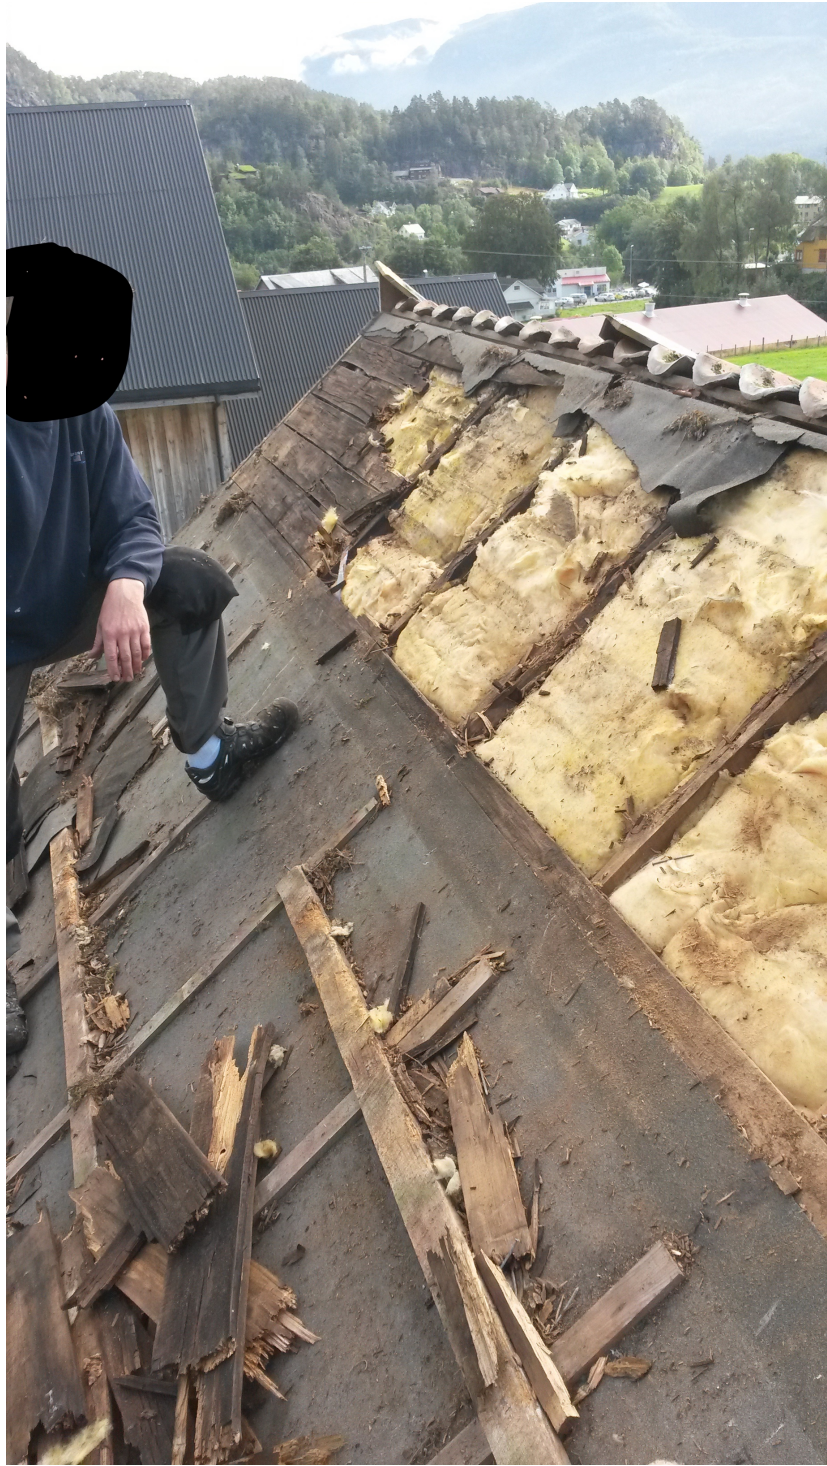
Figure 19: Significant decay along the entire length of the roof.

When the inside air reaches the outer parts of the roof, the water vapor starts to condense on the colder surfaces [22] where the air's saturation point is reached, in this case the timber boards and the outer parts of the beams. Since there is no air gap between the insulation and the timber boards, moist air is not being transported away from the construction [29]. This is further amplified by a roofing felt that is not very vapor open being installed directly on top of the timber boards [36].

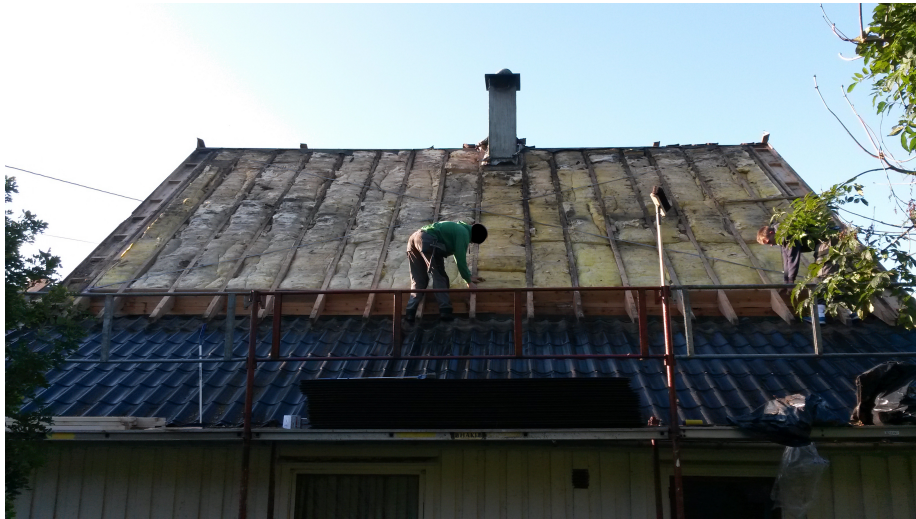
Figure 20: Overview of roof after opening the construction.

It is necessary to make sure that all parts of the construction that is rotten, decayed or showing significant signs of decay, are removed, along with the insulation found in the damaged area [43]. The beams could potentially be dried naturally until satisfying moisture content of $\leq 20\%$ is reached [43], if this is cost effective [43] and practically achievable. Considering the scope of the visible damages due to moisture, the entire outer part of the roof should be removed.
