Experimental assessment of cracked tubular joints repaired with crack-deflecting holes and weld-toe grinding

S Riise, M Atteya, O Mikkelsen and G Ersdal *

Faculty of Science and Technology, University of Stavanger, Norway

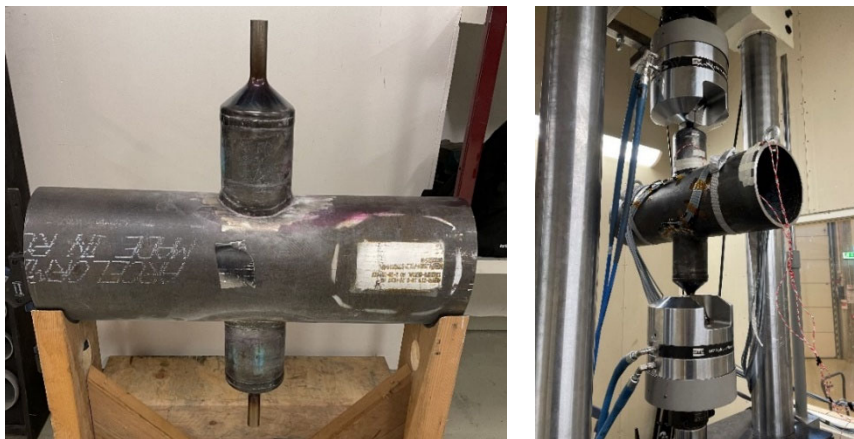
Figure 3. Specimen as-fabricated and installed in fatigue rig, respectively

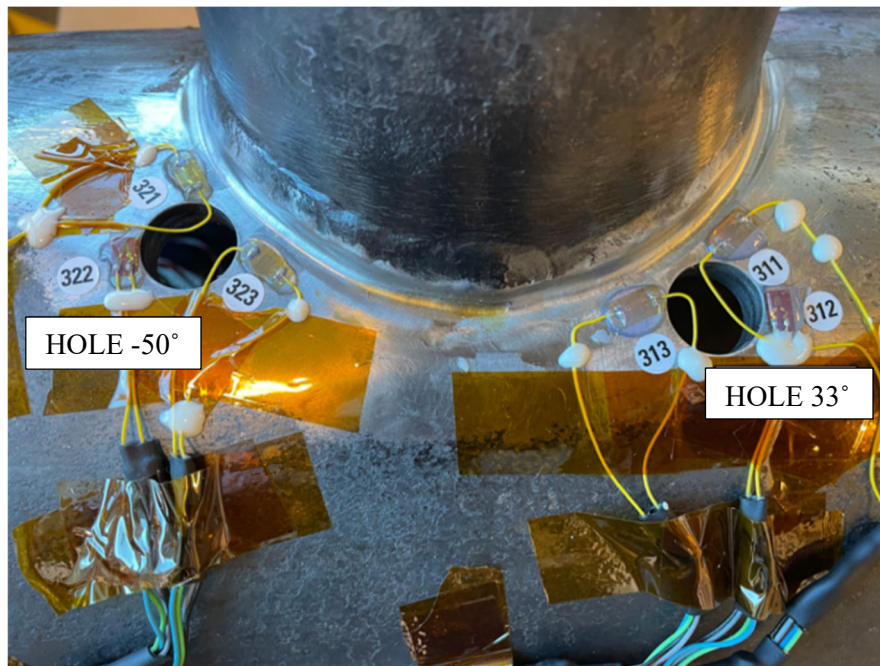
Figure 8. Strain gauge layout in repaired quadrant

3.3.2. Hole drilling and weld toe grinding. The specimen was repaired by drilling 18mm holes in the crack tip proximity. Positioning of the holes was made in alignment with Atteya [8], by centring the holes 12° ahead of the crack tip and shifting them 15mm perpendicular from the weld toe. As the crack spanned from -38° to $+21^\circ$, the holes were placed centred at -50° and $+33^\circ$. The objective of the crack-deflecting holes was to deflect the crack away from the weld toe, which holds significant stresses and arrests the crack in the holes.

In addition to the crack deflecting hole repair, weld toe grinding was performed in Q3 behind the holes. The repair was performed with a rotating "balled-nosed tree" carbide burr with a maximum diameter of 8mm and was used to grind the weld toe in compliance with BS 7608 [11]. The weld toe was further enhanced by sanding the weld toe in a direction perpendicular to the weld toe with a 240-grit paper, which produced a surface roughness of $58.5\mu\text{m}$ [12]. Post repair, the emerged weld toe profile exhibited an average depth and radius of 0.5mm and 3.4mm, respectively, which aligns with the DNV C203 and BS 7608 specifications.

3.3.3. Instrumentation in the repaired quadrant. After the repair, a set of three new strain gauges was installed around each crack deflecting hole in the repaired quadrant to monitor existing and new crack development. The strain gauge layout in Q3 is shown in Figure 8.

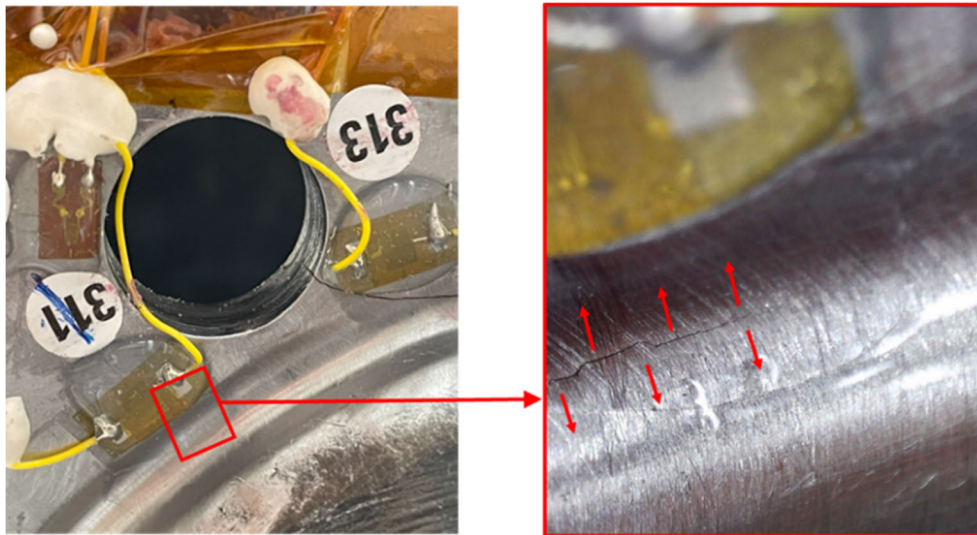
3.7.2. Results from breaking the specimen. Previous testing of equal specimens has shown reverse coalescence, a phenomenon where the crack initiates in the weld toe beyond the crack-deflecting hole (crown side) and propagates back into the hole [8]. This behaviour does not align with the expected behaviour before the work of Atteya [8], where the crack initiates at the hole.

As per Atteya's discovery, the reverse coalescence phenomenon was present at both the crack-deflecting holes in the specimen tested in this experimental investigation, as shown in Figure 9.

Figure 9. Crack initiation in front of SG crown-side at +33° hole

The testing was terminated after 260 000 cycles. At this point, the crack had propagated back into both holes and extended over a total length exceeding 1.5 multiplied by brace diameter marking N4. The fatigue life stages are summarized in Table 3.
