# Effect of Pre-exposure of Sulfur and Iron Sulfide on H<sub>2</sub>S Corrosion at Different Temperatures

Master Thesis  
of  
Brailovskiy Valery

June 2011

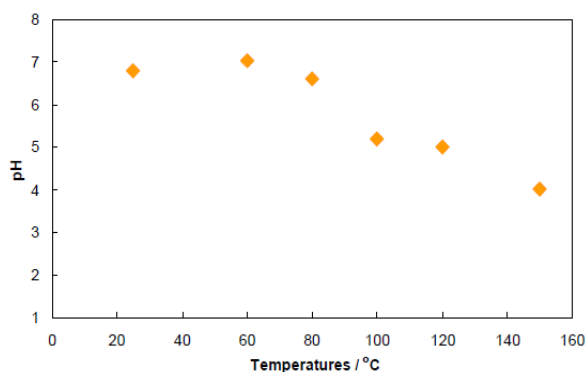
The presence of elemental sulfur could also cause significant acidification of water upon exposure at temperatures in excess of  $80^\circ\text{C}$ . Figure 1 shows the pH at equilibration after mixing with sulfur at various temperatures.

**Figure 1.** pH at equilibration after mixing water with sulfur at various temperatures [23].

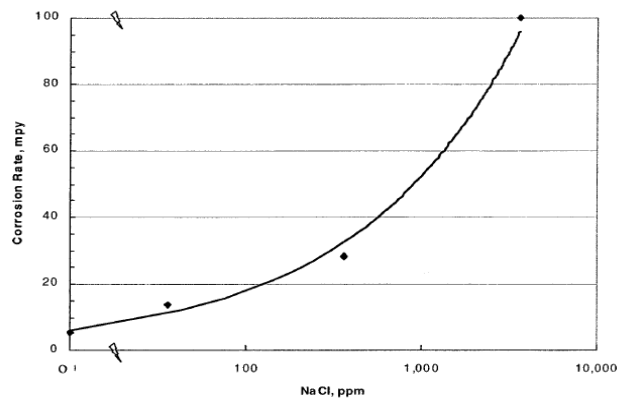
The effect of chloride concentration on the corrosion rate of carbon steel in solutions saturated with H<sub>2</sub>S (at room temperature) is shown in Figure 2. An increase in the chloride concentration, in the range 0 to 3.6% NaCl, increased the corrosion rate exponentially, suggested that the chloride ions inhibit the formation of the sulfide films as well as increase the conductivity of the solution, and, thereby, accelerate corrosion [28].

**Figure 2.** Effect of NaCl concentration on the corrosion rate of carbon steel in a H<sub>2</sub>O-H<sub>2</sub>S-NaCl system (after Foroulis) [28].

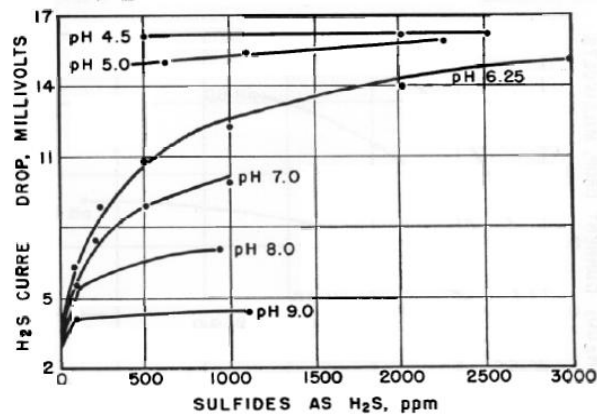
Figure 3 represent effect of pH and H<sub>2</sub>S concentration on corrosion rate.

**Figure 3.** Effect of pH and concentration of H<sub>2</sub>S on corrosion rate [29].

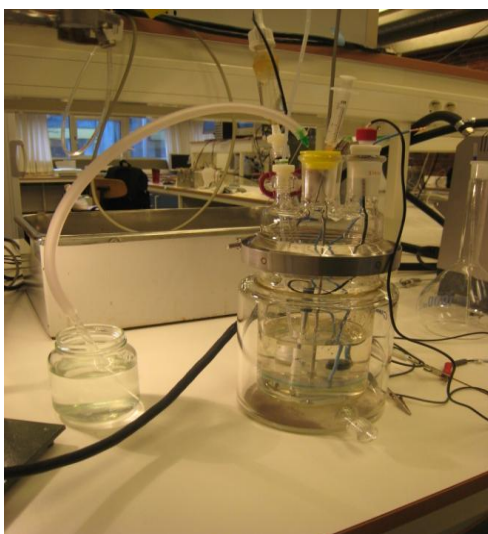
**Figure 4.** The galvanic cell.

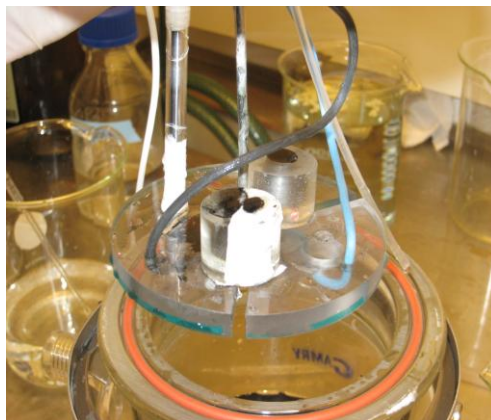
In order to follow the procedure the special support for two working and counter electrode was made which allowed to hold electrodes above the electrolyte surface and submersed it into the solution. This devise could keep electrodes above the electrolyte while the pH was adjusted and nitrogen was purging and be submersed easily into solution after certain time (Figure 5).

**Figure 5.** Support for two working and counter electrodes

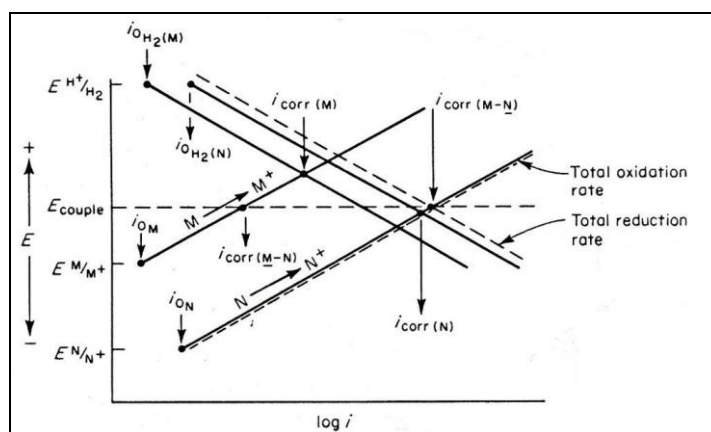
- More active metal corrodes faster when coupled, nobler metal corrodes slower;
- More active metal becomes anode, nobler becomes cathode

**Figure 6.** Galvanic couple between two corroding metals

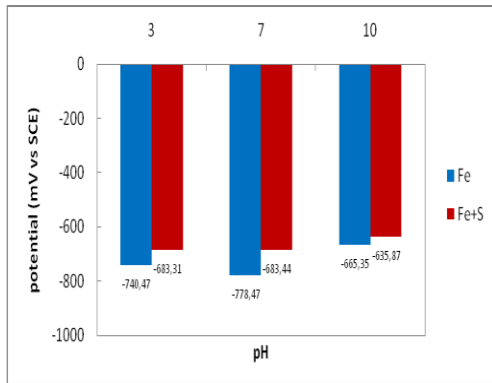
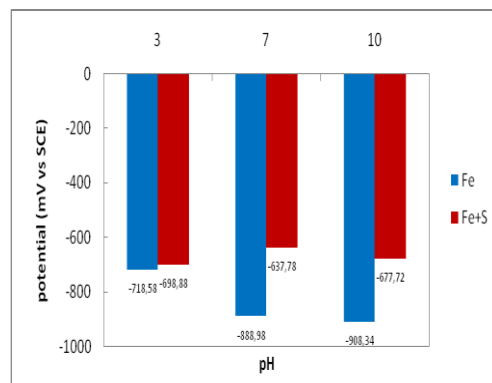
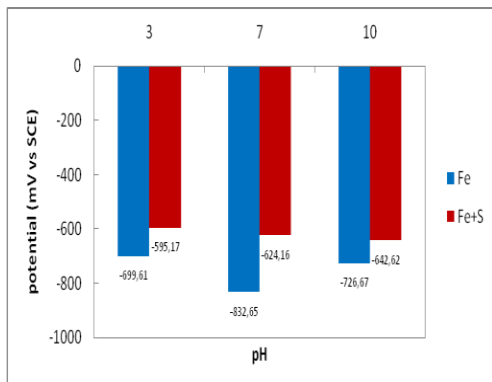
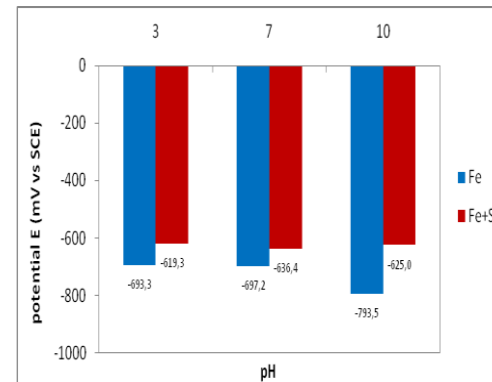
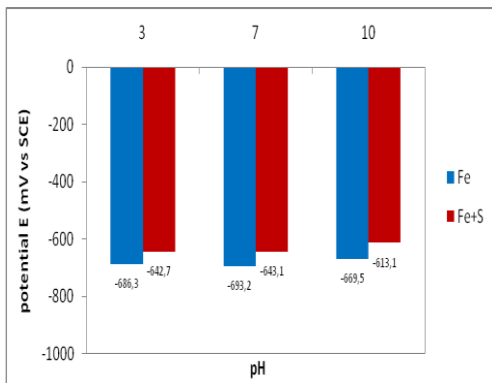
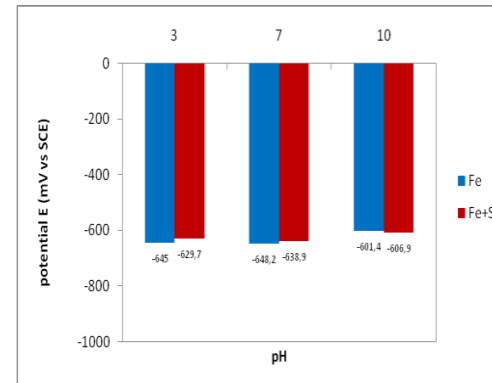
Figure 7 shows that this trend occurred in all tests in Series 1 after 15 minutes. After polarization of covered electrode and 24 hours Rp/Ec scan of coupled metals, measurements of OCP for both decoupled electrodes were repeated. Opposite behavior of the covered electrode was obtained at the pH10 at 80°C (Figure 7, f). The OCP of bare steel electrode was -606 mV (SCE) and the OCP of sulfur-covered electrode was -601 mV (SCE). This suggested that the electrode was no longer protected by a protective film. It was confirmed after the corrosion galvanic scan and pictures of surface were taken after test (Figure 20 text below). The reason of this could be the high pH and temperature conditions. Figure 8 shows the measurements of decoupled working electrodes In Series 2. At pH7 and 80°C potential was -813 for bare electrode and -822 mV (SCE) for iron sulfides-covered, at pH 10 and 40°C: -741 for bare and -803 mV (SCE) for covered electrode after 15 minutes. The covered electrode had lower potential. Same trend was obtained in measurements after 24 hours.

**Figure 7.** The OCP values of Fe/Fe+S galvanic couple after 15 minutes and 24 hours at different temperatures (Series 1).

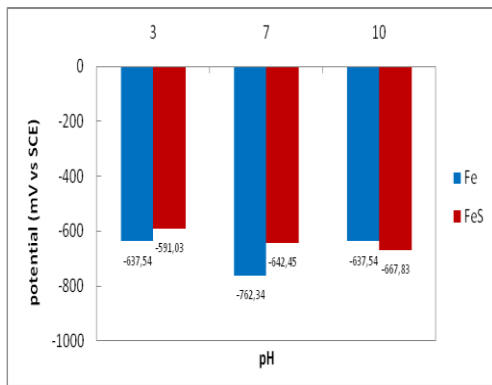
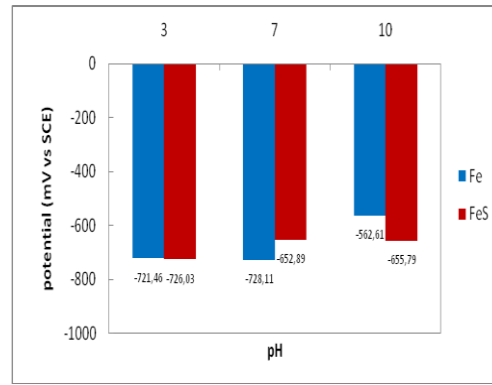
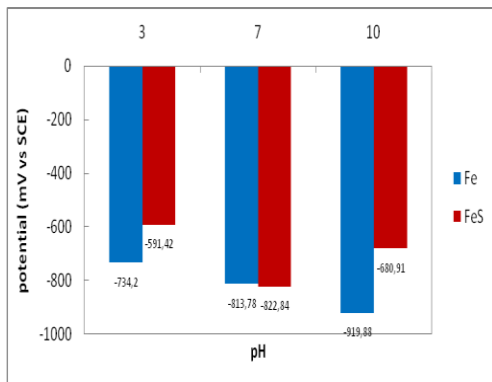
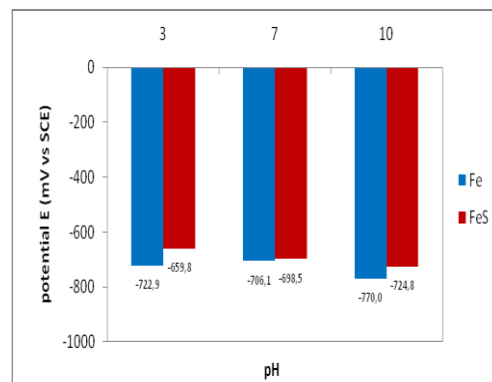
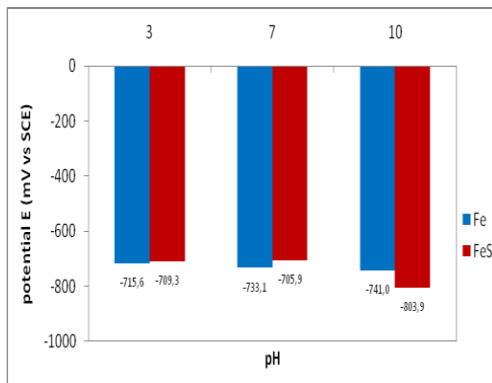
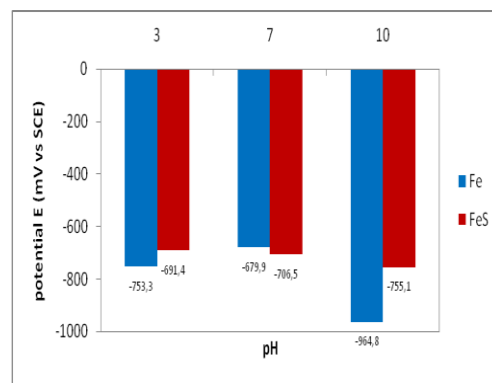
**Figure 8.** The OCP values of Fe/FeS galvanic couple after 15 minutes and 24 hours at different temperatures.

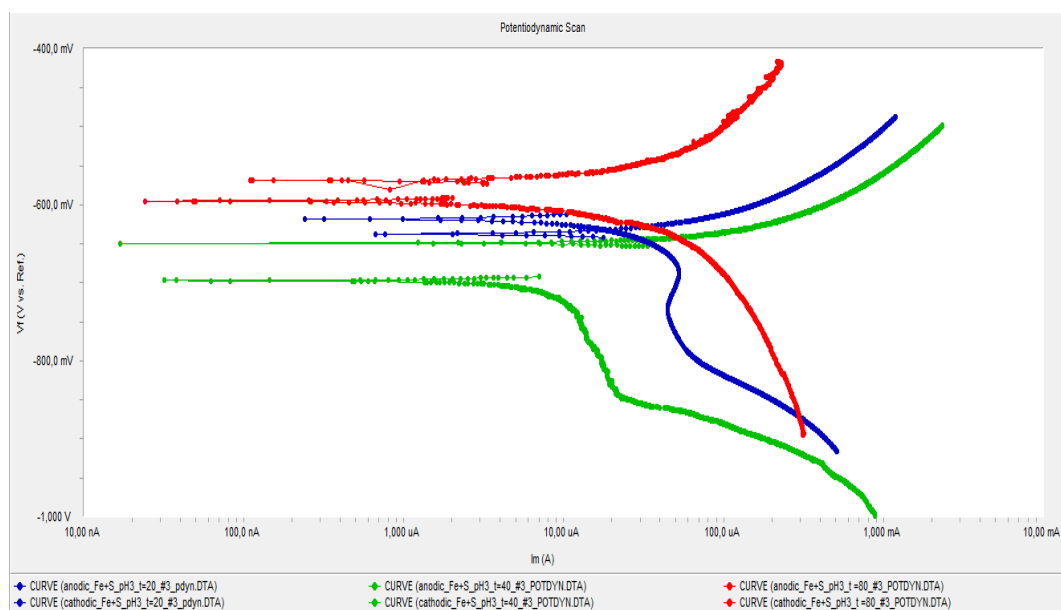
Figure 9 shows that at pH7 at 20°C, the anodic current increased significant in the region with a small shift in potential. Then potential rose slowly to -433 mV with high applied current.

**Figure 9.** Potentiodynamic sweeps for covered with elemental sulfur working electrode at pH3 at 20°C (blue), 40°C (green), 80°C (red) after 15 minutes.

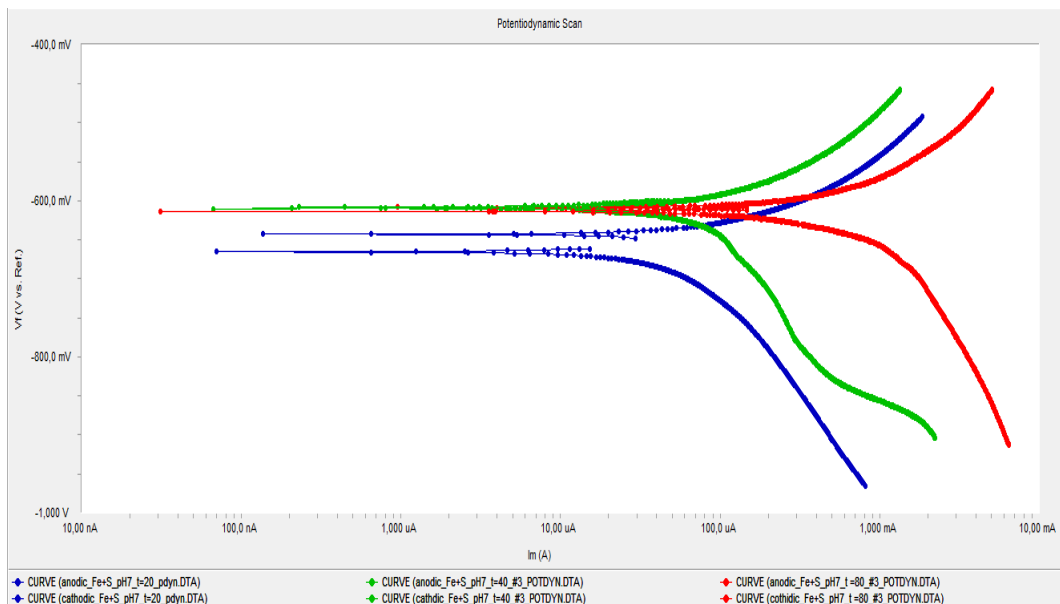
**Figure 10.** Potentiodynamic sweeps for covered with elemental sulfur working electrode at pH7 at 20°C (blue), 40°C (green),80°(red) after 15 minutes.

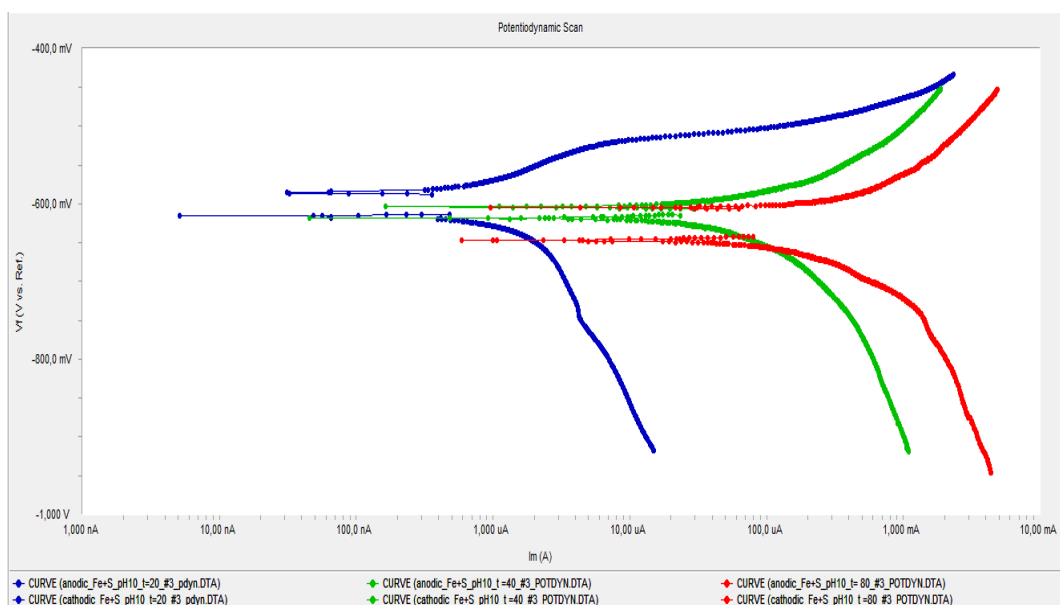
**Figure 11.** Potentiodynamic sweeps for covered with elemental sulfur working electrode at pH10 at 20°C (blue), 40°C (green),80°(red) after 15 minutes.

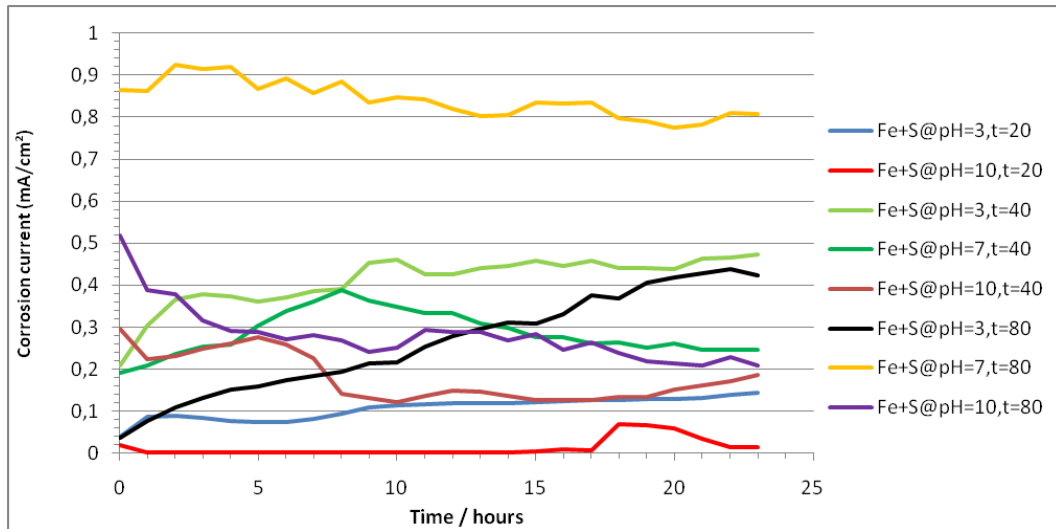
After potentiodynamic polarization tests,  $R_p/E_c$  trend measurements were made to determine the corrosion current density. Figure 12 diagrams the corrosion current density in all tests in Series 1.

**Figure 12.** Changes in corrosion current density in time for decoupled sulfur-covered electrode.

As can be seen from the Figure 12, the higher current density was at pH7 at 80°C. This is surprising high value compared to the other tests results. It was expected to see the higher values of current density at pH3. One possible reason for large divergence in the results could be the specimens were prone to edge attack. Also it could be due to difficulties in adjustment of pH level. In general highest values are observed at pH3 at 40, 80°C. These two lines have tend continuously increase in current density over a period of experiment. In other hand the lines at pH10 at 40, 80°C tended to stabilize and decrease with time. At the pH10 at 20°C current density was almost zero during 17 hours of running and increased not significant after. It means that the covered electrode corroded less because it had the lowest current density. After 24 hours of  $R_p/E_c$  measurements polarization scans were taken. Figures 13-15 show the potentiodynamic curves for covered with elemental sulfur electrode after 24 hours  $R_p/E_c$  trend.

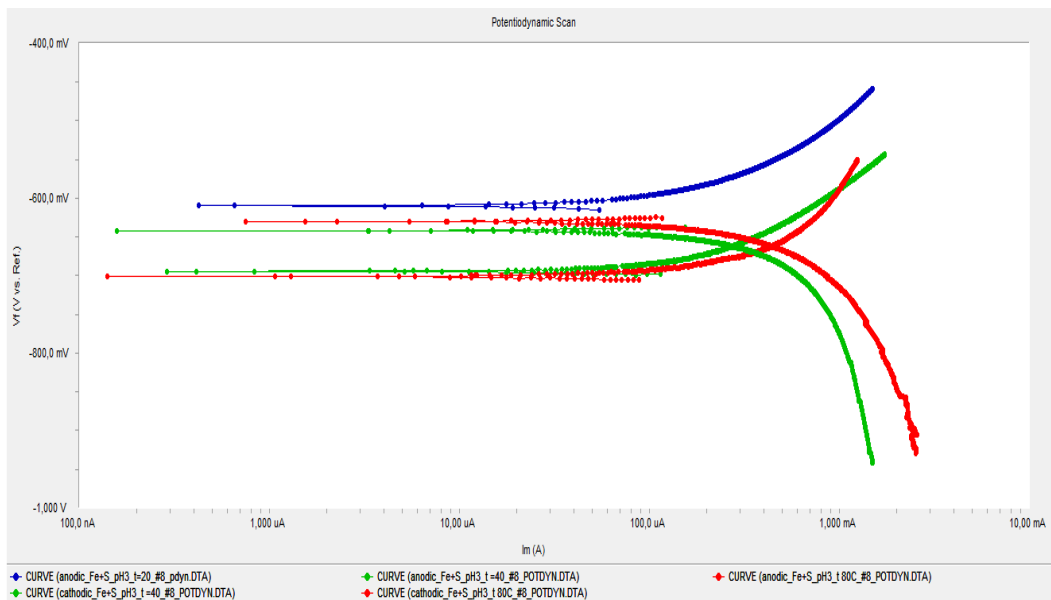
**Figure 13.** Potentiodynamic sweeps for covered with elemental sulfur working electrode at pH3 at 20°C (blue), 40°C (green),80°(red) after 24 hours.

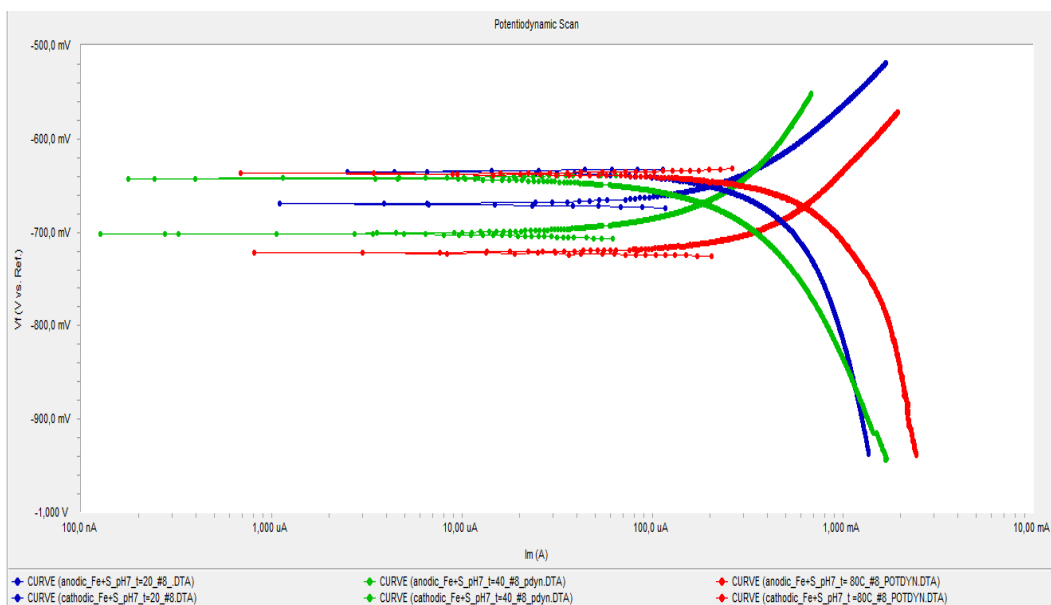
**Figure 14.** Potentiodynamic sweeps for covered with elemental sulfur working electrode at pH7 at 20°C (blue), 40°C (green),80°(red) after 24 hours.

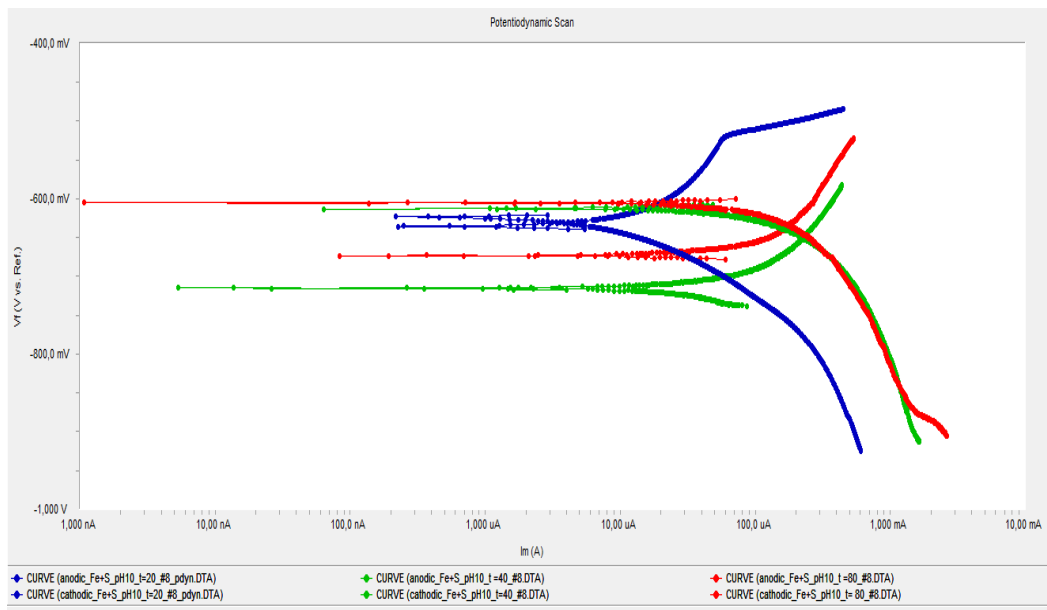
**Figure 15.** Potentiodynamic sweeps for covered with elemental sulfur working electrode at pH10 at 20°C (blue), 40°C (green), 80°C (red) after 24 hours.

In all cases, the steel showed only an active behavior, anodic dissolution, without evidence of any passive layer, except pH10 at 20°C (Figure 15). Under these parameters, potential stopped to increase rapidly with not significant increasing in current at -523 mV (SCE). Then current was increased without big increasing in potential. The cathodic potential decreased comparing to pH7. It may be suggested as inhibition effect due to formation of corrosion products on surface.

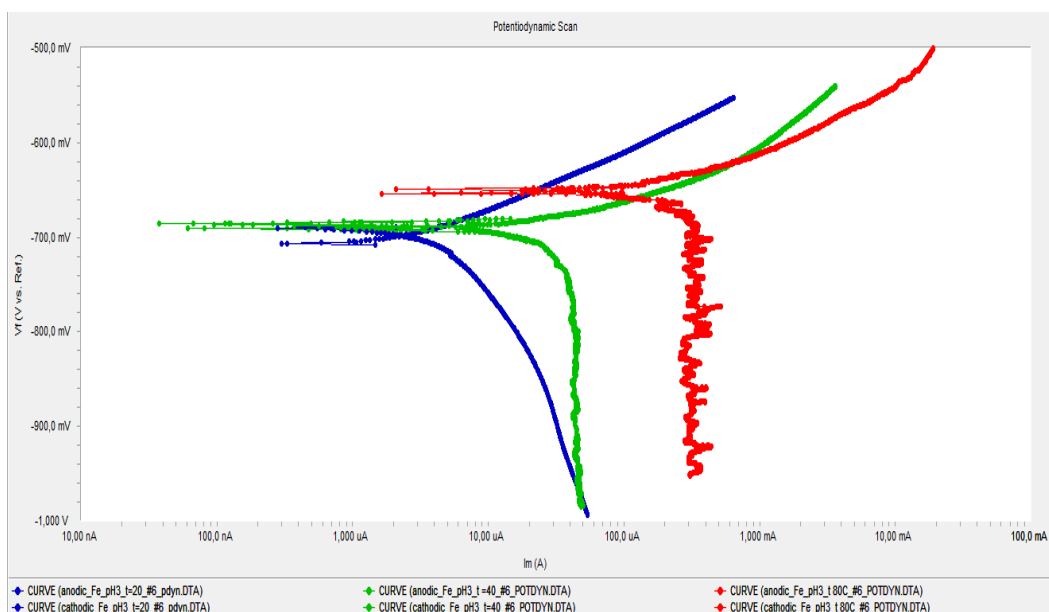
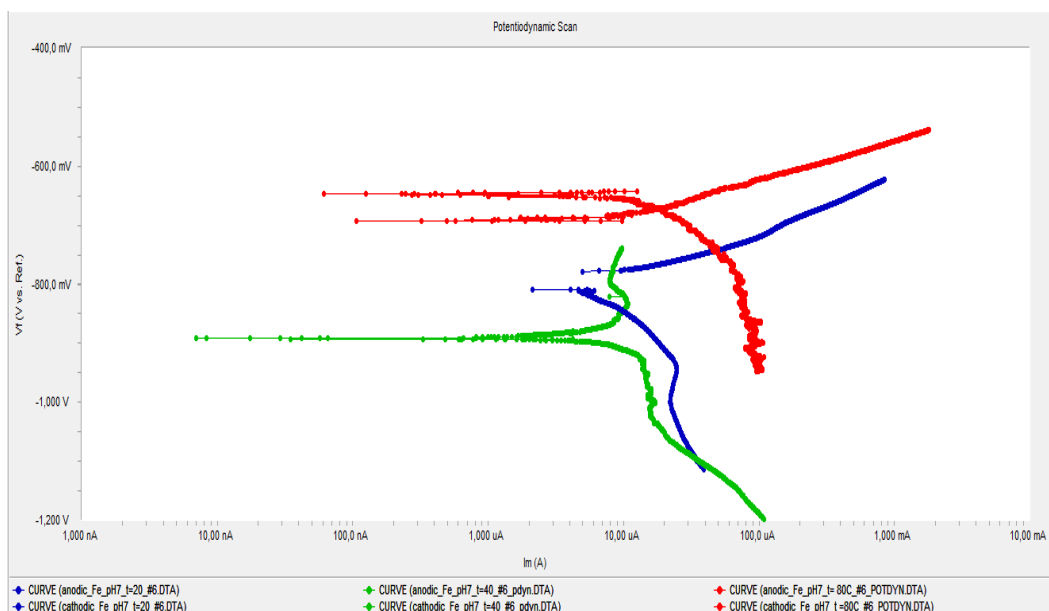
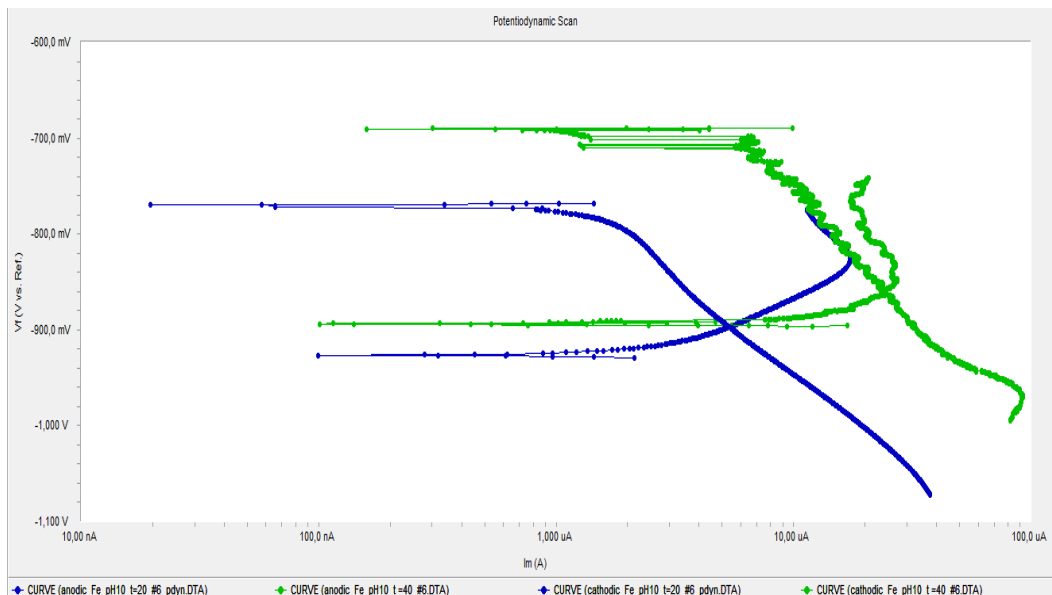
**Figure 16.** Potentiodynamic sweeps for bare working electrode at pH3 at 20°C (blue), 40°C (green), 80° (red) after 24 hours.

**Figure 17.** Potentiodynamic sweeps for bare working electrode at pH7 at 20°C (blue), 40°C (green), 80° (red) after 24 hours.

**Figure 18.** Potentiodynamic sweeps for bare working electrode at pH10 at 20°C (blue), 40°C (green), after 24 hours.

It can be seen from Figures 16-18 that the potentials in these tests were very low and decreased with increasing in pH. The potential also shifted slight with increasing of the temperature in noble direction. In the test under condition of pH10 at 80°C the potentiostat could not record the cathodic and anodic curves for the unknown reason (Figure 18).

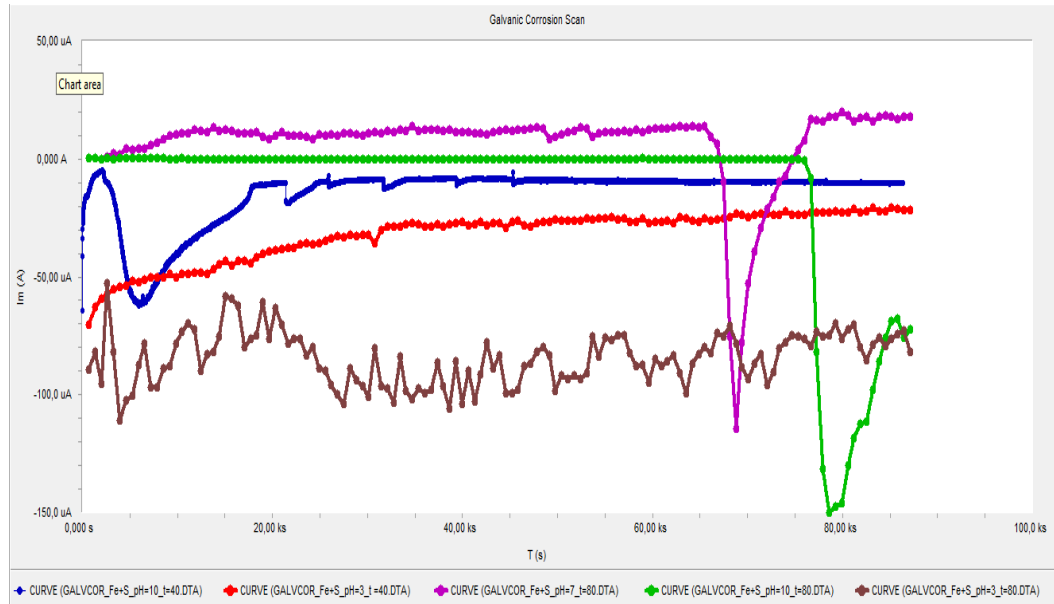
**Figure 19.** Galvanic corrosion: pH10 at 40°C (blue); pH3 at 40°C (red); pH7 at 80°C (purple); pH10 at 80°C (green); pH3 at 80°C (brown).

Table 7 shows the data from galvanic scan in Series 1. Only under conditions of pH7 at 80°C current showed positive value. Lack of the values in rest experiments not allowed tracing the trend under conditions of 20°C. The reason of failure could be investigated in future work.

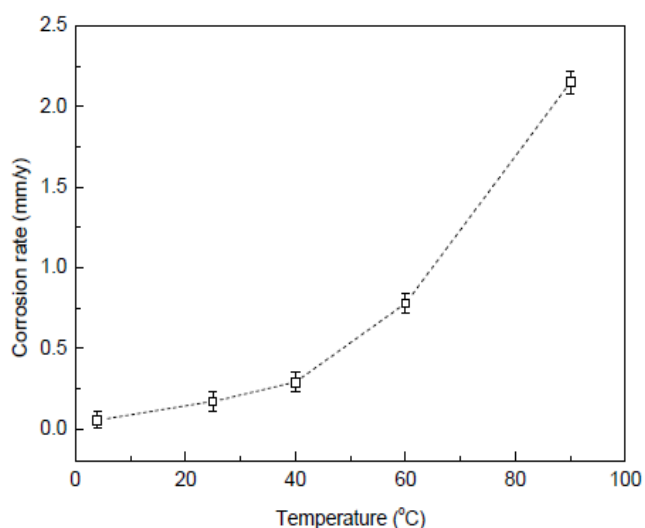
**Figure 20.** Effect of temperature on corrosion rate of the steel [40].

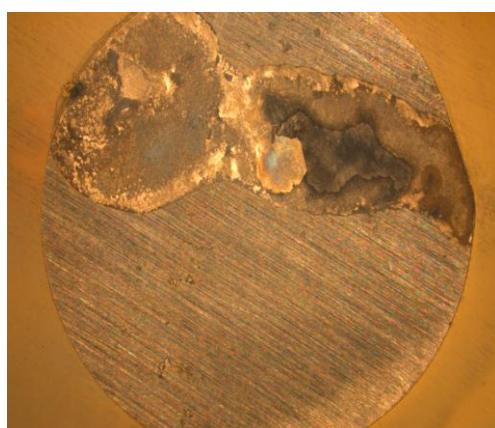
Figure 21 shows the picture of the bare working electrode taken after the end of the experiment at pH10 at 80°C. It shows that steel suffered from general corrosion. Figure 22 is the picture of the covered with elemental sulfur working electrode in the same experiment. It can be seen that the surface is covered with a thick black film which has protected surface from general corrosion, but presence of pitting was also observed.

**Figure 21.** Surface of bare carbon steel electrode (pH10 at 80°C).

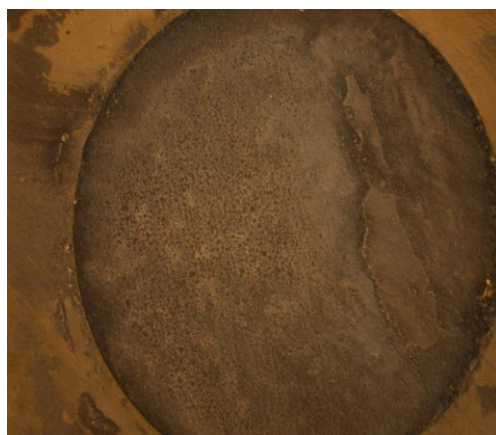
**Figure 22.** Surface of covered with elemental sulfur carbon steel electrode (pH10 at 80°C).

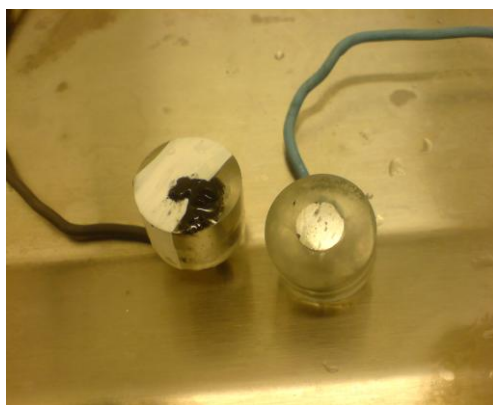
Before the exposure in electrolyte, the surface of one working electrode which suggested being covered was coated with powder (elemental sulfur or iron sulfide). To hold the powder the Teflon tape was used. Not the entire surface was covered with film agent. This is easier to see in Figure 23.

**Figure 23.** Picture of covered with Teflon tape and bare working electrodes.

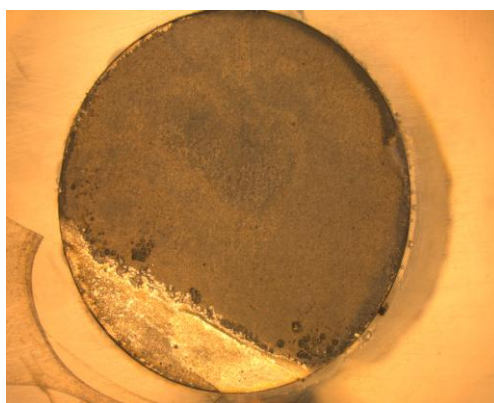
Figure 24 shows one of the example of this situation there the uncovered region suffered from localized/pitting corrosion in the border of tape and thick black

**Figure 24.** Surface of covered with elemental sulfur electrode (pH10 at 20°C) after removal of Teflon tape.

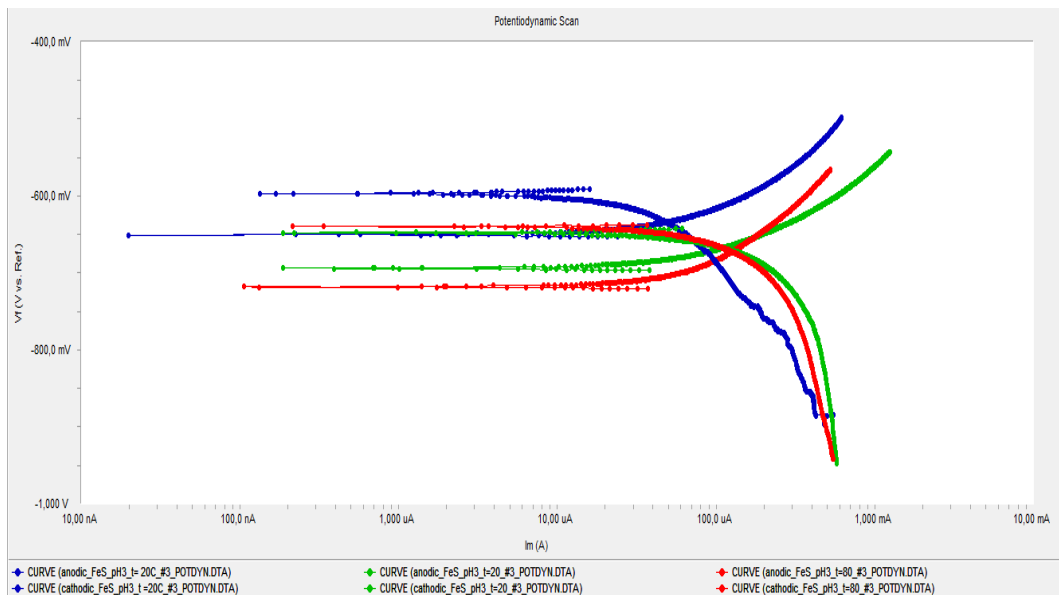
**Figure 25.** Potentiodynamic sweeps for covered with iron sulfide working electrode at pH3 at 20°C (blue), 40°C (green),80°(red) after 15 minutes.

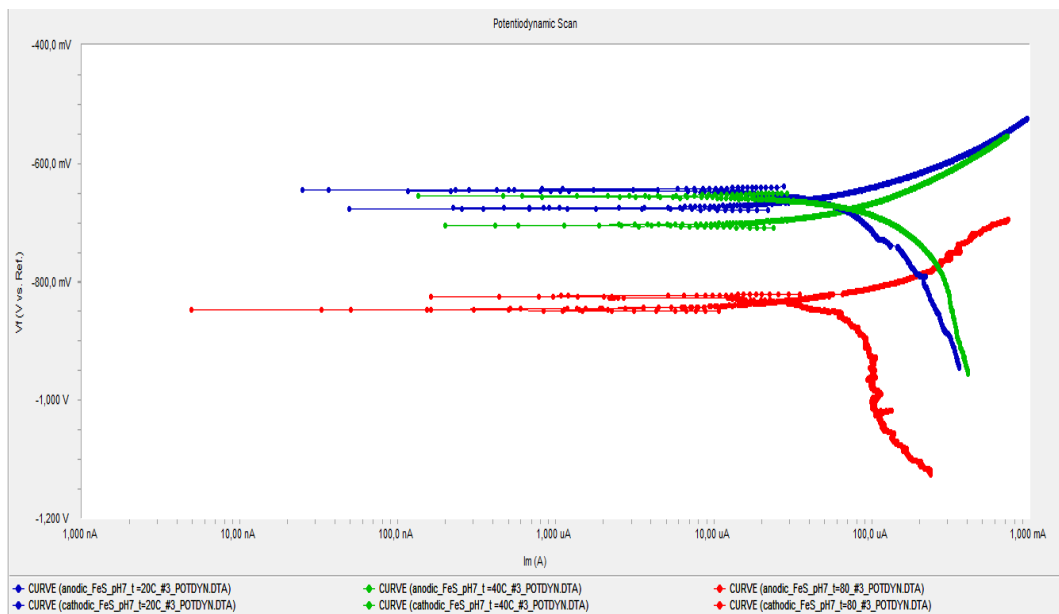
**Figure 26.** Potentiodynamic sweeps for covered with iron sulfide working electrode at pH7 at 20°C (blue), 40°C (green),80°(red) after 15 minutes.

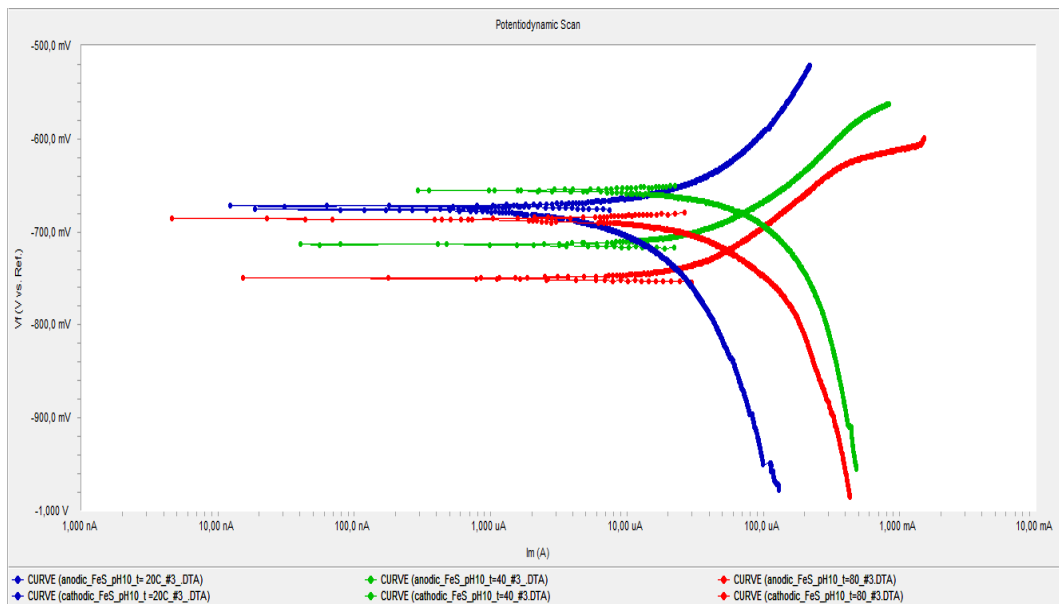
At pH10 at 80°C it can be seen that the limiting current which affected anodic reactions after the potential increased to approximately -625 mV (SCE) (Figure 27). The passivation region was obtained. All curves (Figures 25-27) show no significant shift with the temperature and pH changes (only pH7 at 80°C). The potential decreased slightly with the temperature and pH increasing. More negative values obtained at pH7.

**Figure 27.** Potentiodynamic sweeps for covered with iron sulfide working electrode at pH10 at 20°C (blue), 40°C (green),80°(red) after 15 minutes.

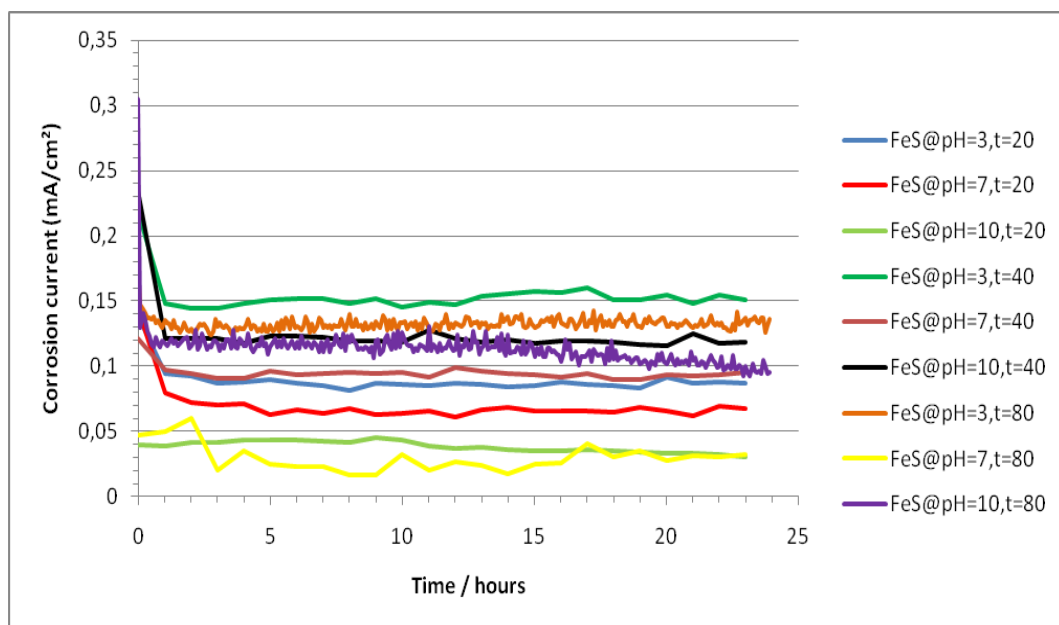
The galvanic corrosion measurements have been performed during 24 hours Rp/Ec. Figure 28 shows the results.

**Figure 28.** Changes in corrosion current density in time for decoupled iron sulfide- covered electrode.

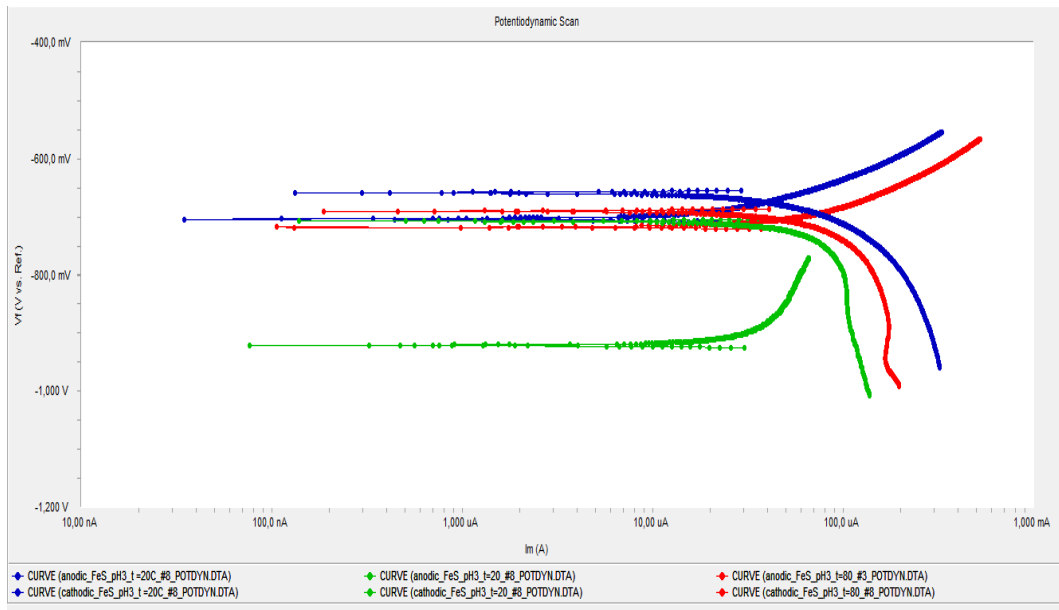
**Figure 29.** Potentiodynamic sweeps for covered with elemental sulfur working electrode at pH3 at 20°C (blue), 40°C (green), 80°C (red) after 24 hours.

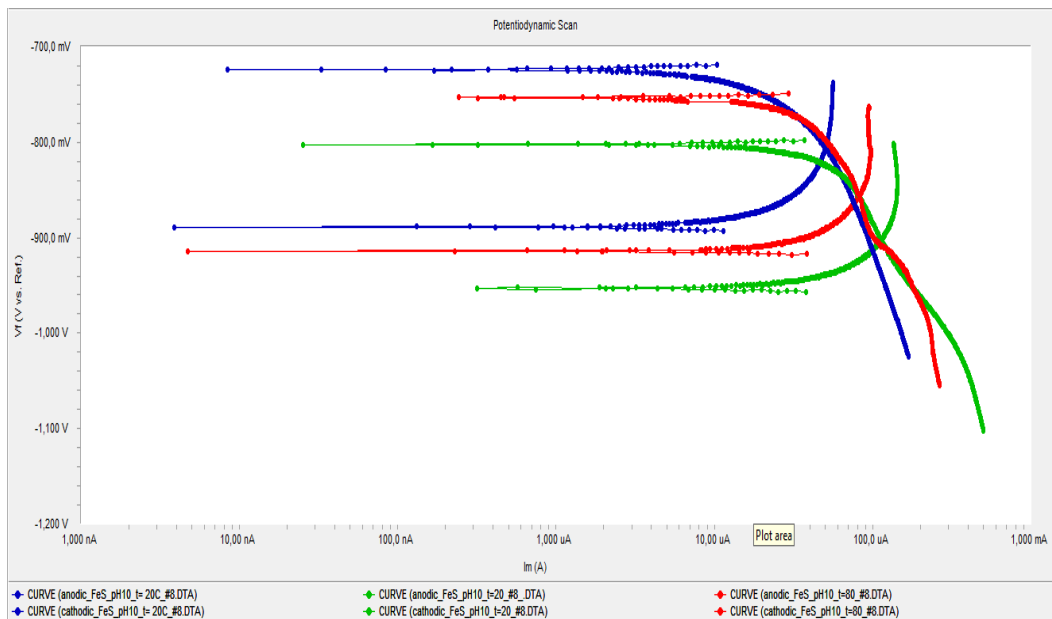
**Figure 31.** Potentiodynamic sweeps for covered with elemental sulfur working electrode at pH10 at 20°C (blue), 40°C (green), 80°C (red) after 24 hours.

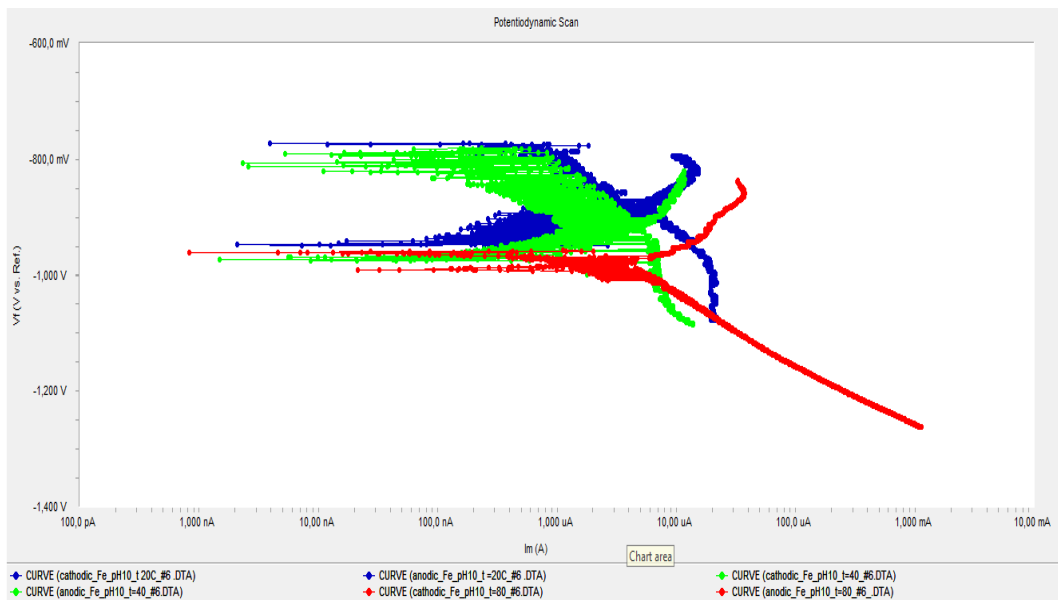
The potentiodynamic scans for bare steel electrode were carried out after polarization sweeps of covered electrode. The more disturb oscillations took place during measurements. It was not possible to read clear information of polarization steps (Figure 32). To determine the possible cause of problem setup was assembled every time the noise was present. Working electrode was tested in three-electrode cell with electrolyte. The polarization sweep was carried out without any evidence of deviation. Reference electrode was tested with ammeter. Also the test of counter electrode was carried out. Inspection showed no problems with equipment. It is mean that the problem was with local electronic environment or chemistry. The chemistry problem is more likely. Electrochemical oscillations can result from either electrochemical or purely chemical origins. An electrochemical oscillation is dependent on the interfacial potential while a purely chemical oscillator is not [40]. During the polarization scans the anodic potential was in a range of -675 to -990 mV (SCE) (Figure 3 in appendix 2). Such a low values could be a reason of the oscillations. The sours of distortion should be investigated further.

**Figure 32.** Potentiodynamic sweeps for bare working electrode at pH3 at 20°C (blue), 40°C (green), 80°C (red) after 24 hours.

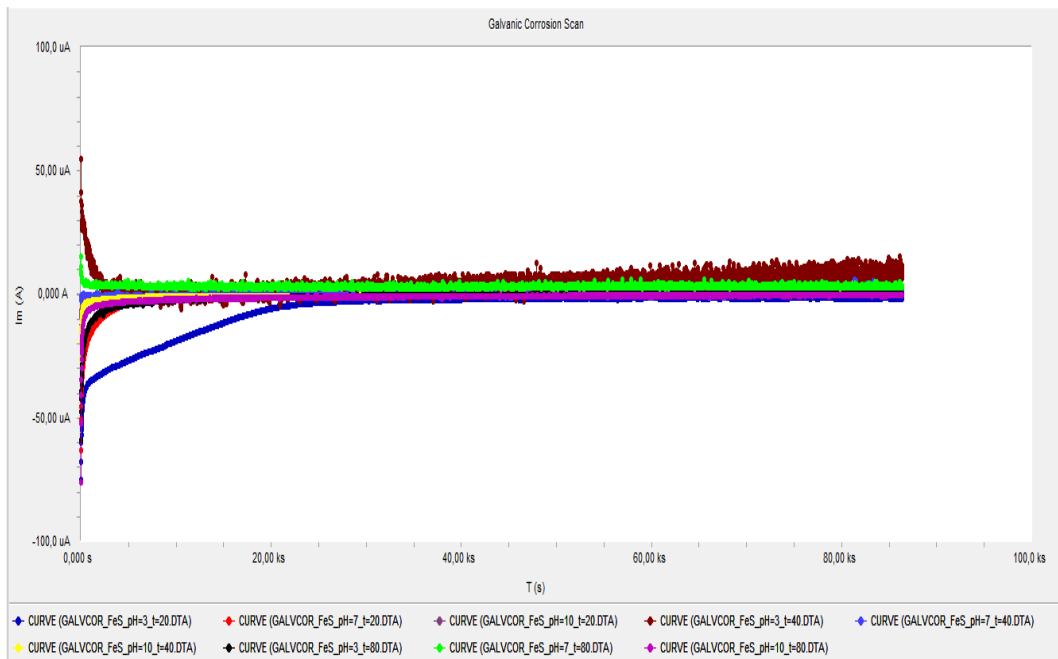
**Figure 33.** Galvanic corrosion scans for Fe/FeS couple in Series 2.

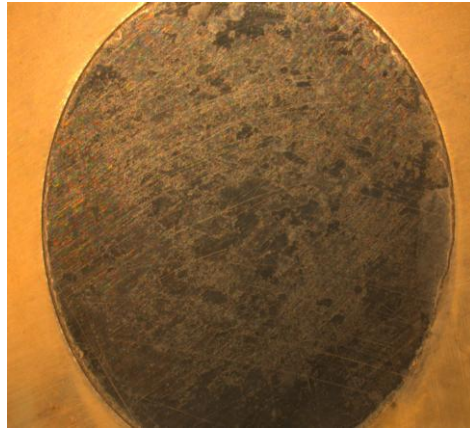
further corrosion (Figure 34). The pictures of the covered electrode show that the corrosion products were mostly generated at the periphery of the iron sulfide pellet [41] uncovered with the Teflon tape (Figure 35). The corrosion type in this region is crevice and it could be a reason of positive current values for iron sulfide- covered electrode during galvanic corrosion scan.

**Figure 34.** Surface of bare carbon steel electrode at pH7 at 80°C.

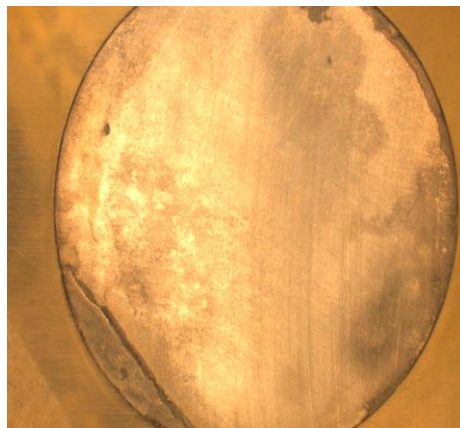
**Figure 35.** Surface of covered (FeS) electrode at pH7 at 80°C after black film has been removed.

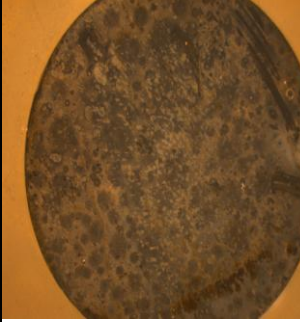
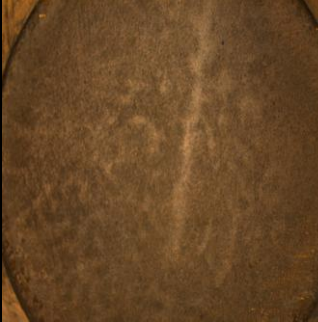
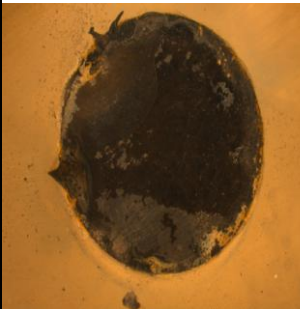
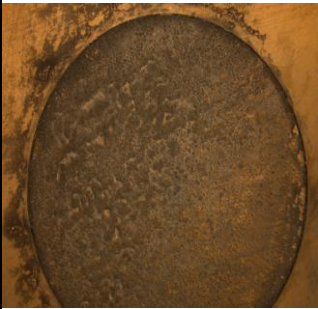
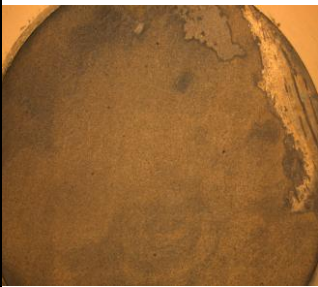
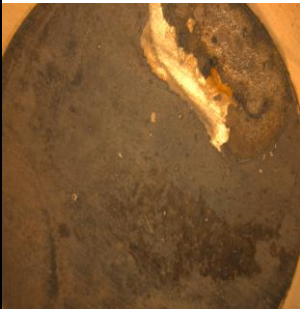
**Figure 1.** Morphology of steel surface of bare and covered electrodes in Series 1.

| | Bare steel (Fe) | Covered steel with sulfur (Fe+S) | Description |
|---|--|--|---|
| pH 3 at 80°C | 1<br> | 2<br> | 1). Presence of thick black film, local corrosion traces;<br>2). Thick black film, general corrosion traces. |
| | 3<br> | 4<br> | 3). Thin black film, easily to remove, general corrosion;<br>4). Thick black film, general corrosion traces. |
| pH 7 at 20°C | 5<br> | 6<br> | 5). Thin black film, under the film metal remained metallic bright, steel suffered local corrosion;<br>6). Thick black film, presence of localized corrosion in non-covered region, several pits. |
| | 7<br> | 8<br> | 7). Thick black film, surface suffered with localized corrosion;<br>8). Thick black film, presence of pitting corrosion in non-covered region and near. |

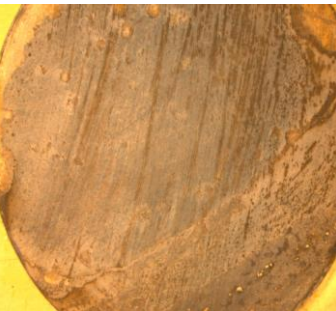
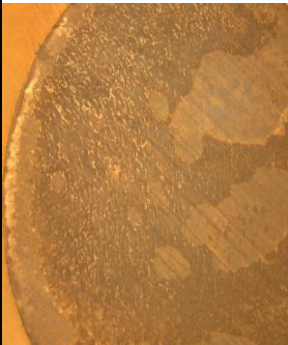
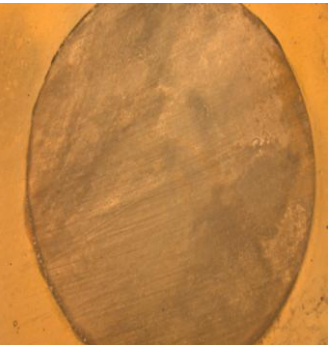
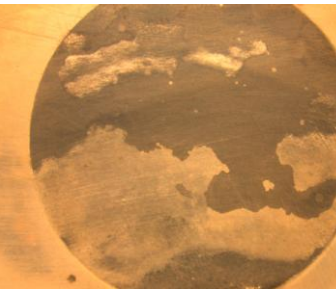
| | Bare steel (Fe) | Covered steel iron sulfide (FeS) | Description |
|---|--|--|--|
| pH10 at 80°C | 1<br> | 2<br> | 1). Thin black film, hard to remove, no evidences of changes due to corrosion;<br>2). Thin black film, after removal, evidences of localized corrosion, surface darkened slightly. |
| | 3<br> | 4<br> | 3). No black film on the surface, traces of localized corrosion;<br>4). Thick black film, after removal the surface slightly darkened, no evidence of corrosion attack. |
| pH 10 at 40°C | 5<br> | 6<br> | 5). Thin black film, hard to remove, traces of localized corrosion;<br>6). Thin black film, non-adherent and cracks easily, no evidence of corrosion attack. |
