# Effect of Pre-exposure of Sulfur and Iron Sulfide on H<sub>2</sub>S Corrosion at Different Temperatures

Master Thesis  
of  
Brailovskiy Valery

June 2011

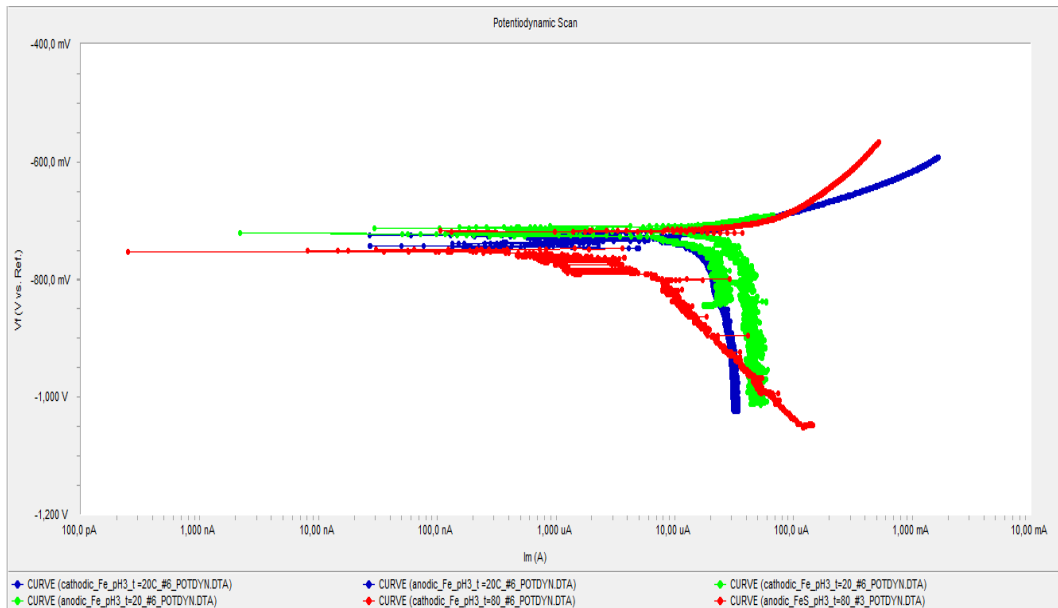
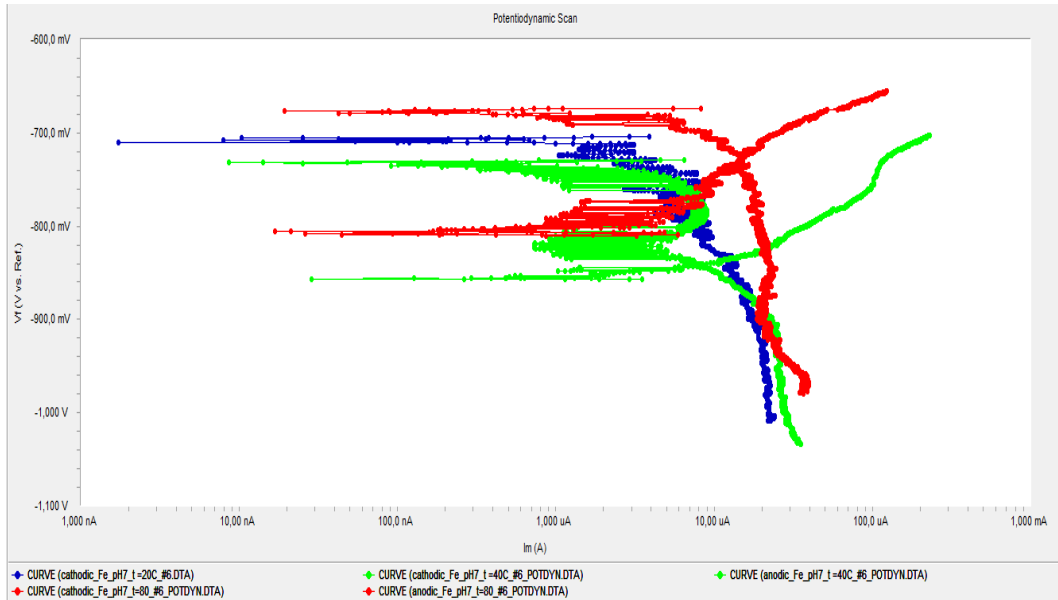
**Polarization sweeps for bare electrode (galvanic couple Fe/FeS) after 24 hours (Series 2).**
