## MASTER'S THESIS

Petroleum Technology / Drilling

**Management of well barriers and challenges with regards to  
obtaining well integrity**

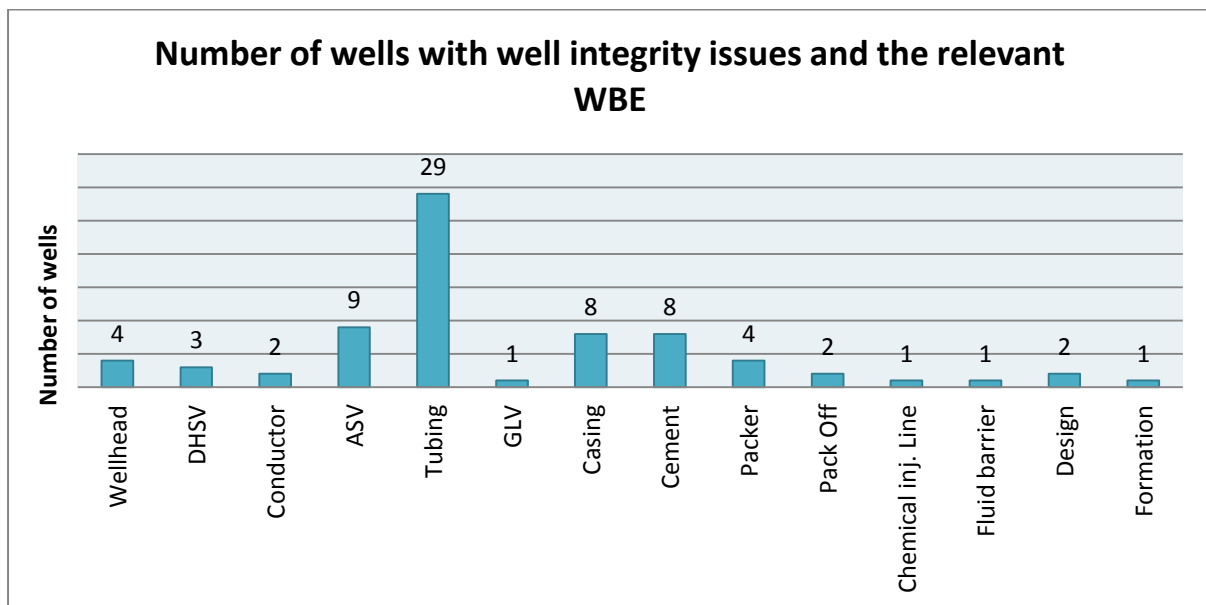
Figure 1: Number of wells with related WBE issues [Based on (Vignes, 2012)]

Out of the 406 wells investigated on the pilot survey, 75 wells (18.5%) presented with well integrity issues (Vignes, et al., 2006). Figure 1 show the amount of wells with issues or uncertainty related to specific Well Barrier Elements (WBE).

Tubing stands out as the WBE with most related issues, caused primarily by tubing leaks. The Annular Safety Valve (ASV), were reported with failures or leakages. Casings had reported leakages which were most likely due to non-gas tight connections. Some collapsed casings were also reported. The cement issues included lack of cement behind the casings, insufficient height of cement, and cement leakages due to either improper bonding to formation/casing or by micro annulus in the cement. Reported wellhead issues included inadequate sealing in the wellhead which caused leakages from A to B annulus.

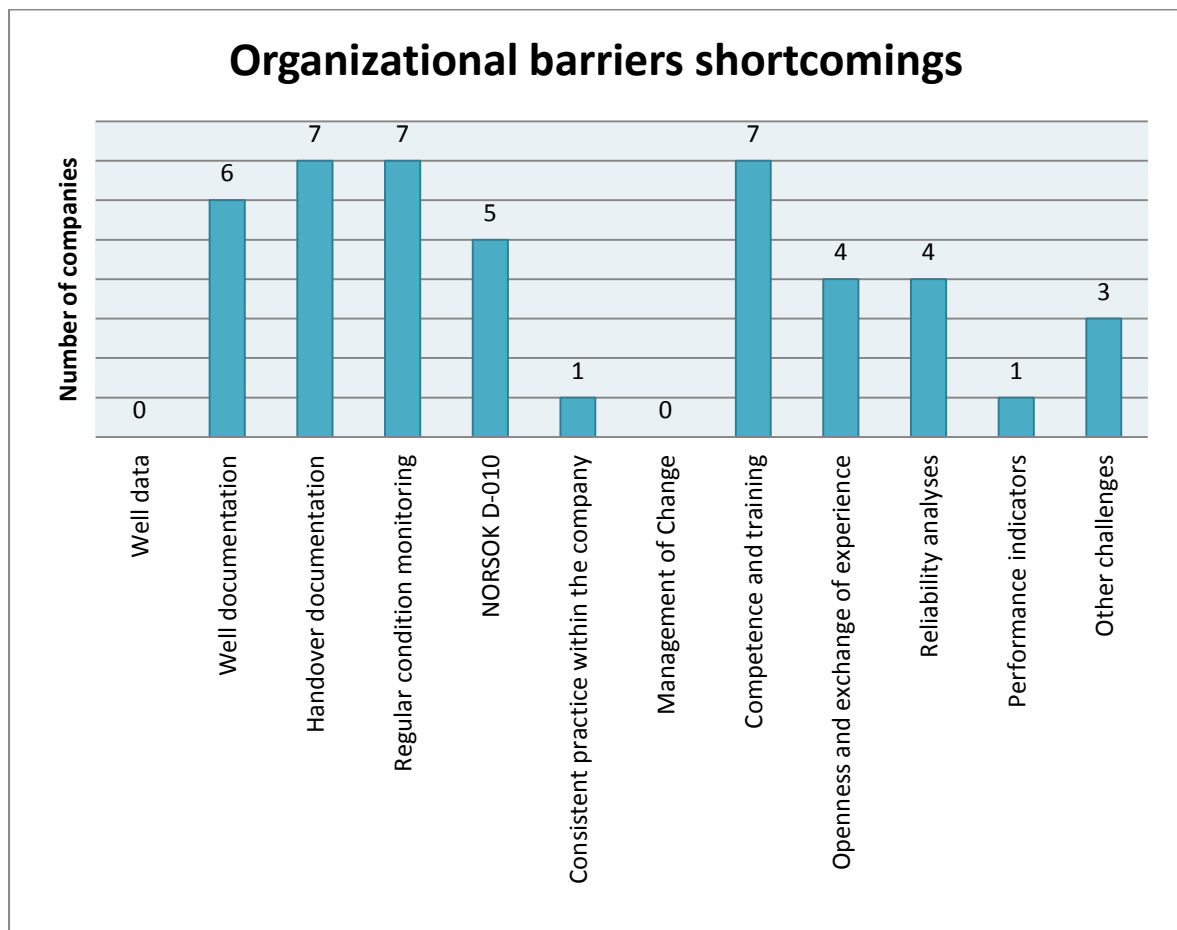
Figure 2: Room for improvement – Organizational barriers [Based on (Vignes, et al., 2006)]

A questionnaire were sent out to the operators in order to try to map how well the companies scored on organizational well integrity aspects and find out if there was room for improvement. The survey covered documentation, adherence to standards and defined practices, performance and competence. Figure 2 presents the areas where the companies had room for improvement regarding organizational barriers.

The most frequent issues were regarding well documentation, well handover documentation, regular condition monitoring, NORSOK D-010 standard compliance and well integrity competence.

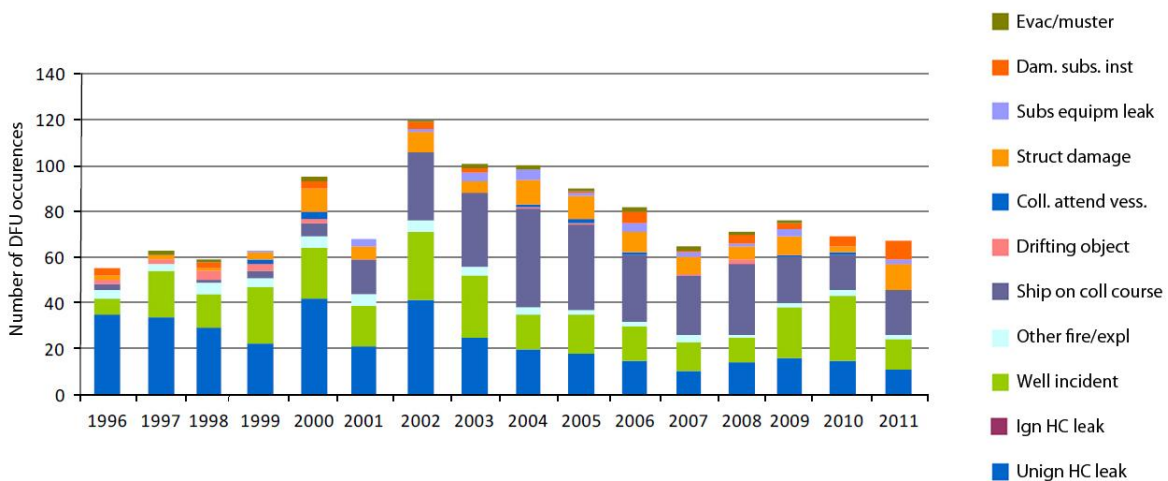
Figure 3: Reported DFUs related to major accident risk (Ptil, 2012)

Figure 3 shows the trend of major accident risks based on reported DFUs (Defined situations of hazard and accident) (Ptil, 2012). The risk contribution for each of the various DFUs varies.

The trend shows a fairly consistent level of reported DFUs, with a slight increase in the period from 1996-2001. In 2002, the number increased a great deal, which according to PSA, might've been due to underreporting of 'Ship on collision course' incidents prior to 2002. 'Well incidents' (green) and 'Hydrocarbon leaks' (blue) might also been subjected to some underreporting, contributing to the low average in this period, but not to the same extent. The change in amount of reported DFUs from the 1996-2001 period, to the 2002 - 2011 period, is therefore not a good indication of the actual trend.

In the period 2002-2007, a consistent annually reduction can be seen until 2007 where a slightly negative trend appears with increasing amount of reported DFUs. This trend can mainly be explained by the varying level of reported well incidents and hydrocarbon leaks. The negative trend of reported "Well incidents" seems however to have turned and are dramatically reduced in 2011. Reducing the risk of major accidents will continue to be one of PSAs main priorities in 2012.

As seen previously in Figure 3, the trend for reported DFUs, well incidents contribute a great deal to the observed trend.

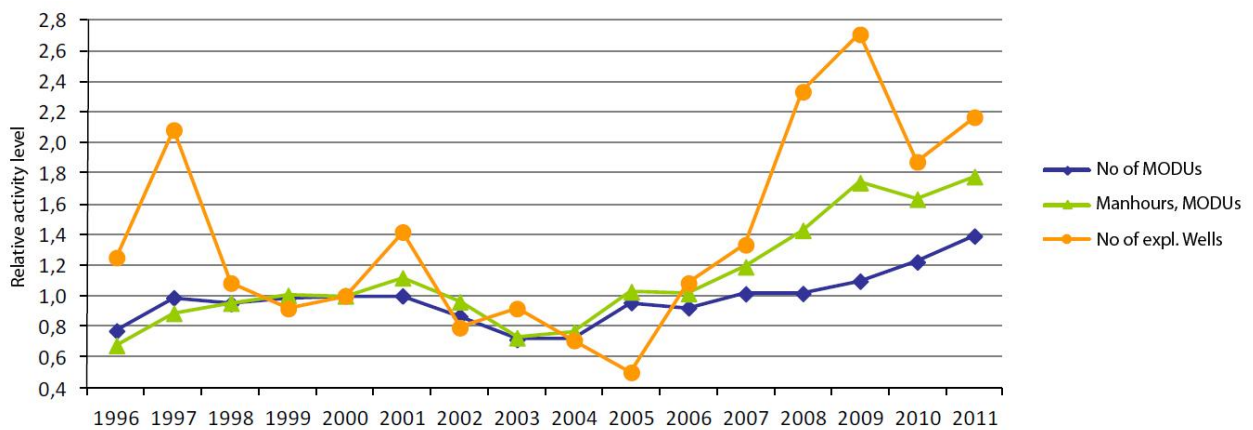
Figure 4: Trend of activity level for exploration, 1996-2011 (Ptil, 2012)

Looking at Figure 4, an increase in both number of exploration wells and mobile units can be seen, which again increases the possibility of potential well incidents (Ptil, 2012). This could explain the increase in reported DFUs and the increase of minor leaks in the period 2007-2011.

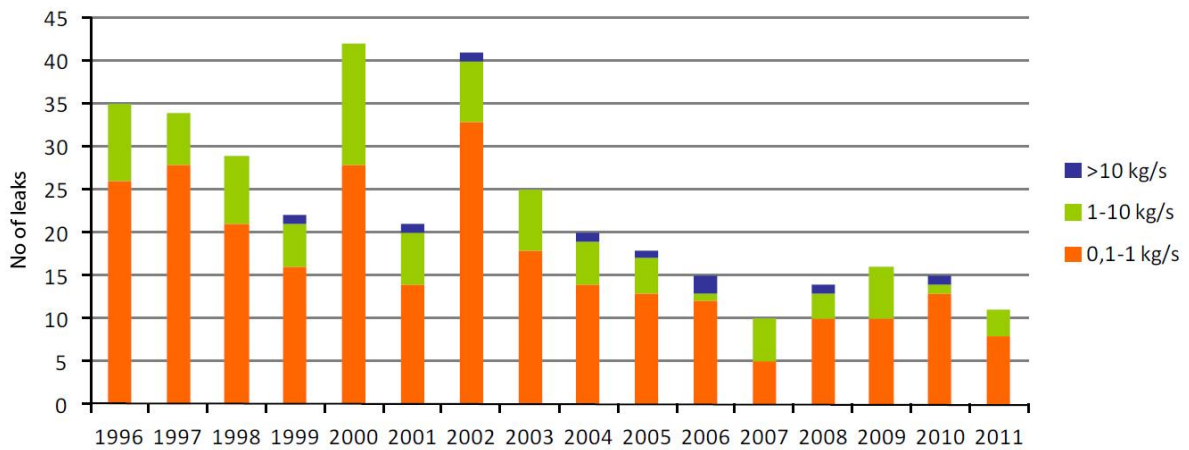
Figure 5: Number of hydrocarbon leaks exceeding 0.1 kg/s, 1996-2011 (Ptil, 2012)

A closer look at the hydrocarbon leaks exceeding 0.1 kg/s in the period 1996-2011 reveals a similar trend (Ptil, 2012). These leaks are situated in the process area and not in the wells. The results might go beyond the scope of this paper but the trends are however worth mentioning as they paint a picture of the organizational integrity.

A positive trend with decreasing amount of leaks was seen in the period from 1996-1999, followed by some years with large variations. From 2003-2007 a positive trend was again seen, until 2007 when the trend turned and stabilized at a slightly higher level. The results from 2011 seem to be at the same low level as in 2007, with a shift towards minor leaks.

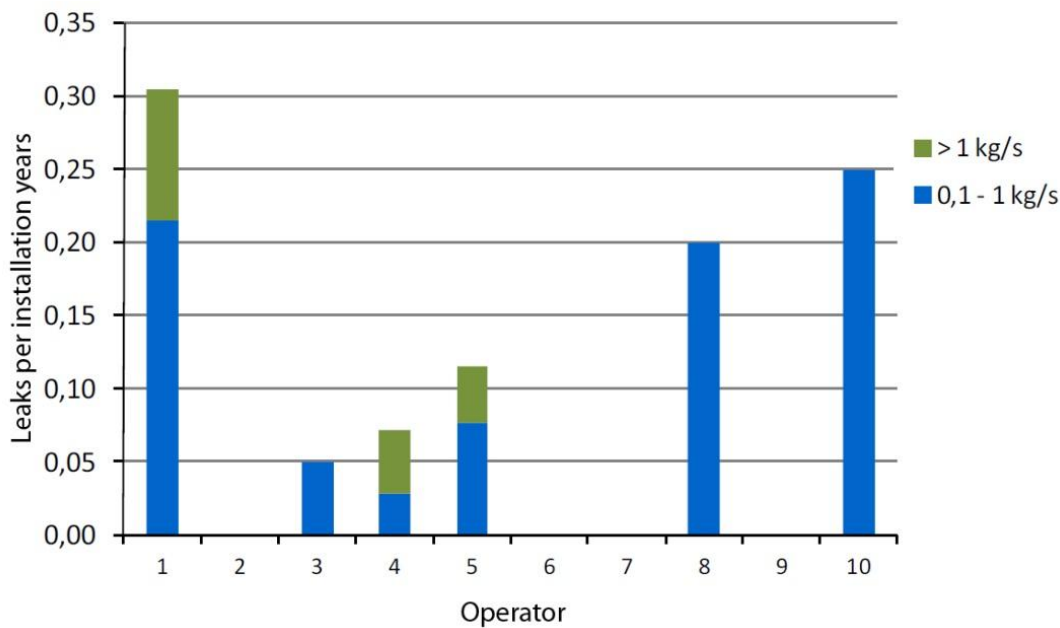
**Figure 6: Average leak frequency, 2007-2011 (Ptil, 2012)**

There are big differences between operator companies regarding amount of hydrocarbon leaks. Figure 6 shows amount of leaks exceeding 0.1 kg/s for ten different operating companies on the NCS in the period 2007-2011.

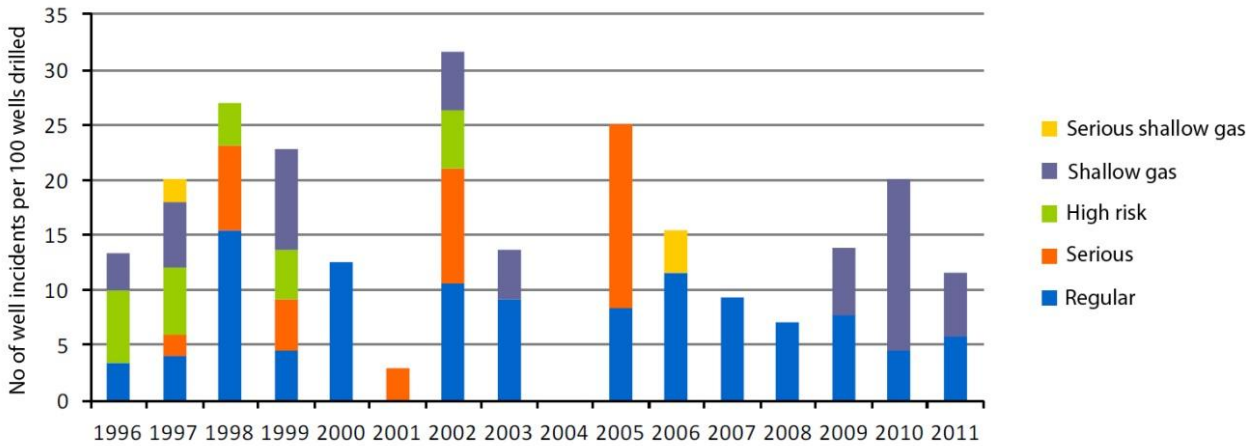
Figure 7: Reported well incidents - Exploration drilling, 1996-2010 (Ptil, 2012)

For exploration drilling, big variations can be seen throughout the period. In the period 2005-2008 a positive trend with significantly decreasing amount of well incidents can be observed, followed by a sharp increase in well incidents the latest years from 2008. This is the result of a significantly increase in shallow gas incidents reported. The big variations are not surprising, and can be explained by drilling in unknown geology.

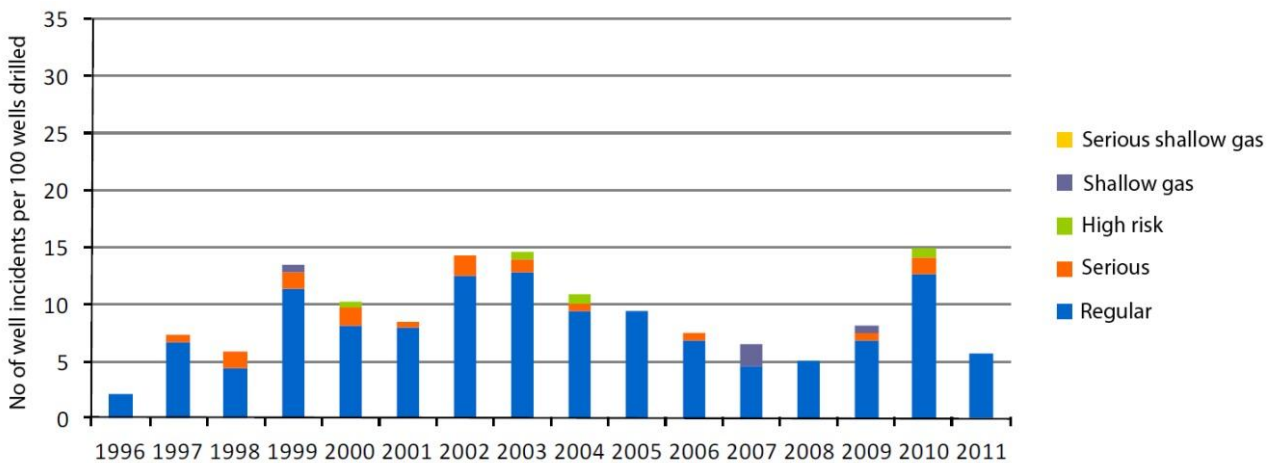
Figure 8: Reported well incidents - Production drilling, 1996-2010 (Ptil, 2012)

For production drilling, an increasing trend from 1996 is seen with minor variations, ending with a peak in 2003. In the period 2003-2008 a positive trend with decreasing well incidents is seen with a sharp increase from 2008-2010, mainly caused by an increase in ‘regular’ events. Results from 2011 indicate a very good year with only a few regular events.

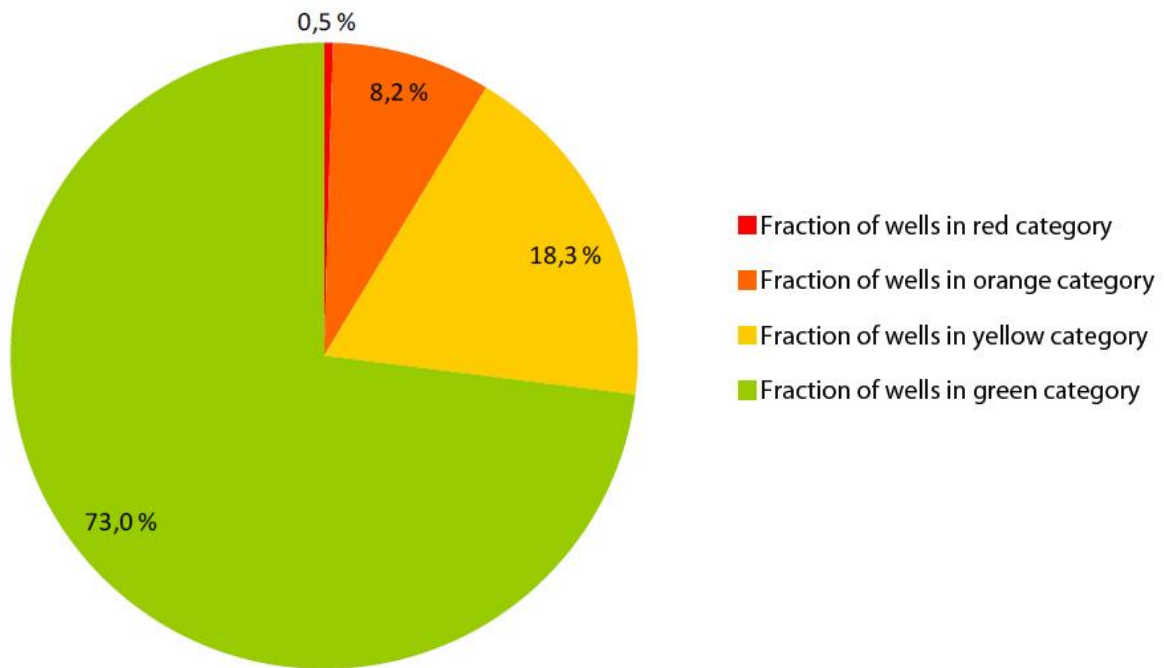
Figure 9: Classification of active wells on NCS – 2011 (Ptil, 2012)

- Red: One barrier failed and the other degraded/unverified or with external leak.
- Orange: One barrier failed and the other intact, or a single fault which may cause leaking into external environment.
- Yellow: One barrier leaking within acceptance criteria or the barrier is degraded, and the other is intact.
- Green: Intact well, with no insignificant integrity factors.

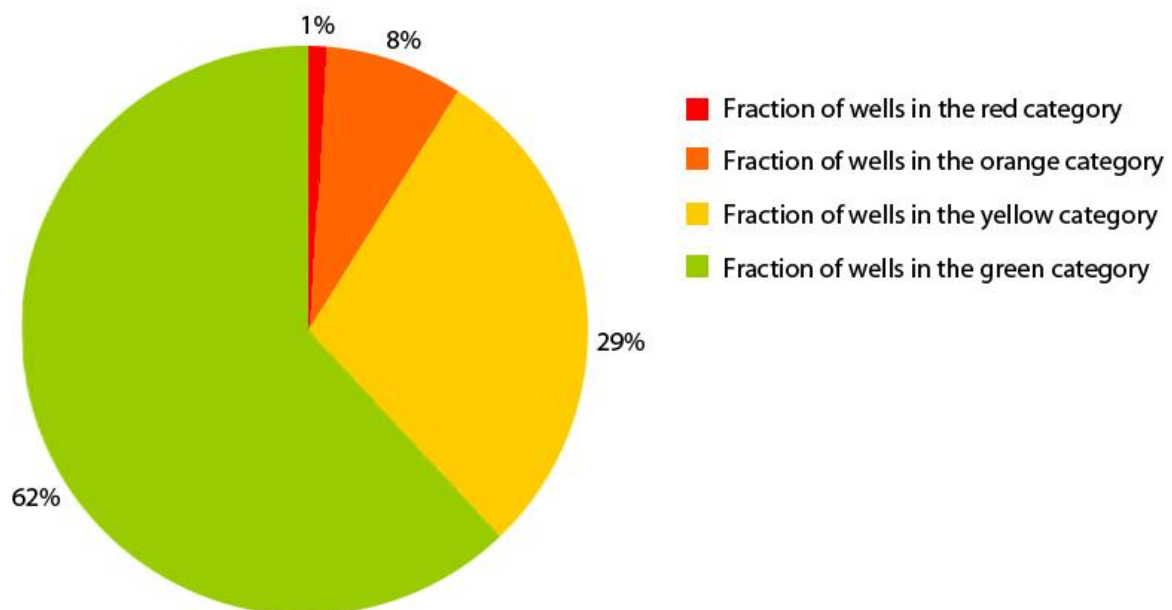
Figure 11: Classification of non-active & non-permanent plugged wells on NCS - 2012 (Vignes, 2011)

Temporary plugged wells only require mechanical plugs in the wellbore, which are not accepted as barrier elements for permanent plugged wells, and are only meant to be used for a short period. Reducing the amount of temporary abandoned wells is one of the focus points of PSA.

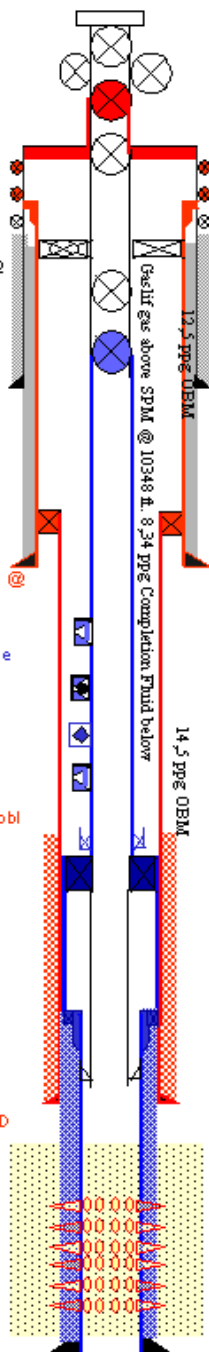
Comments: Deviated Ekofisk and Tor (we) producer. Primary 6 5/8" liner hanger failed to expand, back-up expandable hanger set with seal stem into primary liner PBR

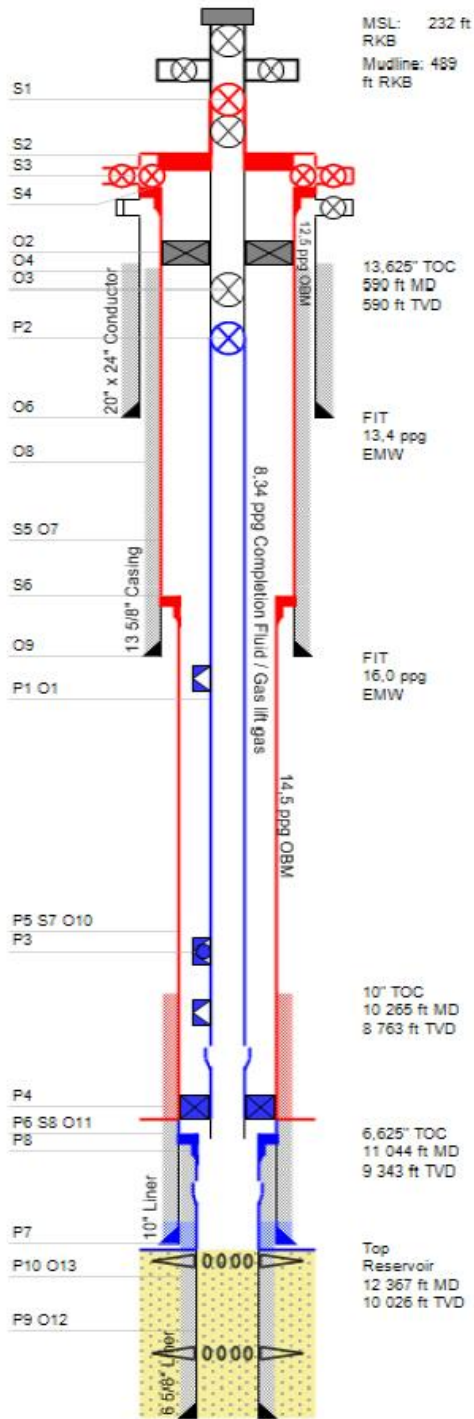
Well Barrier Schematic - 2/4-M-2 - Producing Well

COMMENTS: ASV failure June 2008. Downhole gauges have failed (gauge carrier @ 10819 ft MD)

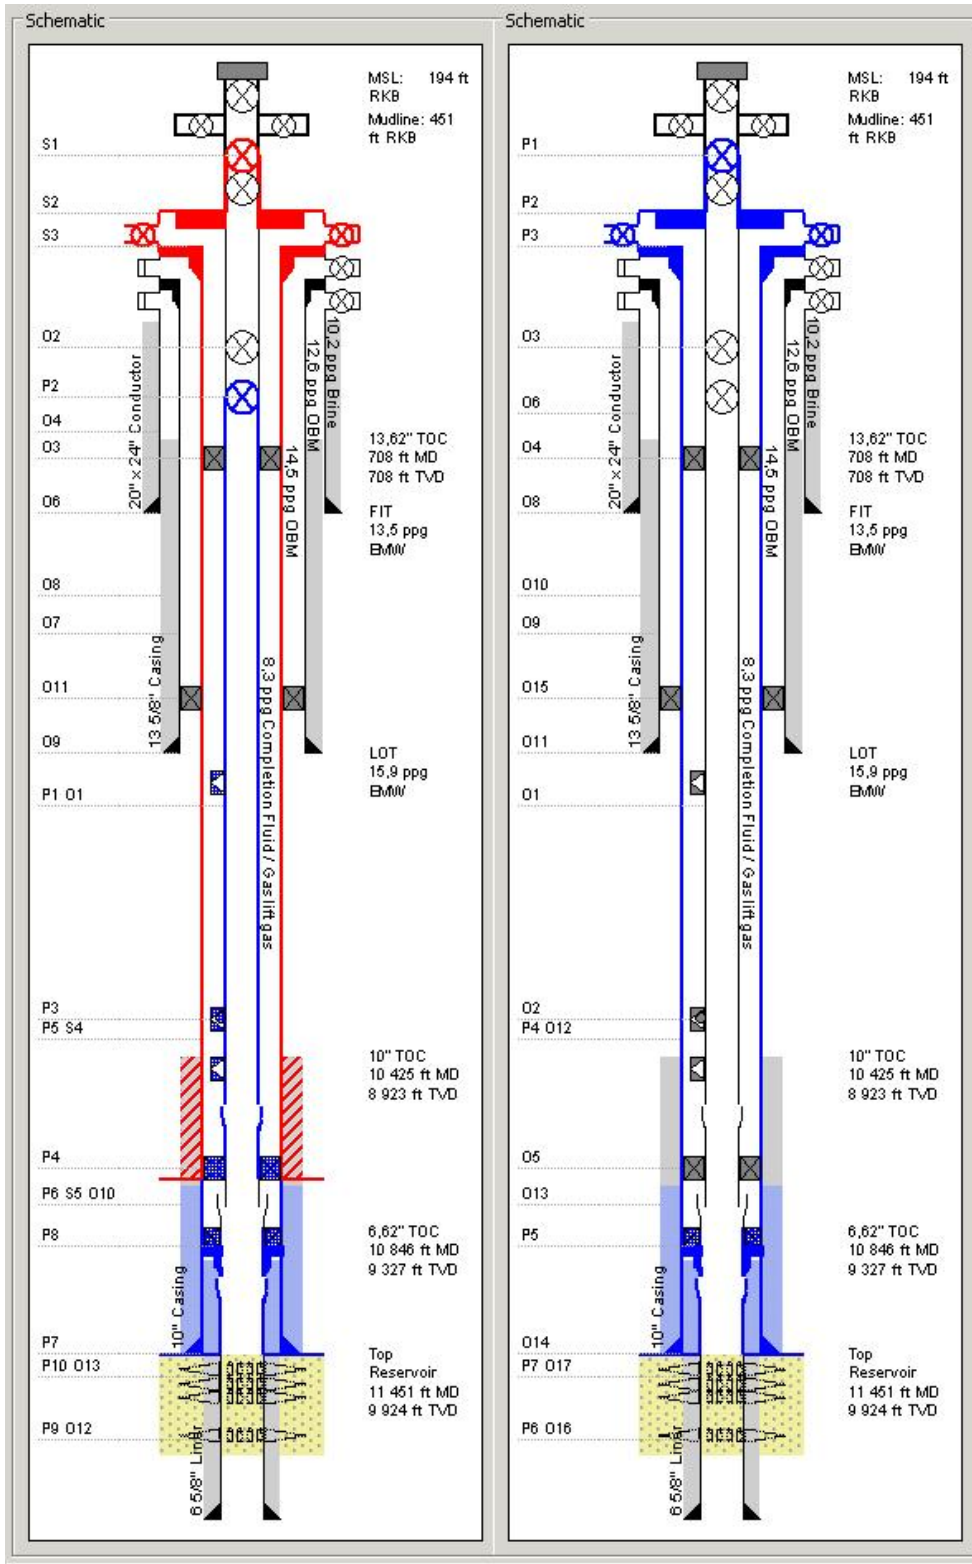
Figure 15: Manually changing barrier status of a well component (ConocoPhillips, 2012)

An example of how this works is seen in Figure 15, where the downhole safety valve (DHSV) has been changed from 'Primary' barrier status, to 'Other' barrier status manually through the add-in user interface, indicating a problem with the DHSV.

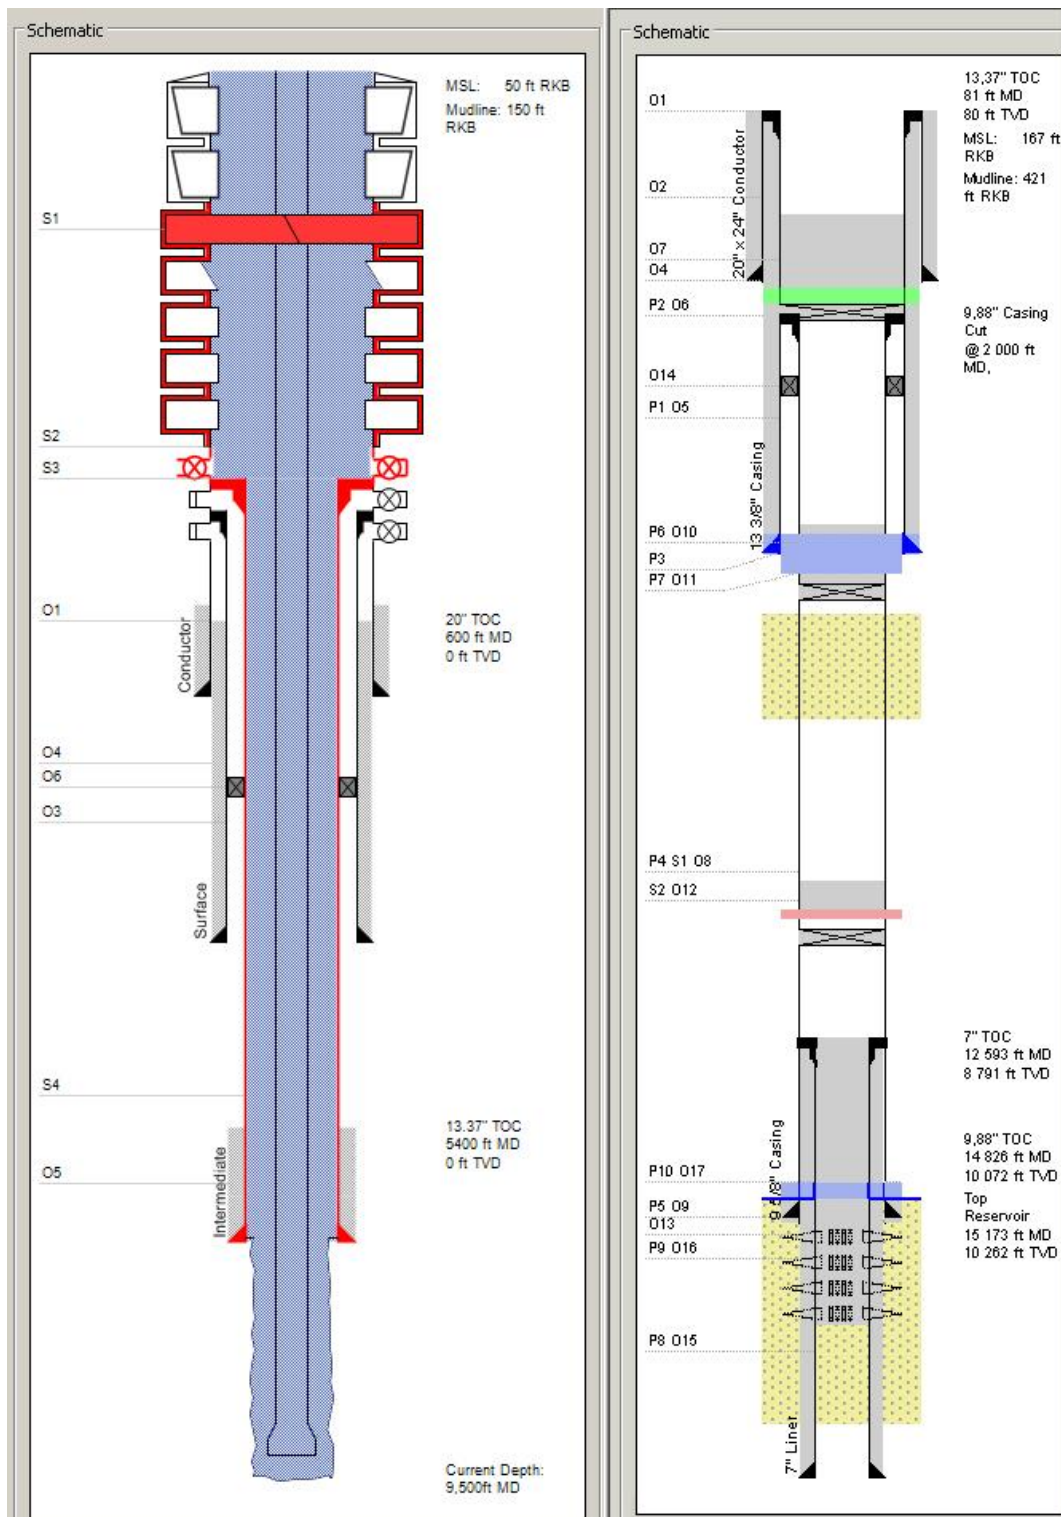
Figure 16: Drilling (left) and P&A (right) functionality of the WBS add-in (ConocoPhillips, 2012)

Finishing touches are currently being made to the add-in with regards to its drilling and P&A functionality. This includes bug-testing, adding any additional functionality and finally publishing. Current status of these functionalities can be seen on Figure 16.

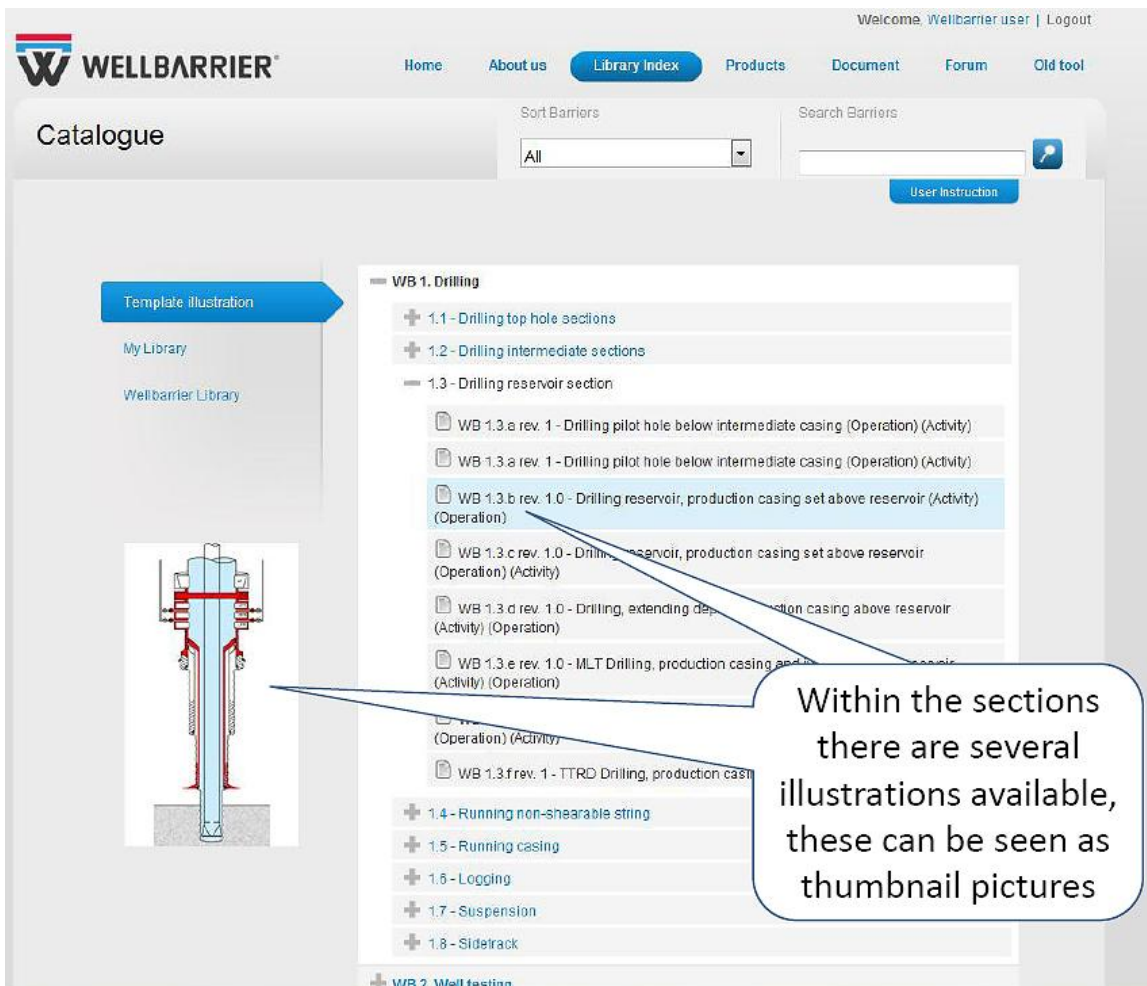
Figure 17: Well configurations on the Wellbarrier tool (Wellbarrier, 2012)

Well configuration can be chosen from a library containing more than 170 illustrations (Figure 17) which can visualize wells in the construction, operation and maintenance phase and is also in line with the Norsok D-010 Standard. A link between the barrier element and the relevant Norsok D-010 acceptance criteria is available.

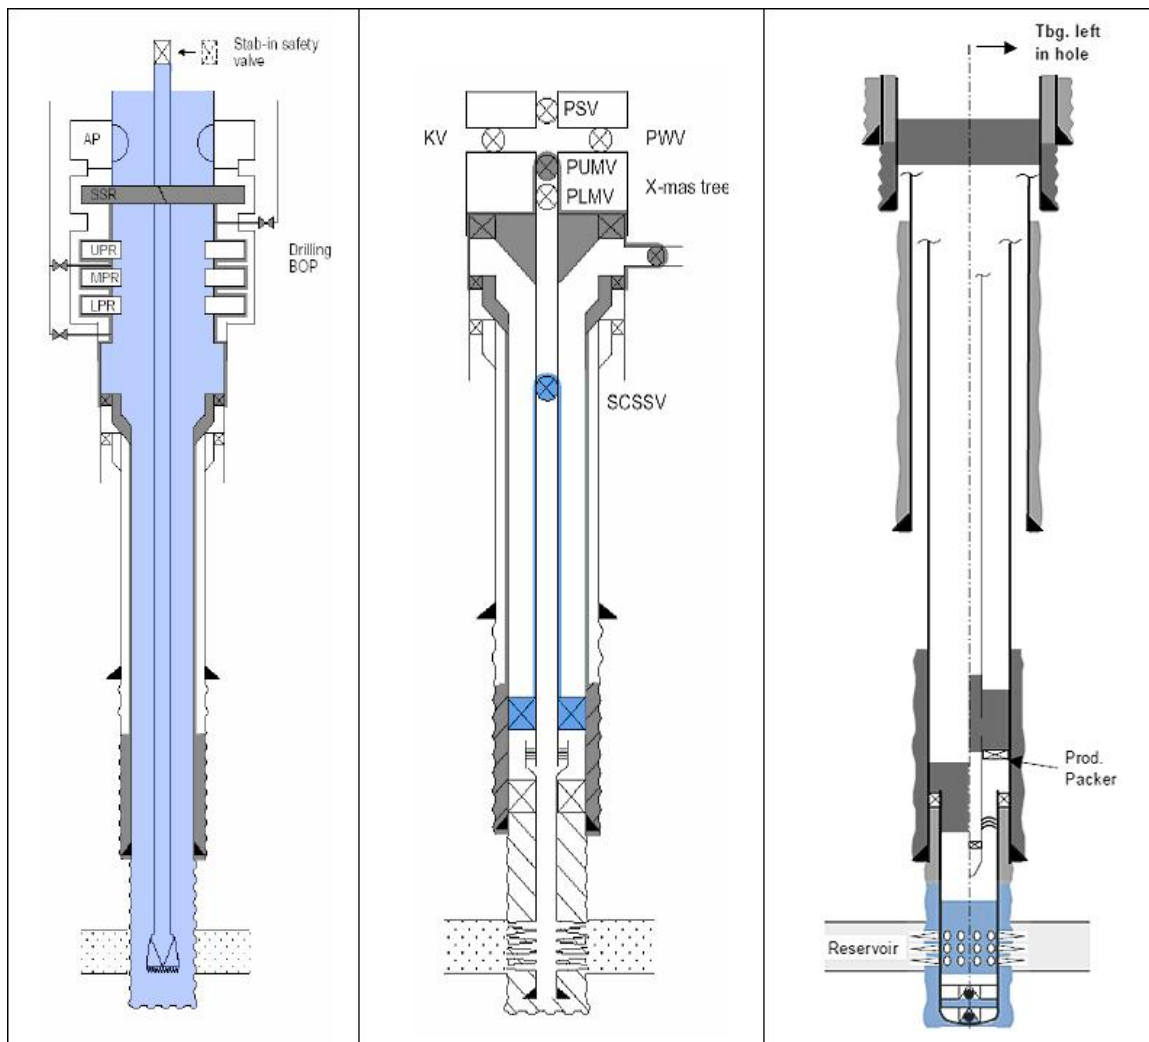
Figure 21: Primary barriers for drilling, operation, and P&A well [Based on (NORSOK Standard D-010, 2004)]

The first barrier envelope, usually drawn in blue on Well Barrier Schematics, is called the primary barrier. This is the innermost barrier which will be the first obstacle that prevents unwanted flow of formation fluid.

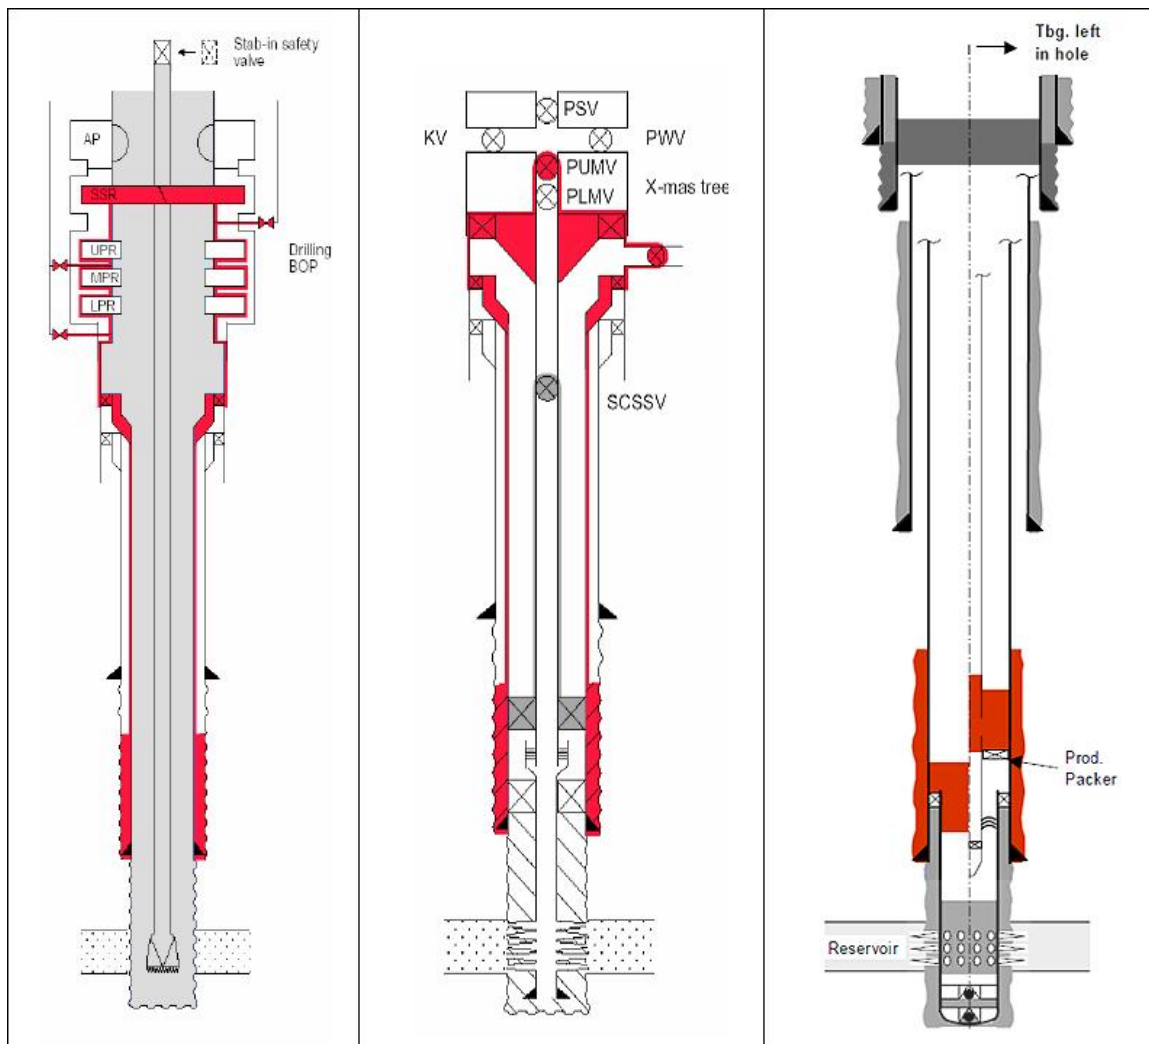
**Figure 22: Secondary barriers for drilling, operation, and P&A well [Based on (NORSOK Standard D-010, 2004)]**

The secondary barrier envelope, usually drawn in red on Well Barrier Schematics, is located outside the primary barrier envelope, and acts as the backup barrier. While not in direct contact with the formation fluid, it shall be capable of handling the well pressures if integrity of the primary well barrier is lost.

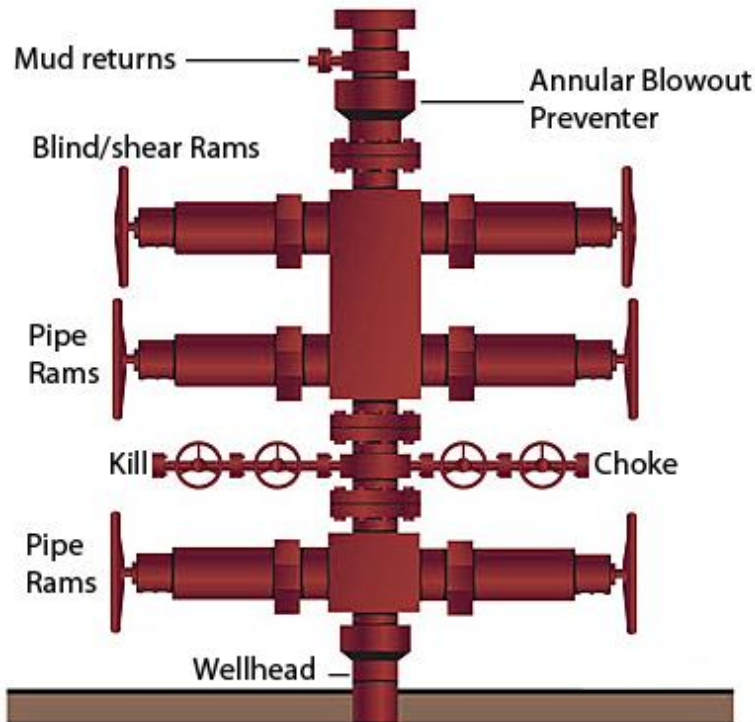
Figure 23: A typical BOP-stack [Based on (AskChesapeake, 2012)]

A blowout preventer (BOP) is a type of equipment installed on the wellhead and is primarily used to contain the pressures in the well in order to avoid kicks and blowouts, and to control & monitor the well. The BOP also prevents casing, tubing, tools and well fluids from being blow out of the wellbore and is therefore a critical well barrier element regarding the safety of the rig and the crew. The BOP is most often a secondary well barrier in the well.

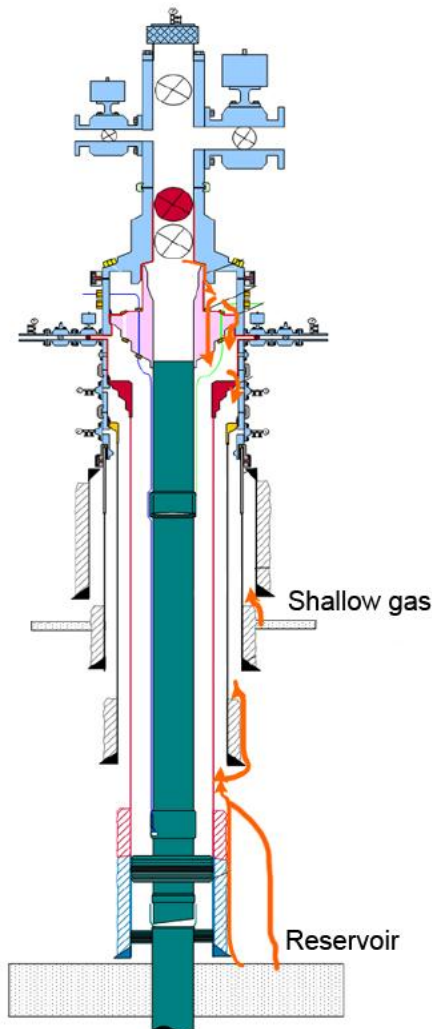
Figure 24: Potential leaks paths resulting in SCP [Based on (Sæby, 2011)]

SCP can occur anytime in the wells lifecycle and will manifest itself at the wellhead. For subsurface wells this presents a real challenge as casing pressure monitoring is unavailable in many wells. Emersons, *Roxar Downhole Wireless PT Sensor System*, as mentioned previously, or similar solutions, could solve this issue.

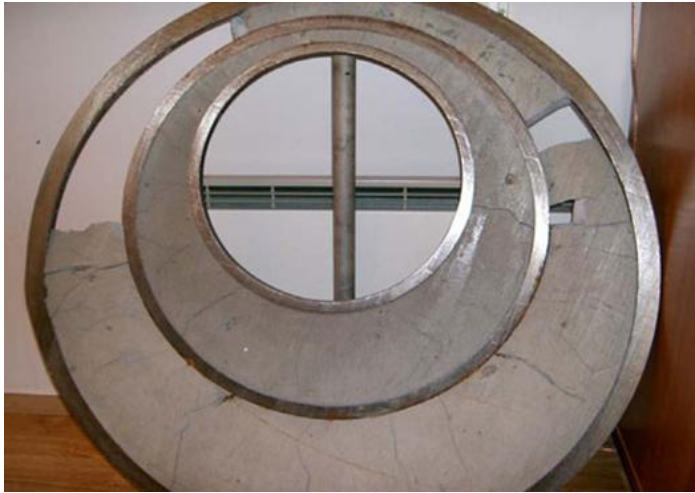
**Figure 25: Bad casing centralization (WellCem, 2012)**

Improper casing centralization, as seen in Figure 25, could lead to reduced cement integrity due to the reduced thickness of the cement.

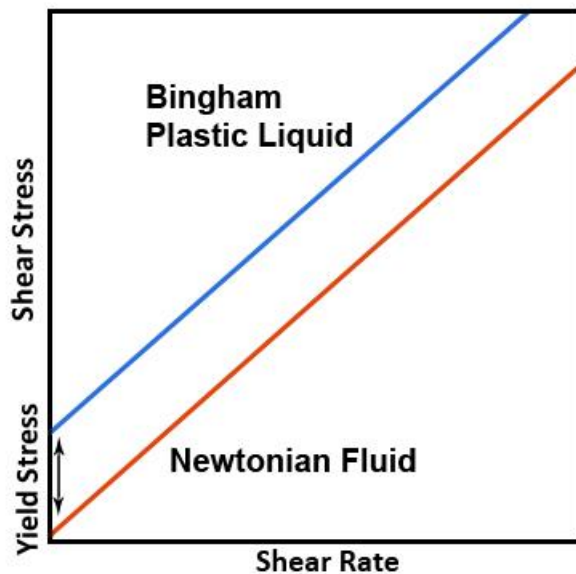
Figure 26: Characteristics of a Bingham fluid [Based on (Schlumberger, 2012)]

Sandaband is a sand-slurry consisting of about three quarters sand particles and one quarter water and other additives (Sandaband, 2006) (Sandaband, 2012) (Sandaband, 2012). The product was developed in Norway to meet the increasing demands of an everlasting plugging material. Sandaband possesses the properties as a Bingham fluid (Figure 26) and act as a deformable solid when it's stationary, but as a liquid when in motion.

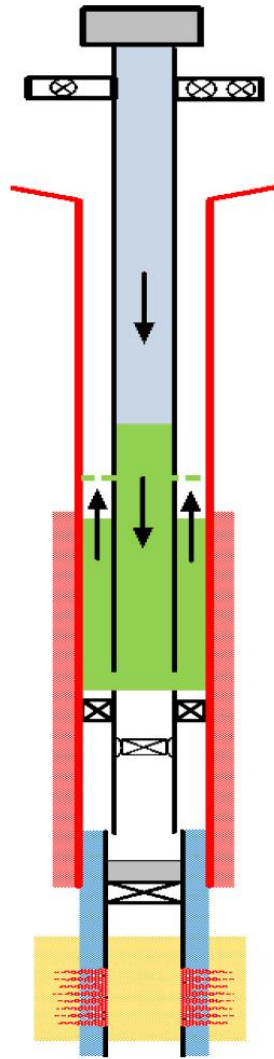
**Figure 27: Embla D-07 - After tubing has been cut – Circulating Sandaband [Based on (Sandaband, 2010)]**

Large holes were punched in the tubing, followed by displacing the tubing and annulus with inhibited seawater (ISW). The tubing was then cut above the production packer and Sandaband was pumped down the well, displaced by ISW. See Figure 27.

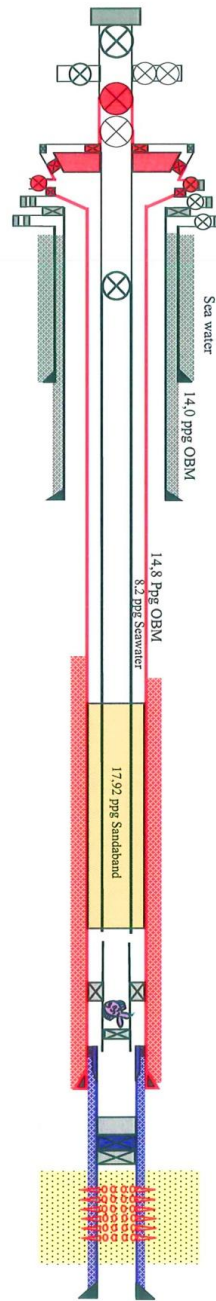
Figure 28: Well barrier Schematic of Embla D-07 – After Sandaband plug [Based on (ConocoPhillips, 2012)]

The Sandaband job was performed with no downtime or HSE incidents and placed according to plan. The well is now currently ready for permanent P&A or for a workover. Figure 28 shows the current well barrier schematic for Embla D-07.

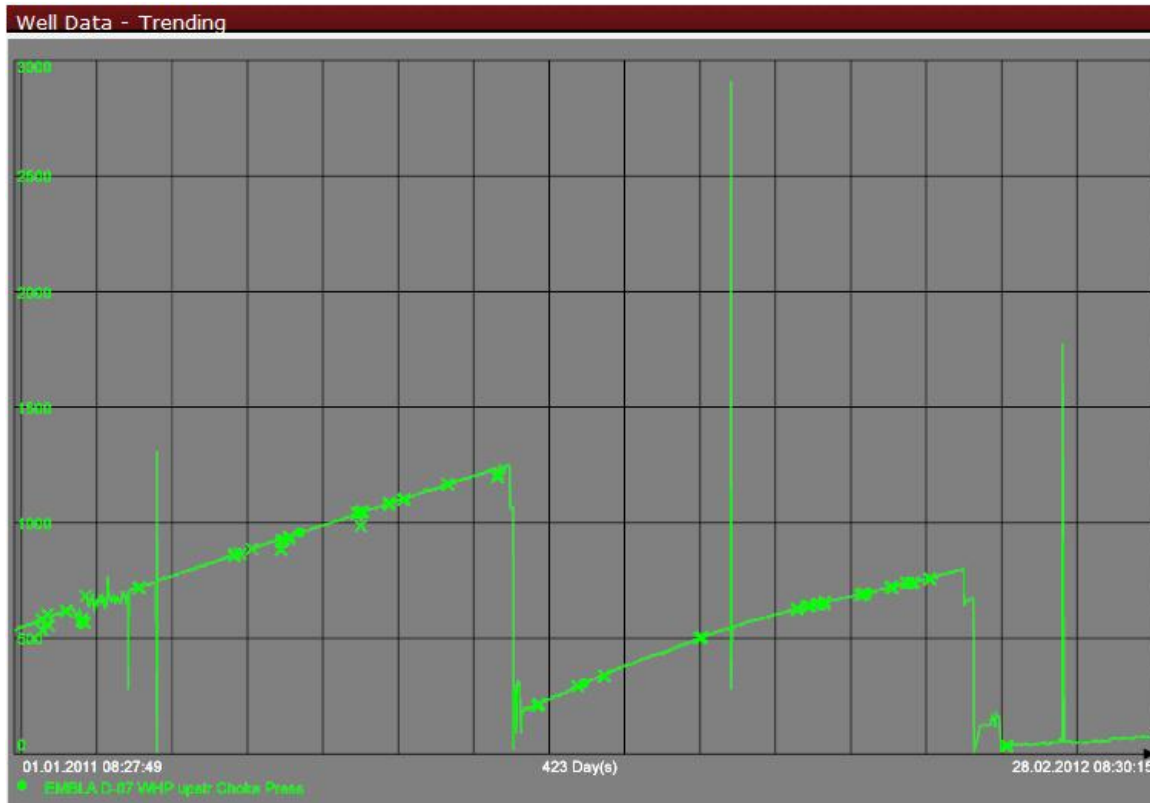
**Figure 29: Wellhead pressure monitoring on Embla D-07 – 01.01.2011 – 28.02.2012 (ConocoPhillips, 2012)**

The well pressure in Embla D-07 has been monitored since the setting of the Sandaband plug. Although the plug was set without complications, there is however, still a pressure build-up in the A-annulus, indicating that the Sandaband plug is not as impermeable as advertised. Figure 29 shows the pressure build in the well from 1<sup>st</sup> January 2011 until present day.

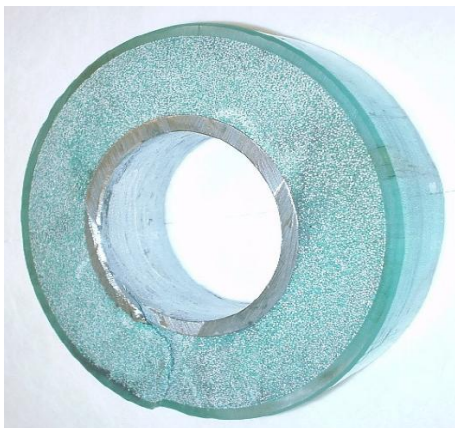
**Figure 30: Epoxy sealing material used with CannSeal (AGR, 2009)**

The CannSeal tool have been tested and approved to temperatures up to 120 °C and pressure up to 345 bar, and is run in hole with a single wire line run.

As of today however, CannSeal cannot promise a long term integrity barrier, and is therefore not suitable for permanent P&A (CannSeal, 2012).

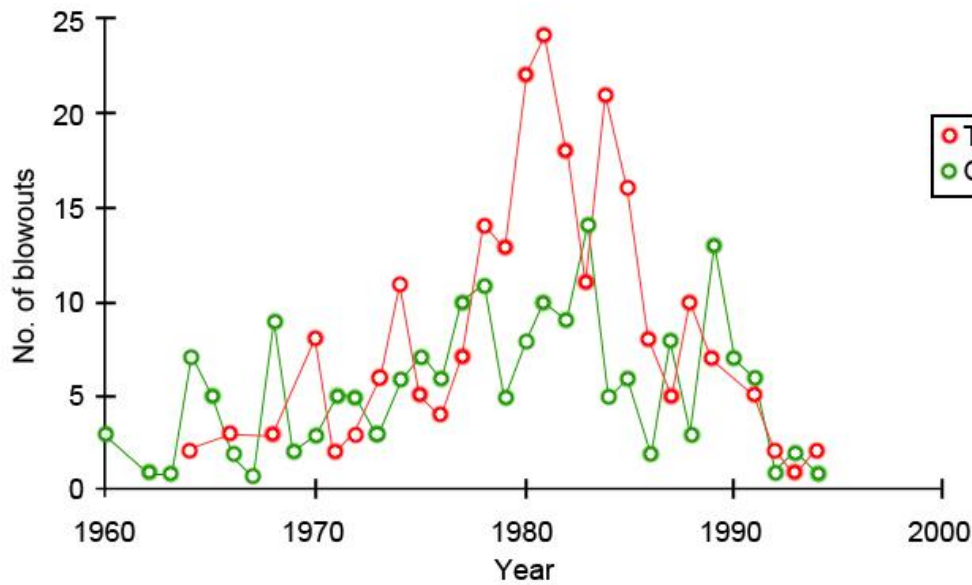
Figure 31: Blowout frequency in the US [Based on (Skalle, et al., 1998)]

By analyzing the database, trends and statistics are revealed. As seen in Figure 31, numbers of blowouts were at its highest in the early 80s. This corresponds to the high level of well activity in this period as seen on Figure 32.

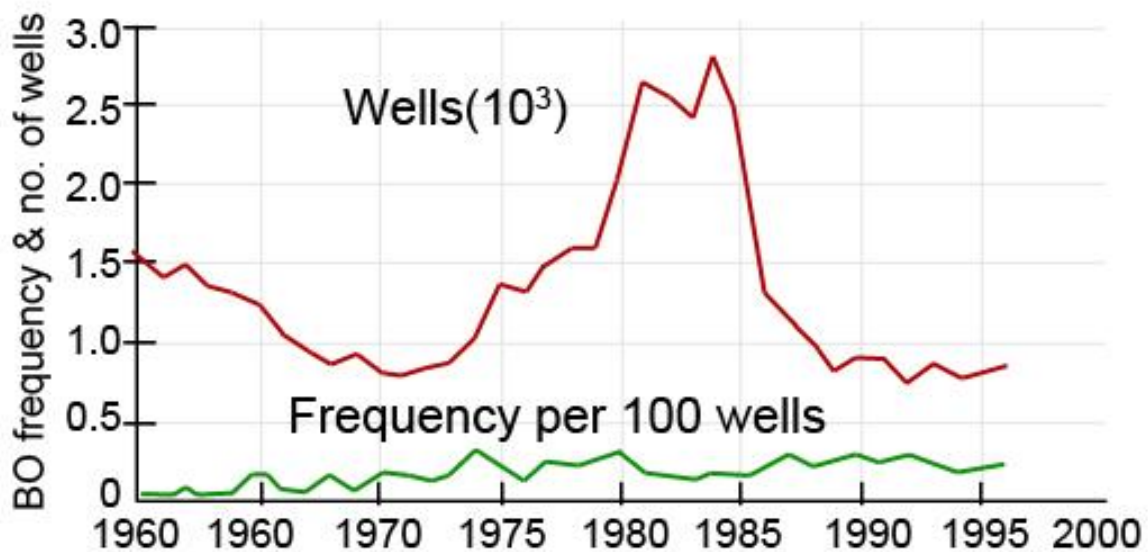
**Figure 33: Blowout frequencies for Texas [Based on (Skalle, et al., 1998)]**

By normalizing well activity and number of blowouts, a blowout risk assessment can be made. This is done by dividing blowout frequencies on amount of wells being drilled. In Figure 33, blowout frequencies for Texas are presented.

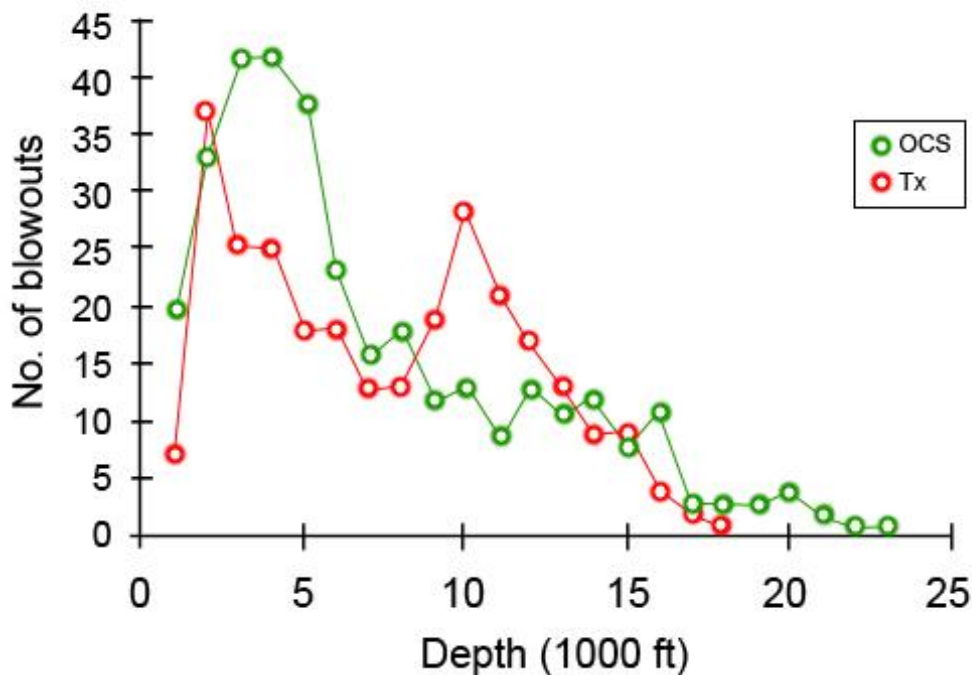
Figure 34: Blowouts in Texas and OCS vs. Depth [Based on (Skalle, et al., 1998)]

Figure 34 however, it is observed that most blowouts occurred at shallow depths.
