## MASTER'S THESIS

Petroleum Technology / Drilling

**Management of well barriers and challenges with regards to  
obtaining well integrity**

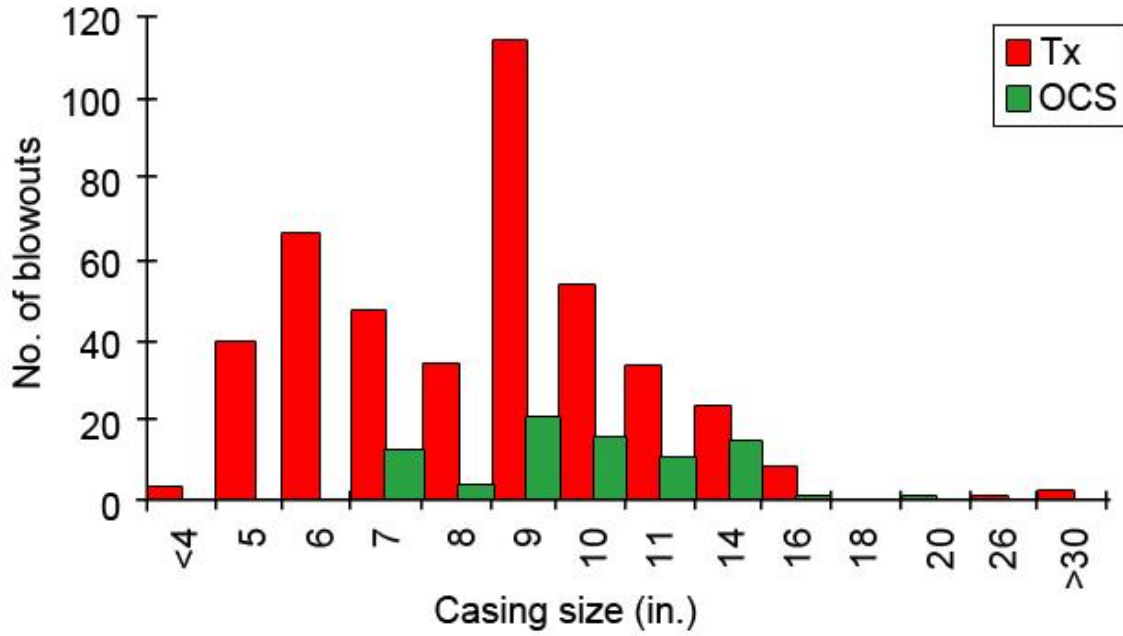
Figure 35: Number of blowouts in Texas and OCS vs. casing size [Based on (Skalle, et al., 1998)]

excluding the number of wells factor, it is observed that blowout frequencies are greater for smaller casing diameters, i.e. deeper wells, as expected.

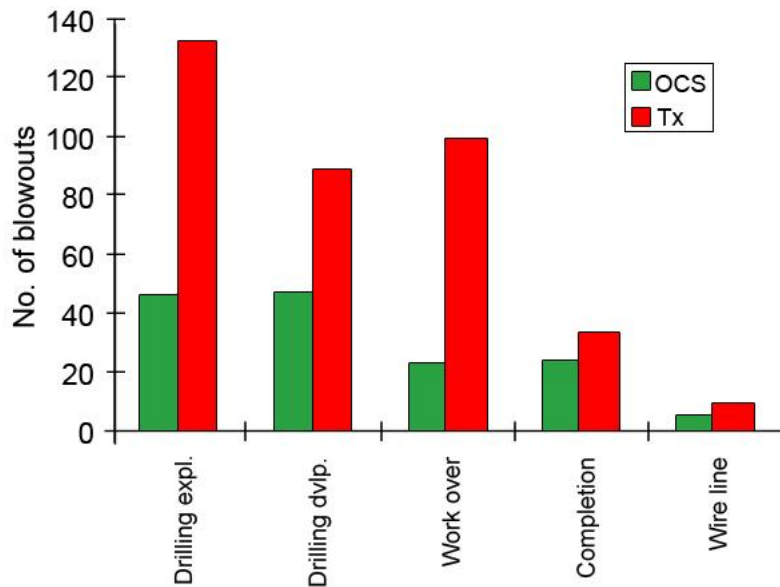
**Figure 36: Blowouts vs. operation type for Texas and OCS wells [Based on (Skalle, et al., 1998)]**

Blowout frequencies heavily depend on what type of operation which is active. In Figure 36, number of blowouts is shown vs. various active operations, such as exploration drilling, development drilling, workover, completion and wire line operations.

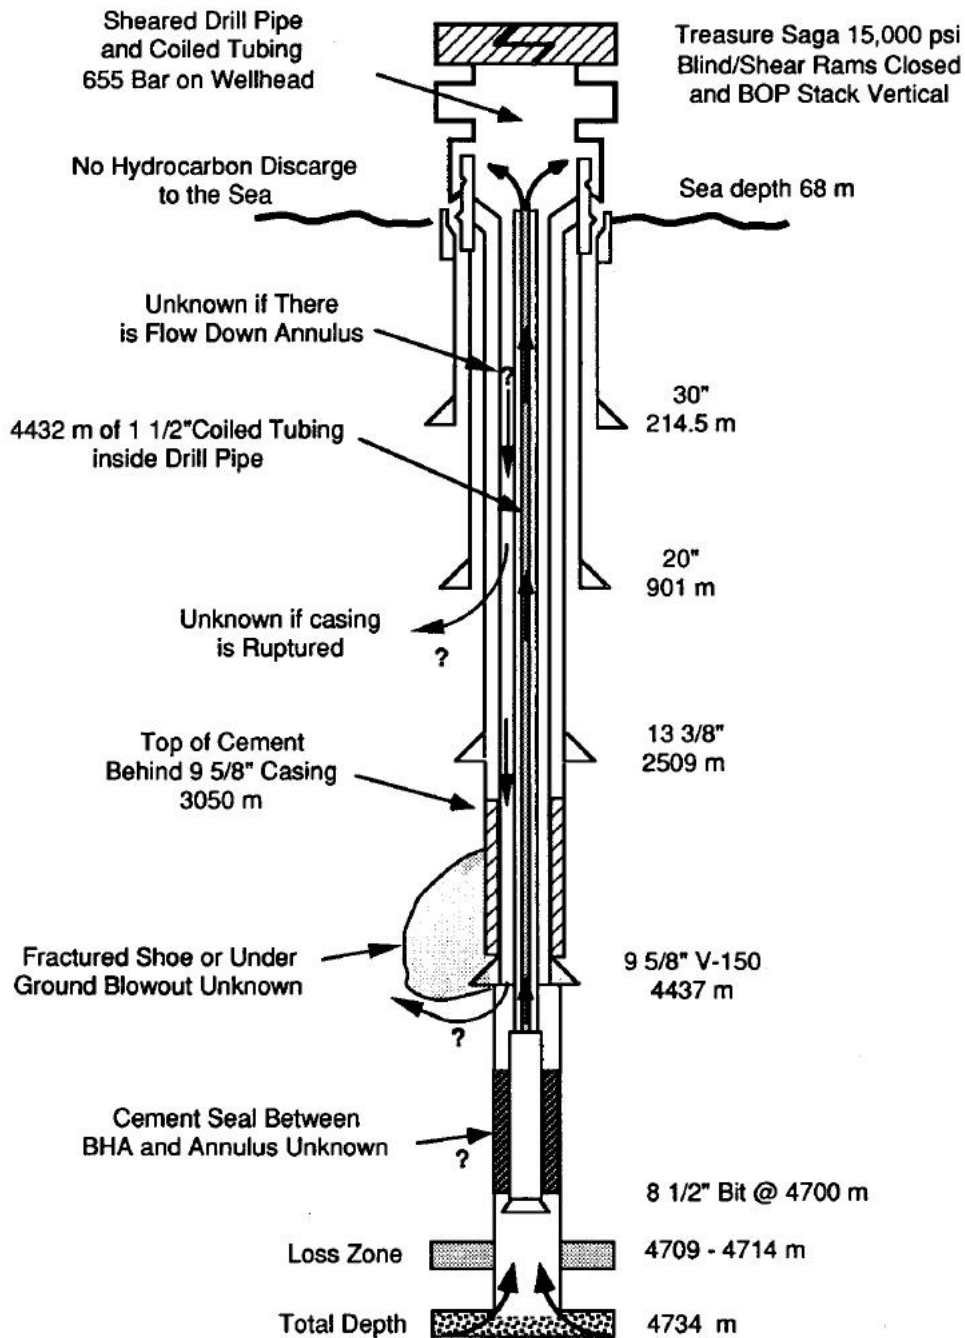
Figure 38: Status of well 2/4-14 after BOP closed (Ølberg, et al., 1991)

During this period, well control was lost, causing the shear-rams to cut the drill pipe, leaving approximately 4500m of drill pipe with coiled tubing in the hole (Figure 38). With the BOP closed, the shut in wellhead pressure reached 10 000 psi.

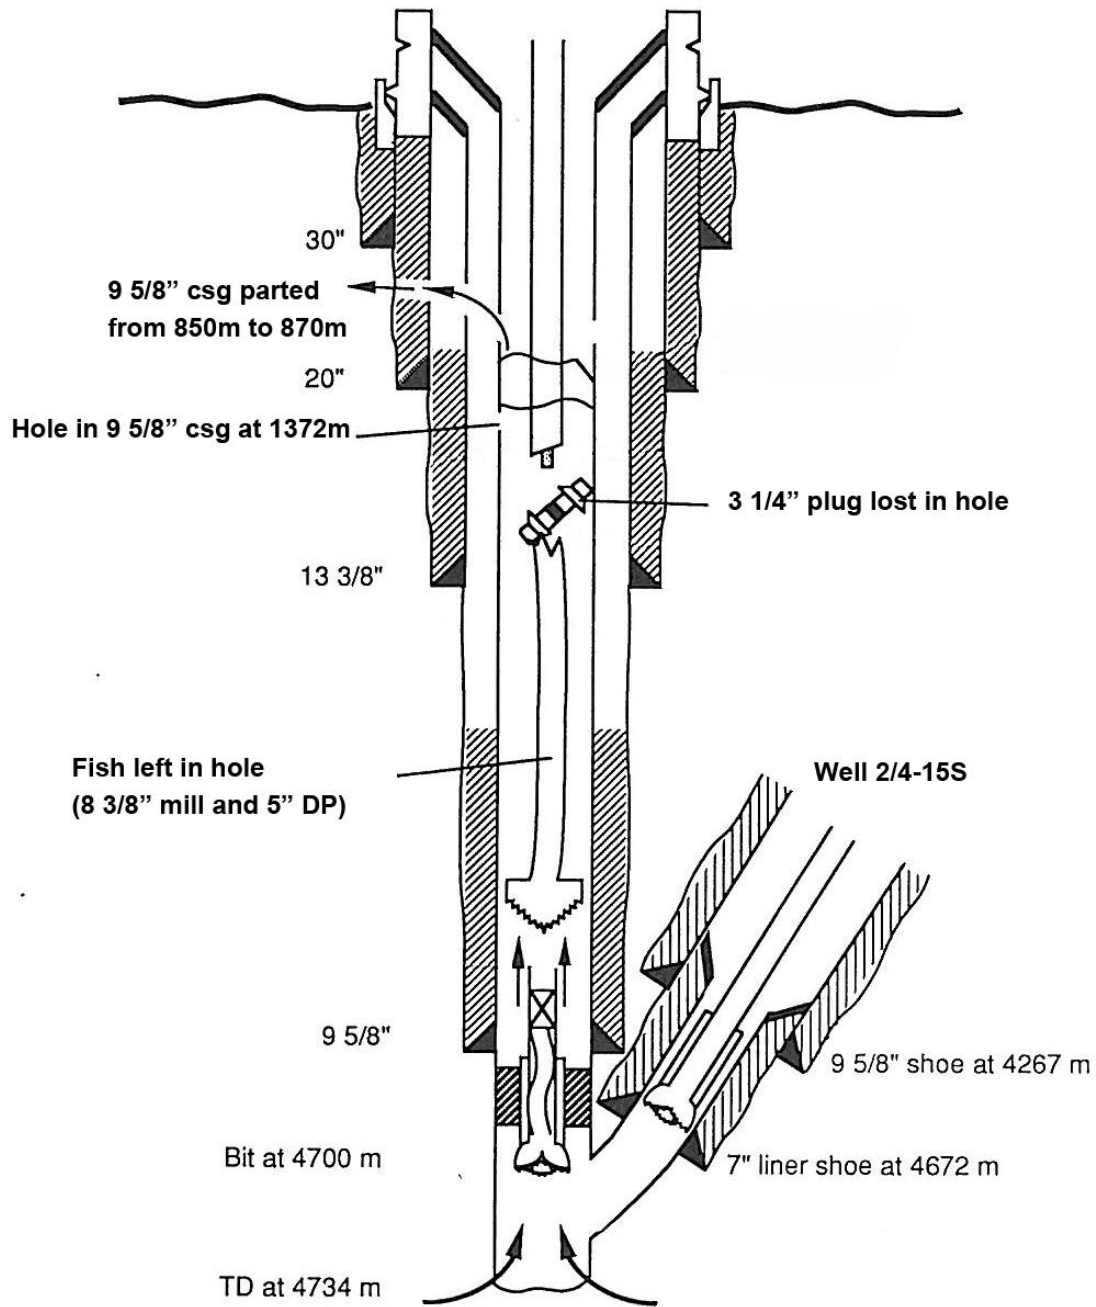
Figure 40: Status of the wells before kill operation started [Based on (Hide, 1994)]

The situation now worsened as not only the drill pipe had to be recovered, but the 9 5/8” casing had also parted, preventing the tieback plan (Figure 40).

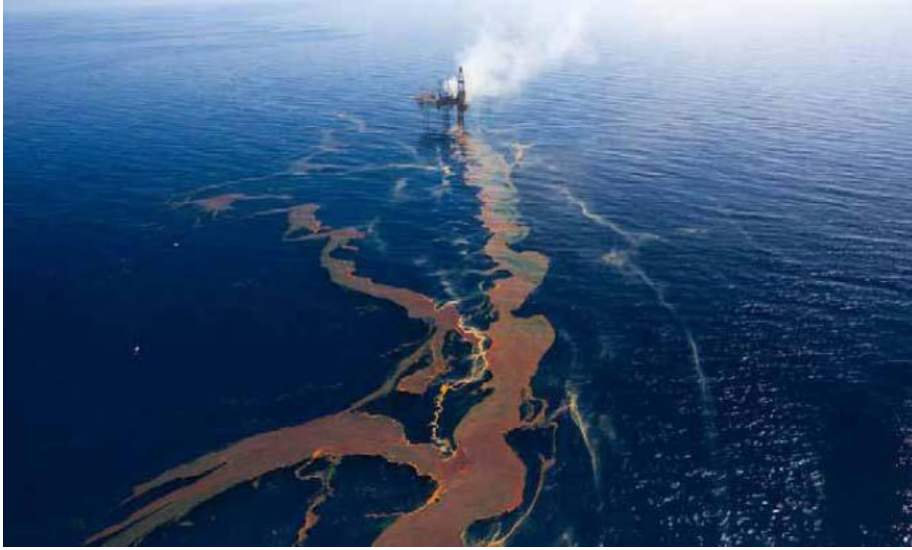
Figure 43: Montara well incident (PTTEP Australasia, 2011)

On the August 21<sup>th</sup> 2009, the Montara well located in Western Australia experienced a blowout which led to loss of the platform, loss of the *West Atlas* drilling rig, and an oil spill which caused major environmental damages (Australian Government, 2011) (SINTEF, 2011).

Montara was a suspended well without tested or verified barriers, and one of the barriers that should've been installed was missing (Vignes, 2012). The 9 5/8" casing had been cemented, but even though some challenges occurred during the cement job, no pressure tests were conducted, leaving this "barrier" unverified. Two pressure controlling anti-corrosion caps (PCCC) acting as secondary barrier elements were planned to be installed. However, according to the manufacturer of the PCCCs, these were not suitable as well barrier elements.

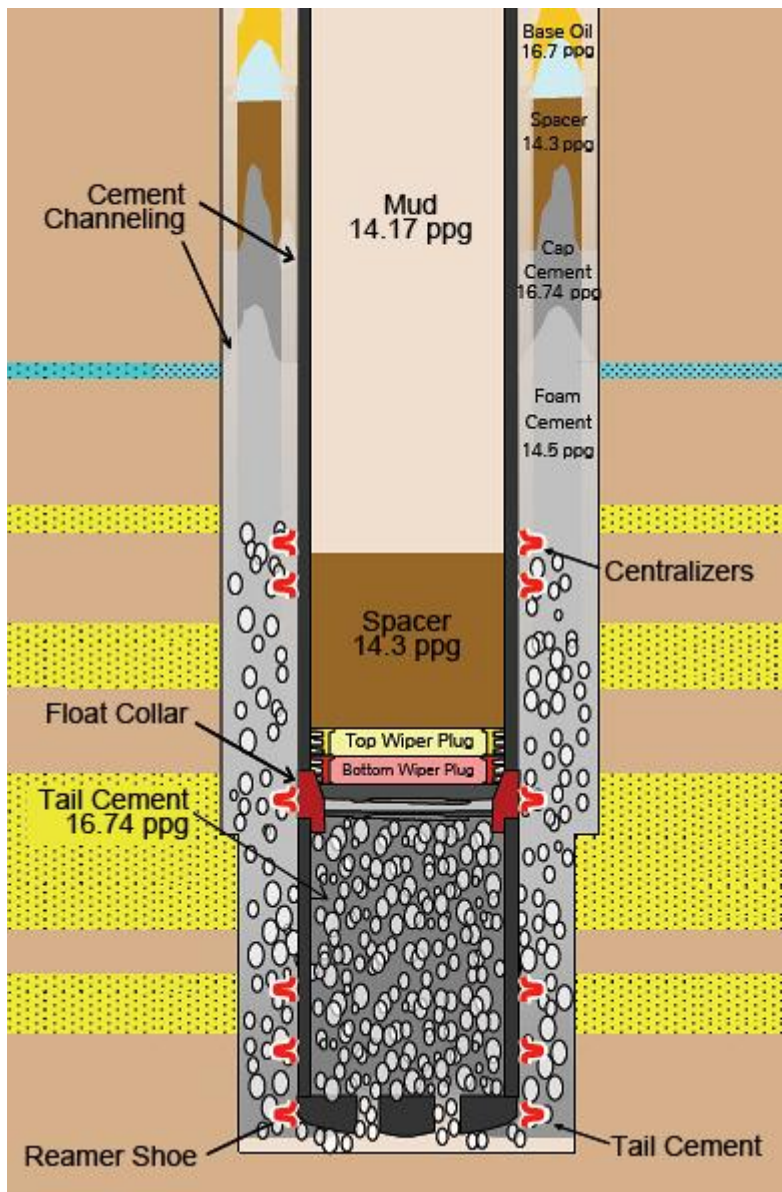
Figure 46: Nitrogen breakout in the cement [Based on (BP, 2010)]

1. The annulus cement did not isolate hydrocarbons due to nitrogen breakout in the cement (Figure 46).
