University of
Stavanger

MASTER'S THESIS

Study program/ Specialization: Petroleum Engineering – Master of Science Degree Programme	Spring semester, 2013 Open access
Writer: Kristine Geitle (Writer's signature)
Faculty supervisor: Merete V. Madland	
Title of thesis: <i>Chemically induced compaction in fractured and intact chalk cores</i>	
Credits (ECTS):30	
Key words: <ul style="list-style-type: none">• Chalk• Mons – Obourg Saint Vaast• Water weakening• SSW• MgCl₂• Fractures• SEM images• Compaction	Pages: 78 + enclosure: N/A Stavanger, 16.06.2013 Date/year

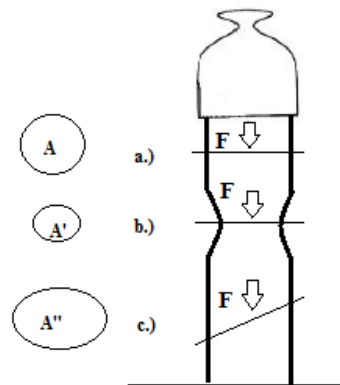
Figure 2.2: Illustration of a weight causing a force to act on a pillar. When the cross-section area is smaller (A'), the stress will be larger here than for the situation in (A).

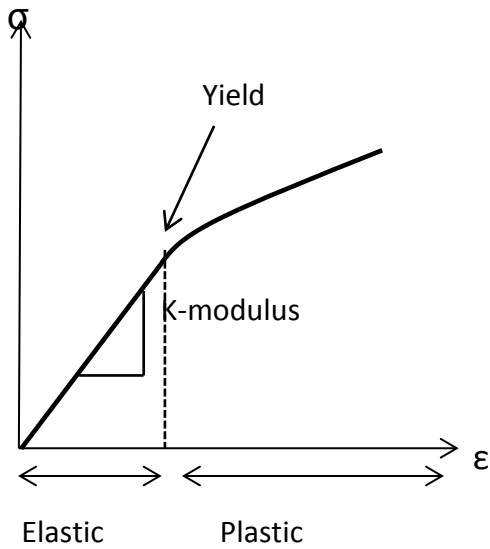
Figure 2.4: Stress-strain relationship. If the material is loaded beyond the yield point, it will be permanently deformed and is no longer able to recover to its original state.

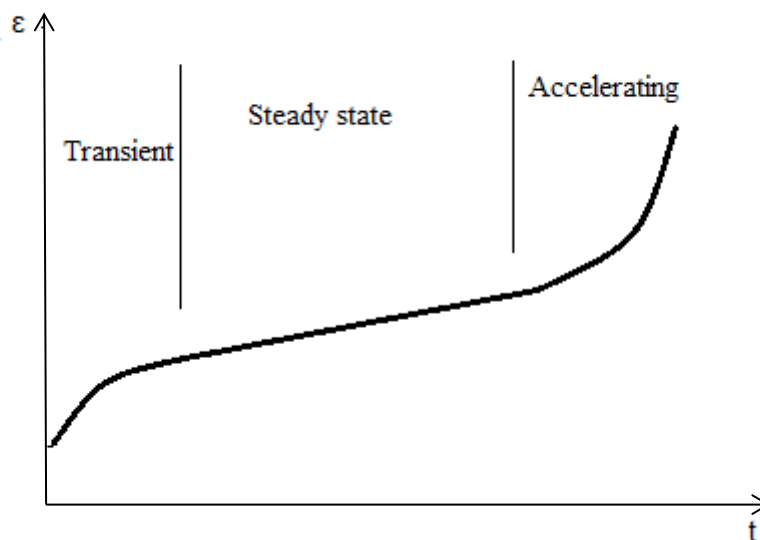
Figure 2.5: Strain versus time for a material which undergoes the three stages of creep.

Creep is defined as a time-dependent deformation that may occur when materials are subjected to constant stress. It is a molecular process, so by increasing the temperature the process becomes faster. Since the stress states are changing, creep is divided into three different phases: transient, steady state and accelerating.

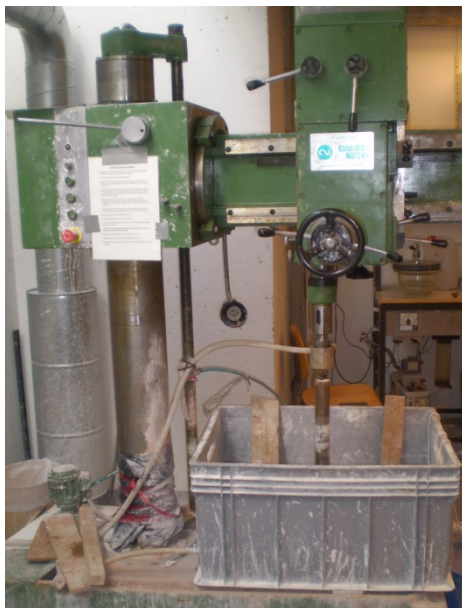
Figure 3.1: The drilling machine used to extract the cores from the Mons chalk block.

Several core samples were drilled out from the Mons chalk block by using a drilling machine with a cylindrical core bit, as shown in figure 3.1. The chalk block was placed inside the container and water is flushed through the core bit, while drilling.

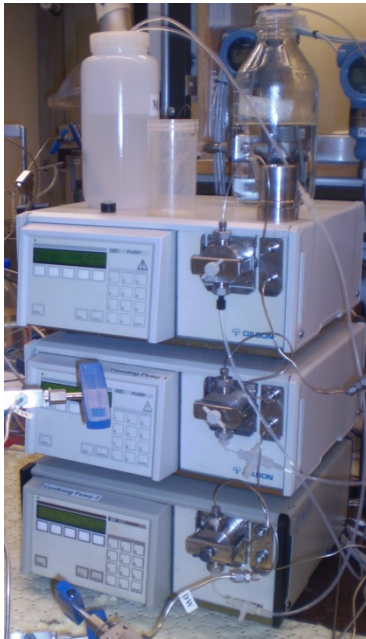
Figure 3.9: Gilson pumps, Model 307 HPLC.

The triaxial cell was operated by three high pressure *Gilson Pumps, Model 307 HPLC* (see Fig. 3.9). One pump called the *flooding pump*, is controlling the rate of the brine passing through the test core. To ensure that force is acting equally in all directions around the core, a second pump is necessary called the *confining pump*. For the core to be deformed in the axial direction, a piston is lowered on top of it. The force needed is supplied by a third pump called *the piston pump*.

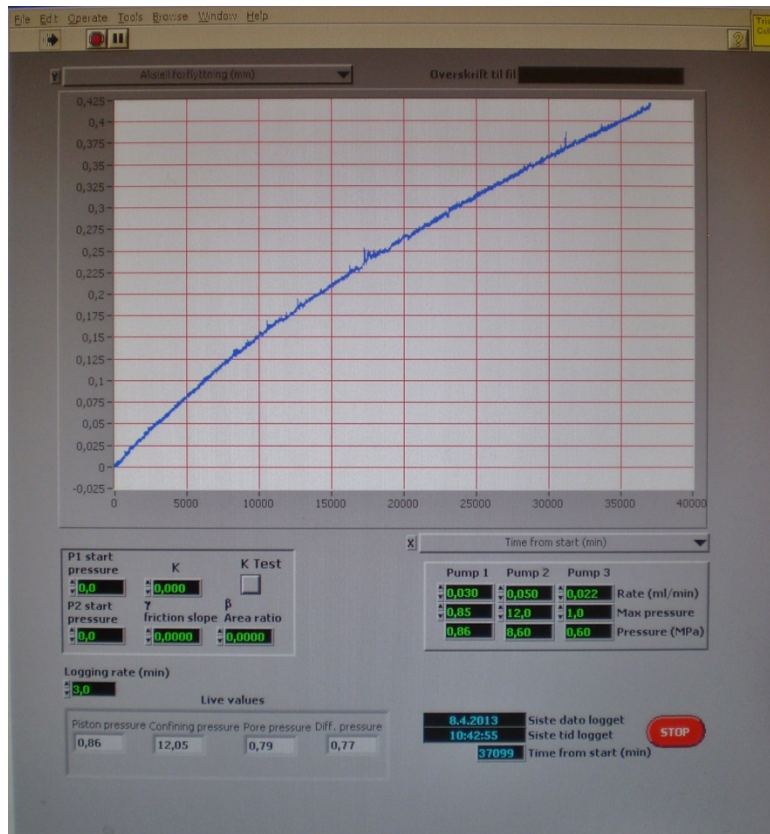
Figure 3.10: The LabVIEW program makes it easy to control and monitor flooding rates, time intervals, maximum pressures and displays the results graphically.

The pumps can be controlled manually, but is mainly operated by using a computer program called *LabVIEW*. Flooding rates and maximum pressure values can be set and changed as desired during testing. These values are logged in an excel sheet, together with information such as temperature, axial deformation and elapsed time. The latter is varied and adapted through different stages of the experiment. For instance it can be beneficial to log every minute in the beginning during hydrostatic loading, and increase the time interval to 3-5 minutes when reaching the creep phase. By using the Labview software program it is possible to always keep track on how the mechanical behavior of the core sample is changed when flooding with various brines. A graph constantly provides updated results over axial movement versus time, or other information needed while the experiment is running.

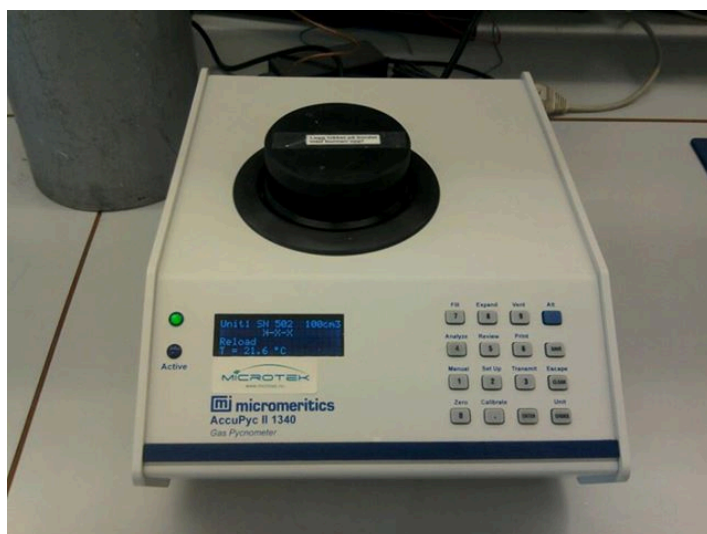
Figure 3.15: AccuPyc II 1340 Gas pycnometer.

Afterwards, the core slices were measured on a scale to find the weight of each slice and then put inside an AccuPyc II 1340 Gas pycnometer (see Fig. 3.15). The pycnometer calculated the samples volume and standard deviation, and made it possible to find the density of each slice after testing.

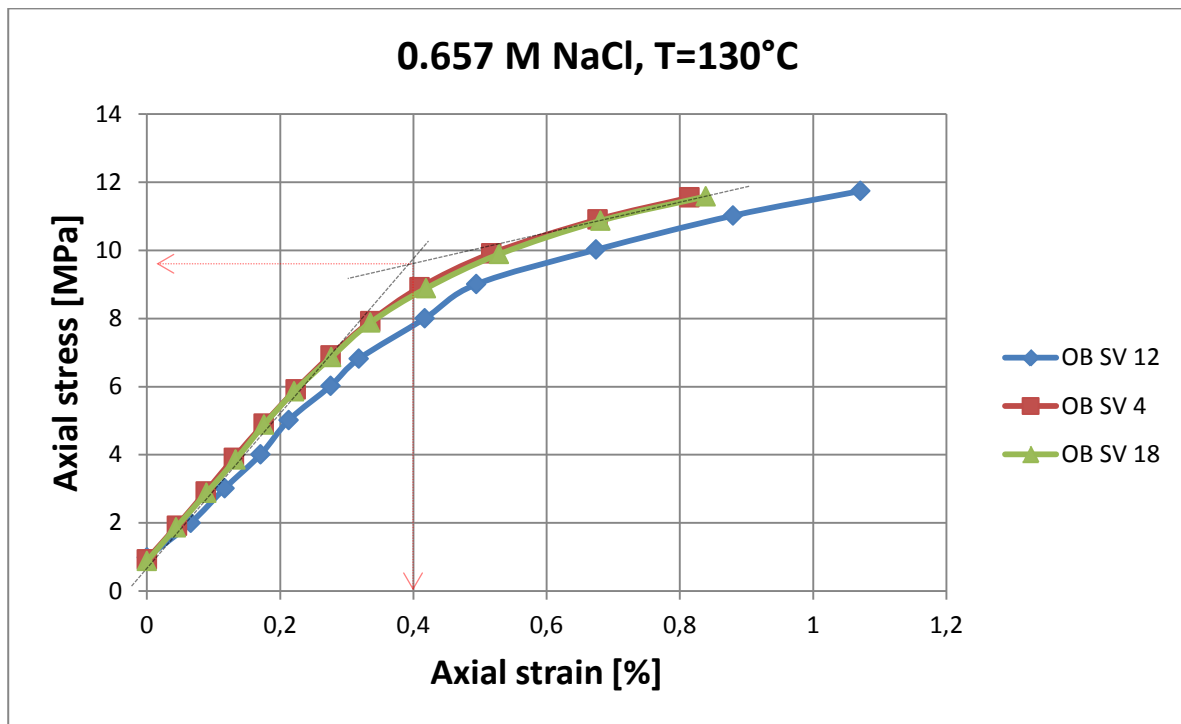
Figure 4.1: Axial stress [MPa] plotted as a function of axial strain [%], for the three *fractured* core samples; OB SV 12, OB SV 4 and OB SV 18.

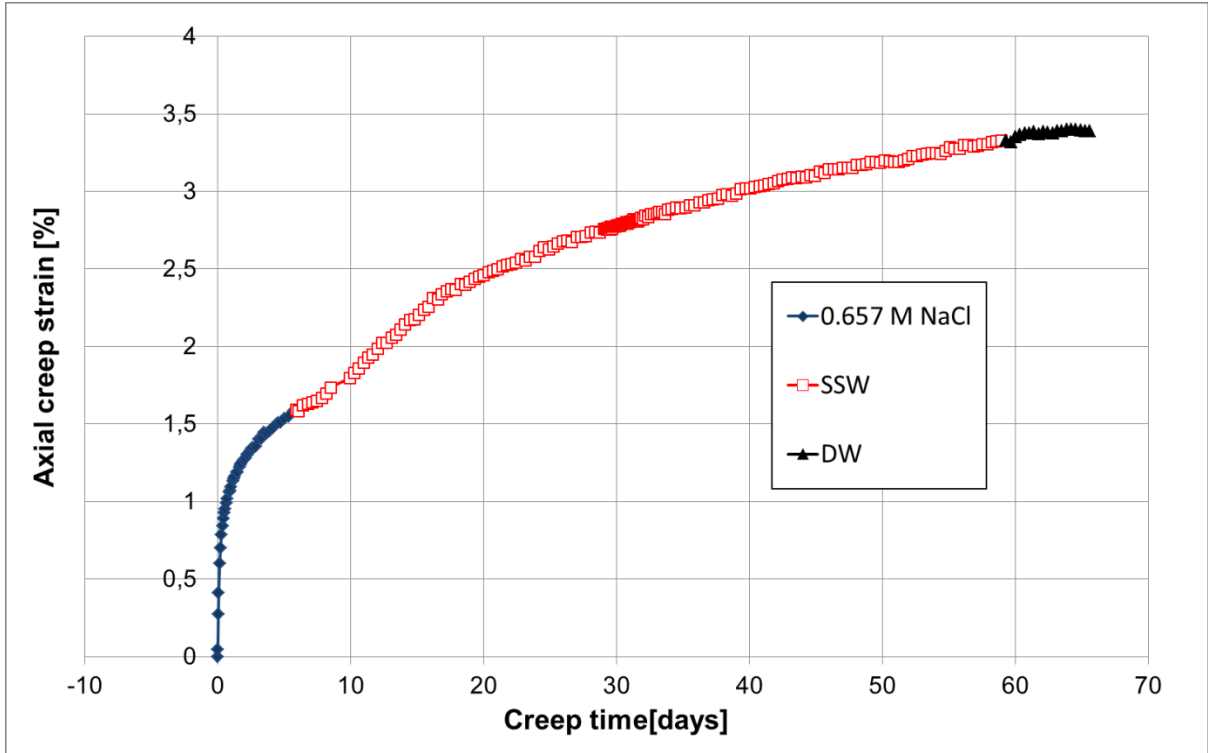
Figure 4.2: Axial creep strain [%] plotted as a function of creep time [days] for the *fractured* core OB SV 12.

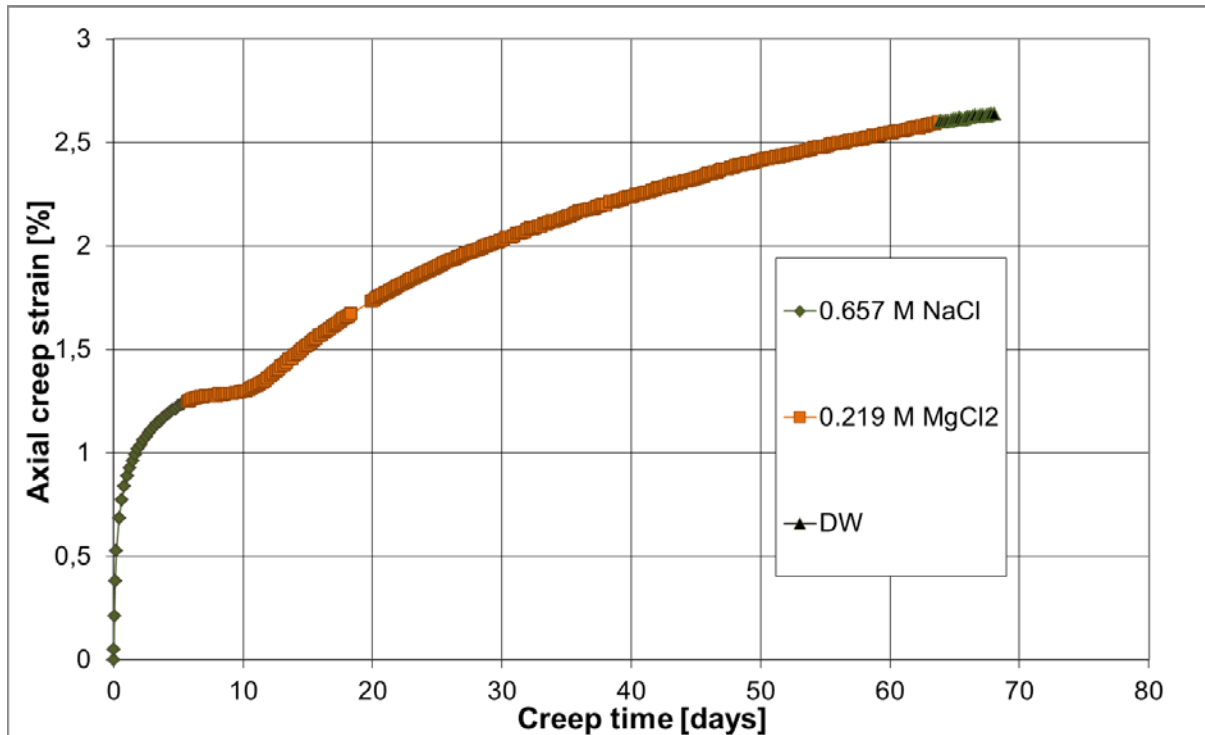
Figure 4.3: Axial creep strain [%] plotted as a function of creep time [days] for the *fractured* core OB SV 4.

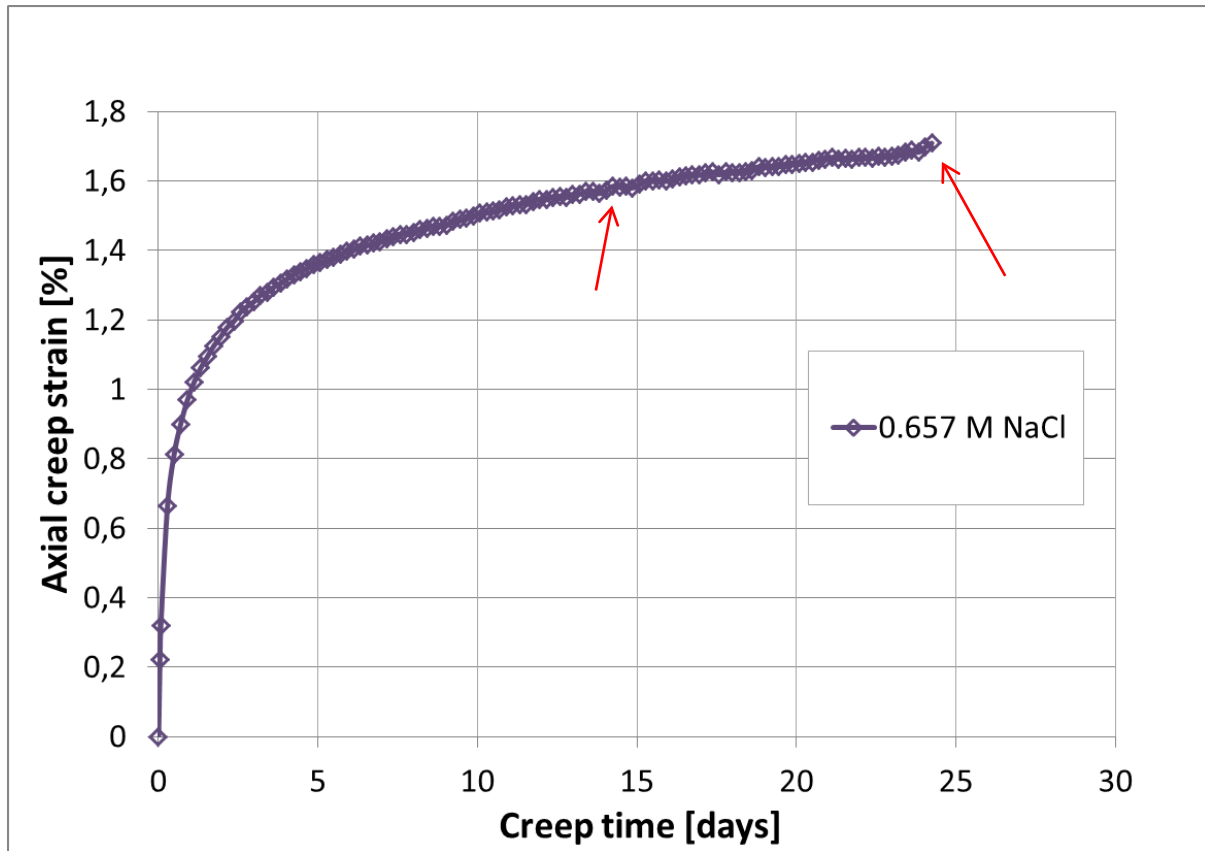
Figure 4.4: Axial creep strain [%] plotted as a function of creep time [days] for the *fractured* core OB SV 18.

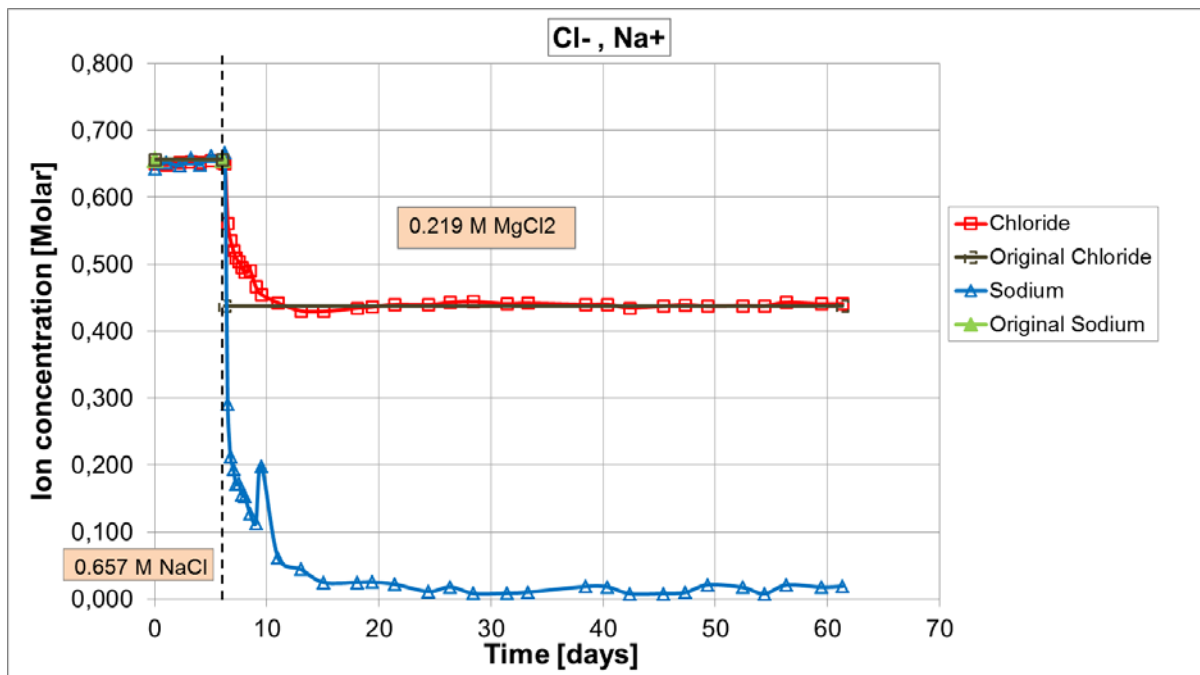
Figure 4.6: Ion concentration [Molar] for chloride and sodium, plotted as a function of time [days] for OB SV 4 (fractured).

From the effluent water collected from OB SV 4, it was observed that both the chloride and sodium concentration fluctuates around their original concentration of 0.657M NaCl prior to brine change. Almost immediately after the flooding brine is switched to 0.219M MgCl₂, the sodium concentration drops to approximately 0,220M and gradually moves towards zero the following days. This is an expected outcome since there is no sodium in the injected MgCl₂ brine. The chloride also experiences a drop in concentration after the brine is changed and starts to stabilize around a value of 0.438M, which is the actual concentration of MgCl₂ in the flooding brine (see figure 4.6).

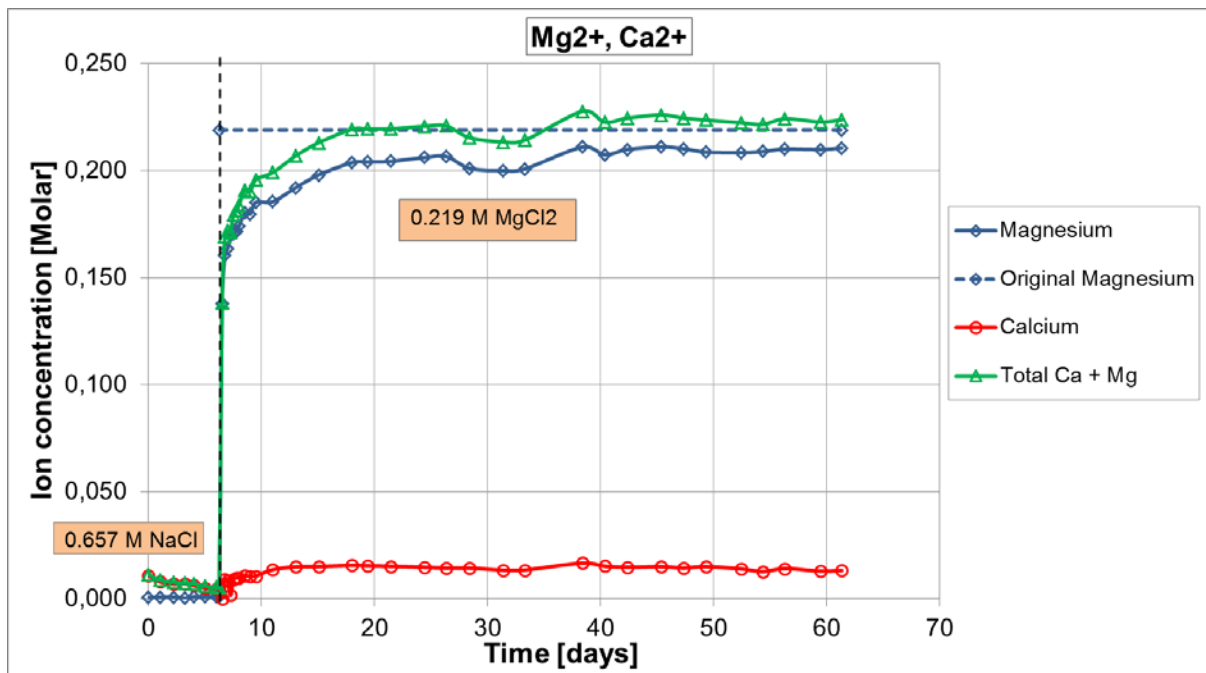
Figure 4.7: Ion concentration [Molar] for magnesium and calcium, plotted as a function of time [days] for OB SV 4 (fractured).

When flooding with 0.657M NaCl there is very small amounts, if any, of calcium in the effluent brine. However, after the brine is changed to 0.219M $MgCl_2$ the calcium concentration eventually starts to accelerate, hence being produced from the chalk core. The calcium concentration tends to stabilize after 10 days at a value of 0.015M. Immediately after brine change it can be seen that magnesium is detected in the effluent as a result of the core containing a hole, and thereby causes the brine to flood straight through. The concentration then tends to gradually increase for the next 12 days. For the following period, the magnesium concentration stabilizes, but it never reaches the original magnesium concentration of 0.219M. This can be an indication that some of the magnesium is left within the core. By adding the loss of magnesium and thereby the production of calcium in the effluent, it can be seen that the total value is fluctuating around the original magnesium concentration (See figure 4.7)

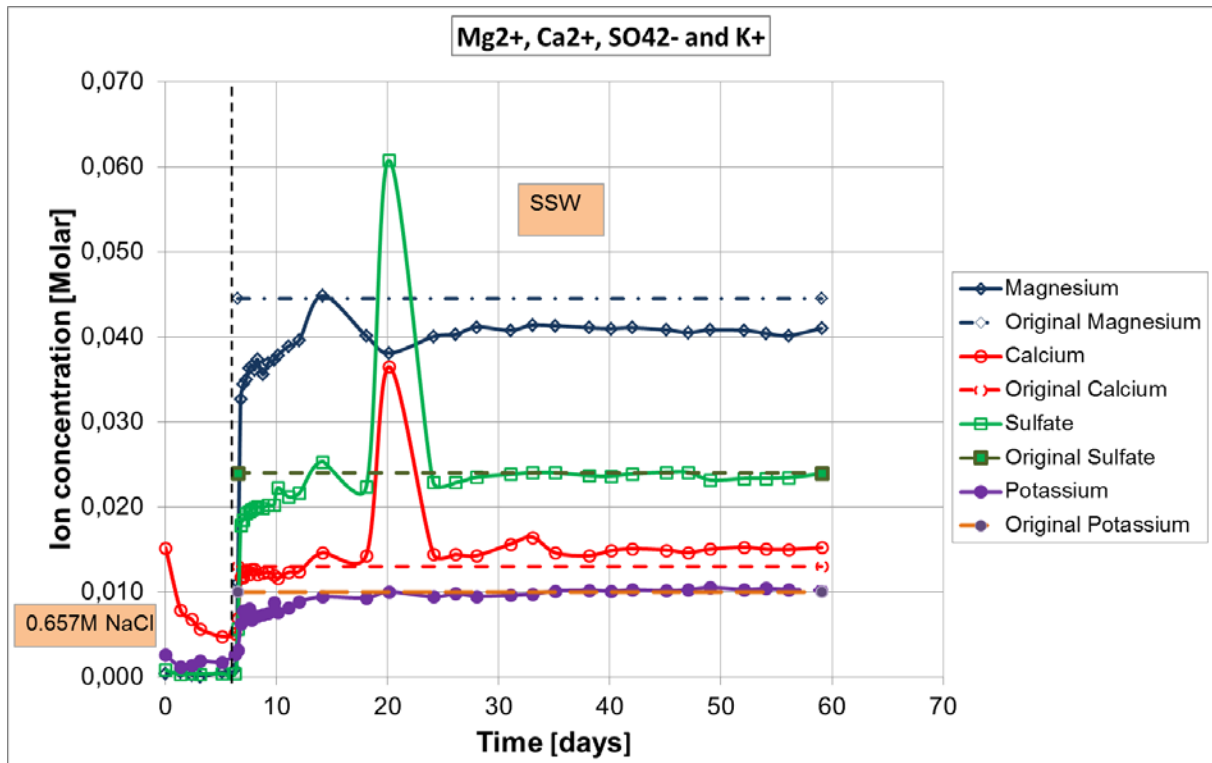
Figure 4.8: Ion concentration [Molar] for magnesium, calcium, sulfate and potassium plotted as a function of time [days] for OB SV 12.

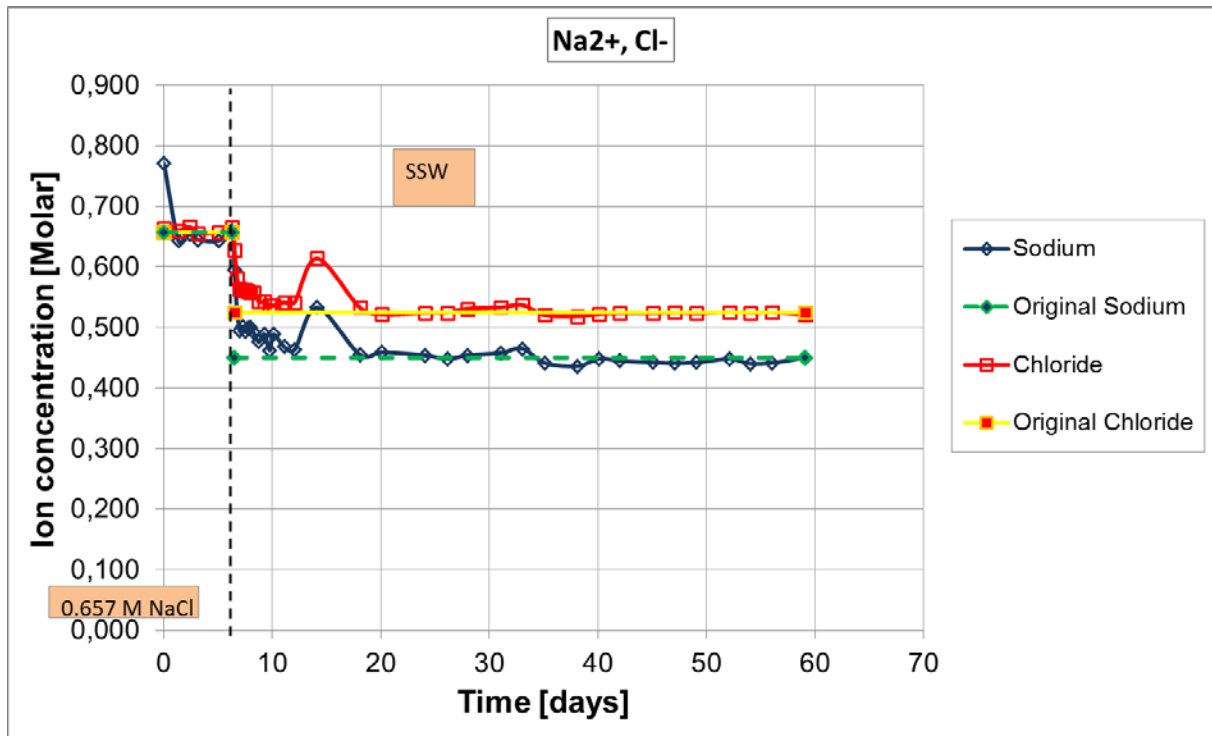
Figure 4.9: Ion concentration [Molar] for sodium and chloride, plotted as a function of time [days] for OB SV 12 (fractured).

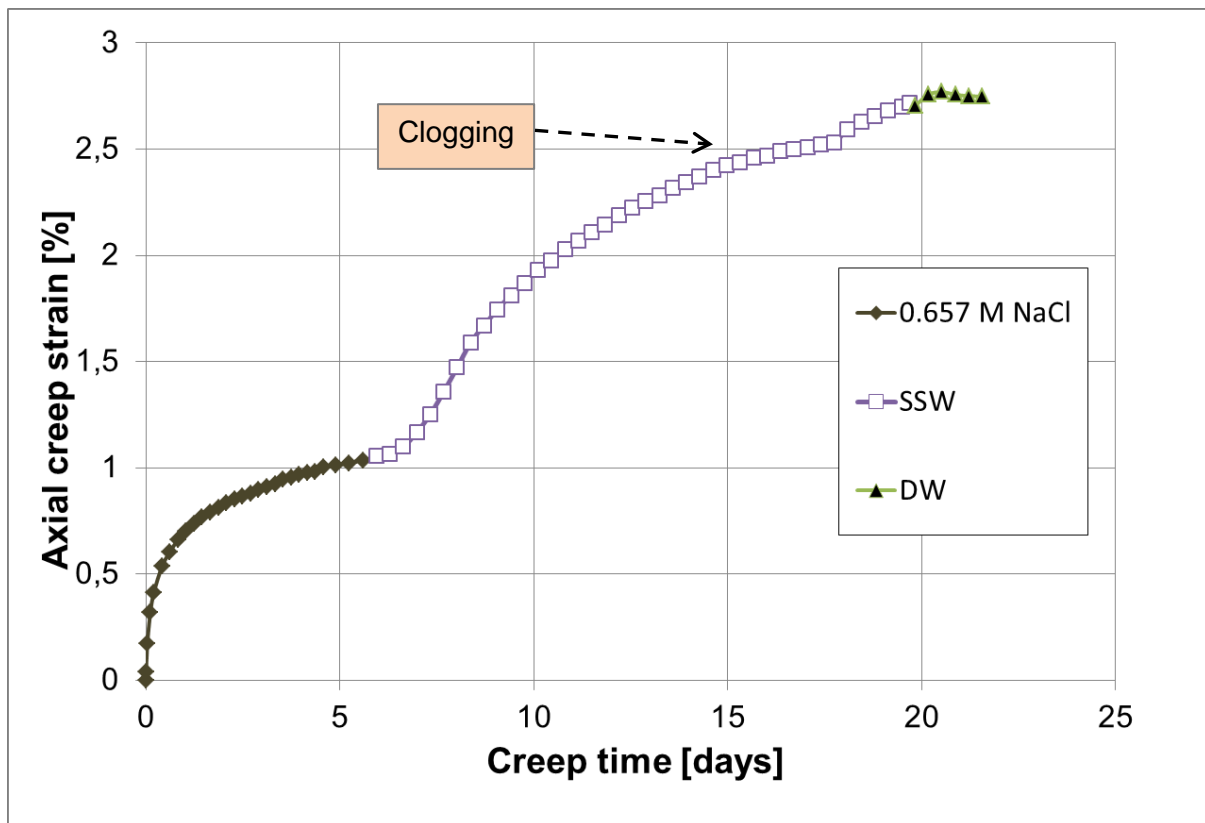
Figure 4.11: Axial creep strain [%] plotted as a function of creep time [days] for OB SV 9.

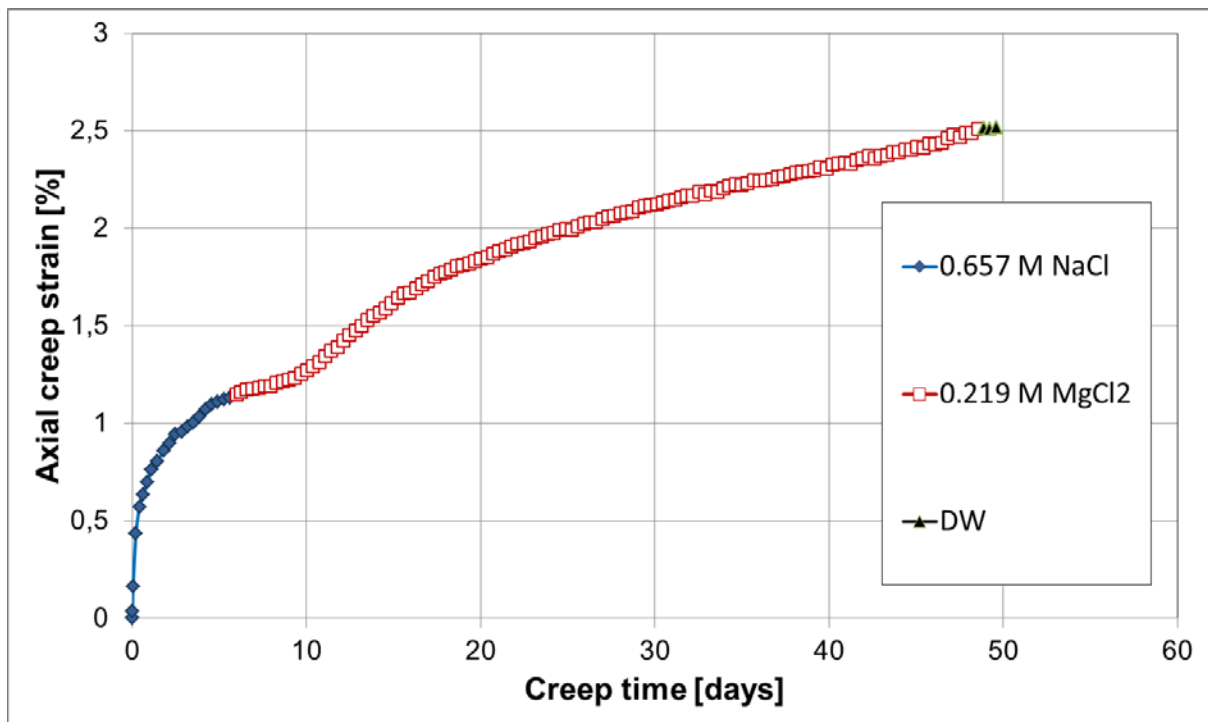
Figure 4.12: Axial creep strain [%] plotted as a function of creep time [days] for OB SV 6.

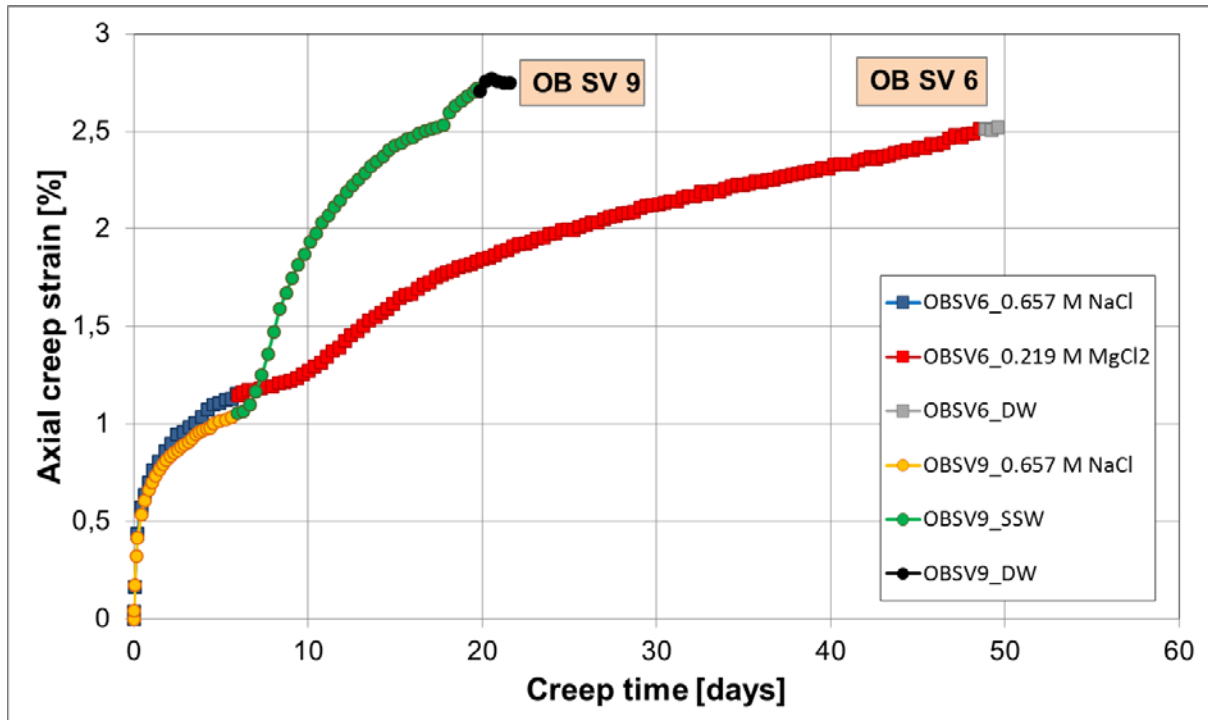
Figure 4.13: Comparison of the axial creep strain [%] as a function of creep time [days] for the fractured cores OB SV 9 flooded with SSW and OB SV 6 flooded with 0.219M MgCl₂.

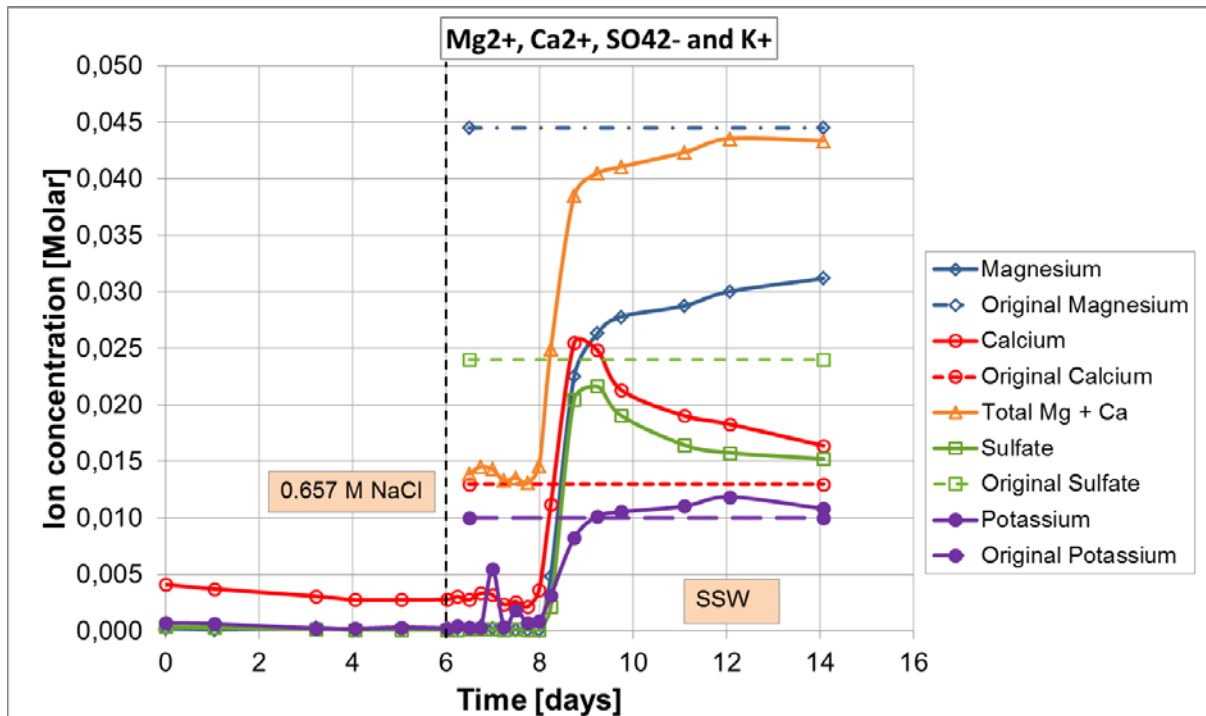
Figure 4.14: Ion concentration present in the effluent brine plotted as a function of time for OB SV 9. Magnesium, calcium, sulfate and potassium ions and their original concentrations in the SSW.

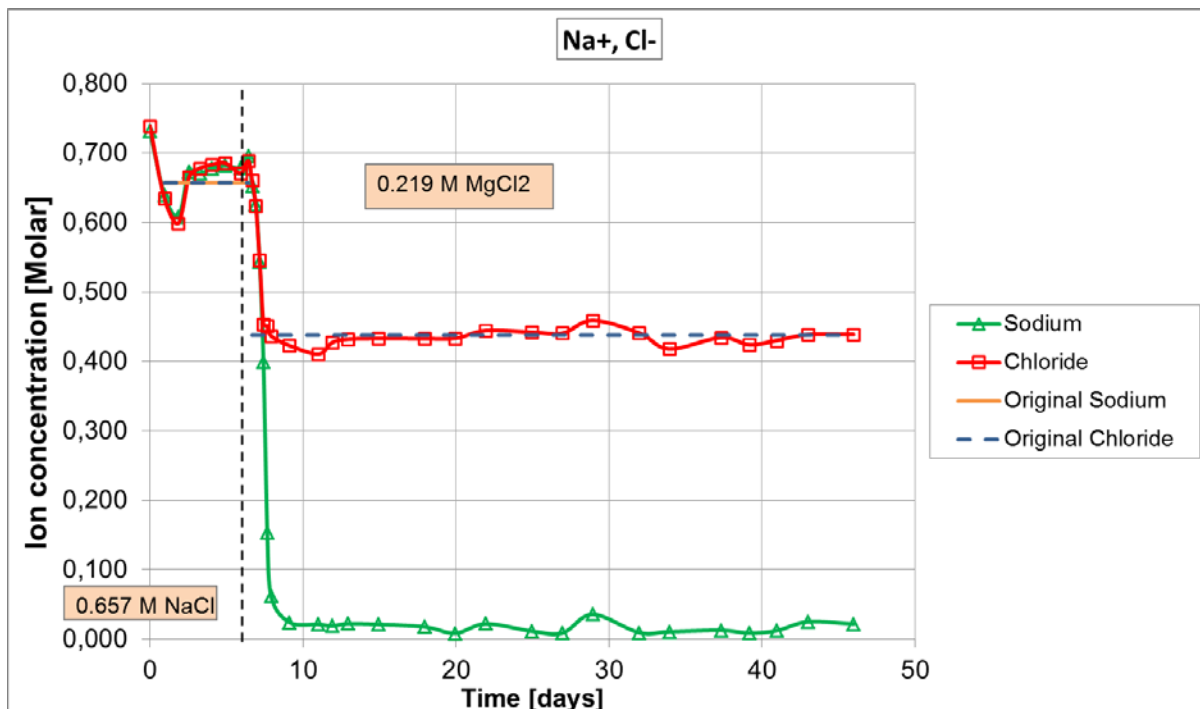
Figure 4.16: Ion concentration present in the effluent brine plotted as a function of time for OB SV 6. Sodium and chloride ions and their original concentrations.

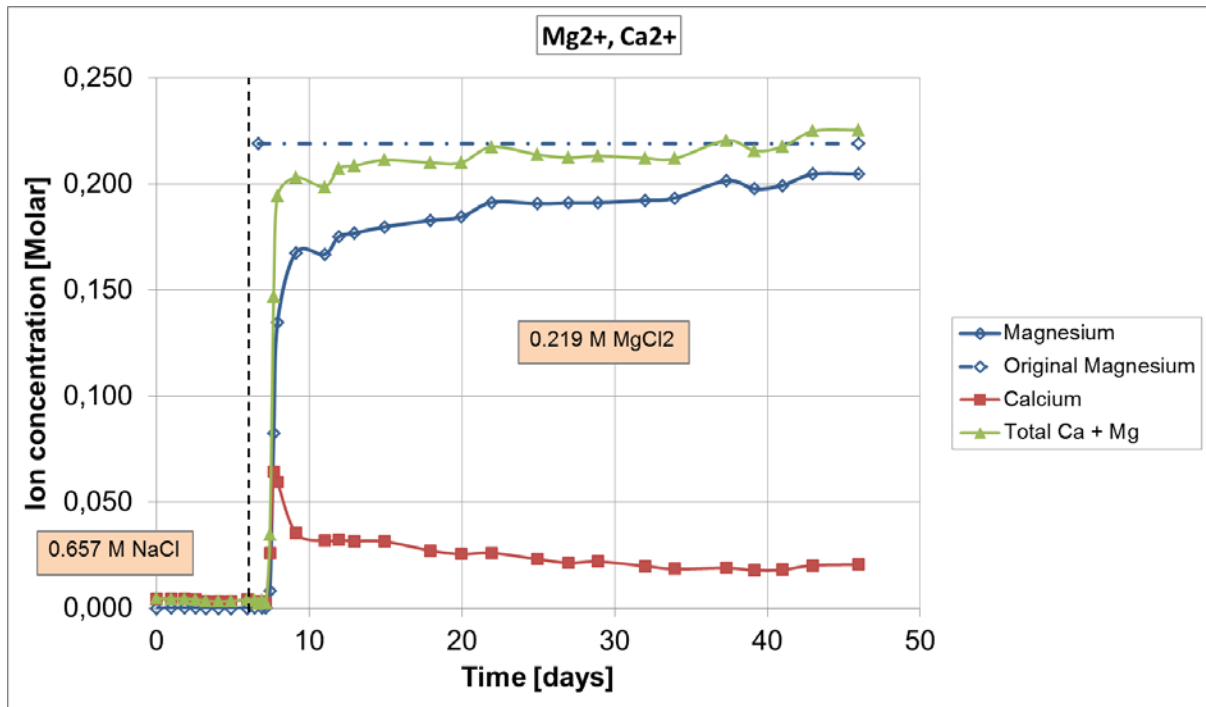
Figure 4.17: Ion concentration present in the effluent brine plotted as a function of time for OB SV 6. Magnesium and calcium ions and their original concentrations.

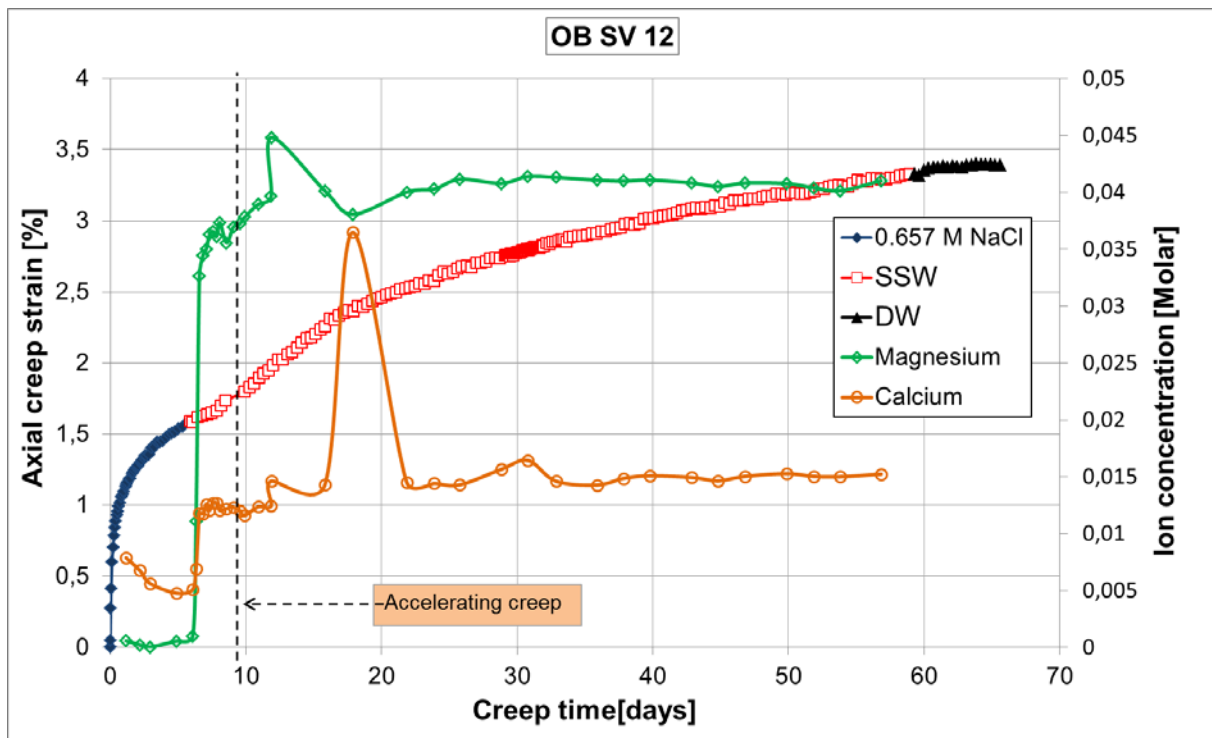
Figure 5.6: Axial creep strain [%] plotted as a function of creep time [days] in addition to ion concentration [molar] for OB SV 12 (fractured).

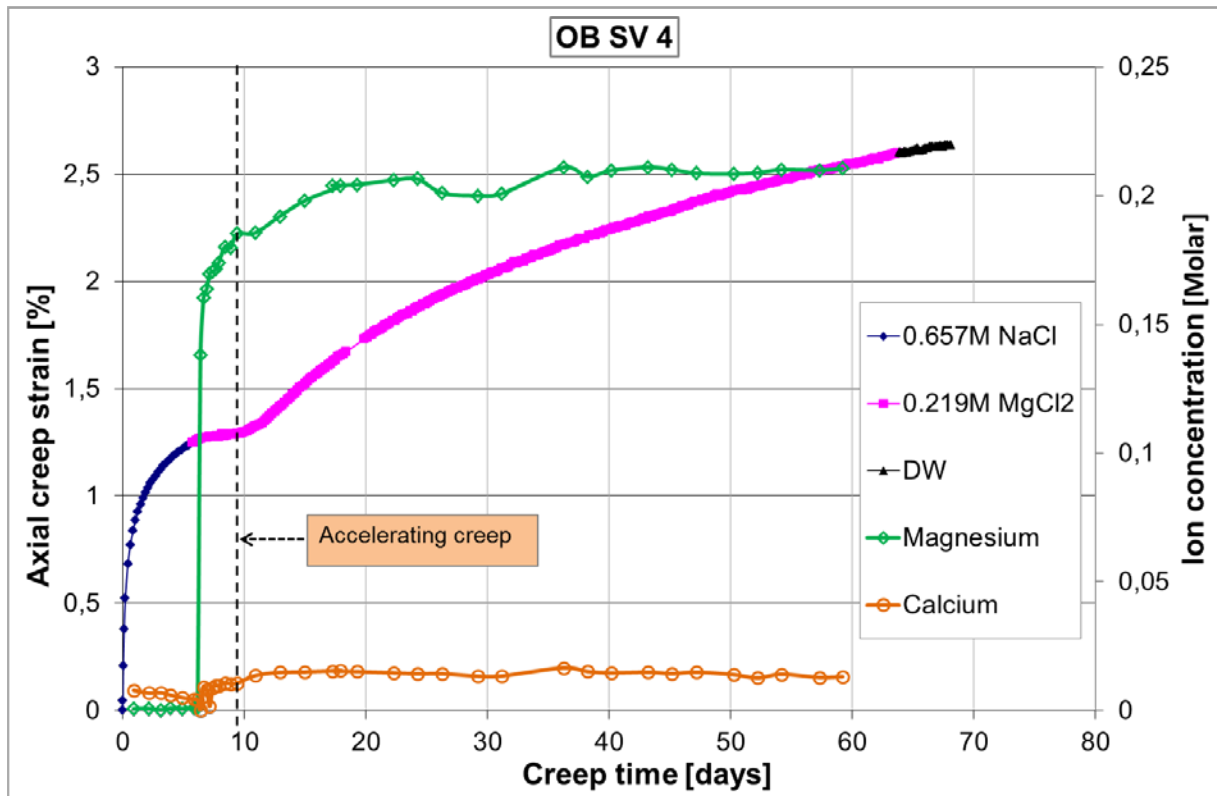
Figure 5.7: Axial creep strain [%] plotted as a function of creep time [days] in addition to ion concentration [molar] for OB SV 4 (fractured).

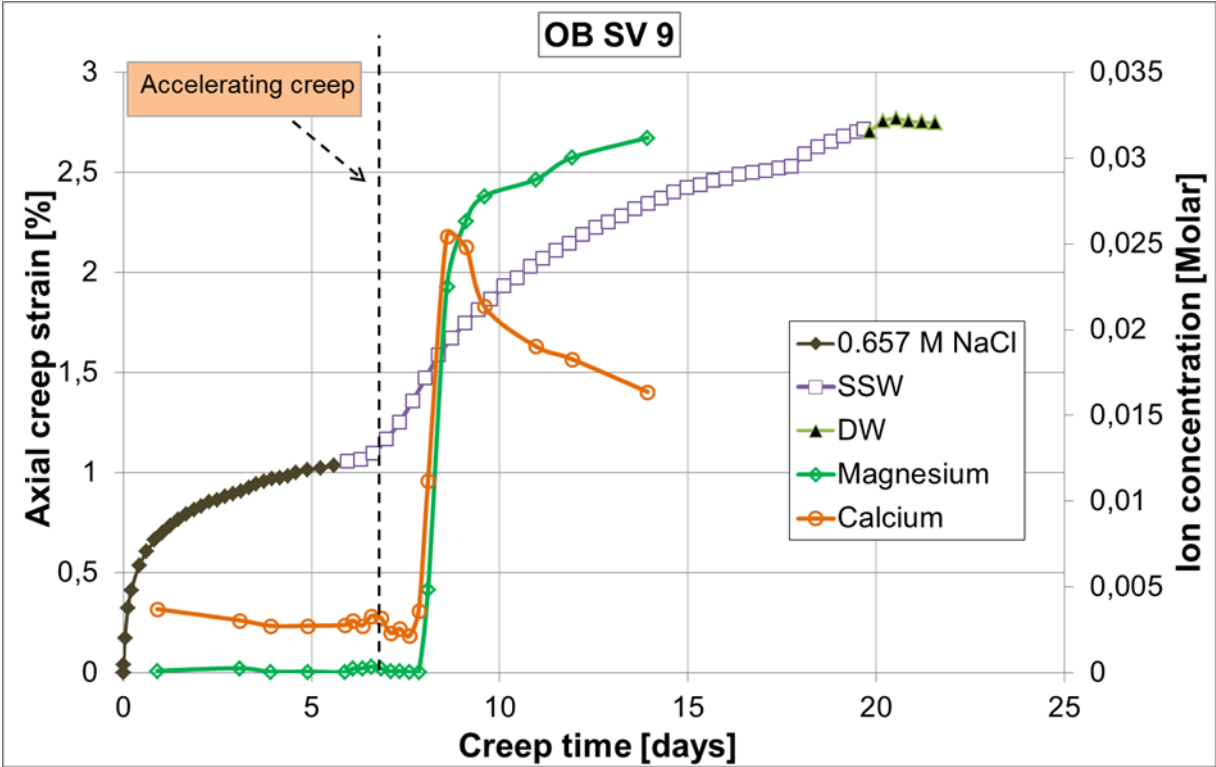
Figure 5.10: Axial creep strain [%] plotted as a function of creep time [days] in addition to ion concentration [molar] for OB SV 9 (intact).
