MASTER'S THESIS

(Writer's signature)
Faculty supervisor: Torfinn Havn External supervisor: N/A	
Thesis title: <i>A comparison of cold strained and solution annealed bolts in super duplex stainless steel in regards to stress corrosion cracking and pitting resistance</i>	
Credits (ECTS): 30	
Key words: Key words: SCC, pitting, cold work, solution annealed, magnesium chloride, alternate immersion, Super Duplex, UNS S32760	Pages: 85 + enclosure: 69 Stavanger, 08.06.2016

The objective of this thesis was to develop a test setup using modified versions of the ASTM G36 and G44 standards testing on as received super duplex stainless steel bolts (UNS S32760) of both solution annealed and cold strained quality.

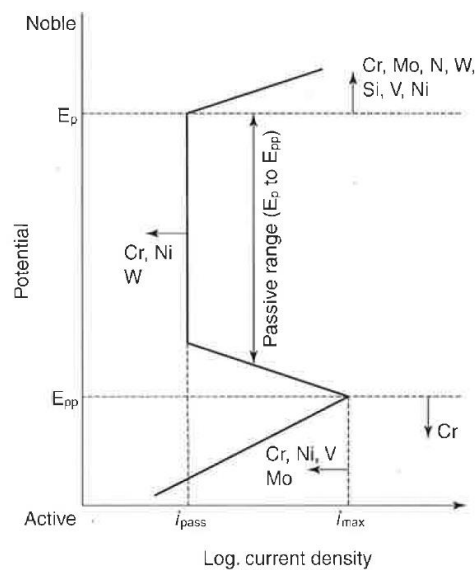
Figure 2: Effect of alloying elements on the anodic polarization curve [7]

Stainless steels are dependent on a passive surface film of chromium oxide to resist corrosion. The minimum level of chromium required is 11 % and there also need to be oxygen present to form this layer [5]. This is due to the fact that the passive range is extended which further reduces the general corrosion as can be seen in Figure 2.

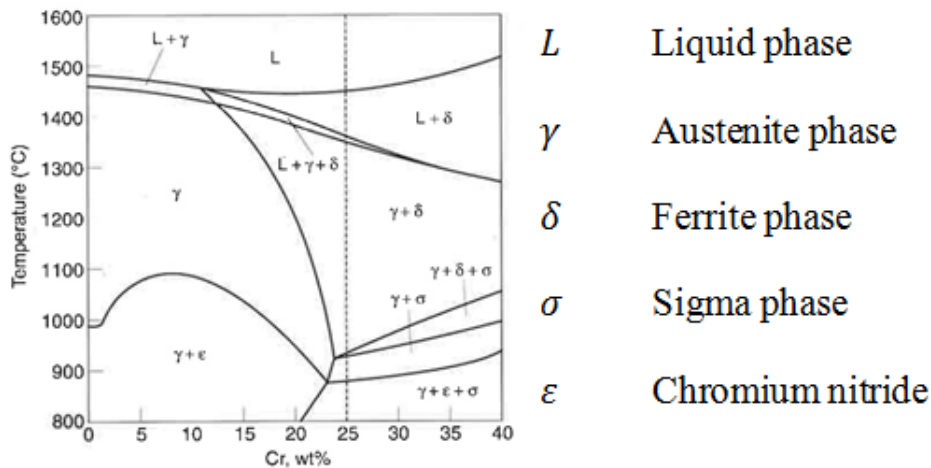
Figure 4: Thermocalc isopleth diagram showing the composition of a SDSS alloy at the dotted line [7]

There are different phase diagrams like Schaeffler diagrams available that show different phases at different temperatures and nickel and chromium additions [7]. To get an accurate result however, a computer program called ThermoCalc, which calculates the phase equilibria over a range of temperatures, is used. Figure 4 shows a calculated phase diagram for a SDSS alloy.

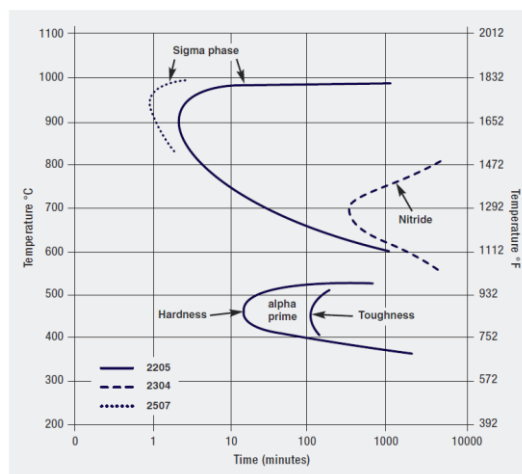
Figure 5: TTT diagram showing three different duplex steel grades 2205 (DSS), 2304 (lean DSS) and 2507 (SDSS) [3]

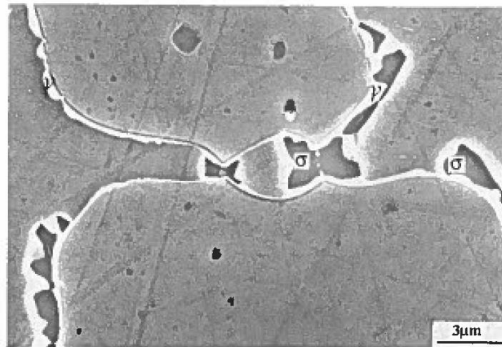
Figure 6: Microstructure of a SDSS SAF 2507 (UNS S32750) aged for 10 min at 850 °C. σ phase is shown at ferrite / ferrite phase boundaries and secondary austenite is visible in bright contrast between the primary austenite and ferrite (SEM) [9]

The precipitation of the sigma phase usually occurs at triple junctions or at ferrite / austenite phase boundaries at the temperature range of 600 – 1000 °C [7]. Also the presence of sigma phase will decrease the pitting resistance due to the depletion of chromium and molybdenum from surrounding areas [3].

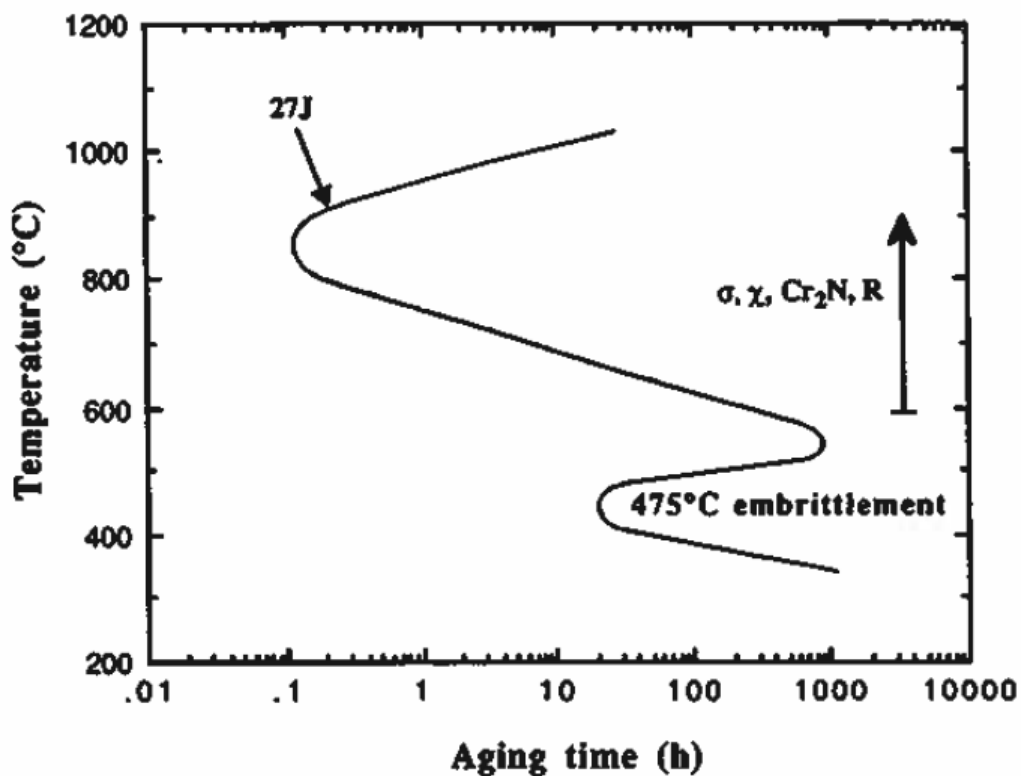
Figure 7: Time-temperature-transformation (TTT) diagram for SAF 2507 (UNS S32750 SDSS) with a curve corresponding to 27J impact toughness indicating rate of embrittlement [9]

Maximum and minimum hardness is also required in some standards. Normal solution annealed DSS have no problems being within these (approx. 277 - 321 HBW). Cold straining and / or intermetallic precipitation however will have an impact on the hardness [7]. This is also shown in Figure 7.

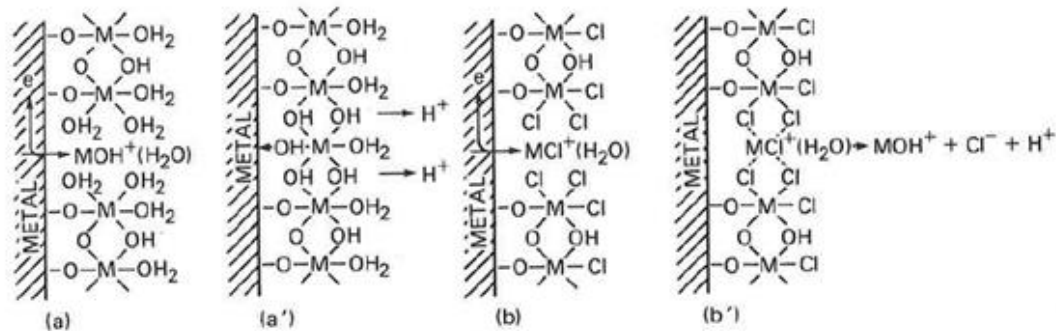
Figure 9: The passive layer is repaired in a', while destroyed in b' [2]

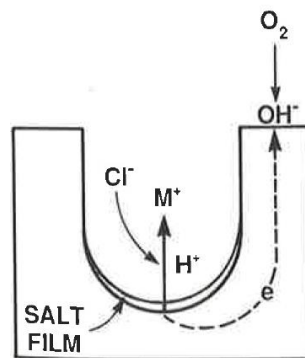
Figure 10: Illustration of the pitting mechanism [2]

When the pitting process has been ongoing for a while, the metal is perforated and the reaction is terminated.

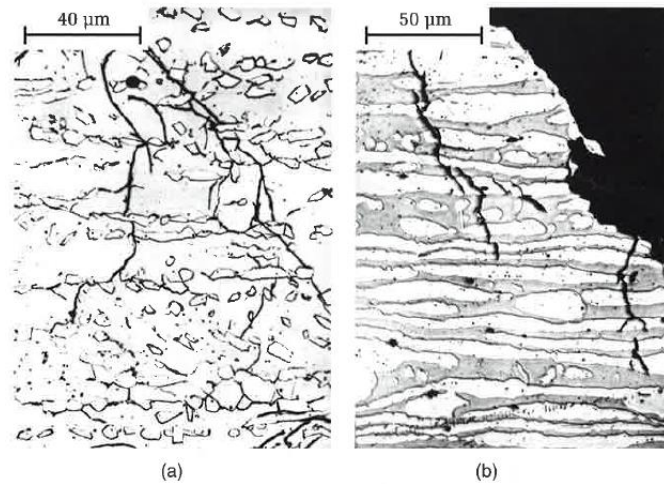
Figure 12: Examples of crack propagation where a) is showing cracking through the ferrite (500X) and b) is showing cracking through both phases (400X) [7]

In DSS the cracking preferably occurs in the ferrite phase which is not expected due to the fact that ferritic steels are known for their increased resistance against this type of corrosion compared to austenitic steels. However the reason for this is that the ferrite in the duplex steel contains approximately 3 % nickel, compared to normal ferritic steels which are usually very low on nickel. The nickel therefore makes the DSS susceptible to SCC [7]. Figure 12 shows typical cracking in duplex steels in the ferrite and through both phases.

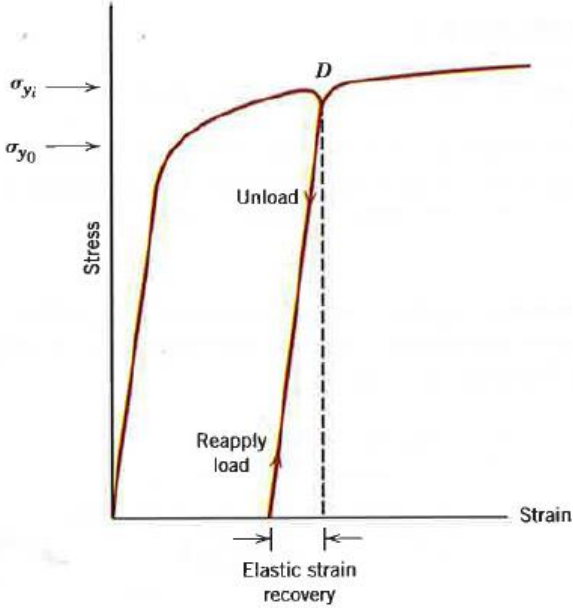
Figure 13: Stress-strain diagram showing the elastic strain recovery and strain hardening. Initial yield (σ_{y_0}) and yield (σ_{y_1}) after releasing the load D is shown [11]

As seen in Figure 13, the effect of deforming the material increases the yield strength, but as a result it has a shorter elongation before fracture after the treatment.

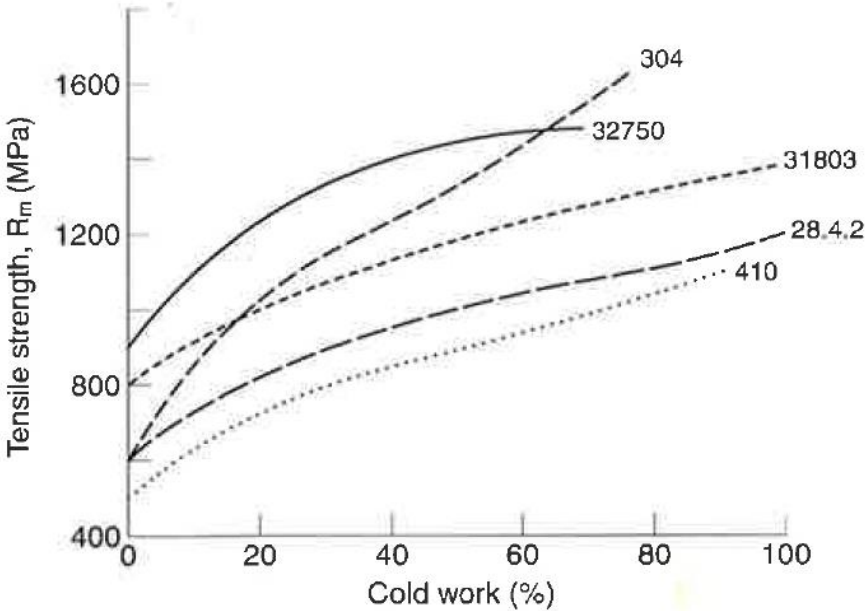
Figure 14: The effect of cold work in regards to UTS for several different SS [7]

The effect of cold work in regards to ultimate tensile strength (UTS) for different SS is shown in Figure 14.

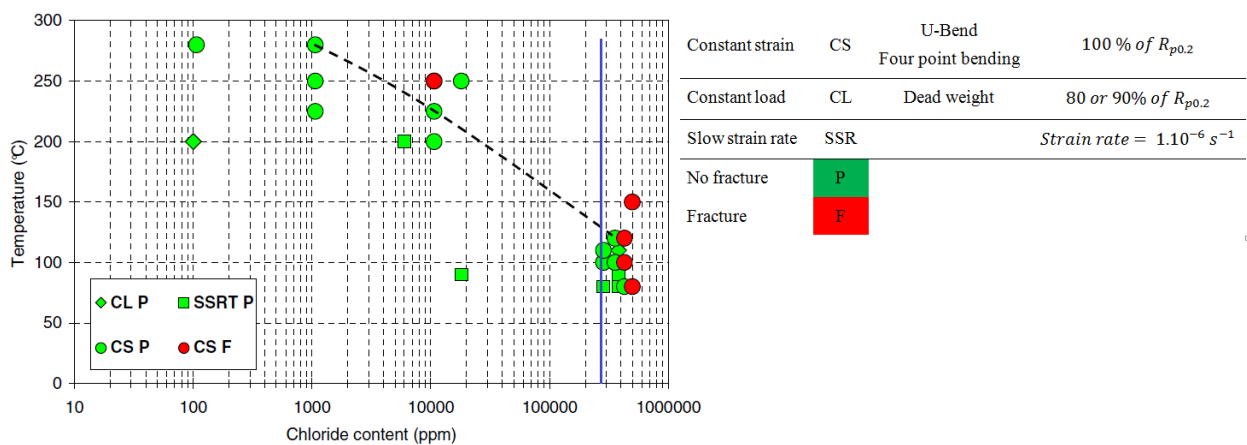
Figure 15: Summary of several studies on a SDSS with varying temperature and chloride concentrations [29]

A summary of earlier studies on SCC resistance for DSS by Manchet, Fanica and Lojewski [29], gives a good overview of what to expect from different load setups and chloride concentrations. Analyzing the results from testing with different concentrations of chloride and loading setups they compiled the results into a graph shown in Figure 15. The blue line indicates a chloride concentration of approximately 26 %. It clearly shows the relationship between temperature and chloride concentration. Also fracture happens at very high chloride concentrations above 40 %. The constant load and strain tests were performed until fracture or 720 hours .

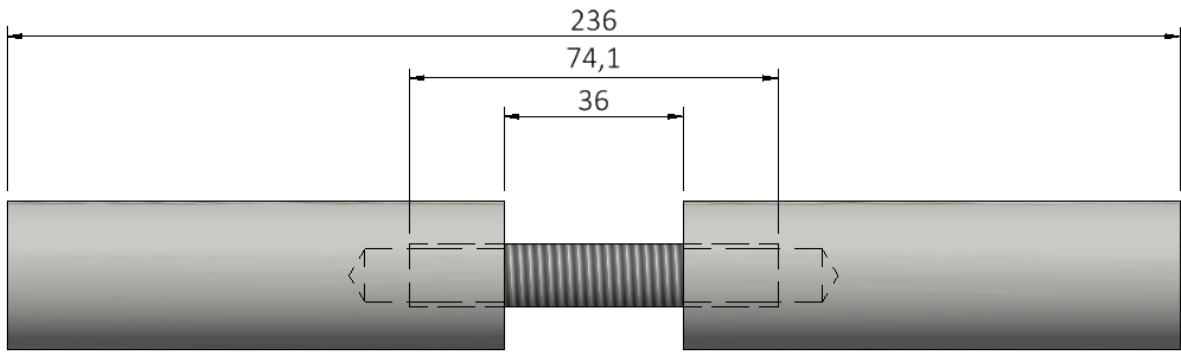
Figure 16: Sketch of the holder setup with the bolt mounted

The purpose of obtaining the stress-strain curve is to be able to determine the elongation when the bolts are at a certain stress level. By analyzing the graph produced by the tensile testing machine, the strain at yield is determined. Then by measuring the length of the bolts when torqueing, one can easily tighten the bolt to the wanted stress level. As there was a small quantity of studbolts available for all the experiments, the goal was to use as few bolts as possible for this destructive testing method. To simulate the scenario of the bolts when mounted on the flange, the length of the gap between the holders were set at the flange thickness which is 36 mm. This is shown in Figure 16. To ensure that the bolts would get minimum friction while mounting them in the holders the lubricant Gleitpaste was used. The MSDS for this lubricant can be found in Appendix B. This grease contains silver, and from earlier experiences from offshore personnel this grease works well with SS.

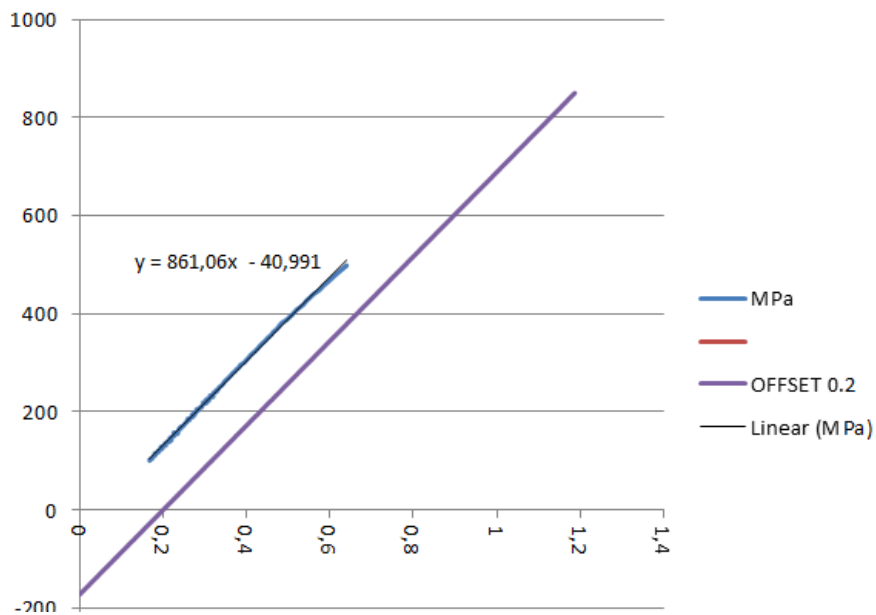
Figure 17: Linear part of the stress-strain curve

The results from the tensile testing are logged as tensile stress versus strain. To be able to determine the Young's modulus which is the gradient, the equation for the linear part of the curve was found by use of Excel. This was offset 0.2 % to be able to find the offset yield and the corresponding strain. An example of this procedure is shown in Figure 17 for the first test on 316L.

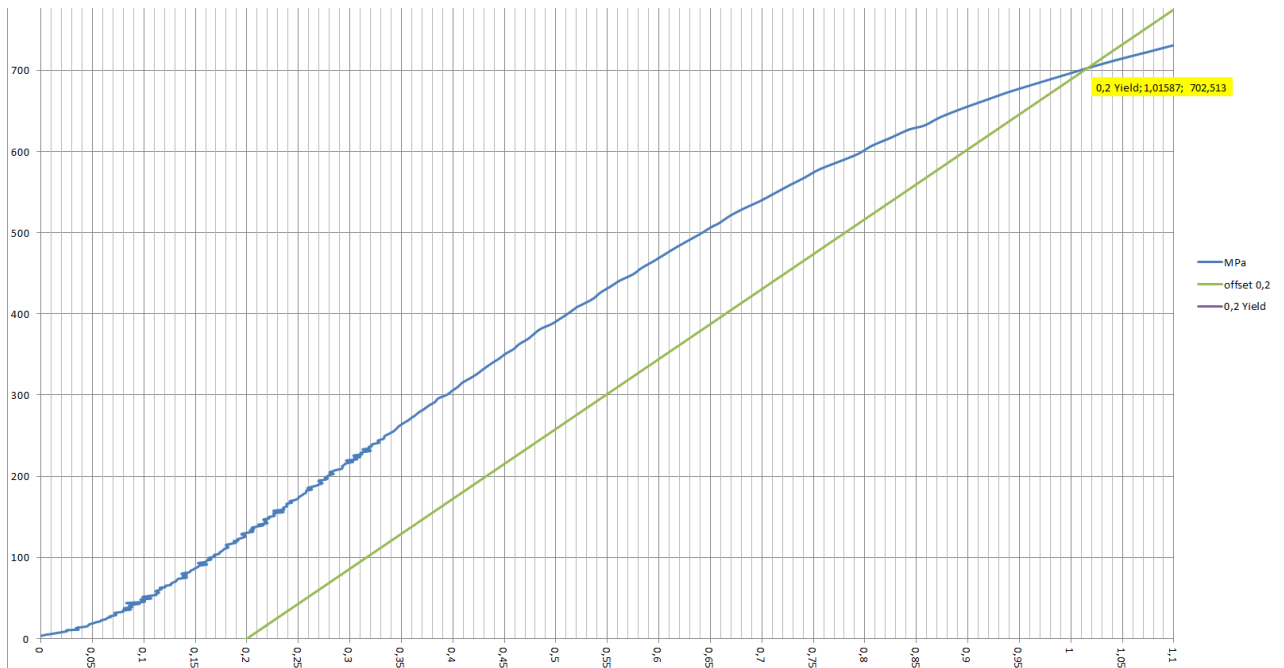
Figure 18: Offset yield stress and strain determined from the curve

This linear offset yield was plotted in the stress strain curve and the offset yield point was found together with the strain at this given point as shown in Figure 18. It also shows that the slope for the start of the curve is not linear, which is caused by the tolerance in the threads of the holders.

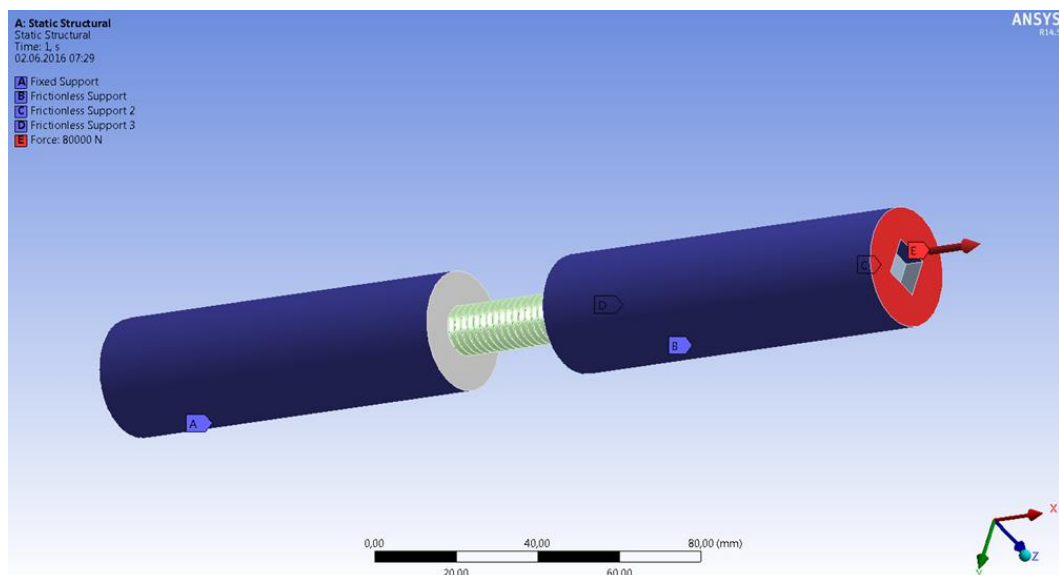
Figure 19: ANSYS setup for verifying the tensile results

An ANSYS analysis was performed and while it did not produce the same results as the tensile testing in regards to elongation it agreed with the fact that the Young's modulus changed when the force increased. It did not however produce the same Young's modulus as the tensile testing. The setup for the ANSYS analysis is shown in Figure 19.

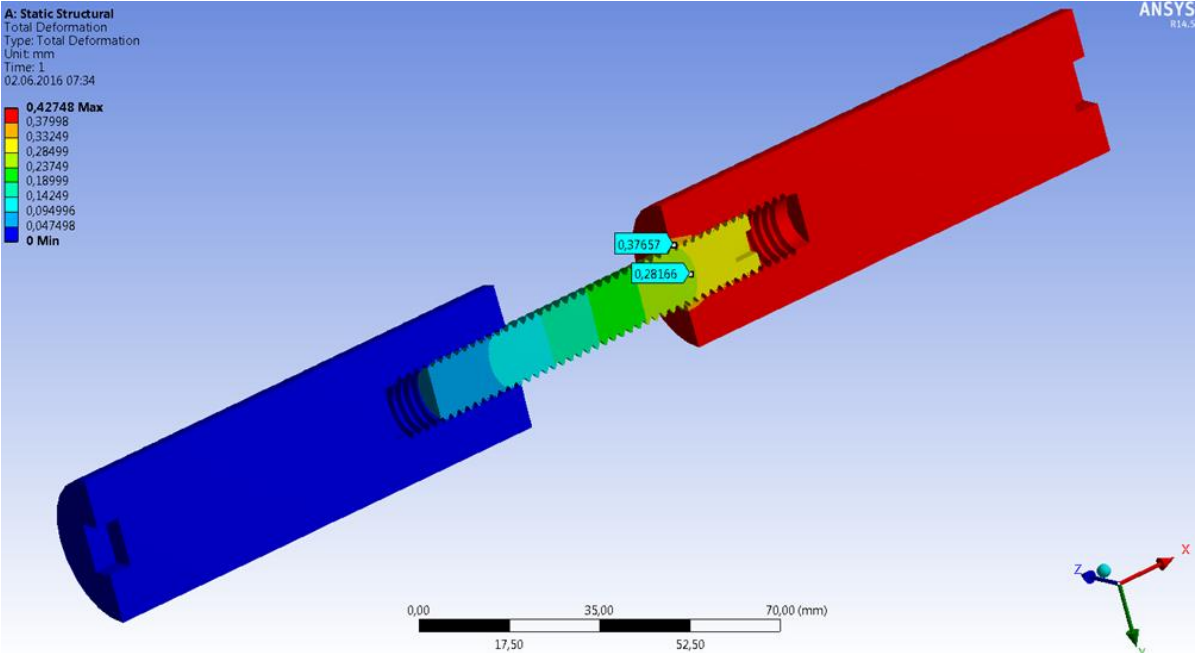
Figure 20: ANSYS result that shows the difference of deformation in the outer and inner parts of the threads

Figure 20 shows that the deformation is different in the outer part of the threads compared to the inner part of the thread, and this might explain the lower Young's modulus experienced in the tensile testing.

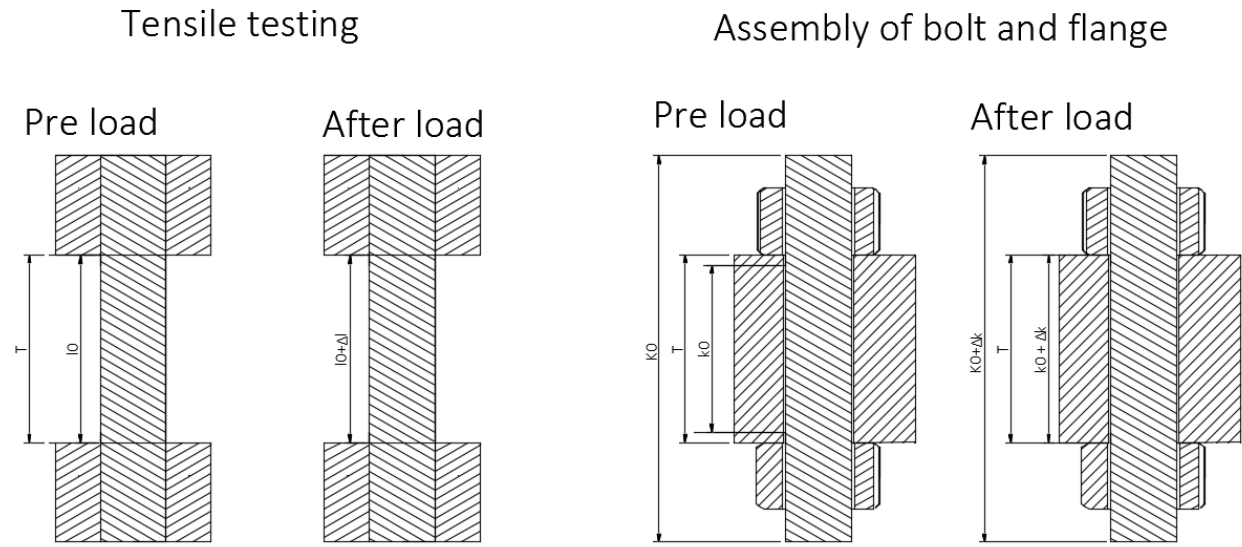
Figure 21: Sketch of tensile testing and assembly of bolt and flange

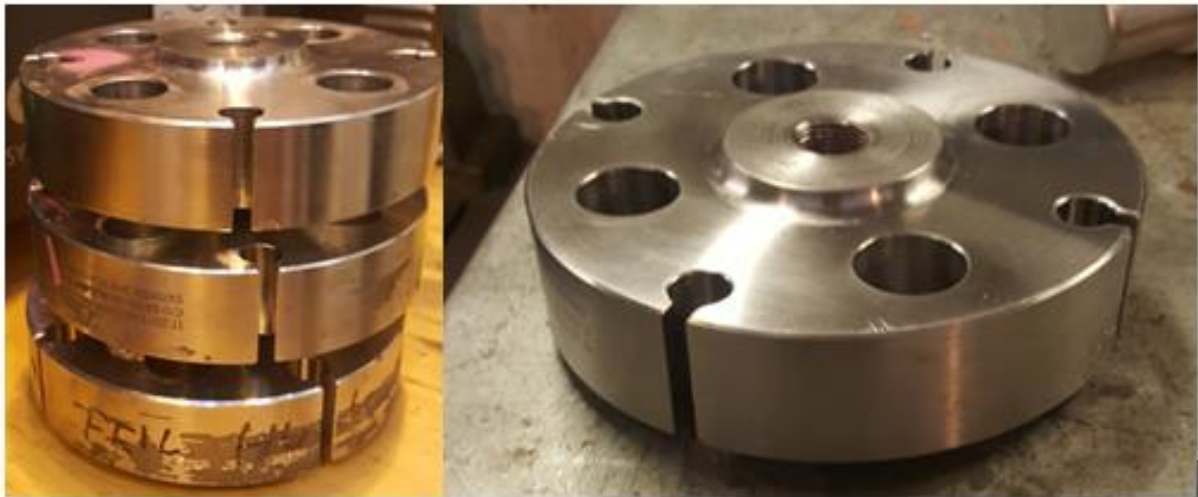
Figure 22: Before and after picture of flanges after cleaning and machining

The flanges were received in used condition from SFF AS, and were cleaned with acid in an ultrasonic cleaner. Before and after pictures can be seen in Figure 22. The flanges had holes of 25,5 mm which did not fit the ½ inch bolts that were delivered, meaning that machining had to be performed. Details for this are discussed in chapter (3.6.2).

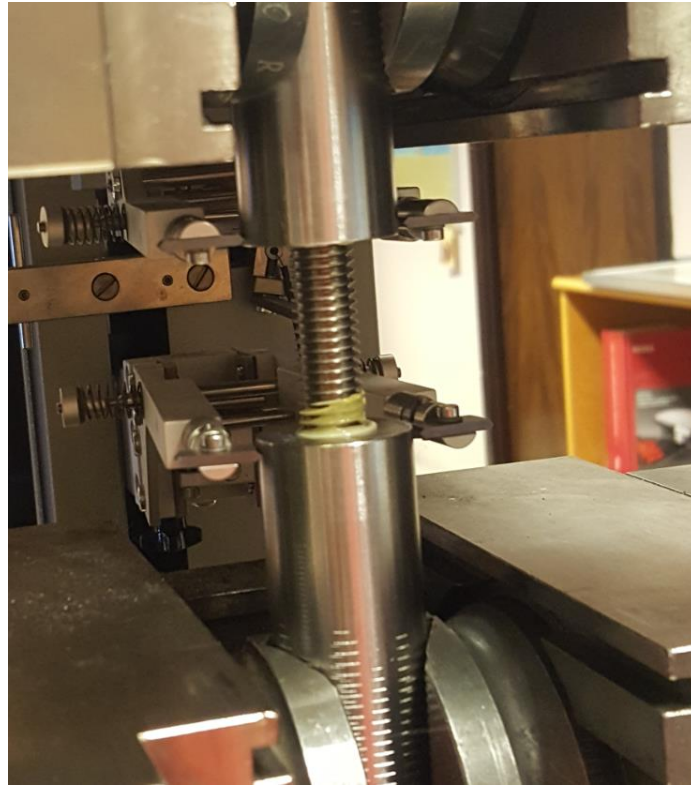
Figure 23: Holders with a bolt mounted in the tensile testing machine

fabrication drawing that can be found in appendix H. The finished manufactured holders assembled with a bolt in the tensile testing machine are shown in Figure 23.

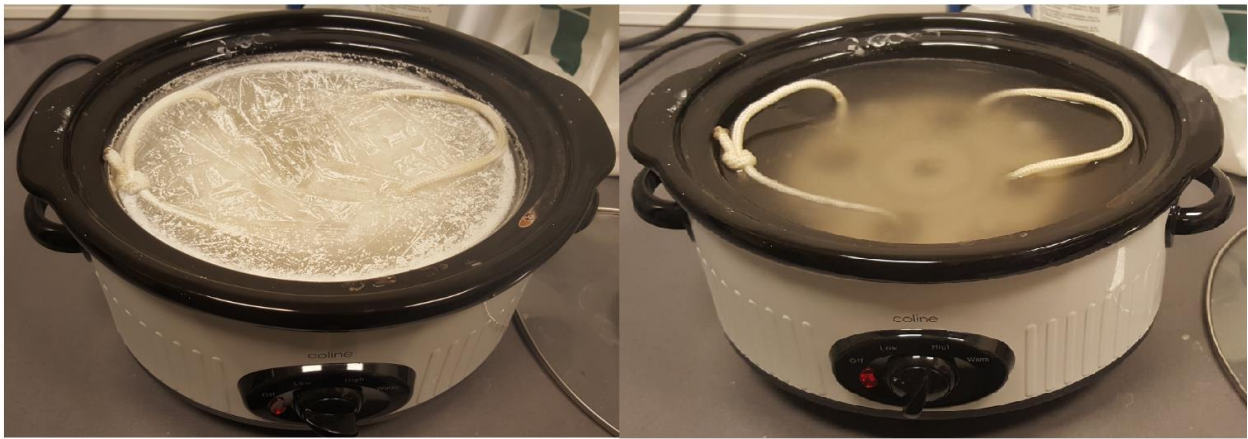
Figure 24: Setup for immersed testing with the left showing the solution at room temperature and the right one showing the temperature at 90 °C

To avoid direct contact between the ceramic container and the flange assembly in regards to heat exchange, a glass plate was placed on the bottom of the container. Also when the flange assembly was in the container, roughly 2 liters of solution was required to keep the assembly fully submerged. Ropes were attached to the assembly to allow for removing the assembly for inspection. See Figure 24 for the setup.

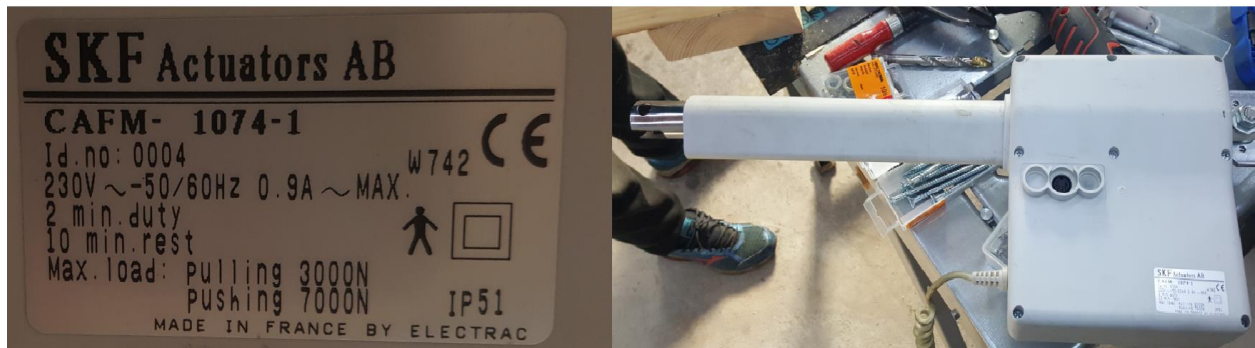
Figure 25: Electrical linear actuator with specifications

The remote control functions by pushing the in or out button for 29 seconds to fully extend or retract the shaft. Also the shaft of the actuator can extend for 31 cm so this needs to be taken into account in regards to the height of the jig when building the frame on which the actuator will be mounted.

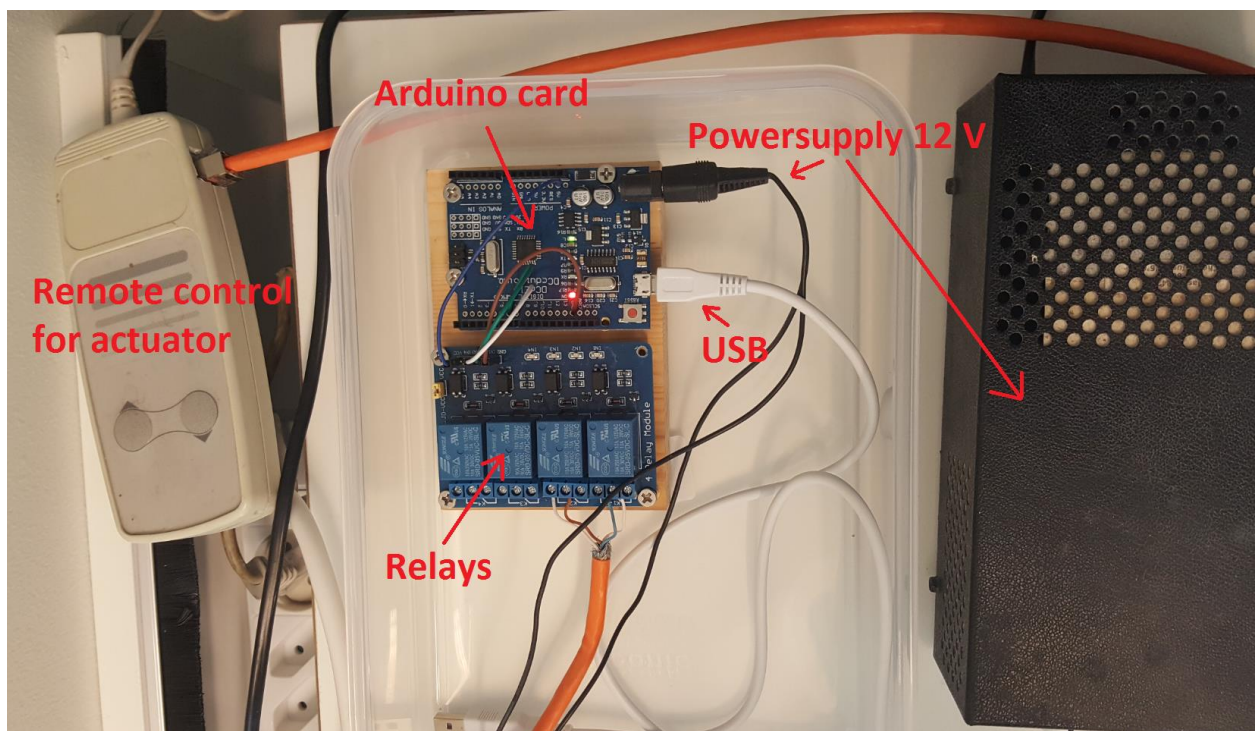
Figure 26: Overview of Arduino setup

Figure 26 shows the main setup. The power supply provides 12 V to the Arduino card. The micro USB is for uploading the code to the Arduino, and the remote control is connected to the relays. Relay 1 controls the out direction, while relay 2 controls the in direction.

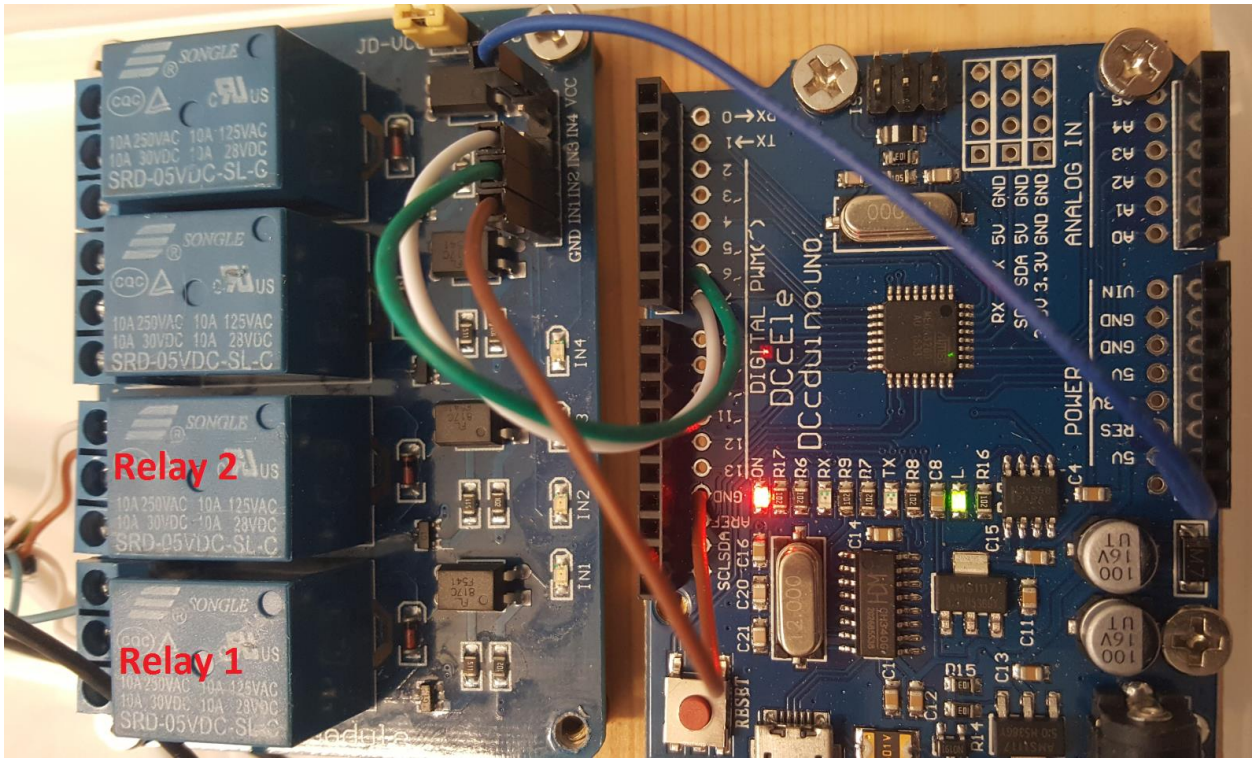
Figure 27: Close up of wiring

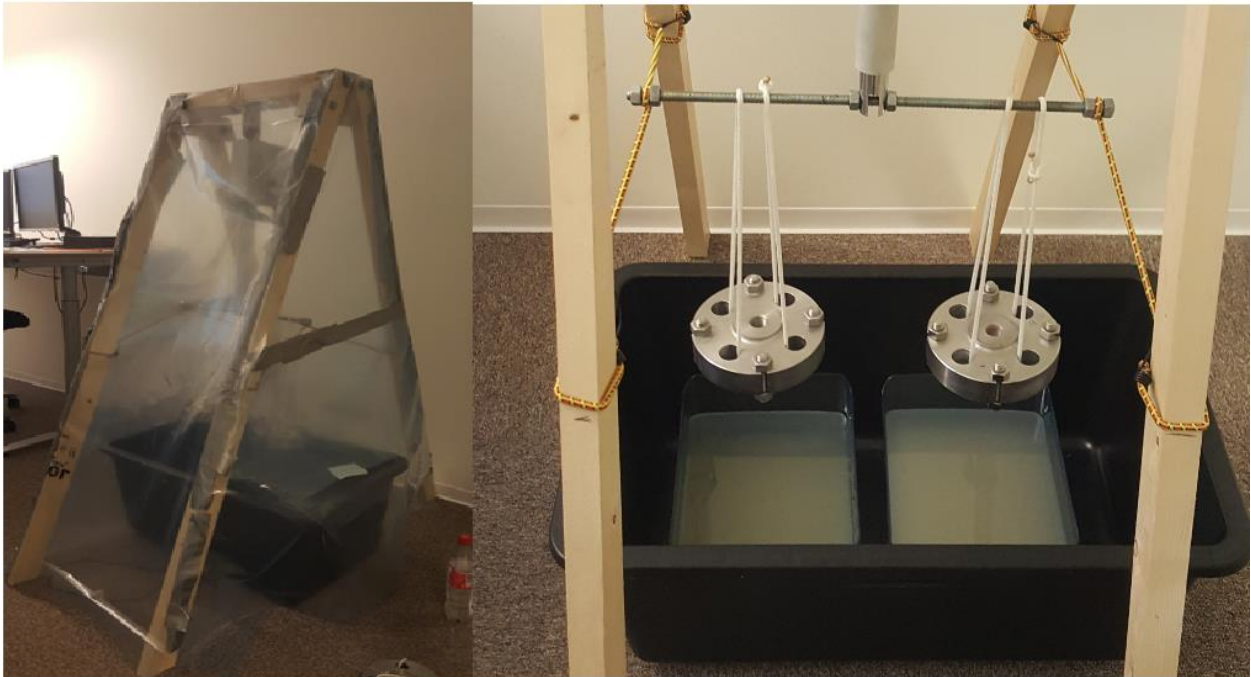
Figure 28: Framework with actuator and bolt assemblies

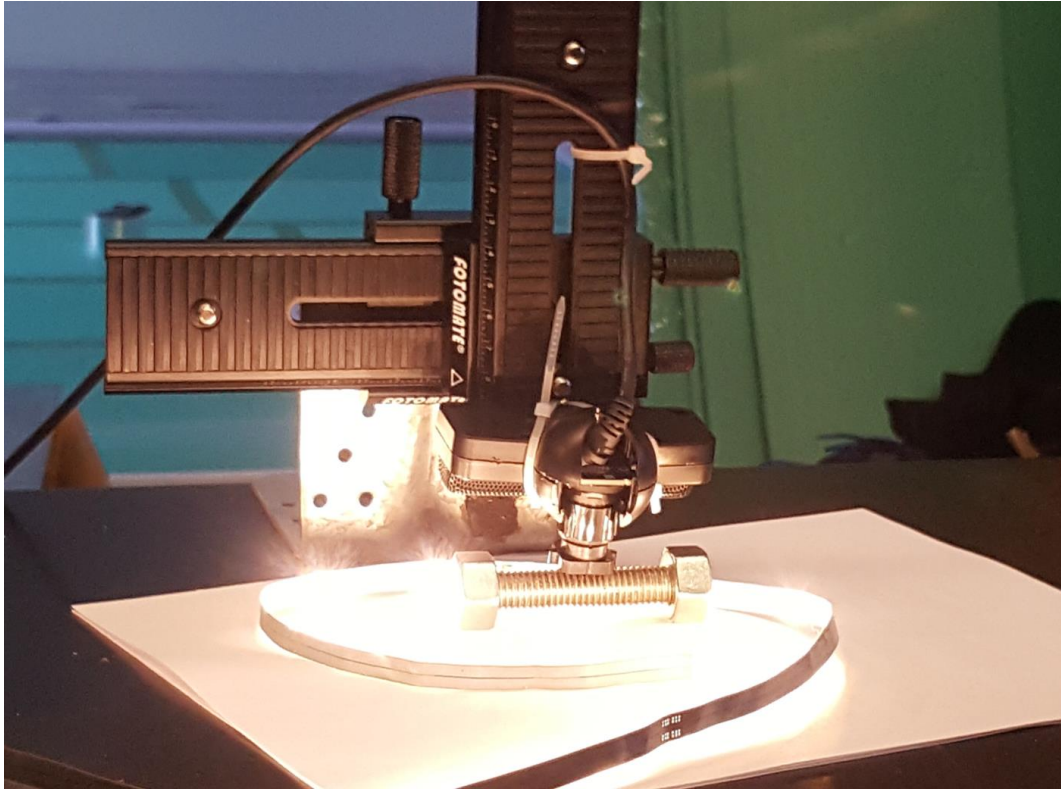
Figure 29: Inspection jig for visual inspection of bolts

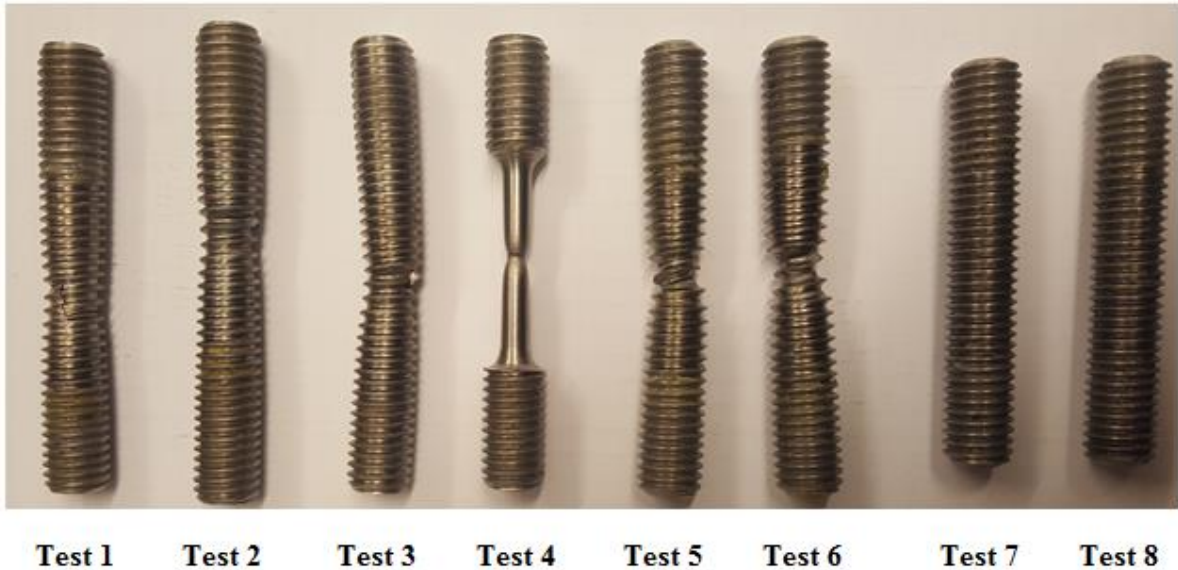
Figure 30: Bolts after tensile testing

Figure 30 shows the test specimens after testing and the stress-strain curves for each test can be found in appendix N.

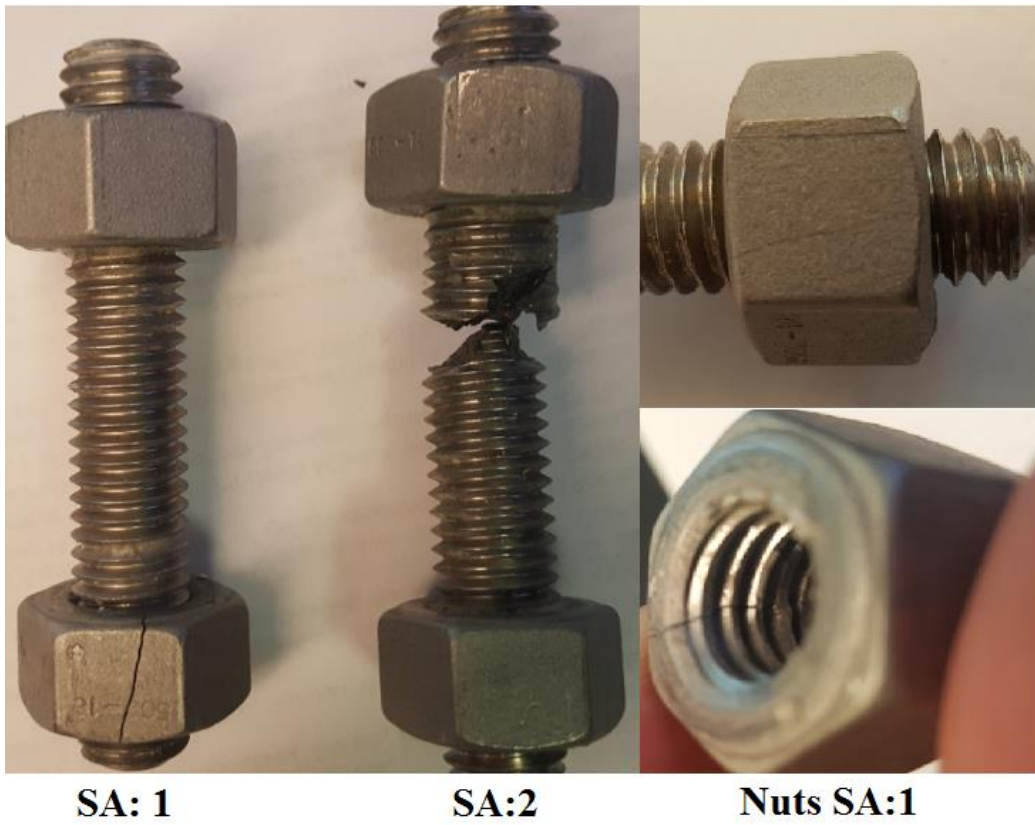
Figure 31: Details of SA bolts from test 1 of immersed testing at 90 °C

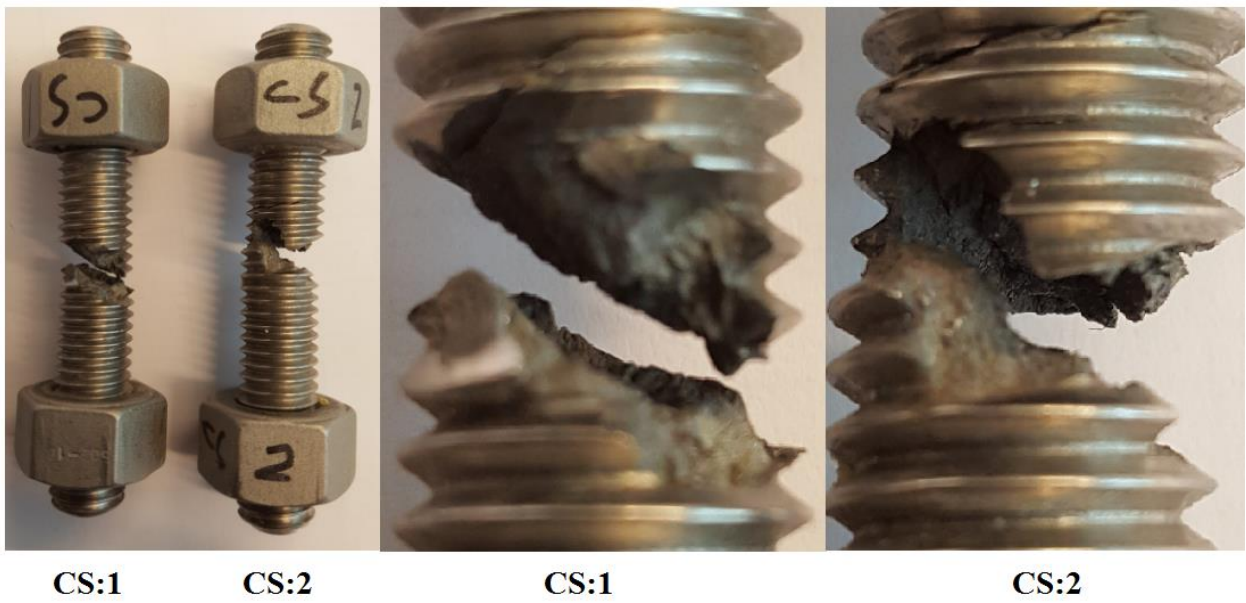
Figure 32: Details of CS bolts from test 1 of immersed testing at 90 °C

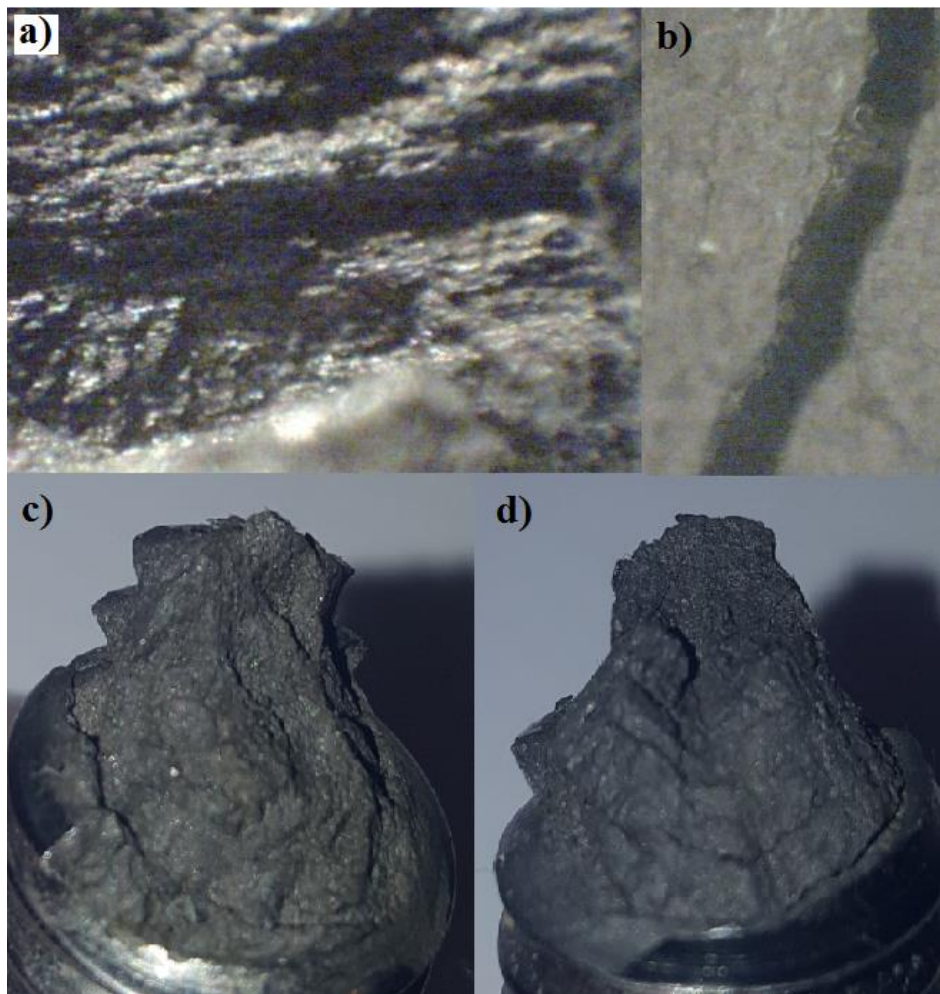
Figure 33: Details of the fractures. a) showing the surface of the fracture (10X), b) showing the crack in the nut for SA:1 (10X), c) the surface of the fracture for SA:2 and d) showing the surface of the fracture for CS:2

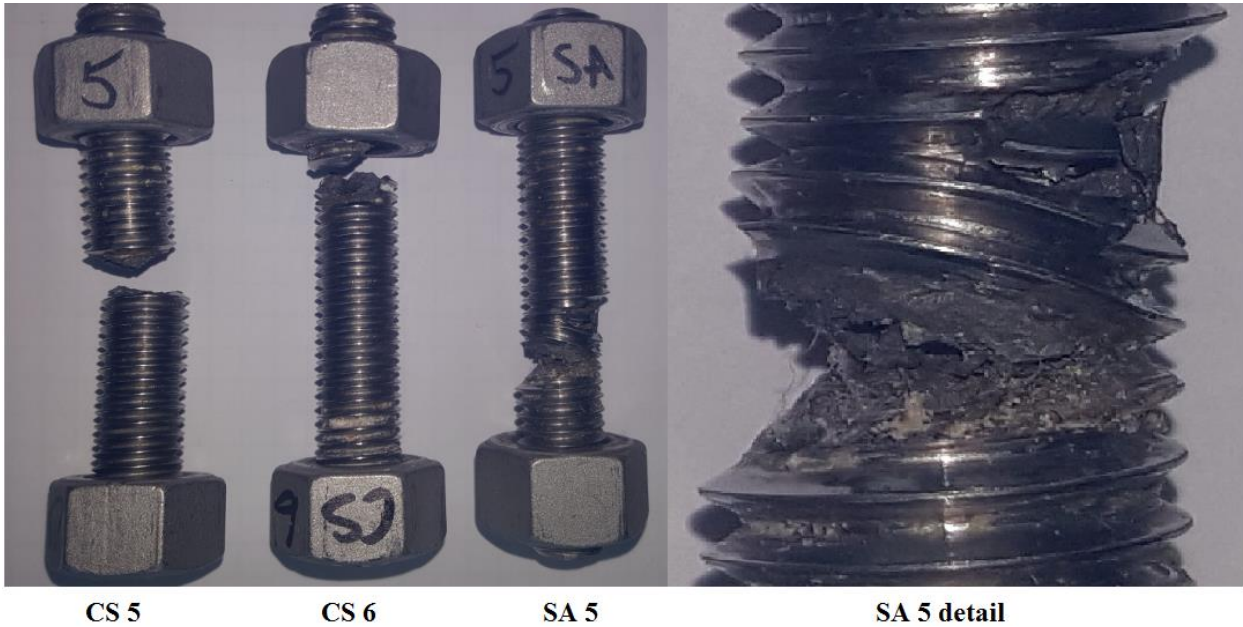
Figure 34: Details of CS bolts from the immersed testing at 90 °C

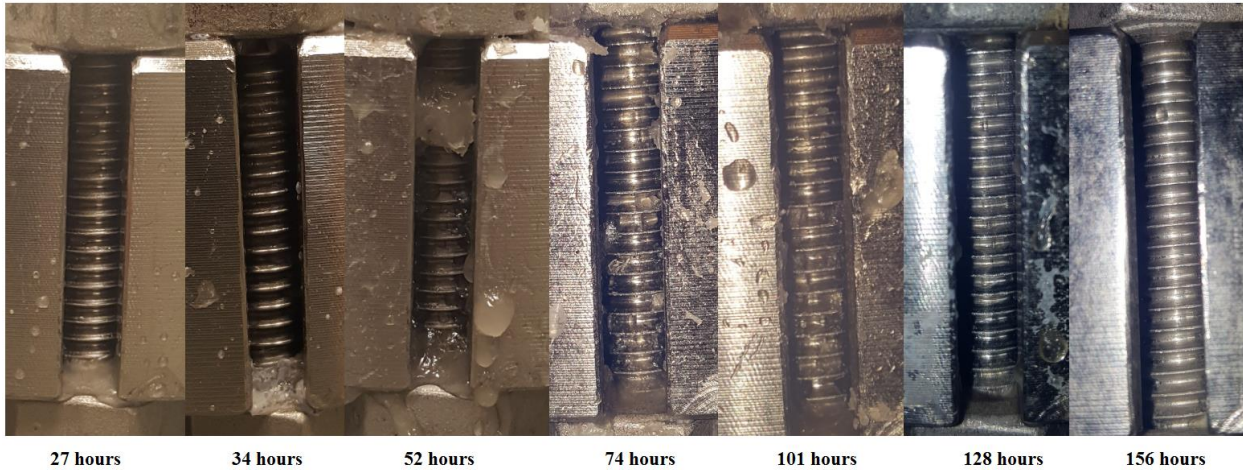
Figure 35: Progress pictures of the SA:6 bolt with hours in the test solution

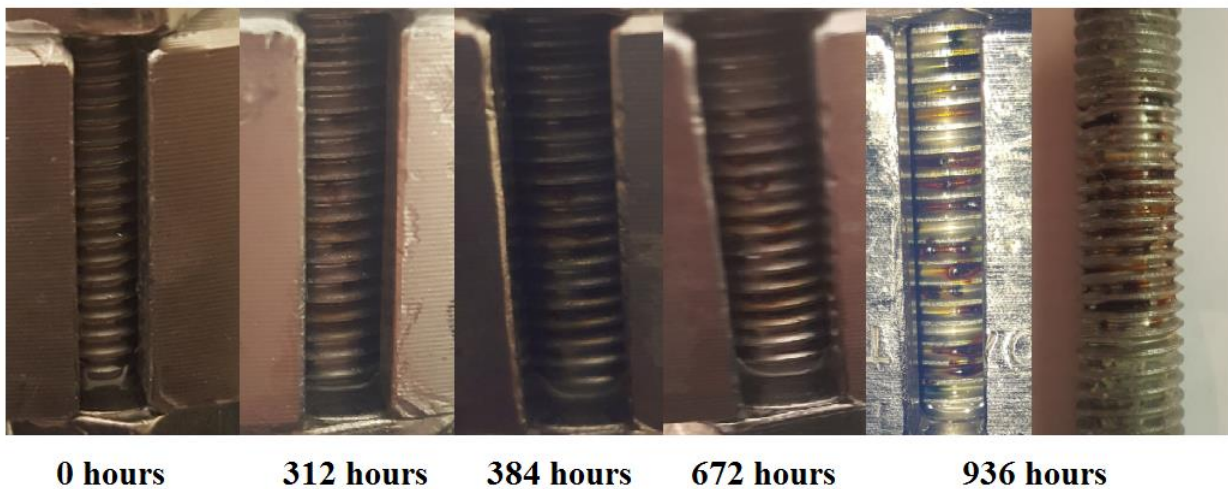
Figure 36: Progress pictures of the 316L bolts alternate immersion experiment for 936 hours

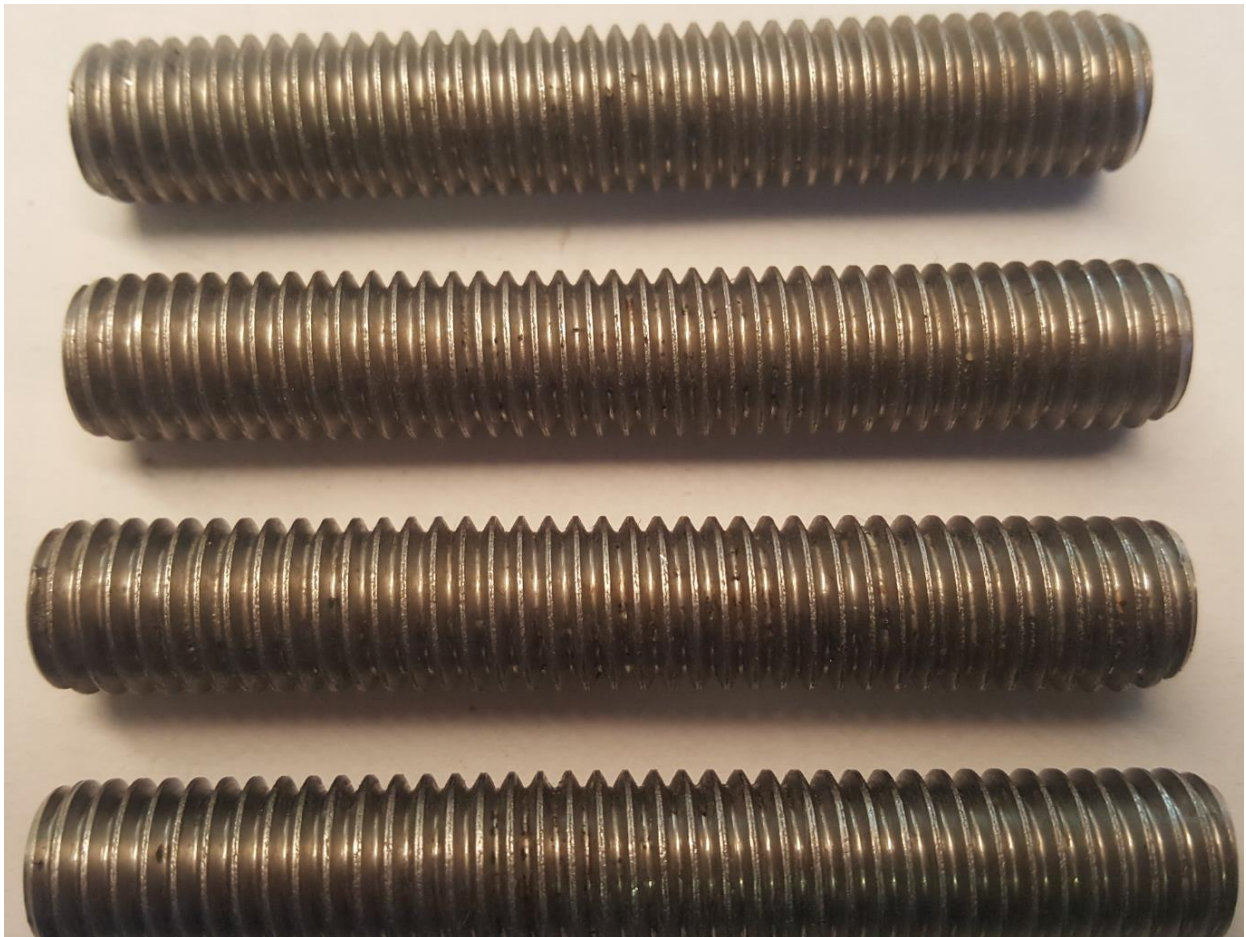
Figure 37: 316L bolts from alternate immersion testing after cleaning
