MASTER'S THESIS

(Writer's signature)
Faculty supervisor: Torfinn Havn External supervisor: N/A	
Thesis title: <i>A comparison of cold strained and solution annealed bolts in super duplex stainless steel in regards to stress corrosion cracking and pitting resistance</i>	
Credits (ECTS): 30	
Key words: Key words: SCC, pitting, cold work, solution annealed, magnesium chloride, alternate immersion, Super Duplex, UNS S32760	Pages: 85 + enclosure: 69 Stavanger, 08.06.2016

The objective of this thesis was to develop a test setup using modified versions of the ASTM G36 and G44 standards testing on as received super duplex stainless steel bolts (UNS S32760) of both solution annealed and cold strained quality.

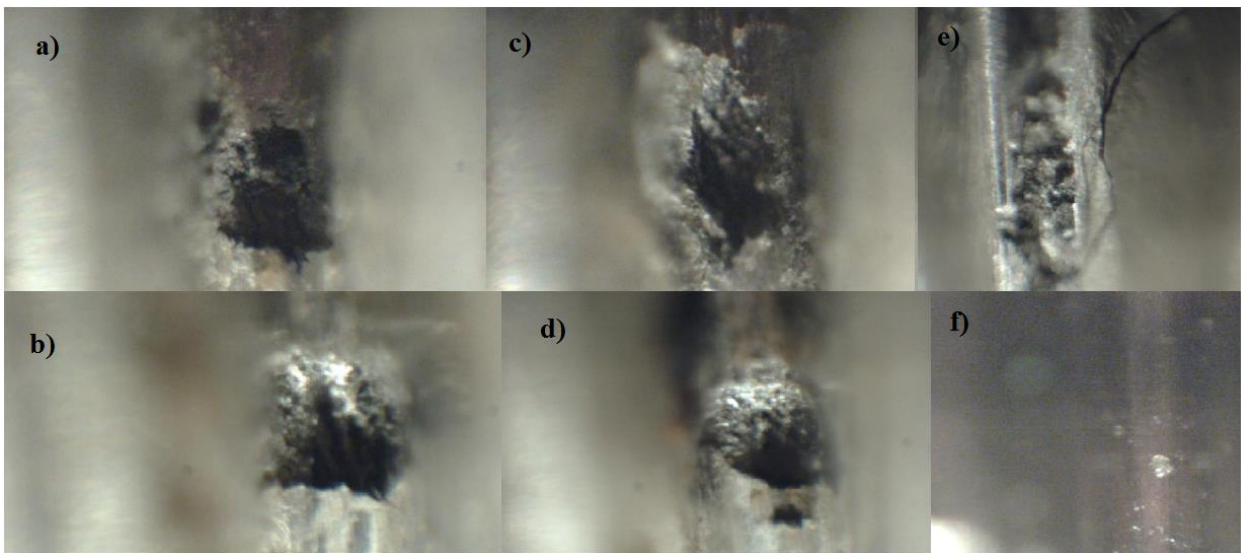
Figure 38: a), b), c) and d) showing pits at the root of the threads at approx. 10X. Picture e) shows a crack going from the top of the thread towards the root and f) shows the root before the experiment.

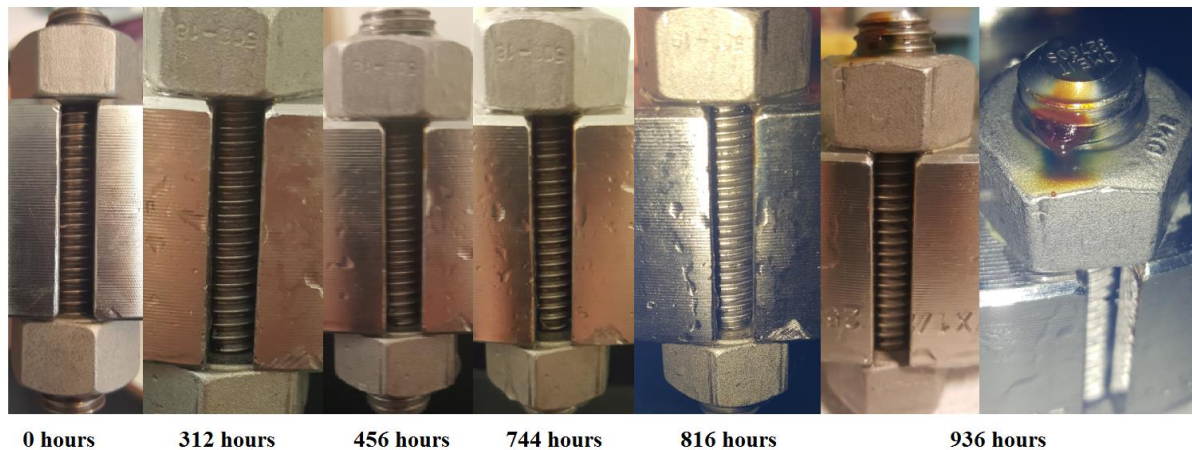
Figure 39: Progress pictures of the SDSS CS:4 bolt in the alternate immersion experiment for 936 hours

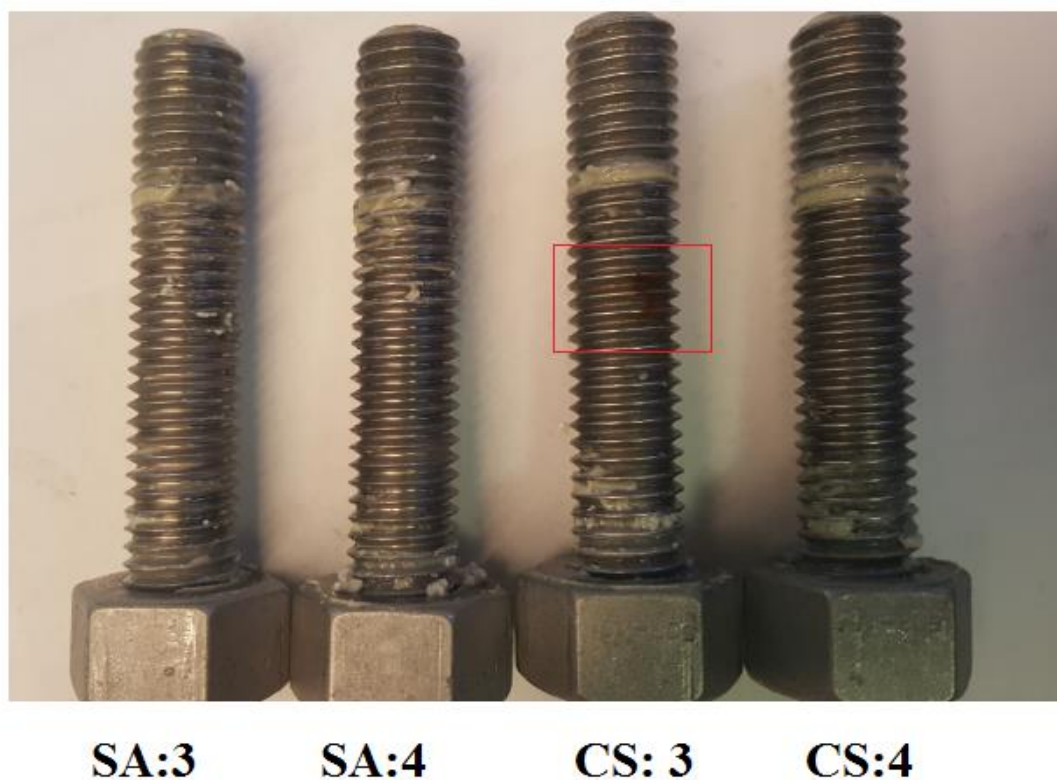
Figure 40: The SDSS bolts after alternate immersion testing for 936 hours

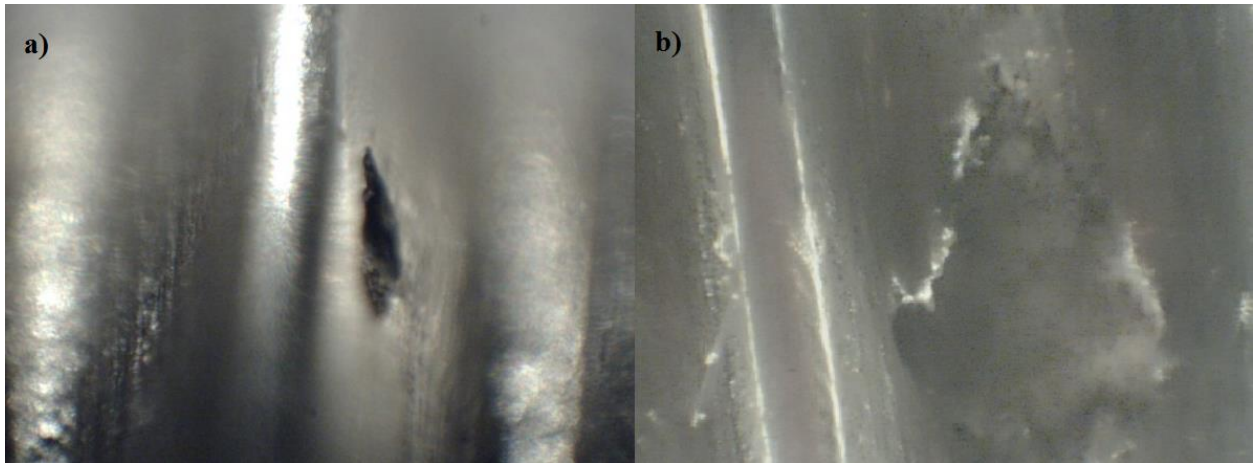
Figure 41: Details of the pitting on the CS bolts. a) shows the pit on the top of the bolt (CS:3) on the side of the thread and b) shows the pit in the center of the bolt (CS:4) at the root of the thread

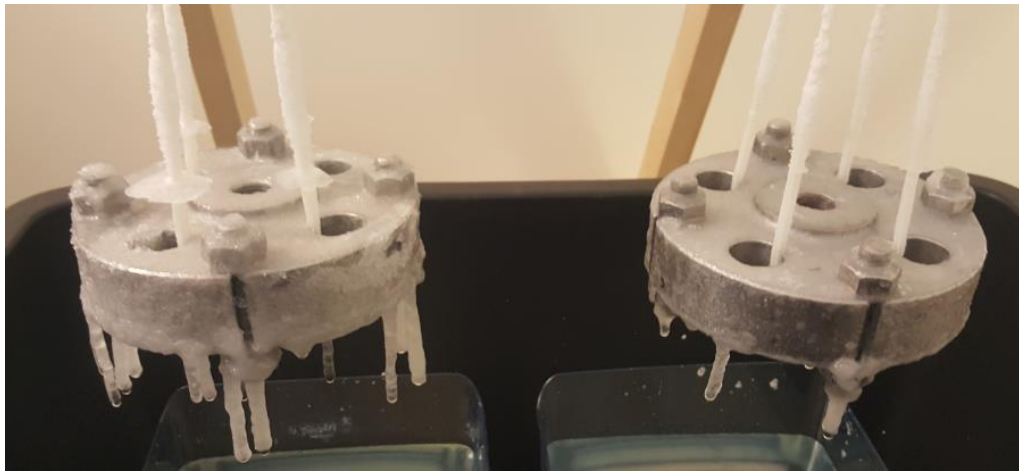
Figure 42: Supersaturated test solutions produced stalactites

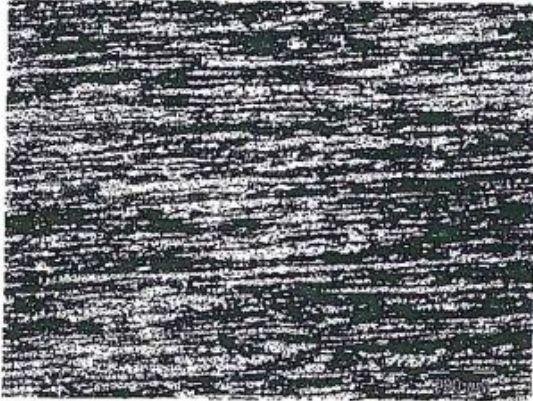
The microstructural photographs were examined at 100x and 500x using light microscopy.

Location: Surface
original photo: 100x

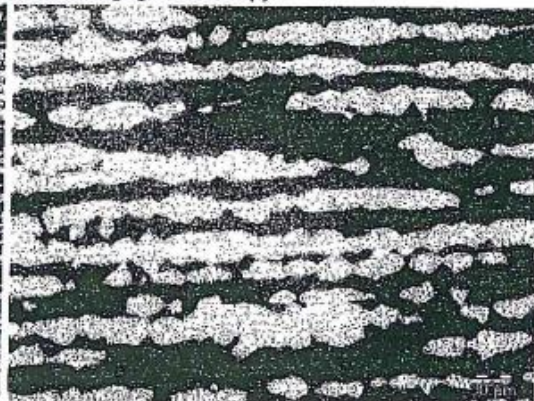
Location: Surface
original photo: 500x

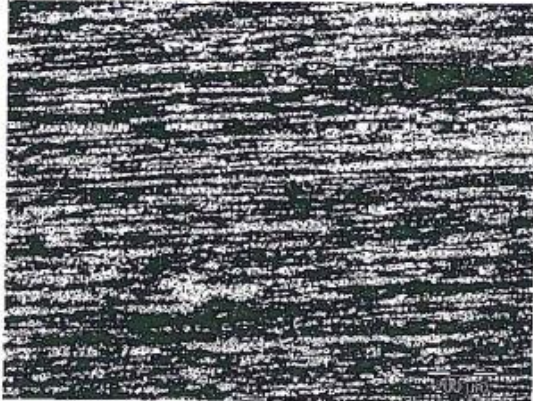
Location: center
original photo: 100x

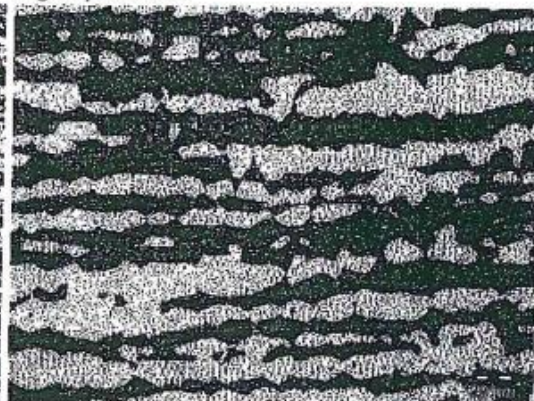
Location: center
original photo: 500x

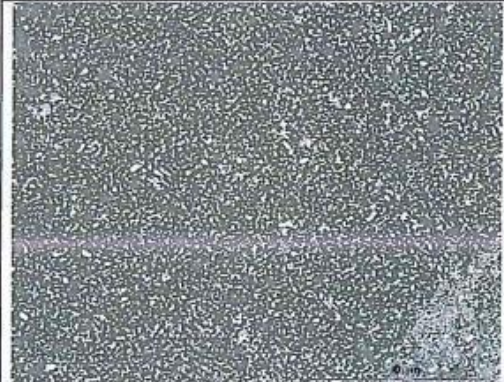
<p>Campione 6.469 – Superficie esterna Ingrandimento 100x - 500x Attacco: NaOH 20 % elettrolitico Specimen 6.469 – Outer surface 100x - 500x Magnification Etch: 20 % NaOH electrolyte</p>

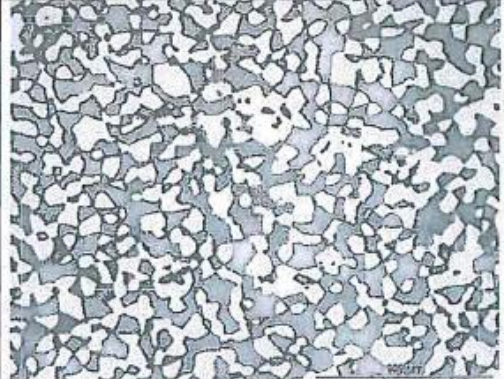
<p>Contenuto massimo di fasi intermetalliche e precipitati <i>Maximum content of intermetallic phases and precipitates</i></p> <table border="1"> <tr> <td>Valori Osservati [%] <i>Observed Values [%]</i></td> <td>< 0.1</td> </tr> <tr> <td>Valori Richiesti [%] <i>Required Values [%]</i></td> <td>≤ 0.1</td> </tr> </table> <p>Contenuto di ferrite secondo ASTM E562-11 <i>Ferrite content according to ASTM E562-11</i></p> <table border="1"> <tr> <td>Valori Osservati <i>Observed Values</i></td> <td>53%</td> </tr> <tr> <td>Valori Richiesti <i>Required Values</i></td> <td>40 ÷ 60</td> </tr> </table>		Valori Osservati [%] <i>Observed Values [%]</i>	< 0.1	Valori Richiesti [%] <i>Required Values [%]</i>	≤ 0.1	Valori Osservati <i>Observed Values</i>	53%	Valori Richiesti <i>Required Values</i>	40 ÷ 60

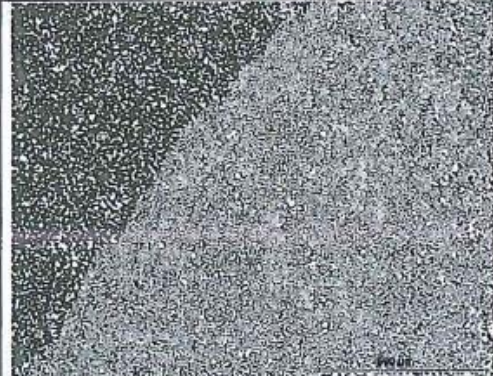
<p>Campione 6.469 – Metà spessore Ingrandimento 100x - 500x Attacco: NaOH 20 % elettrolitico Specimen 6.469 – Mid thickness 100x - 500x Magnification Etch: 20 % NaOH electrolyte</p>

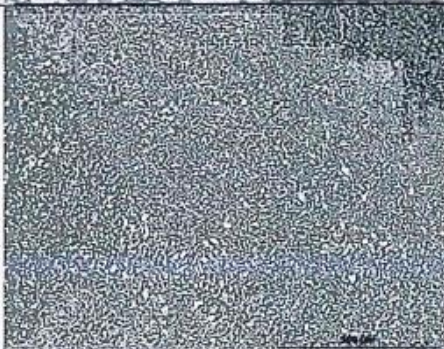
<p>Campione 856 – Metà spessore Ingrandimento 100x - 500x Attacco: NaOH 20 % elettrolitico Specimen 856 – Mid thickness 100x - 500x Magnification Etch: 20 % NaOH electrolyte</p>

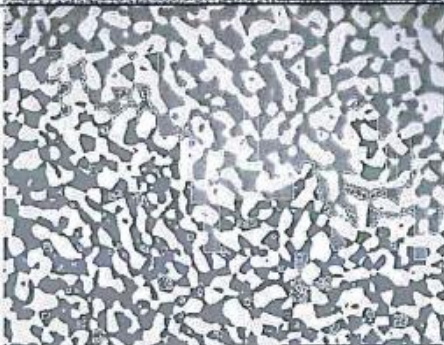
<p>Contenuto massimo di fasi intermetalliche e precipitati <i>Maximum content of intermetallic phases and precipitates</i></p>

<p>Valori Osservati [%] <i>Observed Values [%]</i></p>	<p>< 0.1</p>
	<p>Valori Richiesti [%] <i>Required Values [%]</i></p>	<p>≤ 0.1</p>
	<p>Contenuto di ferrite secondo ASTM E562-11 <i>Ferrite content according to ASTM E562-11</i></p>	
	<p>Valori Osservati <i>Observed Values</i></p>	<p>51%</p>
<p>Valori Richiesti <i>Required Values</i></p>	<p>40 + 55</p>
