MASTER'S THESIS

Study program/ Specialization: Petroleum Engineering / Drilling Engineering	Spring semester, 2017 Open / Restricted access
Writer: Kristi Larsdottir Kalvenes (Writer's signature)
Faculty supervisor(s): Mohsen Assadi Alireza Zare External supervisor(s): Hans Petter Lohne Erlend Randeberg	
Thesis title: Investigation of Corrosion in Geothermal Wells - A Qualitative Risk Assessment	
Credits (ECTS): 30	
Key words: Geothermal Energy Geothermal Well Design Well Integrity Well Barriers Corrosion Risk Assessment	Pages: 54 + enclosure: 6 Stavanger, 15.06.2017

High temperatures and corrosion are the most common contributors to failure in geothermal wells. In this study, a hypothetical case of a downhole corrosion problem was assessed by means of conducting a qualitative risk analysis and identifying well barriers in a geothermal well.

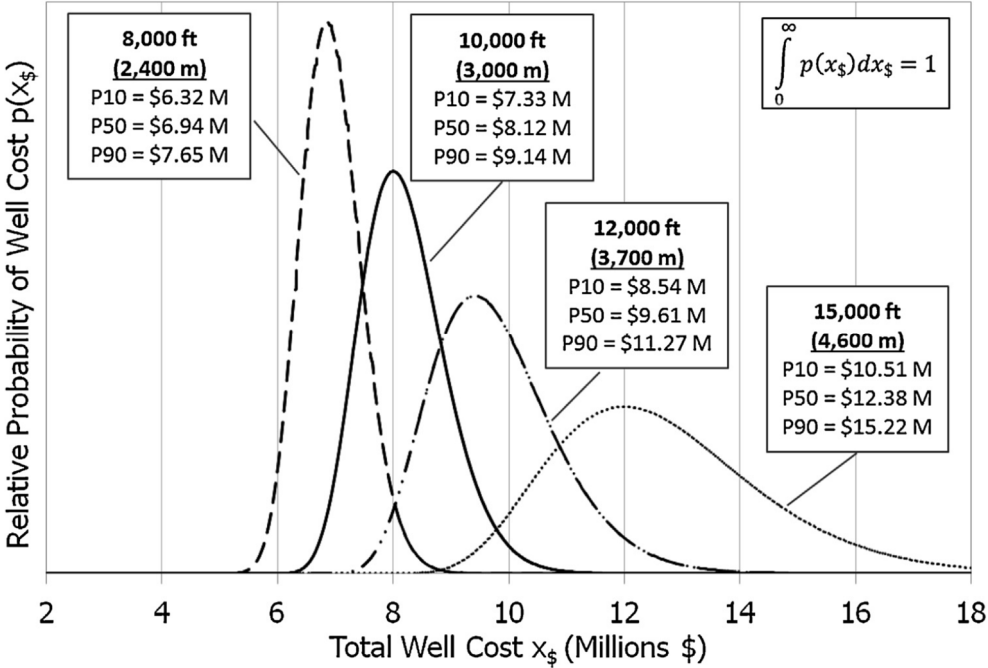
Figure 2-4 The probability of occurrence of a specific well cost $p(x)$ versus well cost is presented for wells with 4 different measured depths (MD) (Lukawski et al., 2016).

higher cost regions as shown in Figure 2-4 (Lukawski et al., 2016). In other words you may say that the deeper the well, the more difficult the well cost estimation will be.

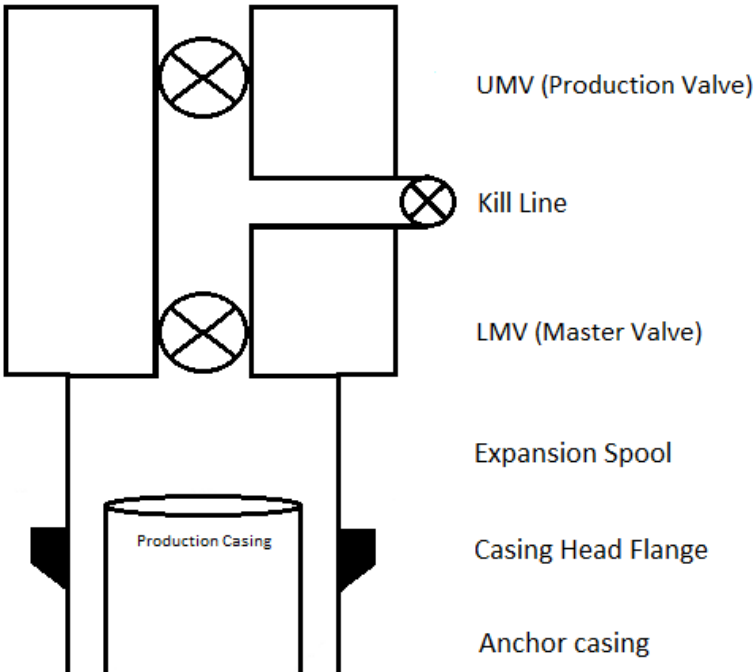
Figure 2-8 Upper part of a typical high temperature well in Iceland

Manufactured expansion spools contain a pressure seal which would need to be maintained pressure tight. Also, the expansion spool and casing head have valves for killing the well and for pressure testing the annulus. In Iceland however, most high temperature wells have expansion spools and casing heads with no valves below the master valve due to frequent problems with valve leaks that can be difficult to seal. The kill line is placed between the upper master valve (UMV) and the lower master valve (LMV) (Þórhallsson, 2003). In Figure 2-8 the Icelandic design of a high temperature well is shown; the wellhead is connected to the anchor (intermediate) casing and the production casing is allowed to move freely inside the expansion spool.

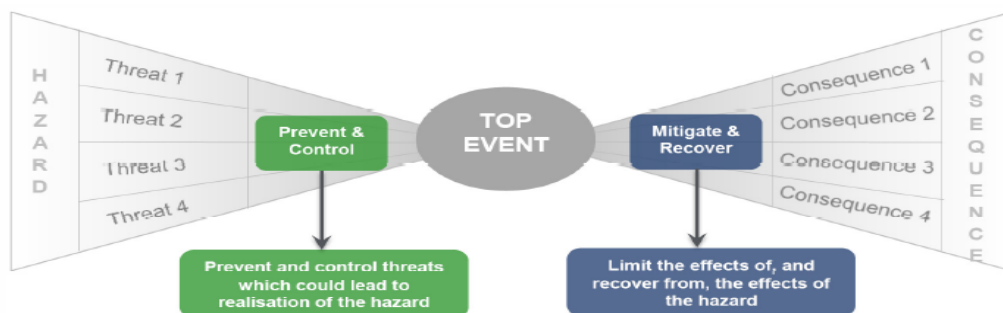
Figure 2-12 Example of a bow-tie diagram (Utvik & Jahre-Nilsen, 2016).

A bow-tie diagram illustrated in Figure 2-12 is a risk management tool demonstrating the risks involved. The causal factors are gathered on the left, including preventative measures, while mitigating action and potential consequences are located on the right (Bower-white, 2012; Utvik & Jahre-Nilsen, 2016).

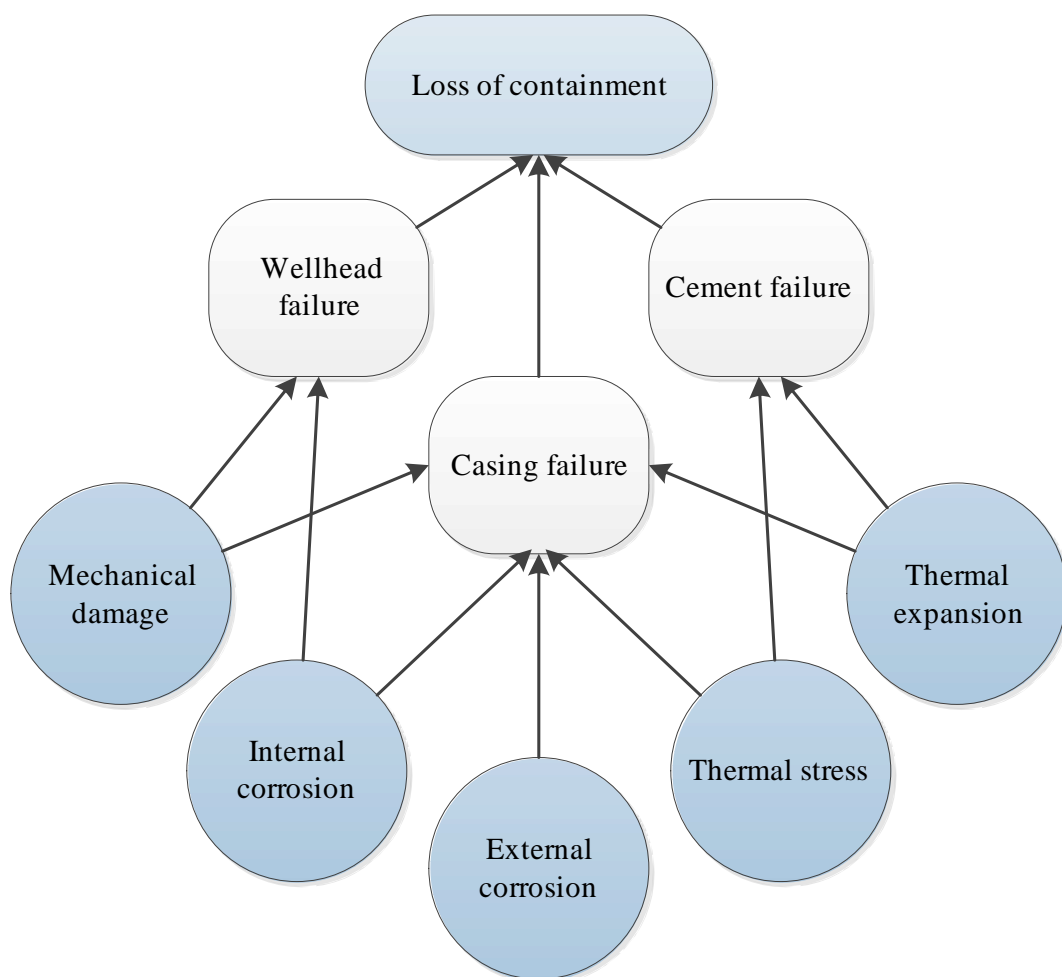
Figure 4-2 Simplified influence diagram of potential hazards in a geothermal well

During drilling or workover situations, the casing wall and wellhead valves are in risk of damage by the equipment (Snyder, 1979). The corrosive geothermal fluids could reduce the casing wall thickness, cause a casing leak or attack the wellhead (Southon, 2005). The temperature changes during quenching and discharge of the well might cause a thermal shock on the casing, resulting in plastic deformation and potentially exceeding the yield limit of the casing. Under the initial start-up of the well, entrapped fluids in the cement between two casing strings can expand and cause the casing to collapse (Southon, 2005). The potential hazards and their effects are illustrated in a simplified influence diagram in Figure 4-2.

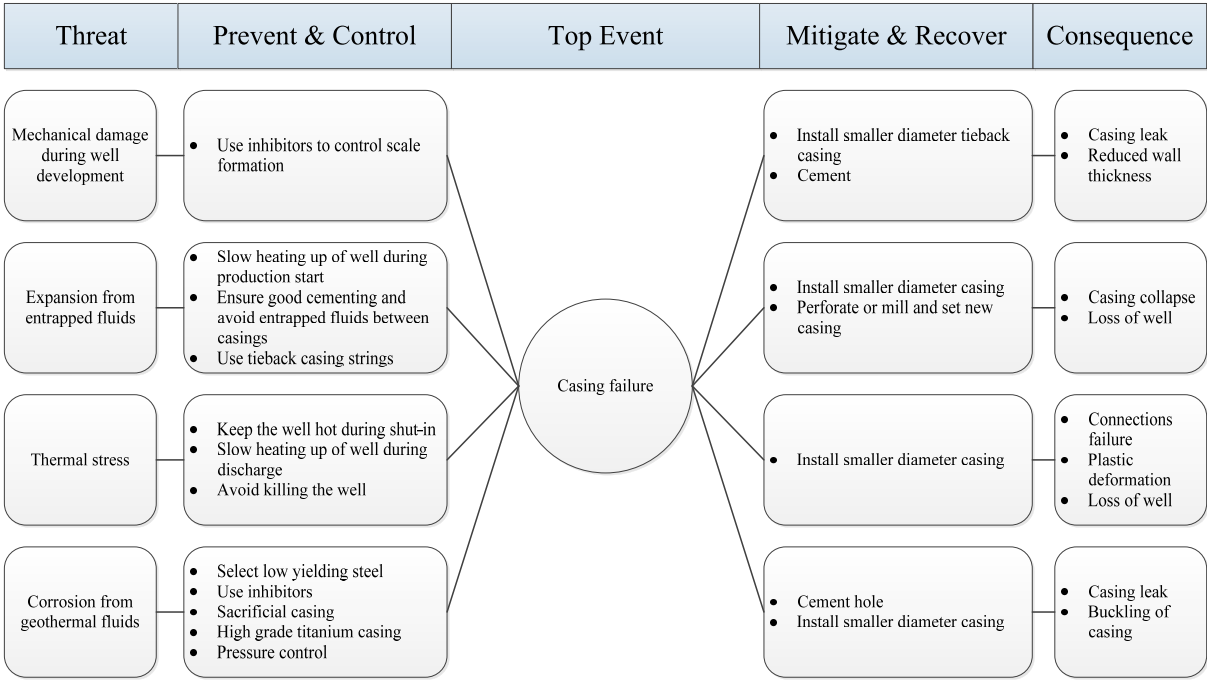
Figure 4-3 represents a bow-tie diagram identifying hazards with the top event being a casing failure. The bow-tie diagram visualizes how the risks of potential hazards are controlled and the possible responses to an event.

Figure 4-3 Bow-tie diagram showing hazards and mitigating actions for casing failure during the production phase (Snyder, 1979; Southon, 2005; Thorhallsson, 2005), Mannvit (personal communication, April 18, 2017).
