University of Stavanger Faculty of Science and Technology MASTER'S THESIS		
Study program/Specialization: Mechanical and Structural Engineering and Materials Science/Offshore Technology Engineering	Spring semester, 2018 Open access	
Writer: Rahela Lokman Hemashrif (Writer's signature)		
<ul> <li>Faculty supervisors: Ashish Aeran and Sudath C. Siriwardane</li> <li>External supervisor(s):</li> <li>Thesis title:</li> <li>A Proposed Framework for Strengthening Mitigations of Offshore Jacket Structures and its Application</li> </ul>		
Credits (ECTS): 30		
Key words: Mitigation methods Life extension Offshore jacket structures Framework Strengthening	Pages: 135 Stavanger, 15.06.2018

The majority of offshore platforms and jacket structures are currently passing their assigned lifetime both on the Norwegian Continental Shelf (NCS), the Gulf of Mexico (GoM), the United Kingdom Continental Shelf (UKCS) and other parts of the world. The concern about ageing related issues and how to solve them is a major concern and presents a significant challenge in all sectors of the offshore oil and gas industry. The reason for mitigation and extending the lifetime of platforms is because there are still

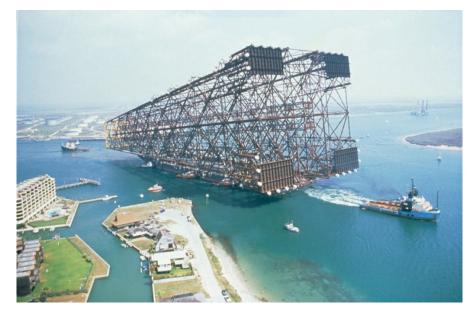
Figure 2.1: Transportation of the jacket-legs for the Bullwinkle platform in the GoM [10]

Offshore jacket platforms have been used in the oil and gas industry since the beginning of offshore oil exploration and production. A fixed platform is built by the use of steel and/or concrete. A steel jacket platform is mainly built by the use of steel. The jacket-legs are anchored directly onto the seabed with piles. The piles provide safe foundation for the platform. The jacket structure is then fixed and supports the deck and topside including all production units, living quarters and drilling rigs. Steel jacket platforms are made of steel tubular members and joints resulting in a very rigid and stable structure. These platforms are built for long-term production and are economically feasible for installation in water depths up to 300 meters. Usually the jacket-legs are constructed onshore and transported into place later in the sea with the use of big transport and installation vessels. After that, the topside is installed on top of the jacket-legs by the use of crane ships.

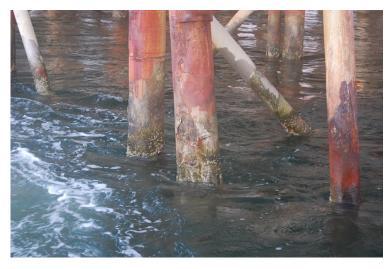
also less effective in the splash-zone due to constant waves, tides and general water movement. In addition, pitting corrosion can start long before the end life of the CPS [3].

Figure 2.4: Example of corrosion near the splash-zone [21]
