MASTER'S THESIS

(signature of author)
Programme coordinator: Dimitros Pavlou Supervisor: Torfinn Havn	
Title of master's thesis: Investigation of Corrosion Resistance of Duplex, Lean Duplex and Austenitic Stainless Steels in Simulated Offshore Environment.	
Credits: 30	
Keywords: General Corrosion, Pitting Corrosion, Marine Atmosphere, Pitting potential, Corrosion resistance, Austenitic Stainless Steels, Duplex, Lean Duplex, Chemical composition	Number of pages: 53 + enclosure: 36 (Appendix) Stavanger, 14 June, 2019

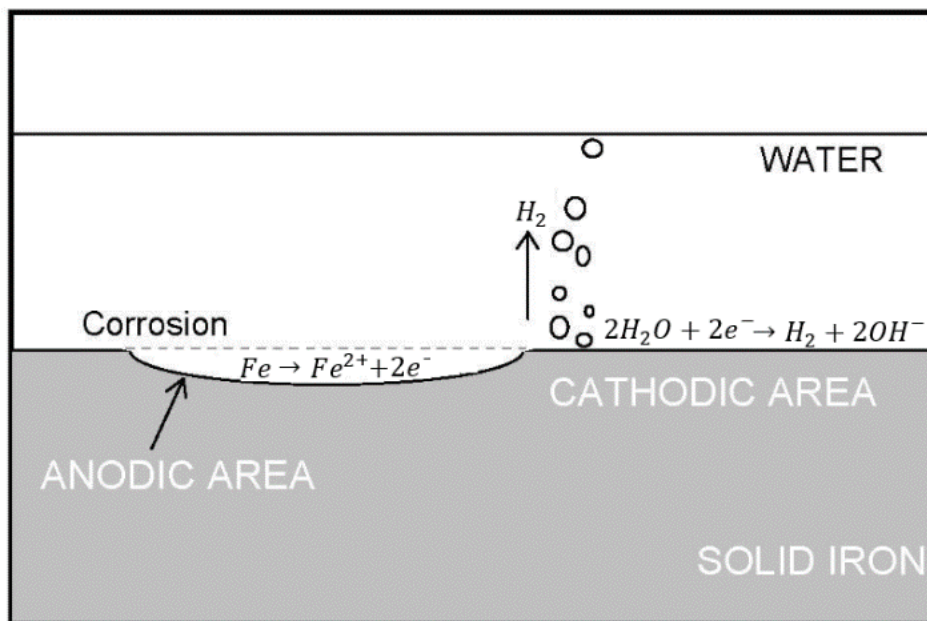
Figure 2: Illustration of the corrosion process of iron [9]

The overall reaction can be broken down into the oxidising anodic reaction (Eq. 2.2) and the reducing cathodic reaction (Eq. 2.3). The corrosion process is illustrated below in the figure 2 [9].

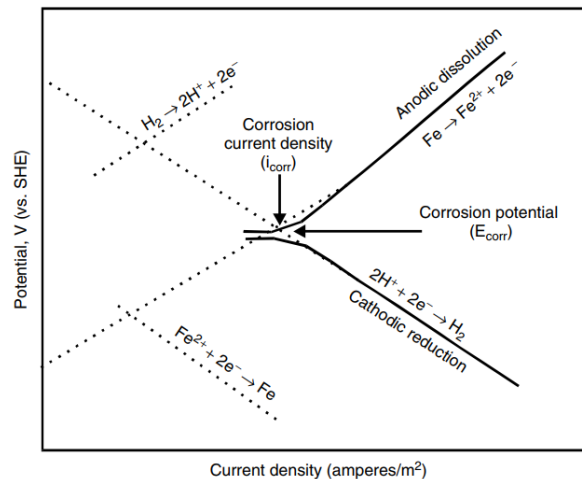
Figure 3: Evans diagram for iron immersed in an acidic solution [12]

From the Evans diagram in figure 3, four important parameters can be found: the corrosion potential (E_{corr}), the corrosion current density (i_{corr}), and the anodic (β_a) and cathodic (β_c) Tafel constants. Straight lines are obtained in the diagram by moving the potential away from the corrosion potential by a set value of $\pm\Delta E$, polarization can be determined with different current (i_{app}), as expressed below [12].

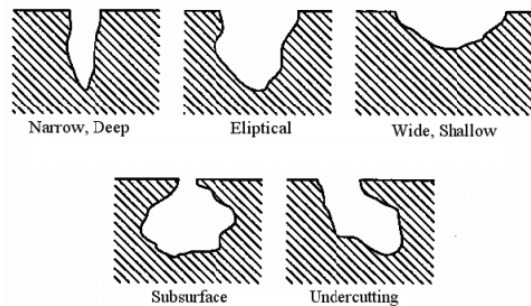
Figure 4: Pitting shapes, ASTM-G46 [13]

Consider a case of stainless steel in seawater. The passive film has a scratch where pitting corrosion has initiated, and the pit continues to propagate. There is usually an extremely corrosive micro-environment developed within the pit, which consists of hydrochloric acid. Inside the pit the pH is lowered significantly, together with an increase in chloride ion concentration, as a result of electrochemical reactions. This causes an increase in pitting growth and will eventually lead to failure of the structure. Shown below in figure 4 are some typical pitting shapes which can occur on the metal surface [13].

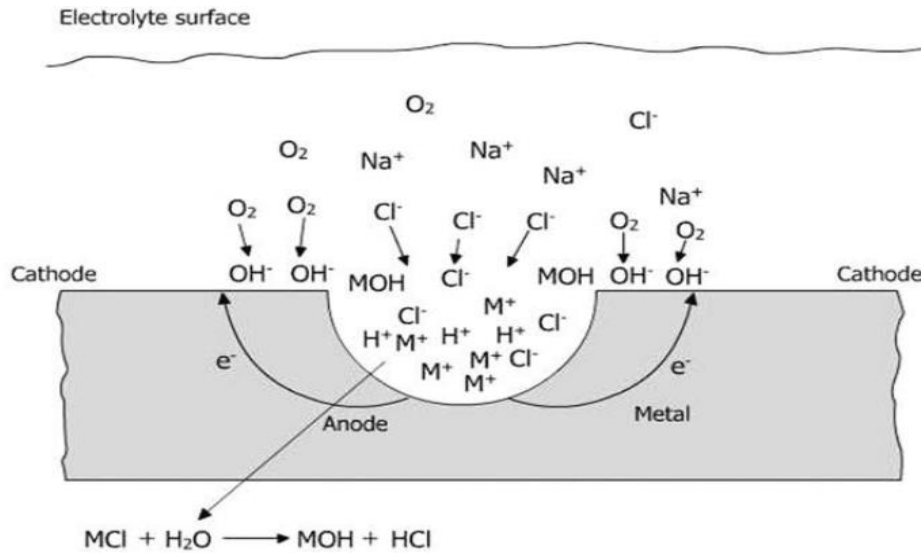
Figure 5: Illustration of pitting corrosion on a metal in chloride solution [8]

The pitting reactions on a metal with a passive film is shown below and illustrated in figure 5. The environment consists of chloride and oxygen. An anodic reaction (Eq. 2.7) occurs inside the pit and is balanced by the cathodic reaction (Eq. 2.8) of oxygen at the surface level. At the beginning of the reaction, the whole surface is exposed to the electrolyte containing oxygen, which leads to reduction of oxygen inside the pit. As the metal continues to dissolve, the system needs to obtain charge neutrality. To accomplish this, an excess of positive ions M^+ and negative ions Cl^- migrate from the electrolyte. The product of this is the formation of hydrolysis (Eq. 2.9), ions of H^+ and Cl^- prevents repassivation and lowers the pH in the pit [8].

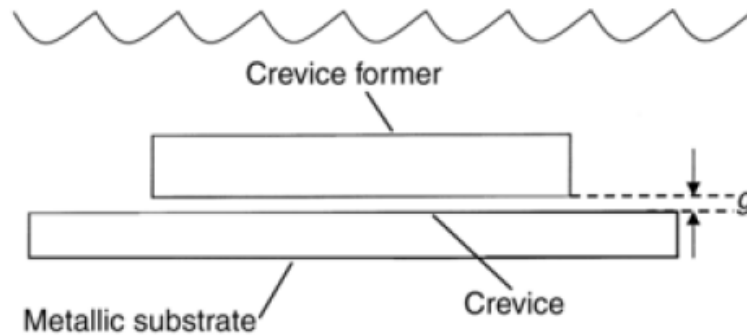
Figure 6: Idealized geometry of crevice corrosion [14]

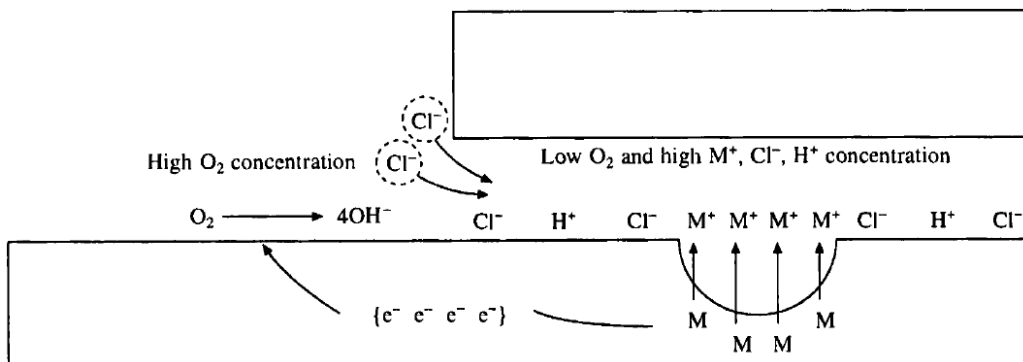
Figure 7: Mechanism of crevice corrosion [16]

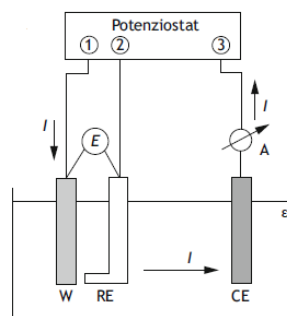
Figure 8: Standard polarization cell [4]

Electrochemical tests are usually performed in a laboratory and used to find the basic corrosion-influencing factors, such as corrosion potential, passivation, oxidation power, anodic and cathodic characteristics, thermodynamic- and kinetic parameters. Test procedures are generally performed with guidelines provided from standards, which gives the results a high reproducibility. Polarization curves can be obtained by the potentiostatic method, usually provided in Evans diagrams. This method requires a potentiostat, a working electrode (W), a reference electrode (RE), a counter electrode (CE) and an electrolyte. This is illustrated in the standard polarization cell shown in figure 8 below [2].

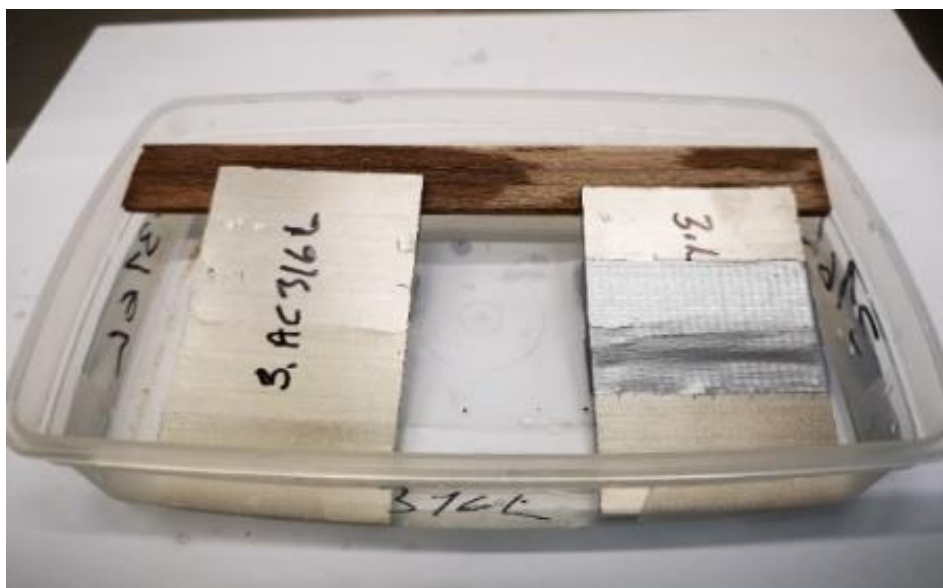
Figure 15: Samples ready for general and localized corrosion testing

The test set-up is illustrated below in figure 15, where each material had their own small plastic containers to store seawater. The material was supported by a small piece of wood so that it could be half immersed in seawater. The seawater used was gathered from the North Sea, close to shore in Fiskepiren, Stavanger. During each round of testing there was evaporation of seawater, the containers were filled up every third day so that the samples would stay half immersed. The heating cabinet provided by Multi Phase Meters is shown below in figure 16 and the inside with the samples in containers in figure 17. The samples were weighted to find their mass before and after the testing rounds, and visual inspection was performed after testing. A total of 30 samples were tested for general and localized corrosion, given in table 9 below is an overview of the materials and sample names.

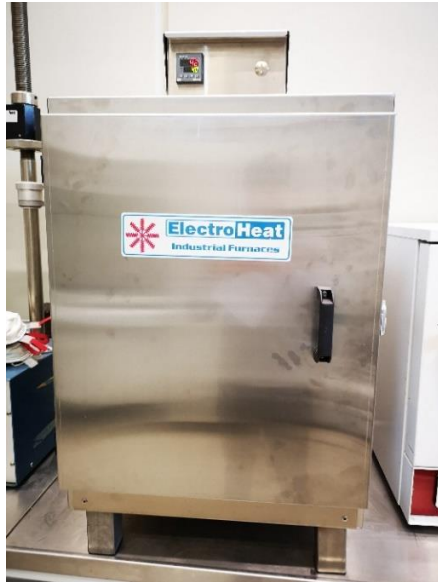
Figure 16: Heating cabinet

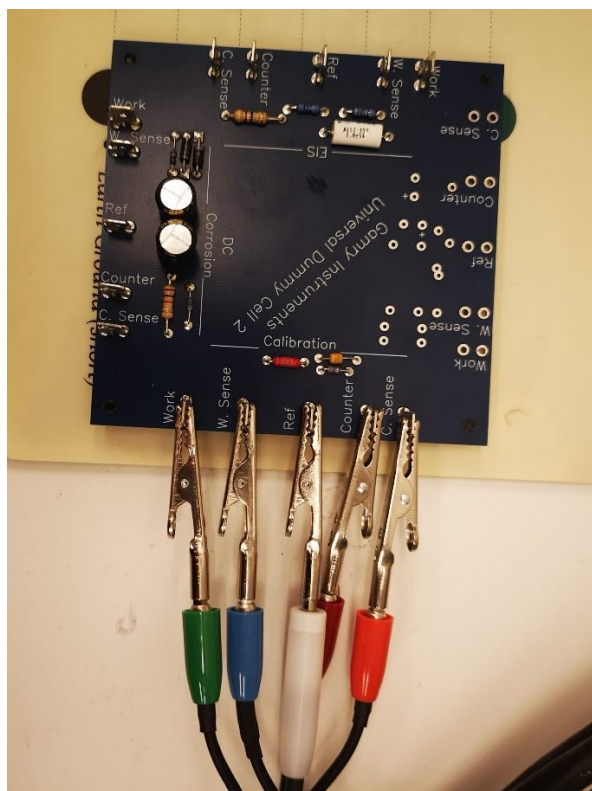
Figure 20: Calibration of Gamry instrument

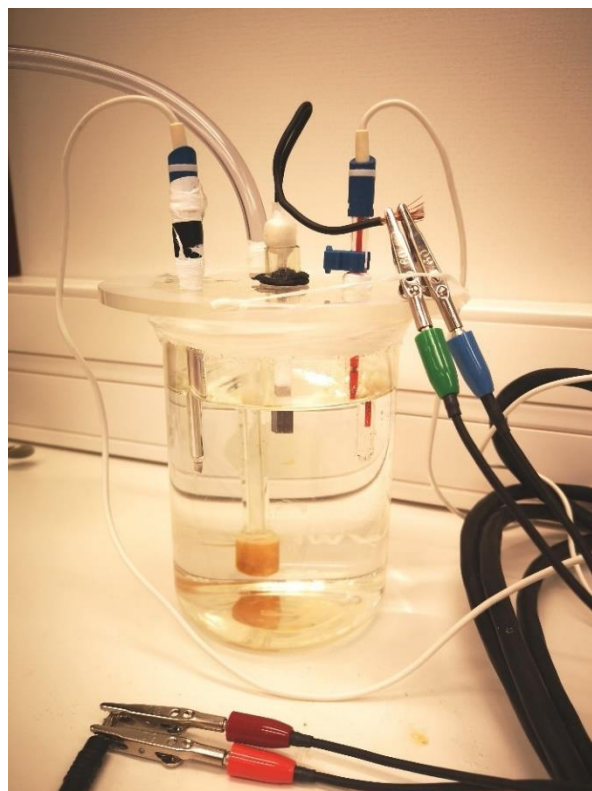
Figure 21: Polarization cell

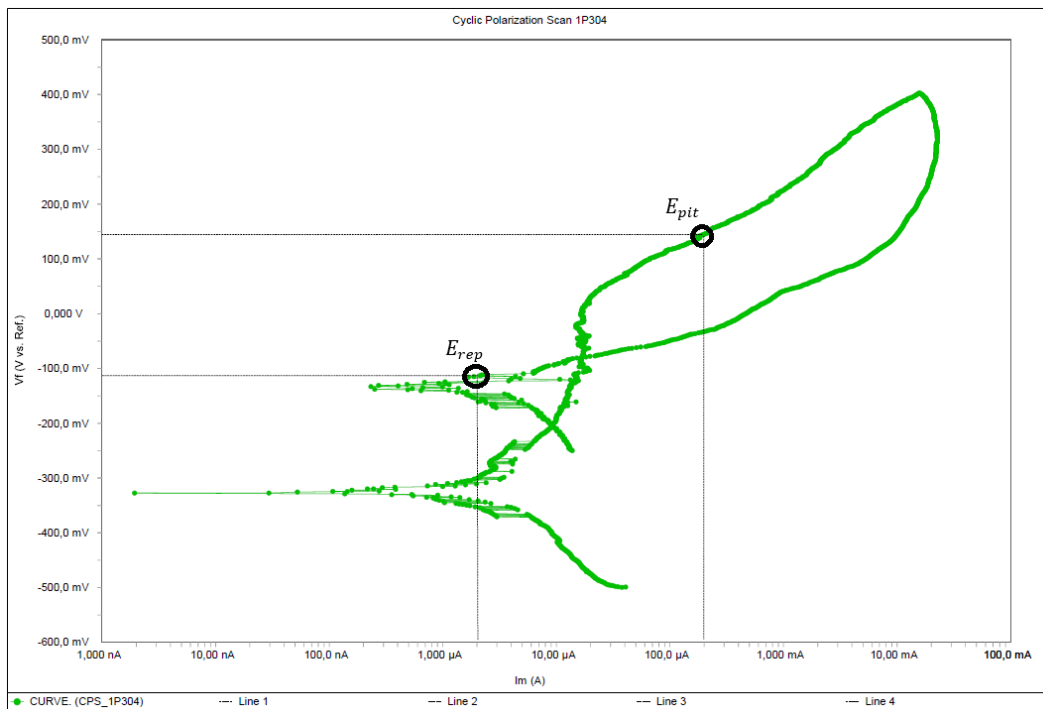
Figure 24: Pitting- and repassivation potential of SS 304 plot

In all the samples, the pitting potential (E_{pit}) is measured at a current of $200\ \mu\text{A}$, just above the occurrence of a sharp increase in anodic current of the forward scan. The repassivation potential (E_{rep}) is measured at a current of $2\ \mu\text{A}$ of the reverse scan for all samples, except samples of duplex where the repassivation is set at the maximum point [32]. This is illustrated below in figure 24 and figure 25.

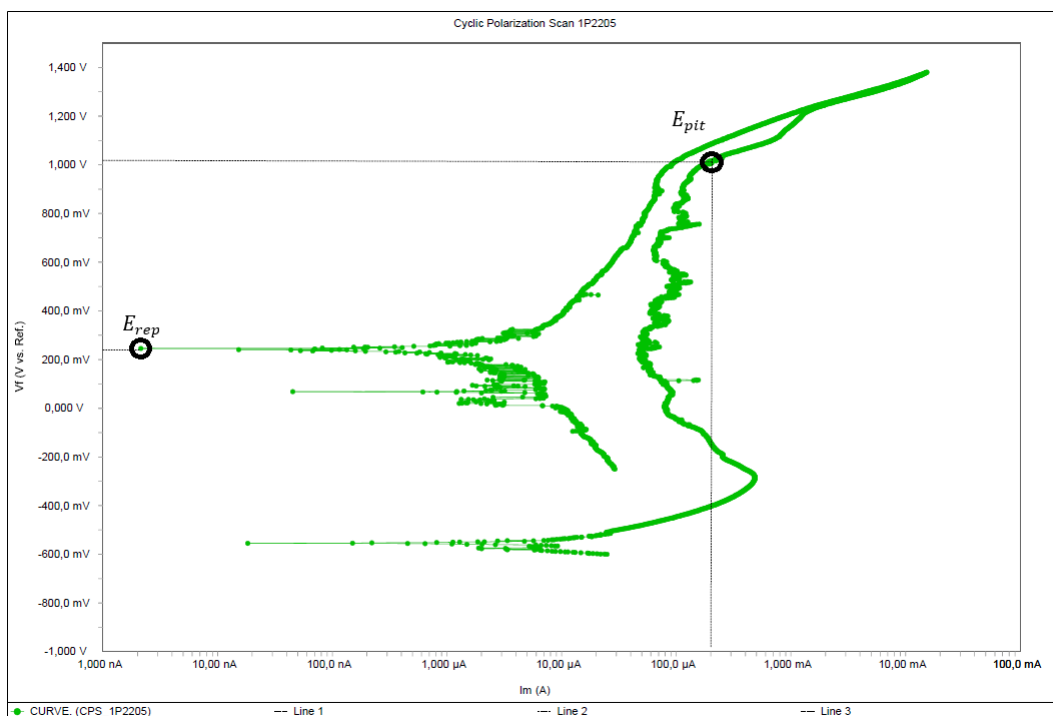
Figure 25: Pitting- and repassivation potential of DSS 2205

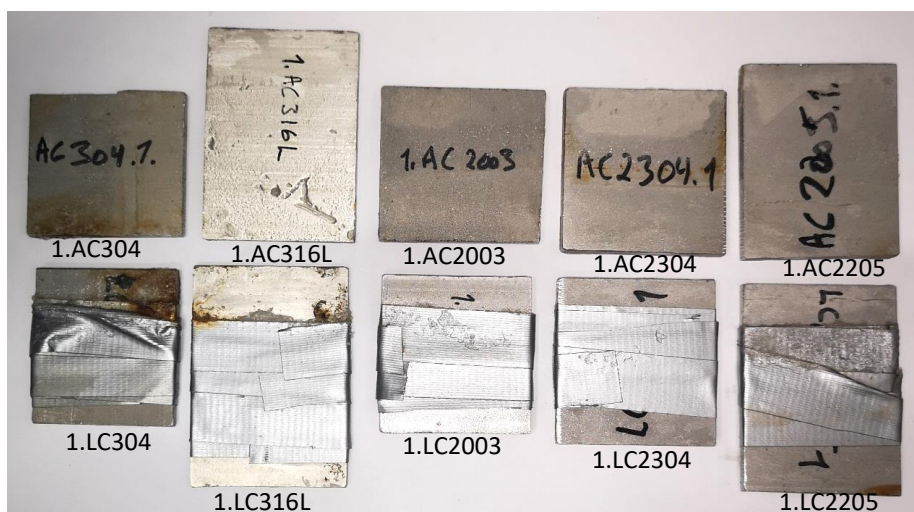
Figure 26: Salt layer on samples after testing of round 1

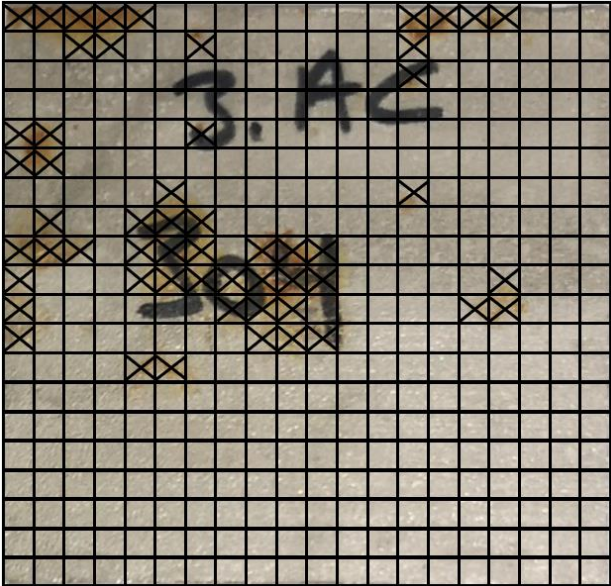
Figure 27: 20x20 grid illustrated on sample 3.AC 304

The percentage of the corroded surfaces were estimated by applying a 20x20 grid, such as illustrated for one sample below in figure 27. The X on each grid point indicates a corroded area by general corrosion of the sample surface. The amount of these corroded areas is divided by the total grid area and then multiplied by 100 to get the estimated percentage of corrosion. In figure 28 below, the percentage of corrosion are shown for each sample from table 11.

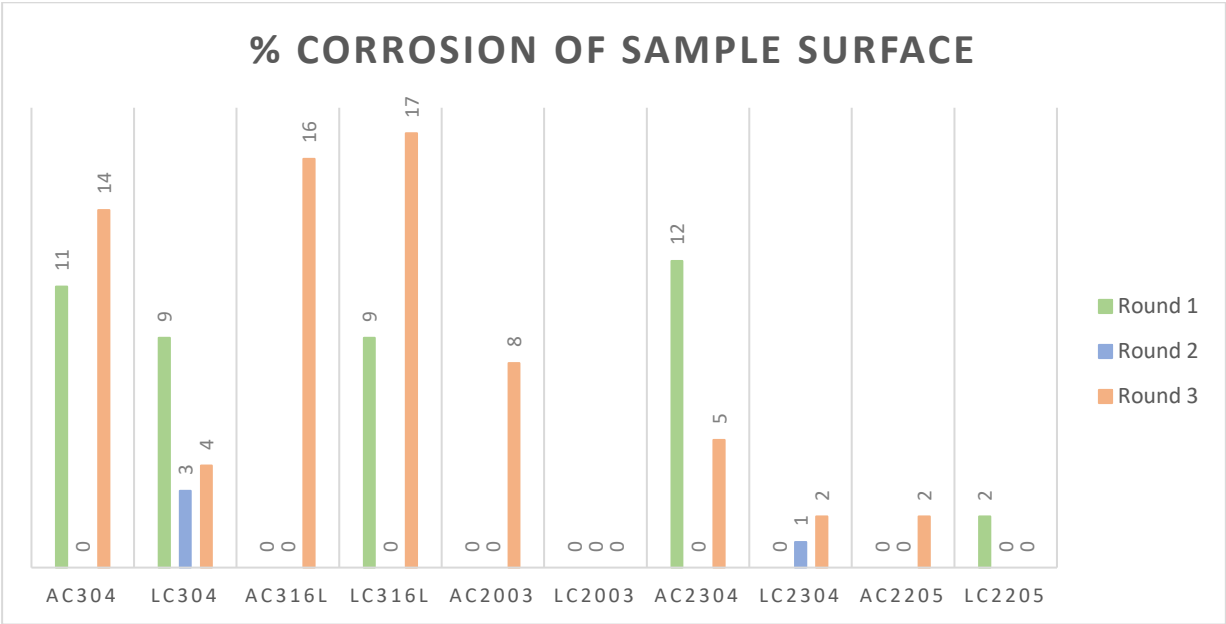
Figure 28: Percent corrosion of the sample surfaces

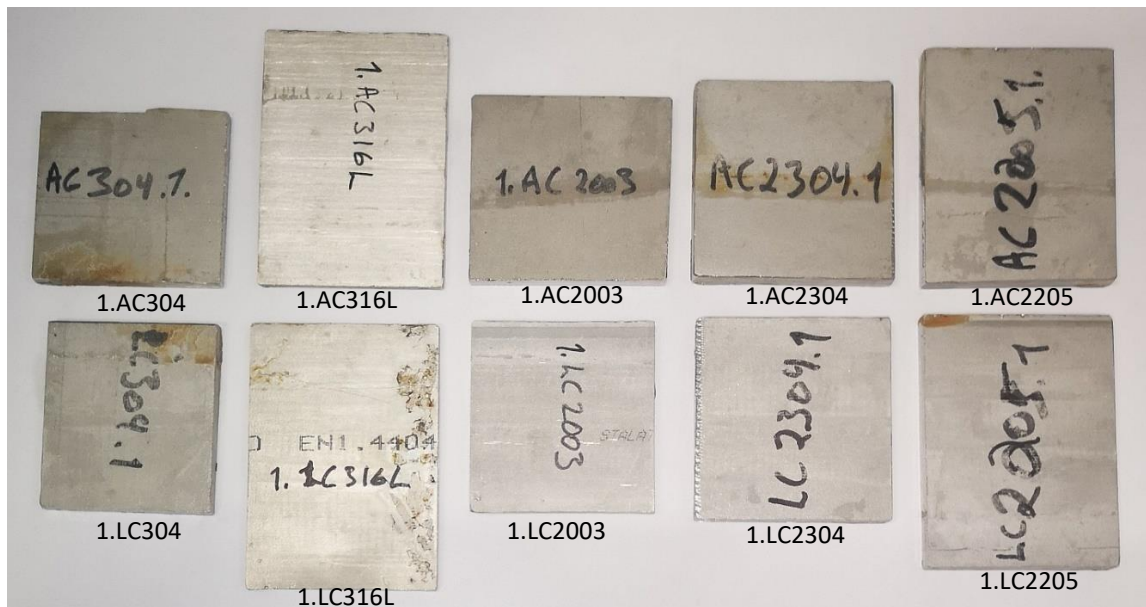
Figure 29: Frontside of the samples after test round 1

Some of the samples from test round 1 showed signs of general corrosion initiation, while the other samples showed zero corrosion activities. Samples 1.AC316L, 1.AC2003 and 1.AC2205 tested for general corrosion was not affected by the chloride environment and have not corroded. None of the samples tested for localized corrosion showed initiation of localized corrosion, however sample 1.LC304 had initiated general corrosion above the tape level. General corrosion can also be spotted on sample 1.AC2304 at water level, sample 1.LC316L had begun to initial general corrosion on tape level. Sample 1.LC2205 showed a small area of general corrosion on the burr edge. The front- and backside of the samples are shown below in figure 29 and figure 30.

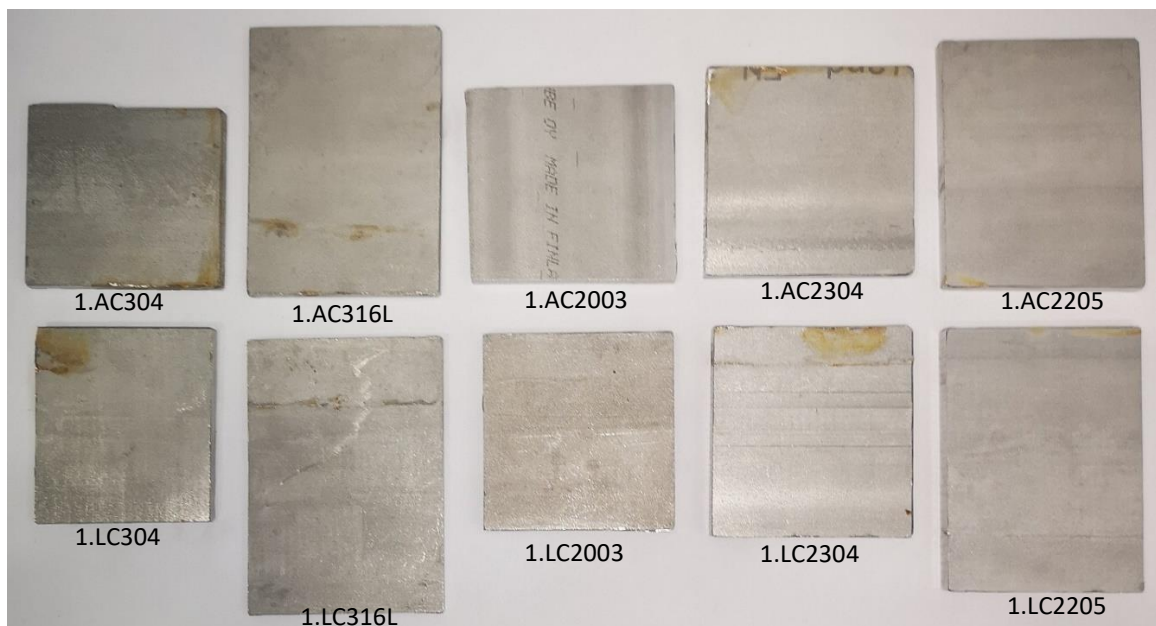
Figure 30: Backside of the samples after test round 1

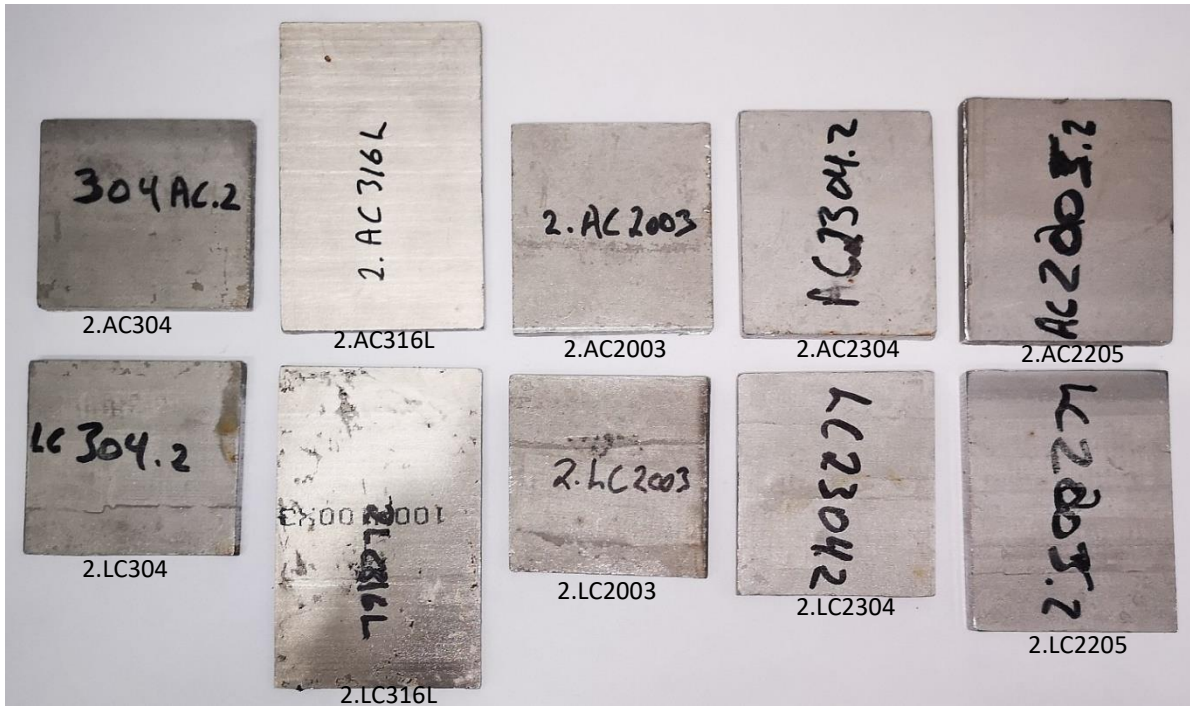
Figure 31: Frontside of the samples after test round 2

The result from test round 2 reveals almost no corrosion on the samples. The only samples affected by general corrosion initiation were 2.LC304 and 2.LC2304. Sample 2.AC316L had one small spot of corroded area on both the front- and back-side, these spots were less than 0.2% corrosion by using a 20x20 grid. This can be seen below in figure 31 and figure 32.

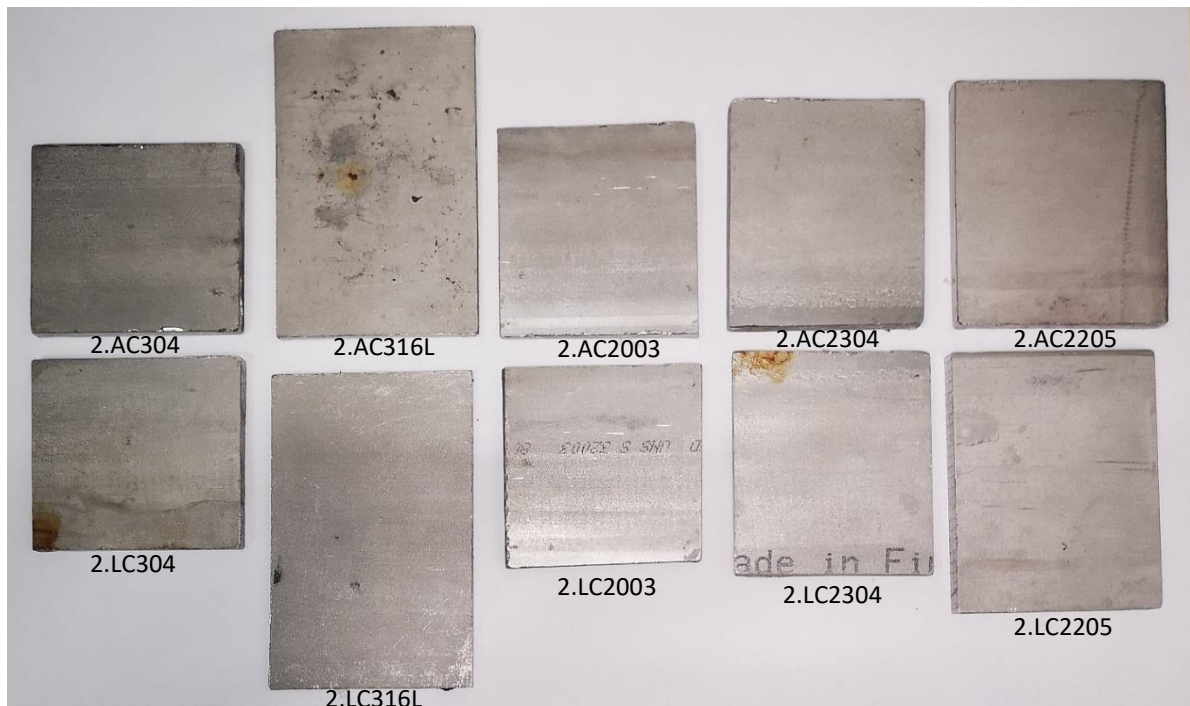
Figure 32: Backside of the samples after test round 2

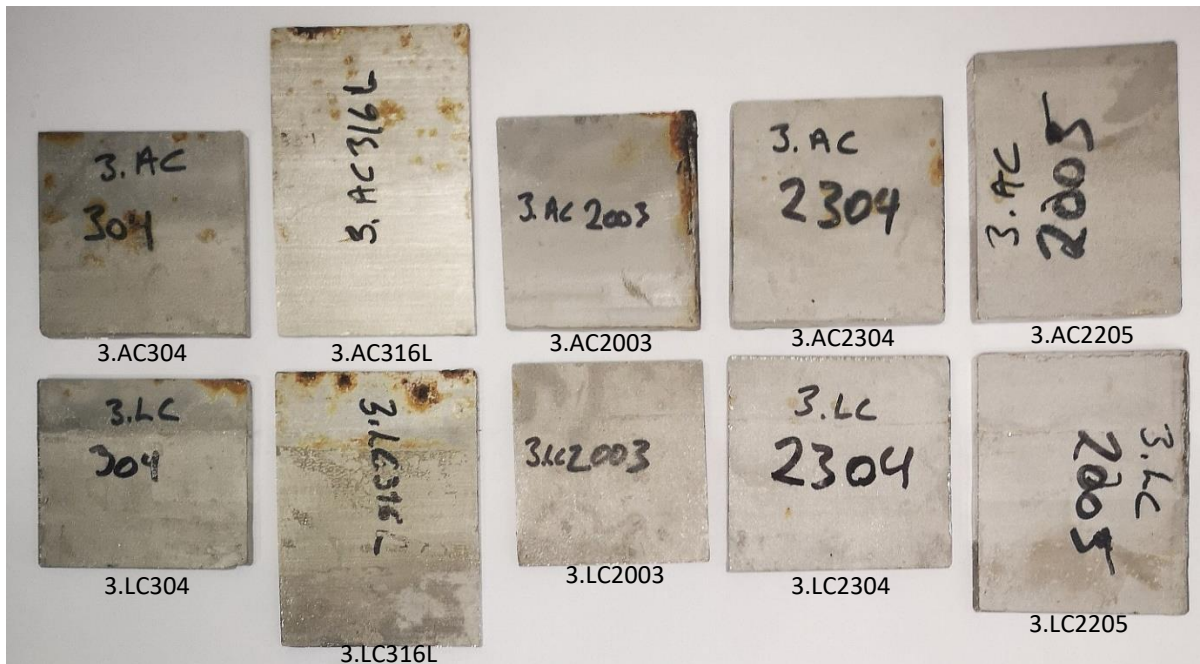
Figure 33: Frontside of the samples after test round 3

The samples gathered from test round 3 appears to be the most corroded samples of all the test rounds due to high temperature. All samples were affected by general corrosion, except samples 3.LC2003 and 3.LC2205. Samples 3.AC304 and 3.LC304 have general corrosion on the burr edges, which can be seen on the backside of the samples. This was also observed with the frontside of sample 3.AC2003. Samples 3.AC2304 and 3.AC2205 were little affected by corrosion and have only initiated small areas of general corrosion on their surfaces. The front- and backside of the samples are shown in figure 33 and figure 34 below.

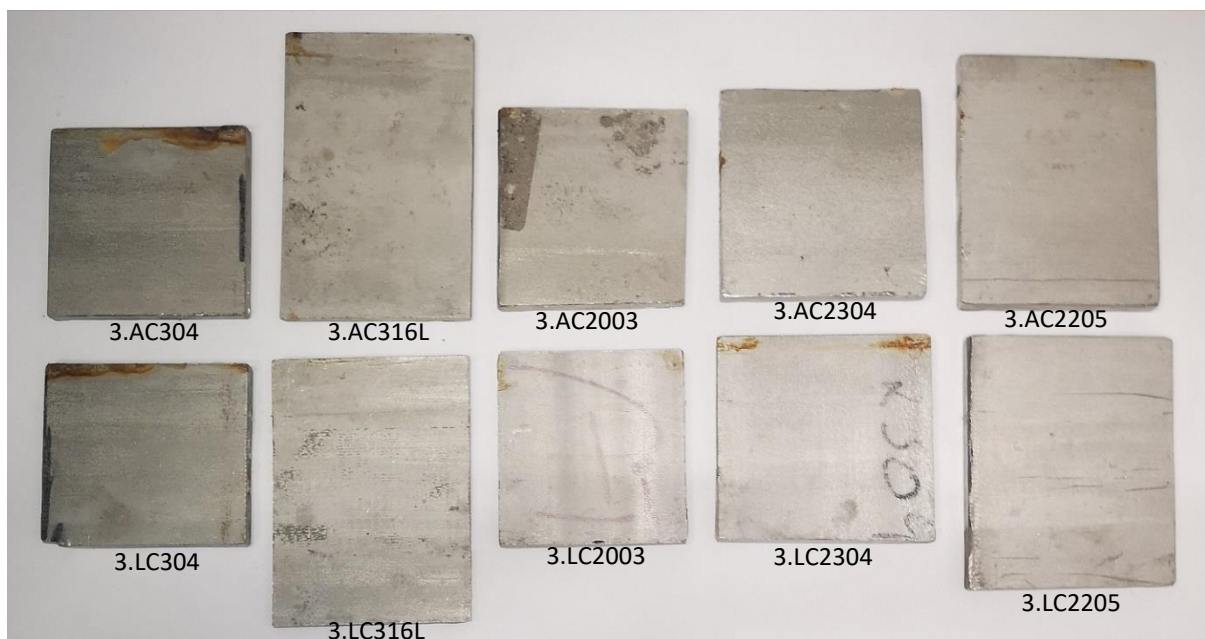
Figure 34: Backside of the samples after test round 3

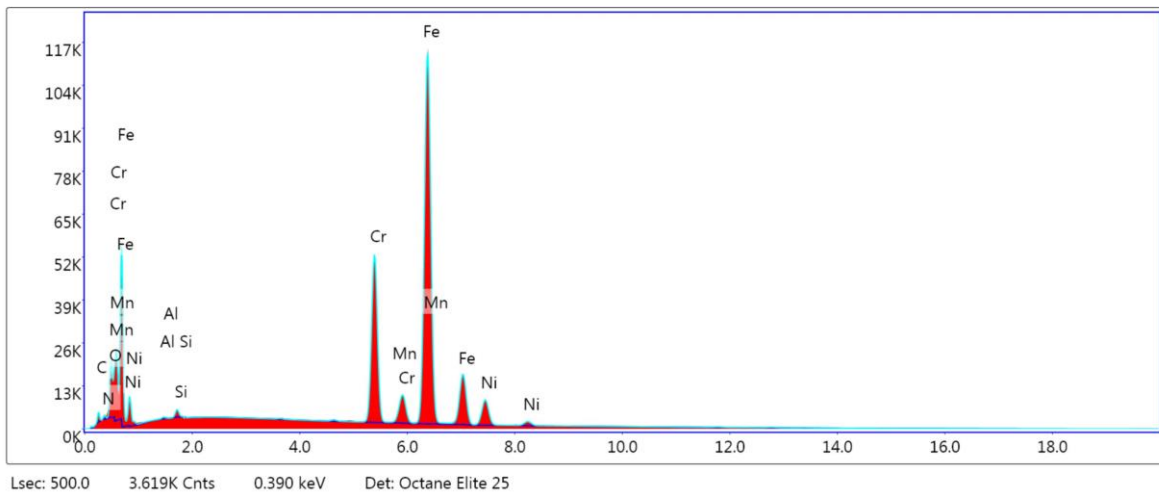
Figure 35: EDS spectrum from one sample

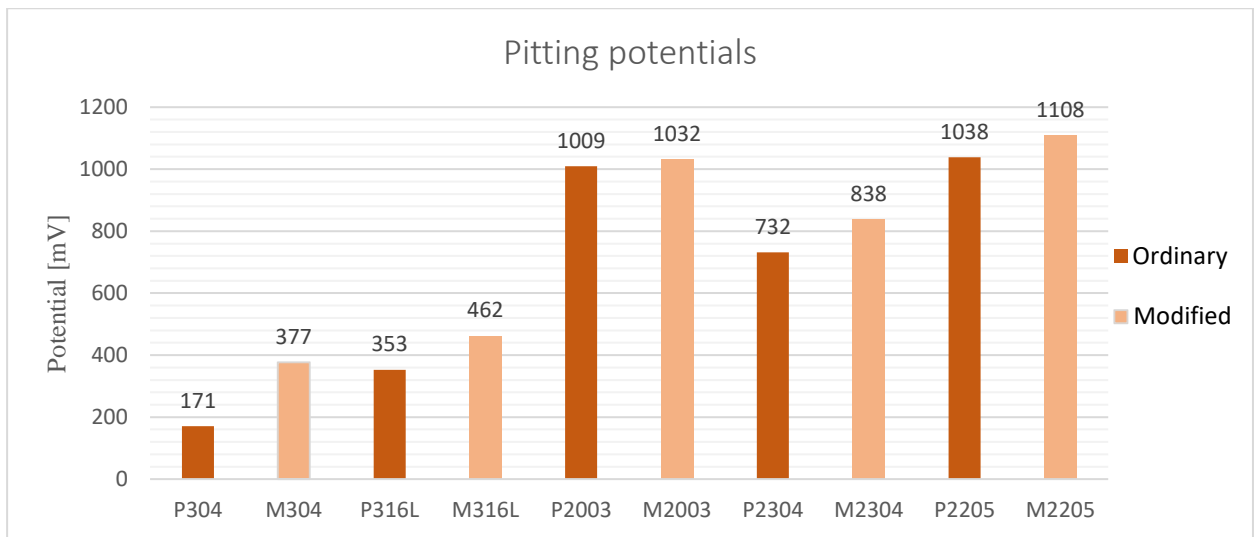
Figure 36: Pitting potentials of the samples

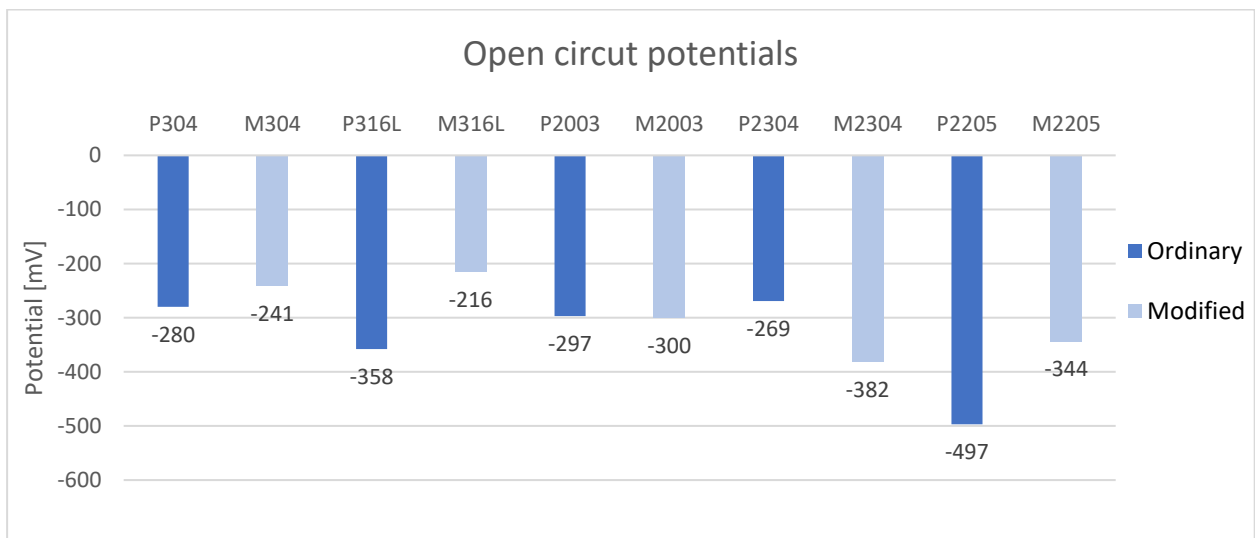
Figure 37: Open circuit potentials of the samples

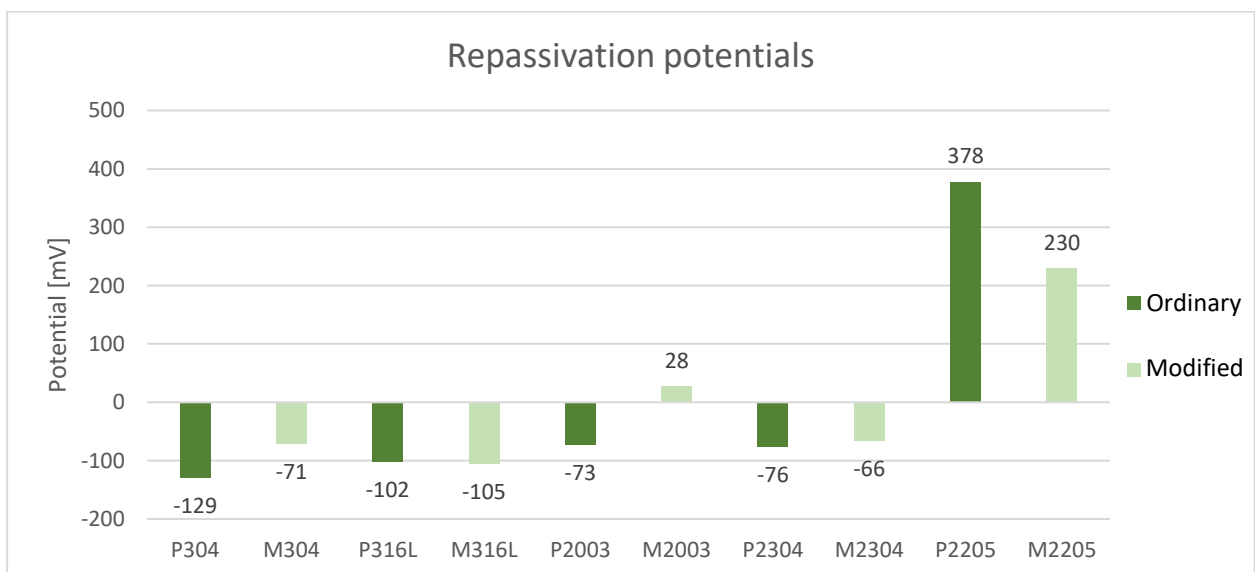
Figure 38: Repassivation potentials of the samples

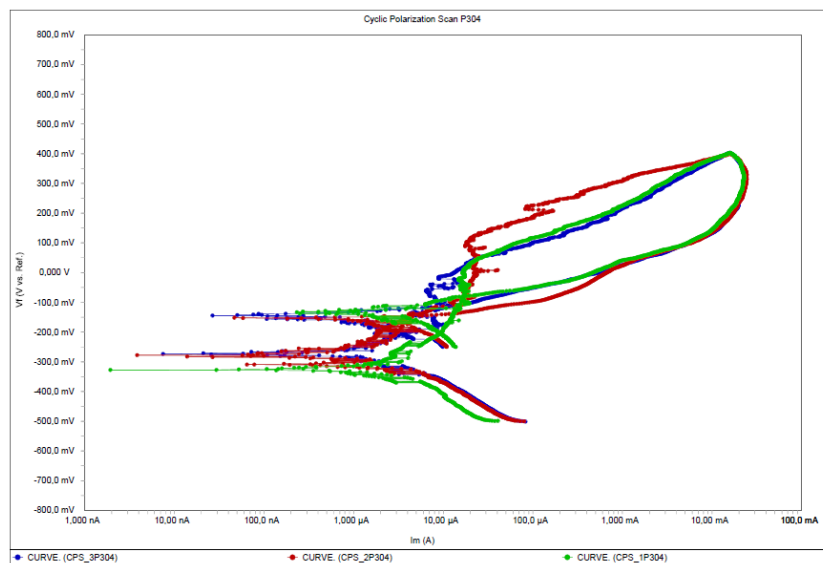
Figure 39: CPS ordinary P304

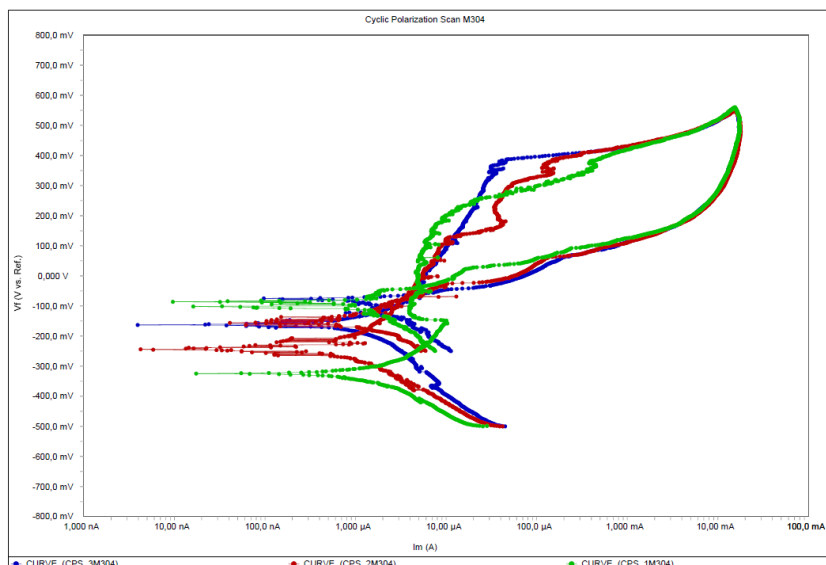
Figure 40: CPS modified M304

In the modified scan it was observed some fluctuations in samples 2M304 and 3M304, while sample 1M304 showed the lowest pitting potential. Pitting- and repassivation potentials of the M304 scan are 377 mV and -71 mV.

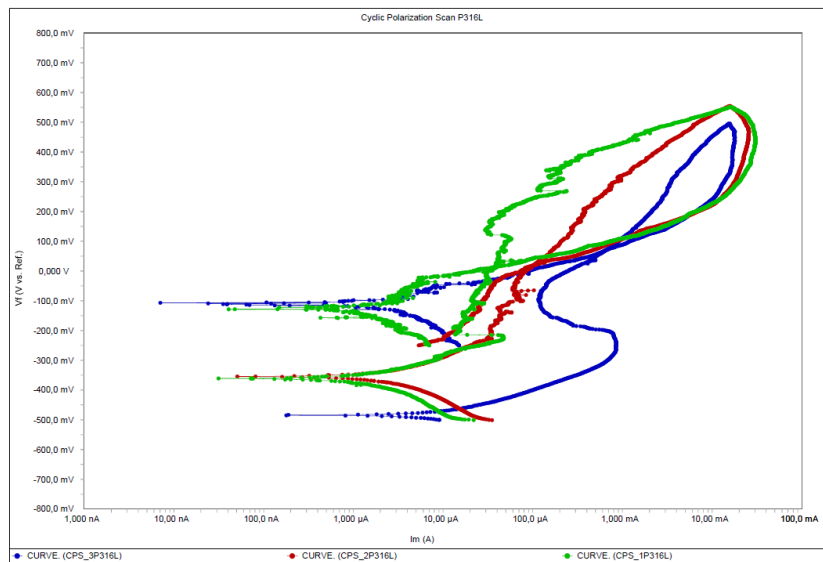
Figure 41: CPS ordinary P316L

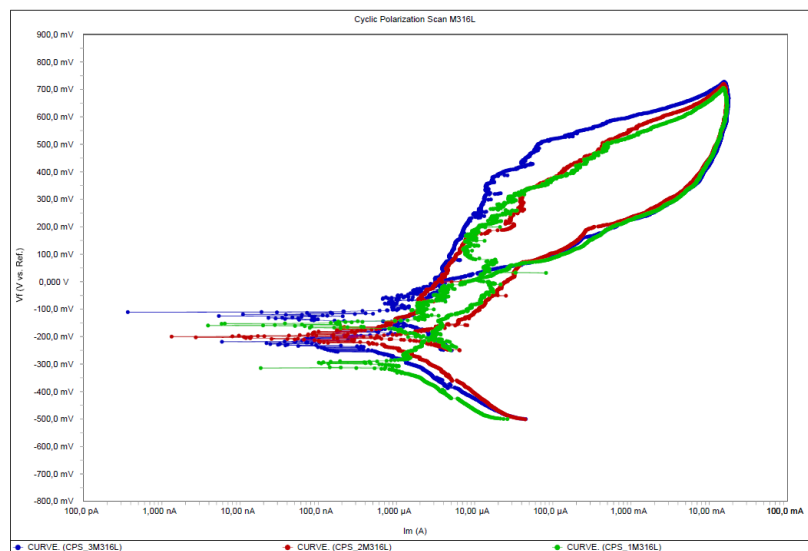
Figure 42: CPS modified M316L

From the results of the modified scan in figure 42, the pitting- and repassivation potentials of the M316L scan are 462 mV and -105 mV. The samples in this scan showed repeatability, sample 3M316L had some fluctuations and a larger pitting potential than the others. Both ordinary and modified scans have large areas of positive hysteresis loops, leading to poor resistance against localized corrosion in chloride environments.

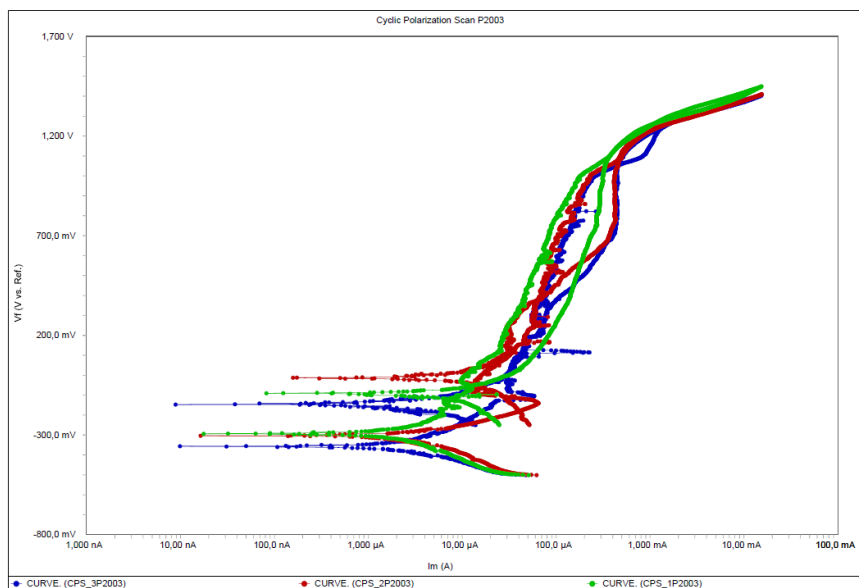
Figure 43: CPS ordinary P2003

The scans of both ordinary and modified scans shows similarities between the samples with some fluctuations, as shown in figure 43 and figure 44. After a rapid increase in anodic current the hysteresis becomes negative, and at a lower current it becomes positive with a small hysteresis area, which occurred in all the samples of 2003. This indicates that the material is susceptible to localized corrosion, the pitting- and repassivation potentials of P2003 are measured to 1009 mV and -73 mV. In the modified experiment, sample 1M2003 showed a difference in the forward scan due to fluctuation. Pitting- and repassivation of M2003 was measured to be 1032 mV and -300 mV.

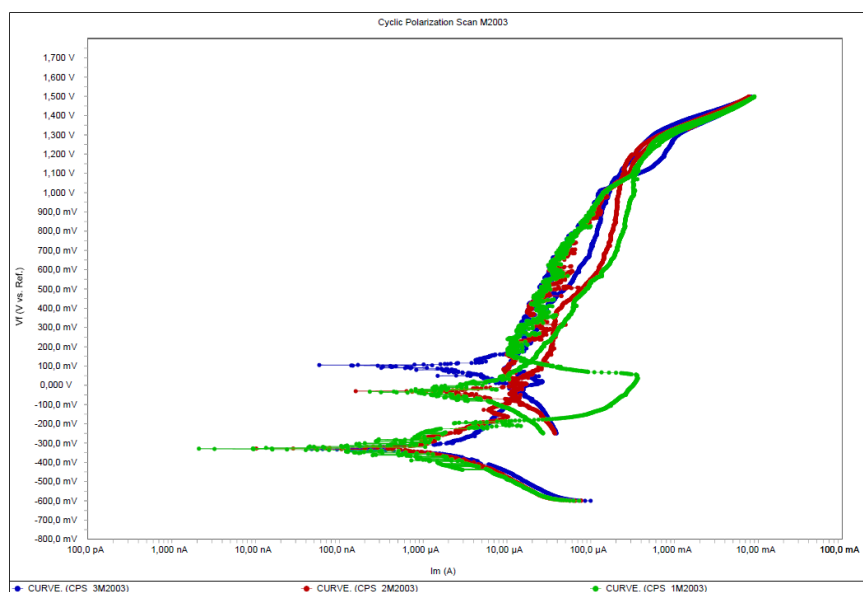
Figure 44: CPS modified M2003

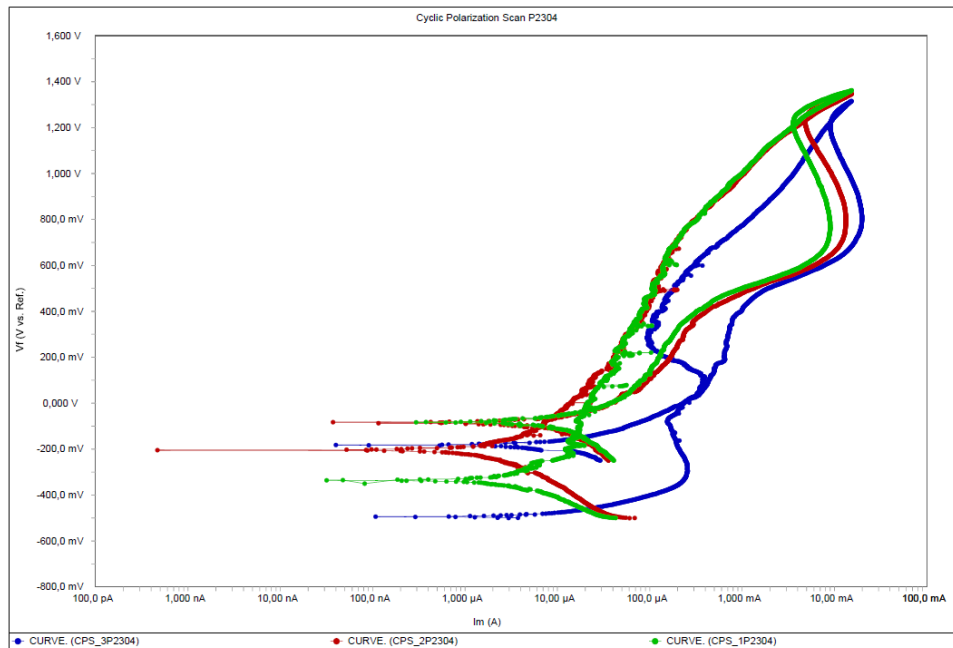
Figure 45: CPS ordinary P2304

The hysteresis loops of all the samples of P2304 and M2304 shows similarities, as seen in figure 45 and figure 46. The hysteresis loops become negative after a rapid increase in current and positive in the reverse scan with large areas, which indicates poor pitting resistance. In the ordinary scan, potentials of pitting and repassivation was obtained to be 732 mV and -76 mV. The modified scan showed a pitting- and repassivation potential of 838 mV and -66 mV.

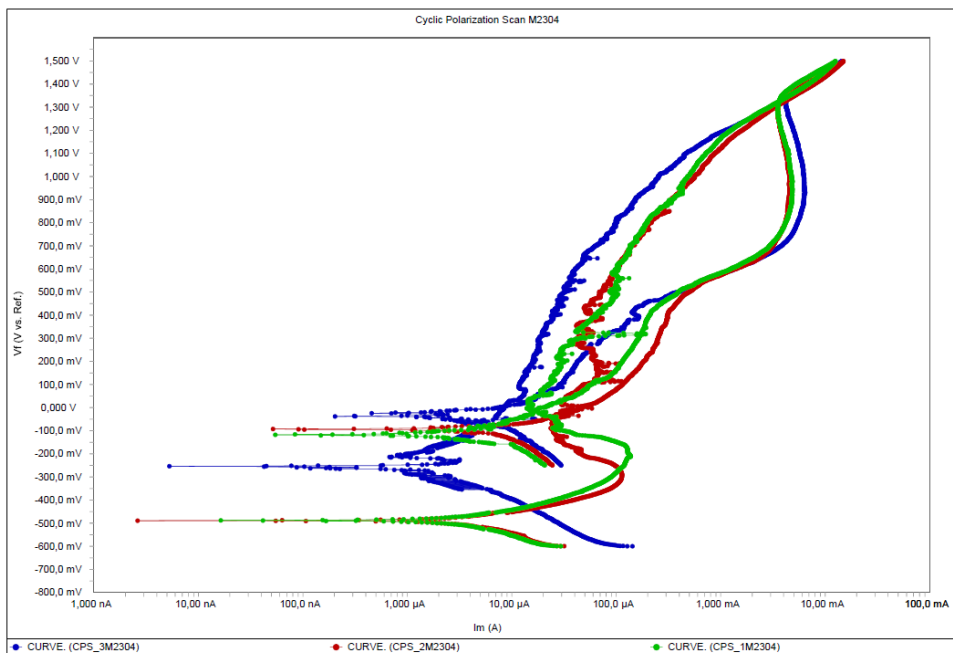
Figure 46: CPS modified M2304

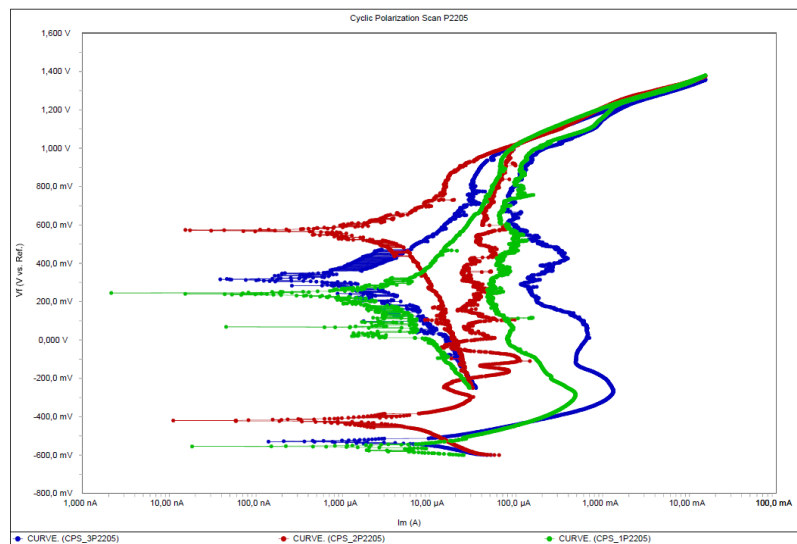
Figure 47: CPS ordinary P2205

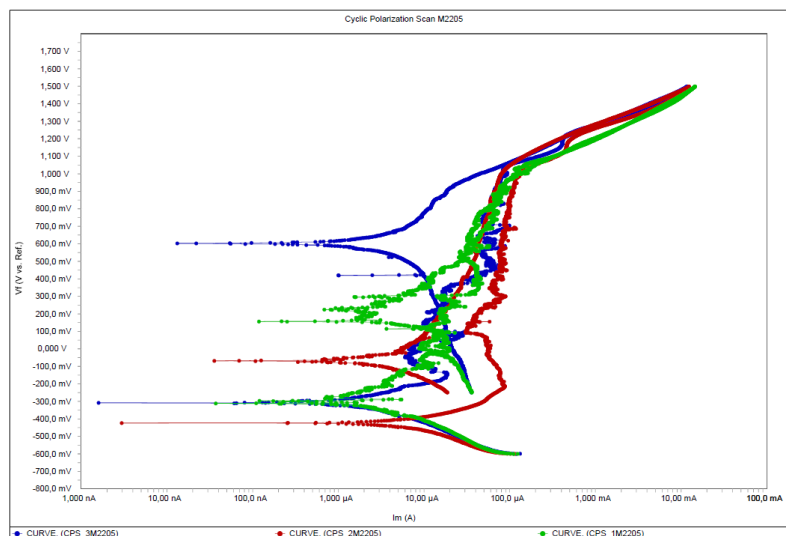
Figure 48: CPS modified M2205

The modified scan showed similar results, where sample 1M2205 and sample 3M2205 showed negative hysteresis loops while sample 2M2205 had no hysteresis loop as seen in figure 48. All the samples of the modified and ordinary scans show high pitting potentials with proximities to each other. Pitting- and repassivation potential of M2205 was measured to be 1108 mV and 230 mV.

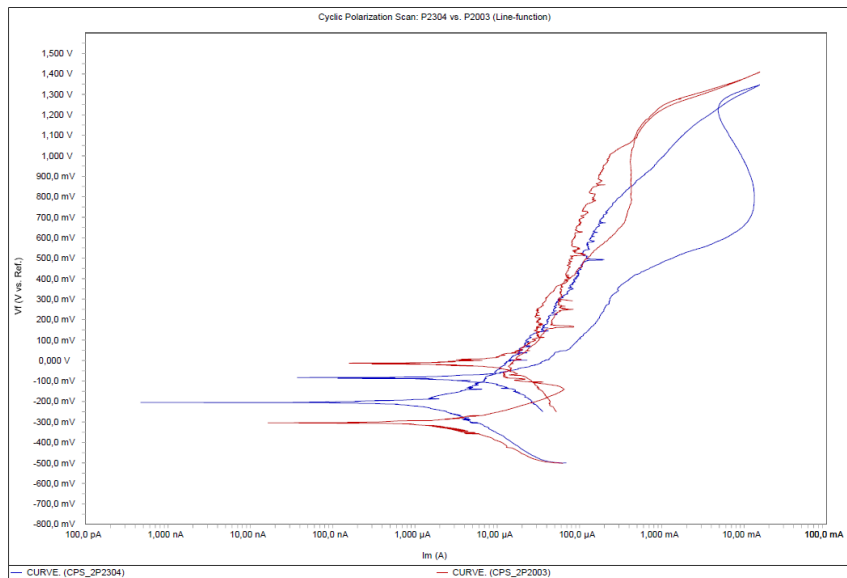
Figure 49: CPS samples; 2P2304 vs. 2P2003
