MASTER'S THESIS

(signature of author)
Programme coordinator: Dimitros Pavlou Supervisor: Torfinn Havn	
Title of master's thesis: Investigation of Corrosion Resistance of Duplex, Lean Duplex and Austenitic Stainless Steels in Simulated Offshore Environment.	
Credits: 30	
Keywords: General Corrosion, Pitting Corrosion, Marine Atmosphere, Pitting potential, Corrosion resistance, Austenitic Stainless Steels, Duplex, Lean Duplex, Chemical composition	Number of pages: 53 + enclosure: 36 (Appendix) Stavanger, 14 June, 2019

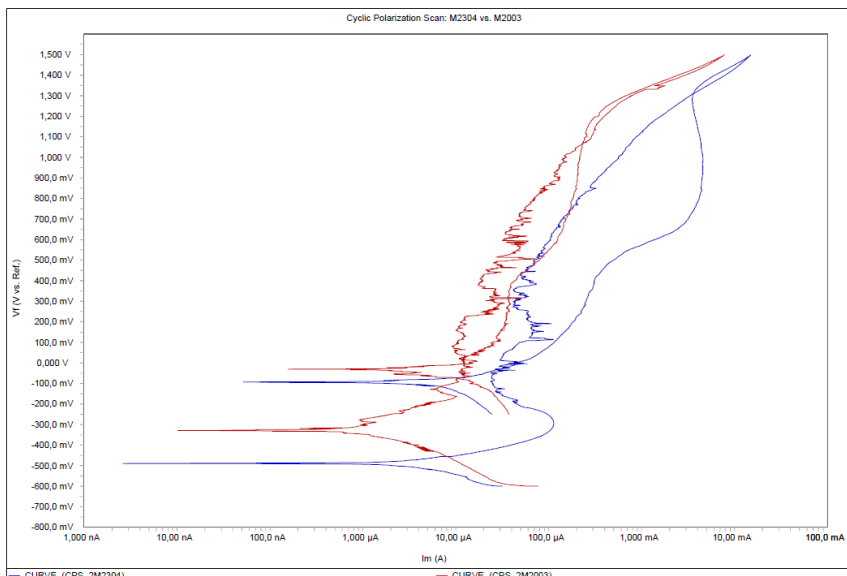
Figure 50: CPS samples; 2M2304 vs. 2M2003

Figure 50 below shows the modified scan with samples 2M2304 (marked as blue) and 2M2003 (marked as red). It has similarities to the ordinary scan. 2M2304 also has a larger area of positive hysteresis loop and a lower pitting potential than 2M2003.
