MASTER THESIS

Study program/specialization:
Master of Science in Engineering Structures
and Materials/Mechanical Systems

Title of Master Thesis:
Investigation of Material Property changes in HSLA Steel due to Weld Proximity.

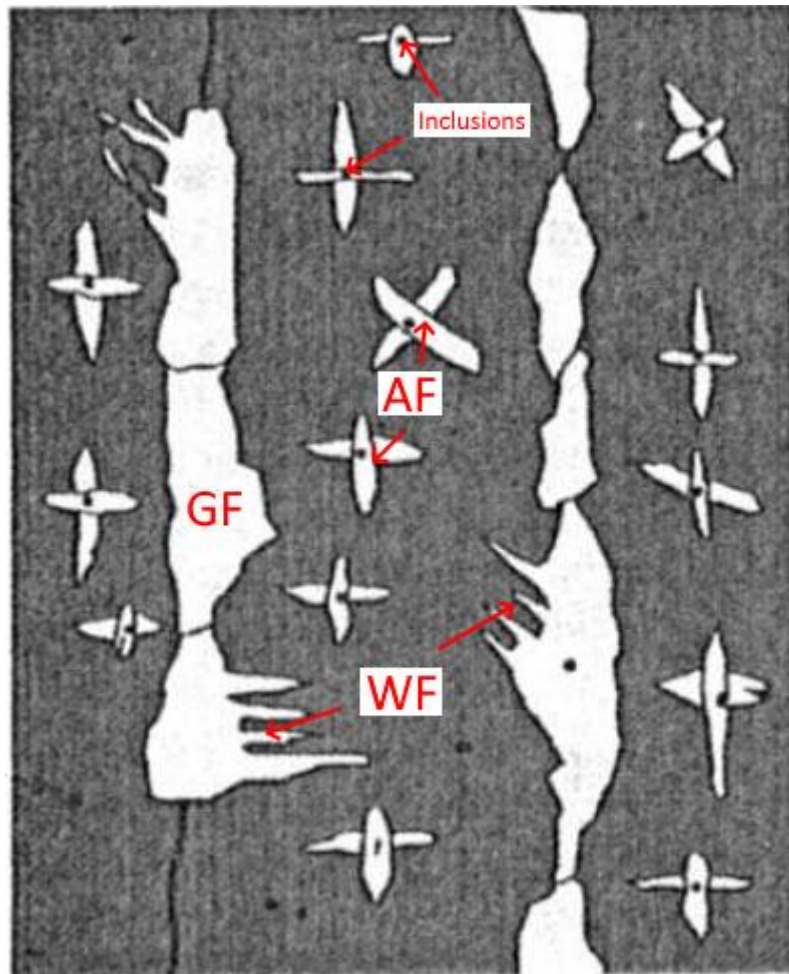
Figure 3-2 – Schematic diagram of the primary microstructure in the columnar austenite grains of a steel weld deposit. The terms *GF*, *WF* and *AF* refers to allotriomorphic ferrite, Widmanstätten ferrite and acicular ferrite, respectively. Modified from Bhadeshia [7].

The microstructure of the weld metal in the fusion zone is called the as-deposited or primary microstructure. Figure 3-2 illustrates the major microstructural constituents in the primary microstructure. These are grain boundary (or allotriomorphic) ferrite (GF), Widmanstätten ferrite (WF), and acicular ferrite (AF). There are also traces of martensite, retained austenite and degenerate pearlite in the deposited weld microstructure, but due to its limited occurrence, these are referred to as microphases [7].

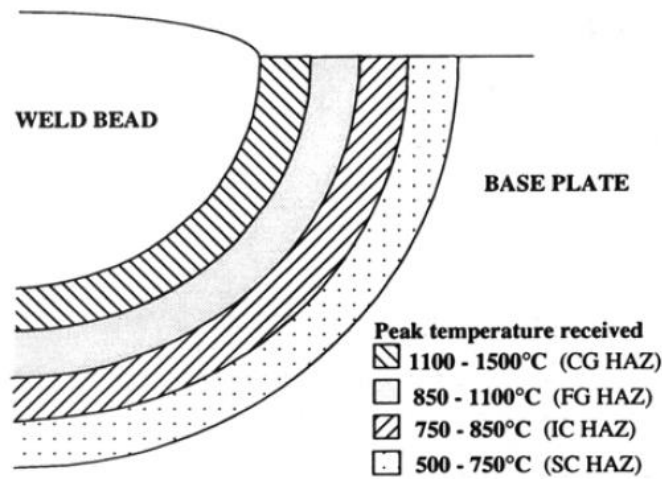
Figure 3-5 - Schematic diagram of a single pass weld [9].

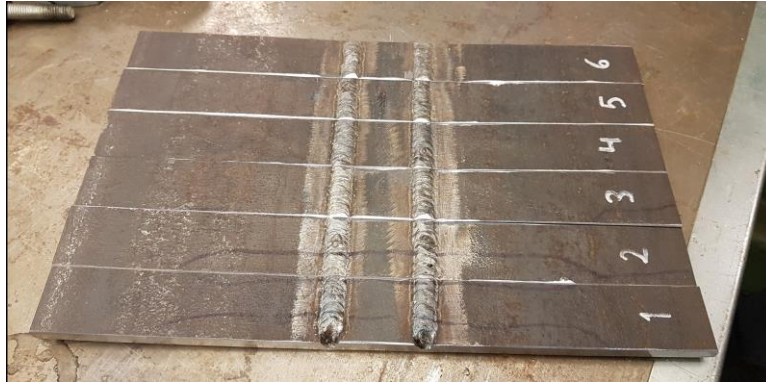
(a) The test plate was cut into 6 parts and each specimen received a ID. The plate thickness was 10mm. What is missing in the picture is the letter F (fatigue) on specimen F1-F5 and the letter T (Tensile) on specimen T6.

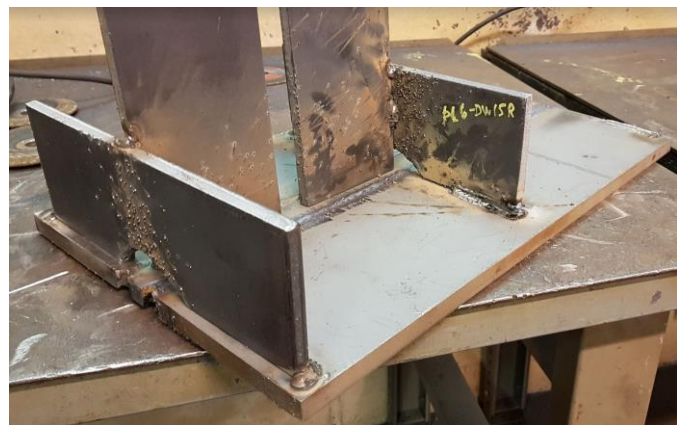
(g) Cracked tack weld was discovered after finished weld operation.

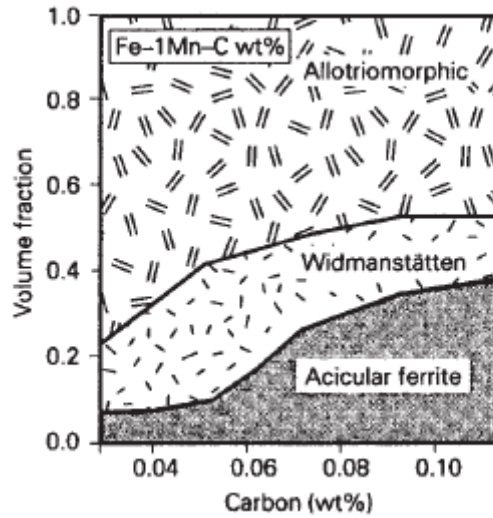
Figure 8-7 - Graph showing the prevalence of the different phases in a primary microstructure as a function of carbon content [7].

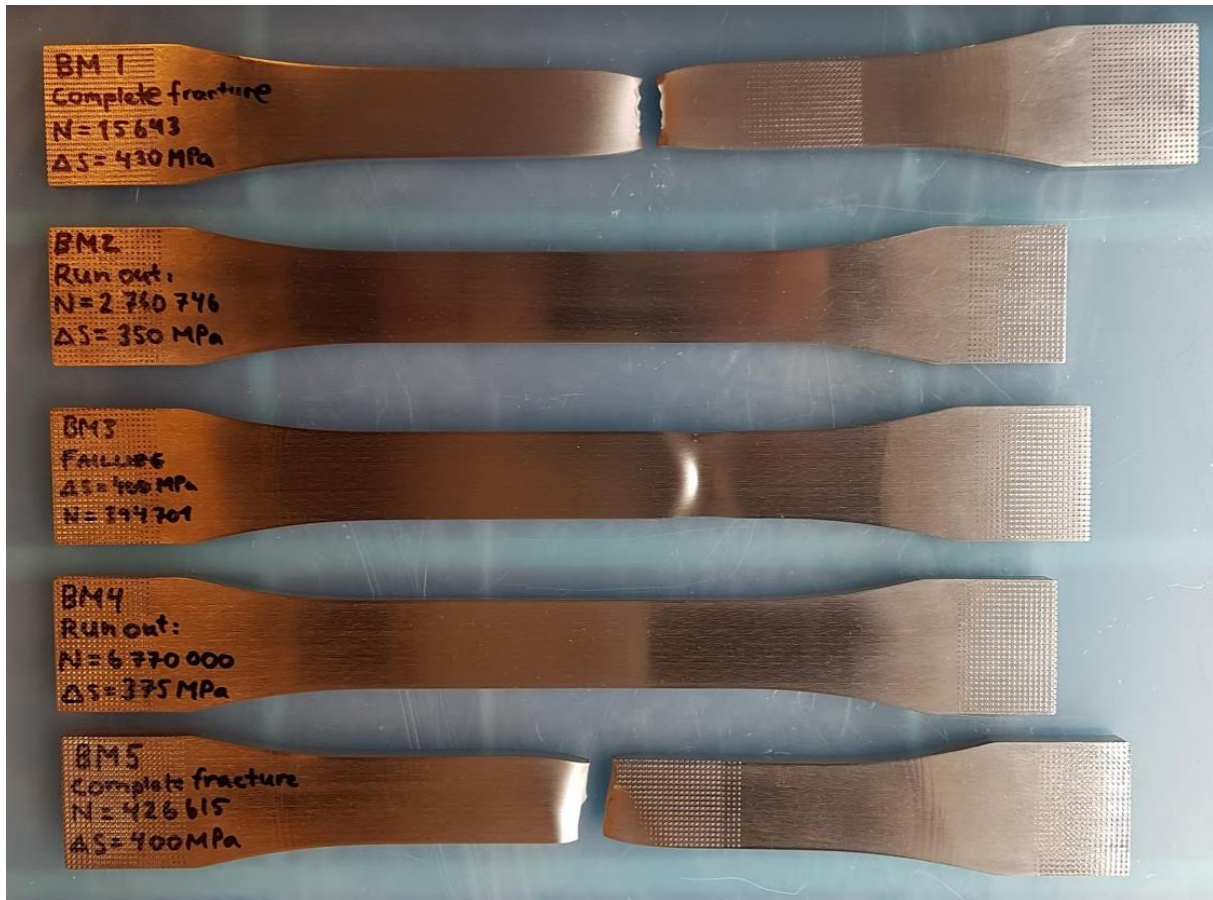
Figure 9-8 - Unwelded base material fatigue specimens after testing.

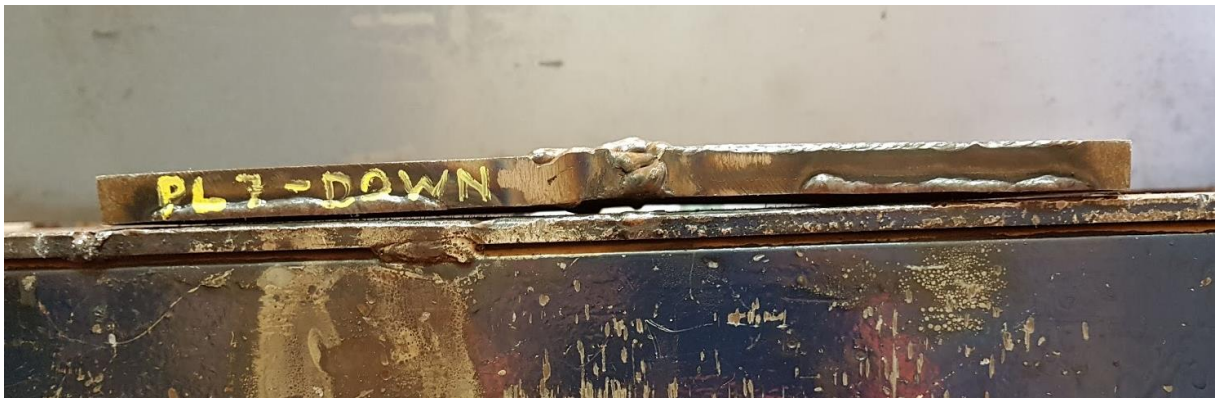
Figure 9-11 - Weld distortion after second weld PL7.

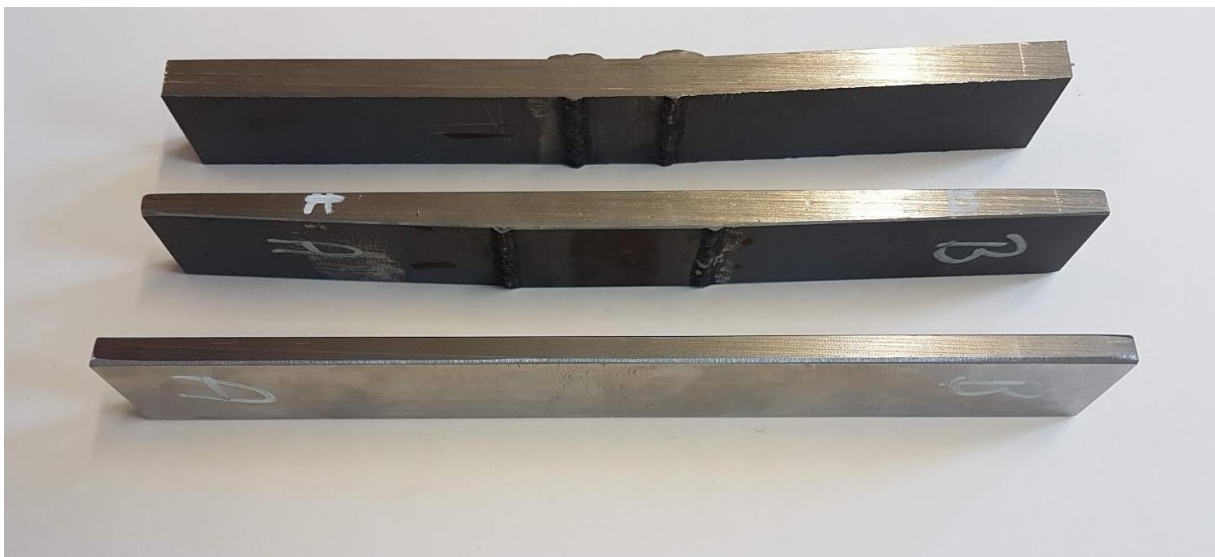
Figure 9-12 – Machining of fatigue specimens from welded S420G2+M plates in order to remove stress concentrations and misalignments the top face was initially machined until parallel followed by the machining of the bottom face.

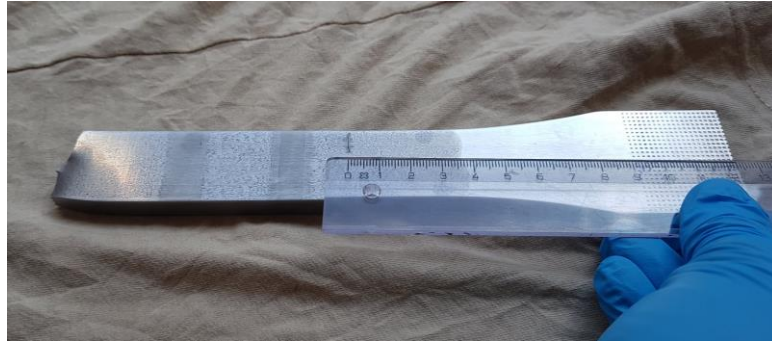
Figure 9-13 – Final fracture and location of crack initiation of 8612-3 A3 specimen.

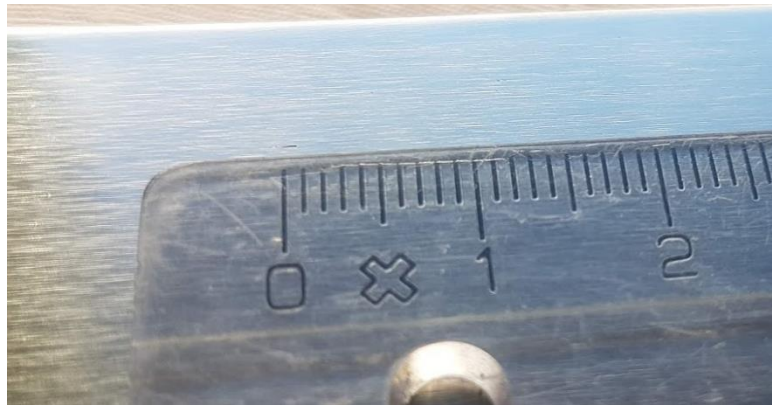
Figure 9-14 – Location of a small defect in the base material surface where fracture occurred.

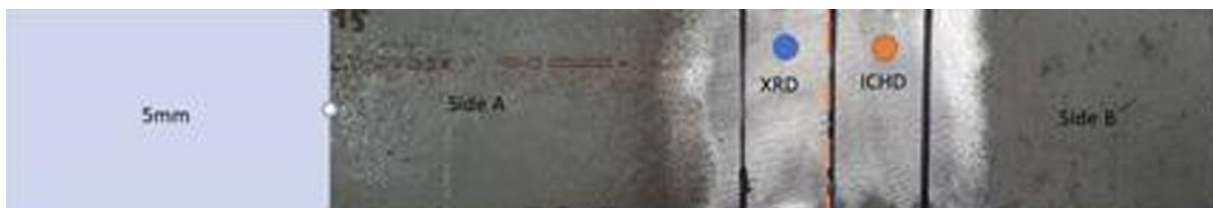
Figure 10-6 - Specimen test locations in the as-welded specimen.
