University of
Stavanger

MASTER'S THESIS

Life extension of ship-shaped floating production units

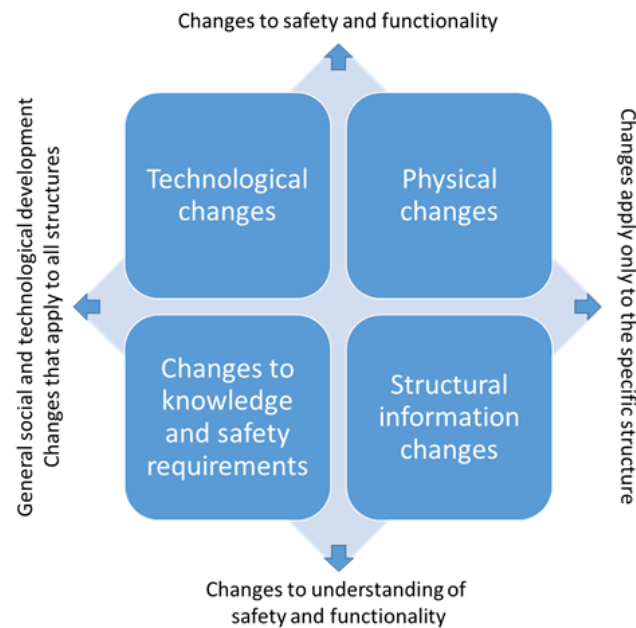
Figure 3: The four main elements of ageing of a structure (Ersdal et al., 2019).

Figure 3 shows these four groups of ageing changes to a structure. The two upper boxes, technological and physical changes, will change the safety and the functionality of the structure directly. The two lower boxes, knowledge and requirements, and structural information changes primary will improve the understanding of safety and functionality of the structure. Groups can also be made from the two right boxes, where information gathered from physical and structural information changes applies to one specific structure. The two left boxes, technological changes, and changes to knowledge and safety requirements are applicable for all structures and are a result of social and technical developments.

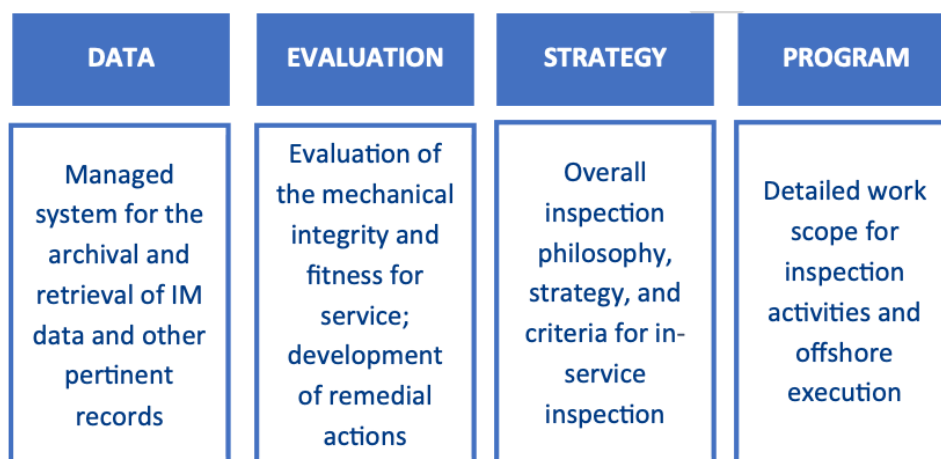
Figure 4: FSIM process (API, 2019).

The purpose of floating systems integrity management (FSIM) is to ensure a proactive process for demonstrating the integrity of an FPSO throughout its life on a fitness-for-service basis. This involves the collection of information of the FPSO, periodically evaluating the data, and using the evaluation to set a strategy for subsequent inspection and maintenance plans. FSIM consists of the continuous process, as illustrated in Figure 4.

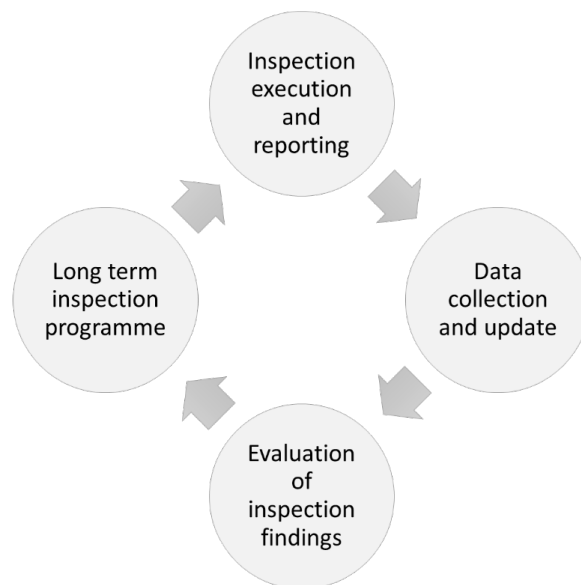
Figure 5: Inspection process cycle (ISO, 2007).

The process in Figure 5 is a cycle for inspection planning, performance, reporting, and evaluation, including:

- Collection and retention of data from present and previous inspections, in addition to data from design, fabrication, and installation.
- Evaluation of findings and anomalies in the data (e.g., cracks, corrosion, changes in loading, standards, and knowledge, etc.).
- Update on the long-term inspection program based on the evaluation of the data, which contains an overall plan for what needs to be inspected, when, and how.
- The development of an inspection work scope which contains the detailed specification for inspection activities and the means of offshore execution and procedures for reporting data.

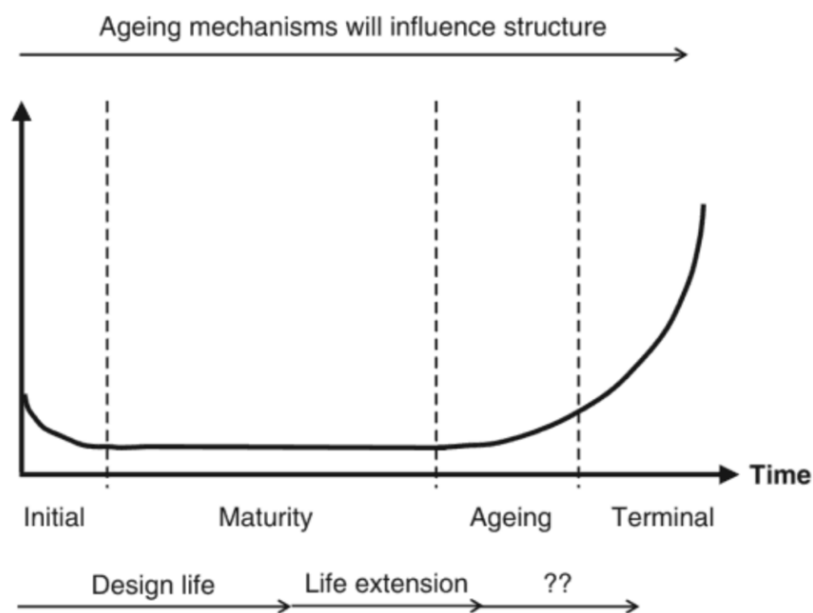
Figure 8: An ideally representation of design life and life extension in relation to the bathtub curve (HSE, 2006).

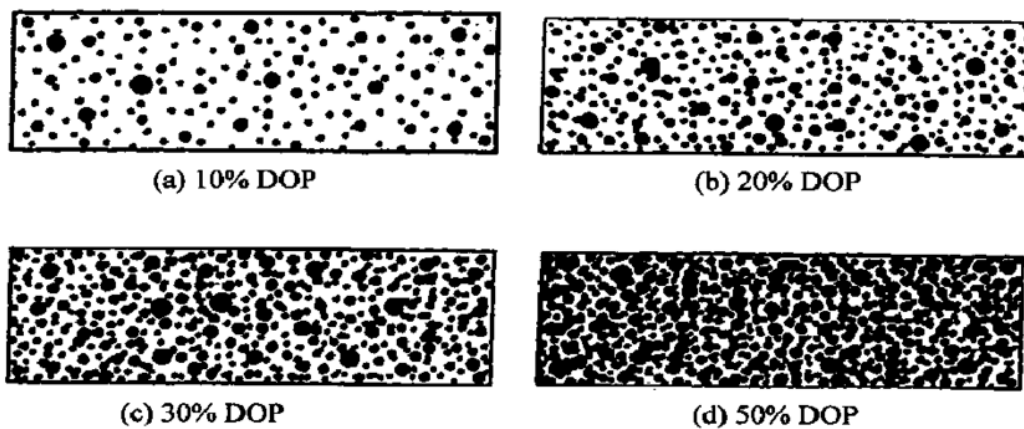
Figure 13: Pitting Intensity Diagrams (DOP = Degree of Pit Corrosion Intensity as a Ratio of the Pitted Surface Area to the Original Plate Surface Area): (A) 10% DOP; (B) 20% DOP; (C) 30% DOP; (D) 50% DOP.

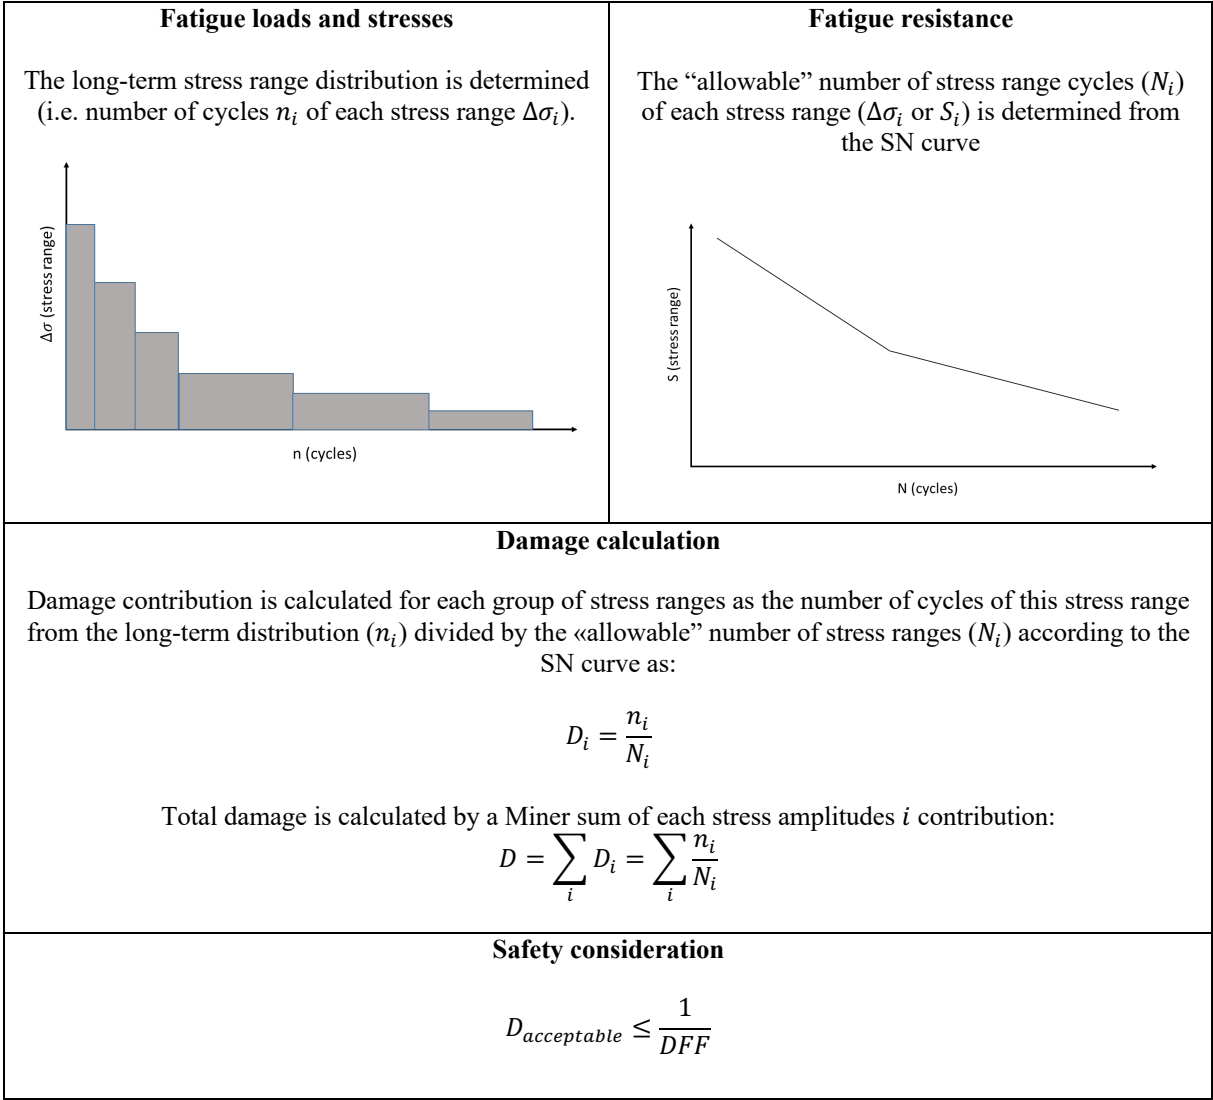
Figure 15: *S – N* approach calculation flow diagram (Ersdal et al., 2019).

The traditional method of performing fatigue life assessment is the *S – N* approach, which is based on the use of *S – N* curves in addition to a long-term fatigue stress range distribution or spectrum, providing the number of fatigue cycles (*N*) for each stress range (*S*). A substantial amount of effort has been practiced in recent decades to generate *S – N* curves in general and specifically for offshore structural components. Figure 15 shows the basic principles of the *S – N* fatigue approach.

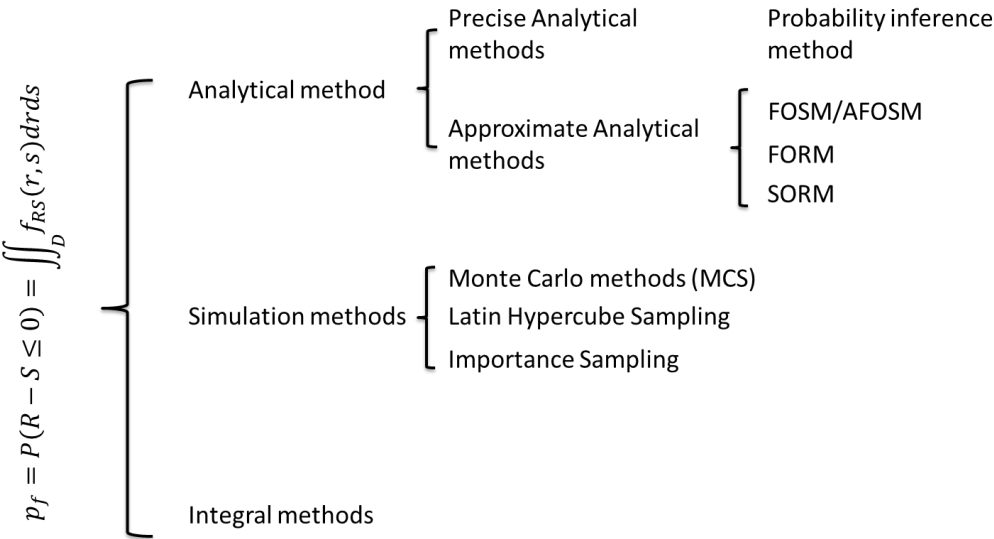
Figure 17: Probability of limit state failure calculation methods (Ersdal et al., 2019).

This integral may generally not be solved analytically. Numerical methods, simulation methods such as Monte Carlo simulations or semi-analytical approximate methods, such as FOSM (First Order Second Moment), AFOSM (Advanced First Order Second Moment), FORM (First Order Reliability Method) or SORM (Second Order Reliability Method), may be applied, see the overview of methods in Figure 17.

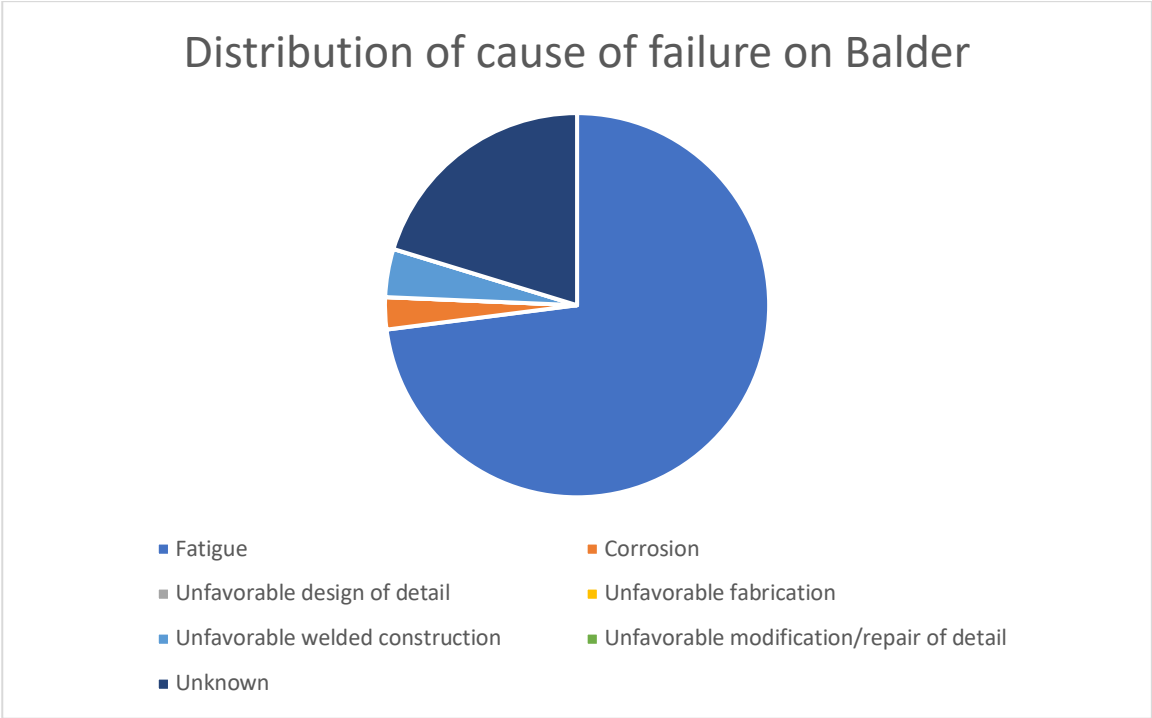
Figure 25: Distribution of cause of failure on Balder.

Figure 25 shows the distribution of cause of failure on Balder. This distribution is based on the author’s subjective evaluation and has not been quality assured by the PSA. Most of the cracks seem to be caused by unfavorable design of details and fatigue failure. However, some of the cracks are also caused by unfavorable welded constructions and unknown reasons. A small portion of the cracks is also caused by corrosion and unfavorable modification/repair of details.

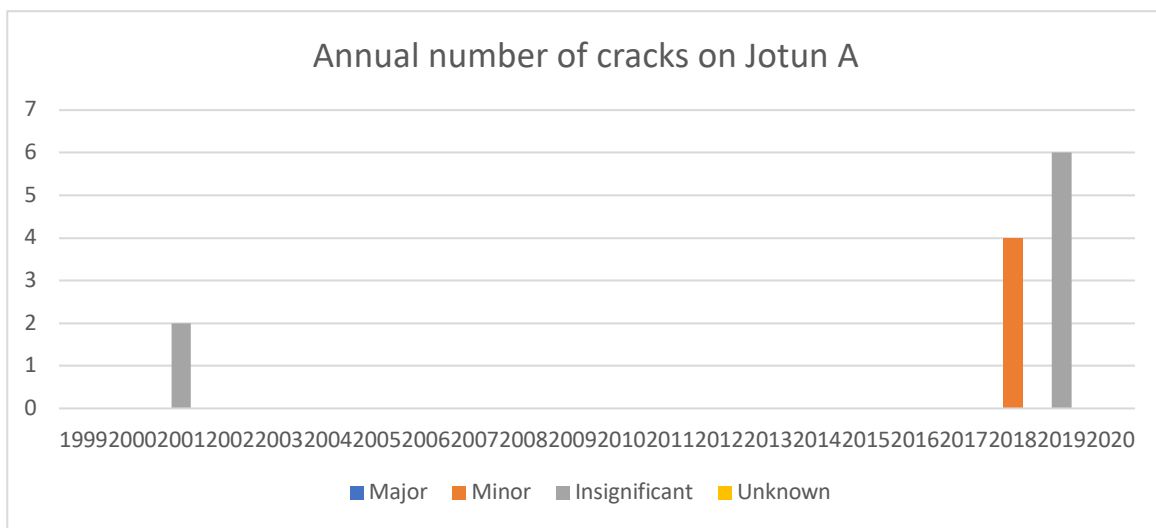
Figure 26: Annual number of cracks on Jotun A.

Figure 26 identifies the annual number of cracks in the hull on Jotun A as a function of yearly reported cracks and the severity of each crack in the period 1999 to 2020. These classifications are based on the author’s subjective evaluation and have not been quality assured by the PSA. The total number of cracks found at Jotun A during this period is 12. Figure 26 indicates that the majority of the cracks have an insignificant severity classification. During this period, the number of insignificant cracks found at Jotun A is 8, and the number of minor cracks is 4.

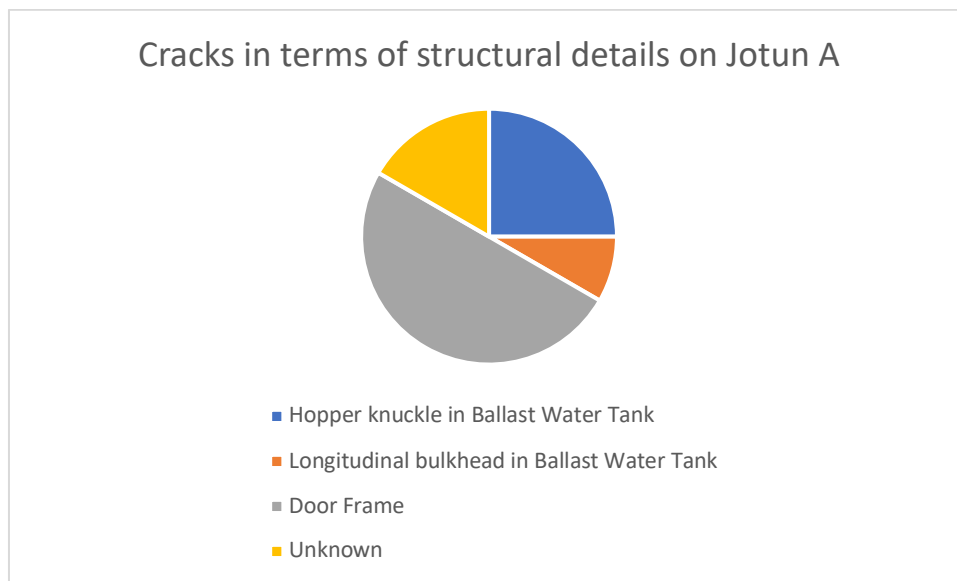
Figure 27: Cracks in terms of structural details on Jotun A.

Figure 27 illustrates the cracks in terms of structural details in the hull on Jotun A. This is based on the author's subjective evaluation of the photos in the inspection reports. Some of the structural details were not possible to evaluate from the photos and have been classified as unknown. Most of the cracks were found in void spaces at door frames. These types of cracks are typically caused unfavorable design of details with a small radius in the corners of the cut-outs. Further, cracks are also found ballast tanks in longitudinal bulkheads and hopper knuckles. These cracks are usually caused by reduced effective shear area in the bulkheads of the hull girder in combination with unfavorable welded constructions.

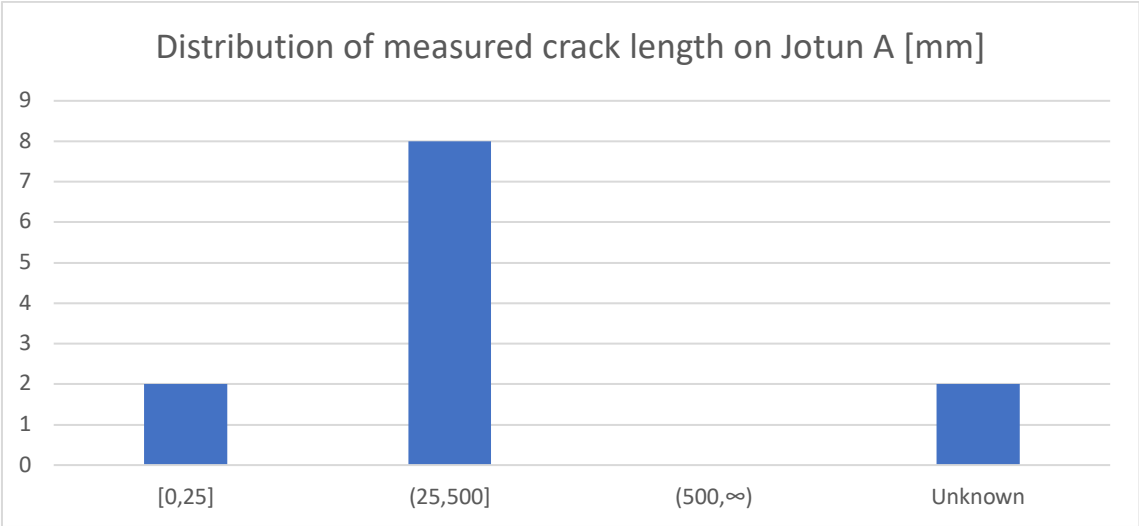
Figure 28: Distribution of measured crack length on Jotun A.

A closer study has also been performed on the crack lengths and the causes of failure of the cracks. Figure 28 is illustrated in shows a distribution of measured crack length on Jotun A. This is based on the reported length of the cracks in the inspection reports. Most of the cracks found at Jotun A has a length between 25-500 mm. The total number of cracks in between 0-25 mm is 2, 25-500 mm is 8, and 2 cracks are reported as unknown.
