University of  
Stavanger

## MASTER'S THESIS

**“Effect of Electron Beam Welding on the  
Microstructure and Mechanical Properties of Nickel Alloys”**

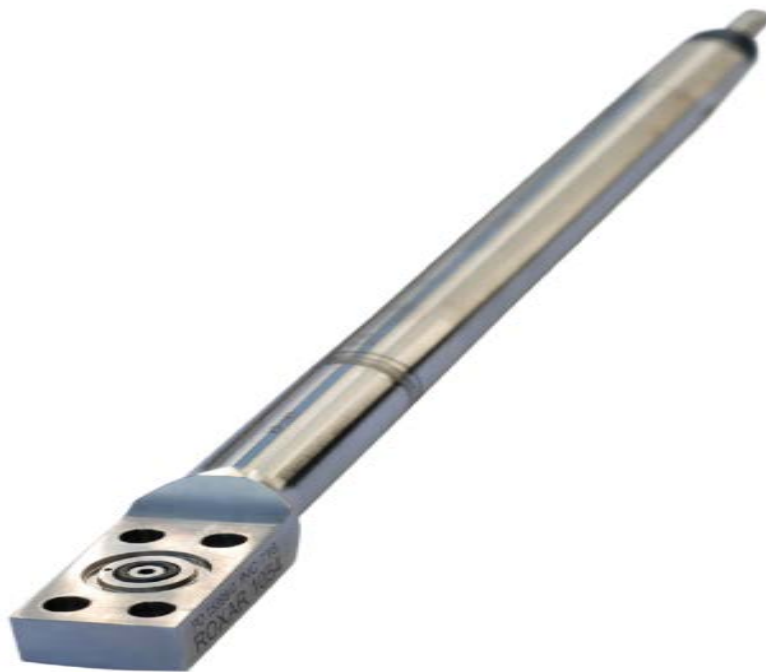
A vital component of this system is the HM/HS Gauge, seen in Figure 1-1. The instrument is installed in the lower part of the well to measure and transmit information regarding temperature and pressure. Longevity is a requirement as the instrument is designed to function the entire lifetime of a well. A notable application is the permanent installation of the HM/HS Gauge at Statoil's Gullfaks C production platform, where the instrument has been operating since 1990.

*Figure 1-1: HM/HS Gauge. Image courtesy of Roxar.*

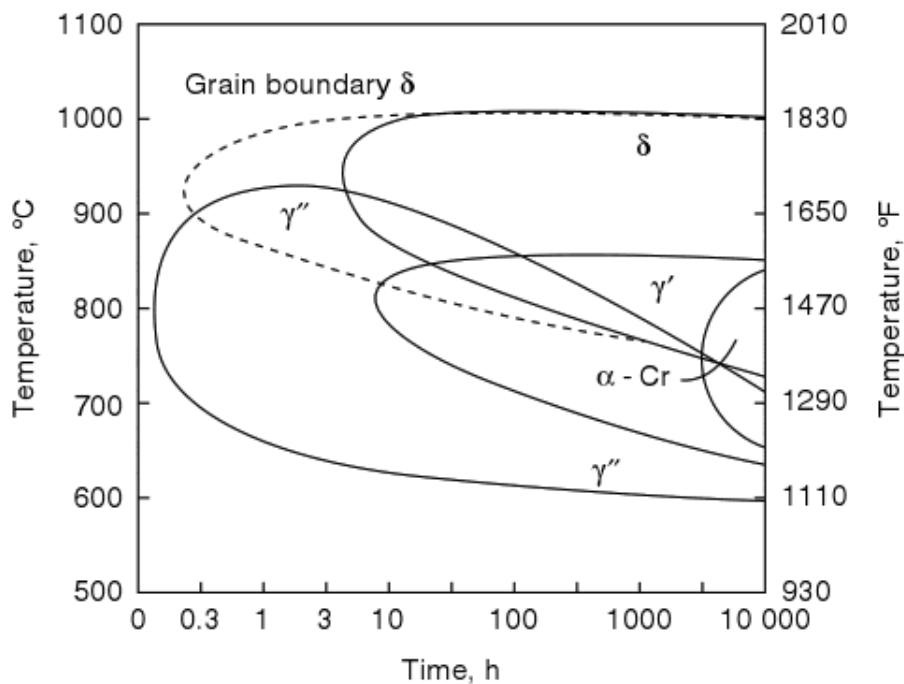
Figure 2-1: TTT diagram for Inconel 718 [2].

The main strengthening phase  $\gamma''$  is a metastable precipitate. High temperature heat exposures over long periods of time will lead to the formation of the stable, but deleterious  $\delta$ -phase. Unlike  $\gamma''$ ,  $\delta$ -phase is incoherent with the  $\gamma$ -austenite matrix and is associated with reduction in creep strength and ductility. The fastest rate of this phase transformation occurs at around 900°C, as shown in the TTT diagram in Figure 2-1. However, use of these alloys is often restricted to service temperatures under 650°C because of the precipitation of  $\delta$ -phase at long temperature exposures [9, 10].

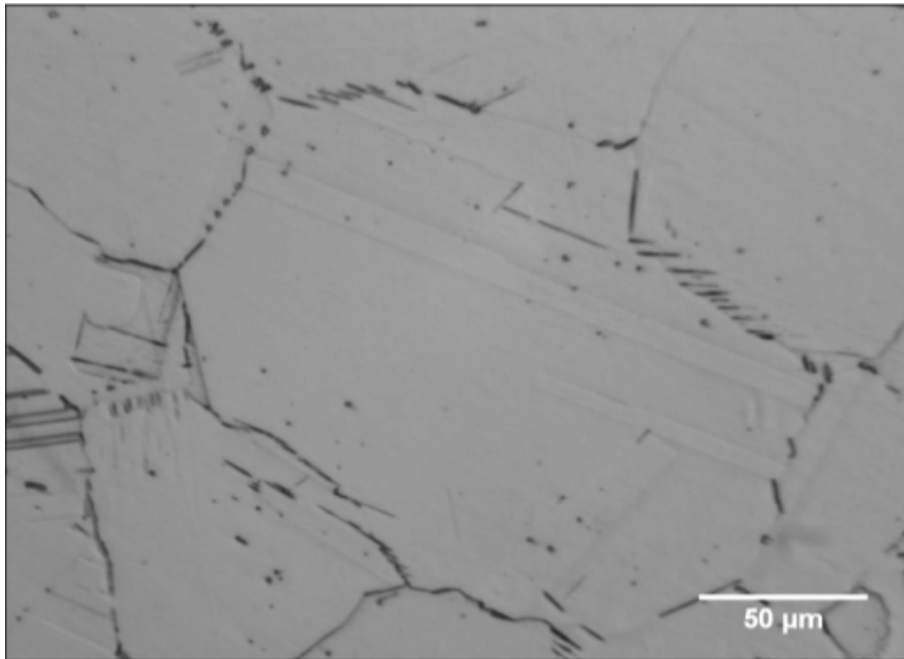
Figure 2-2 shows an image of the characteristic needle shaped  $\delta$ -phase associated with an unacceptable microstructure, according to API’s standard.

*Figure 2-2: Needle shaped acicular  $\delta$ -phase decorating the grain boundaries, extending into the grains of Inconel 718 [11].*

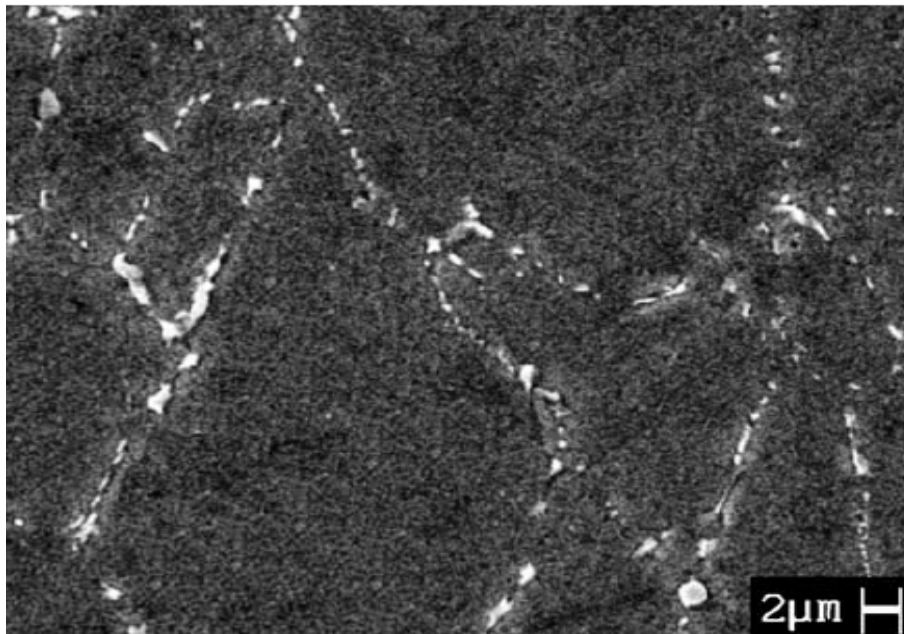
*Figure 2-3: Fine globular  $\delta$ -phase decorating the grain boundaries of Inconel 718 [12].*

The phase can also exist as strings of circular or slightly elongated, relatively coarse particles termed globular  $\delta$ -phase as shown in the scanning electron microscope (SEM) image in Figure 2-3. These particles originate from the fragmentation of the larger needle-shaped  $\delta$ -phase [9].  $\delta$ -phase is known to form and accumulate after repair welding of weldments that

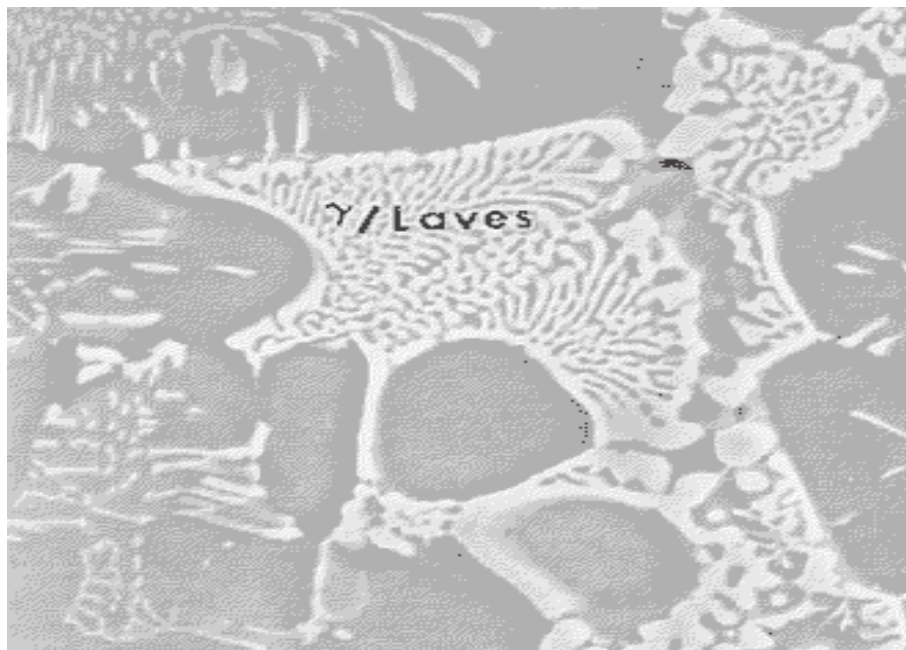
**Feil! Fant ikke referansebildet.** shows the eutectic formation of a  $\gamma$ /Laves section in the gray  $\gamma$ -austenite matrix during solidification. The image is from specimen heavily alloyed with Fe to increase the segregation behavior of Nb and the formation of the bright appearing, continuous Laves sheets.

*Figure 2-4: Laves phase in a eutectic formation with  $\gamma$ -austenite after solidification [13].*

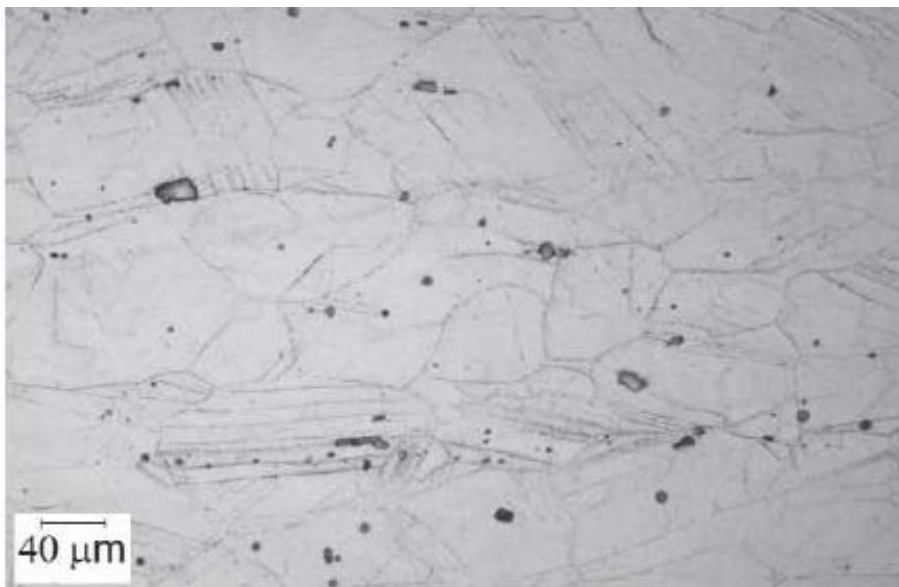
Figure 2-5: Carbides at the grain boundaries in a superalloy [2].

The MC carbides may form at grain boundaries or in the interdendritic regions at the end of solidification of the metal in a eutectic-type reaction. MC carbides may be observed as discrete particles, or as strings of a few particles. These carbides vary in size between 0.01-10 μm and appear as rounded precipitates with a dark or slightly shining appearance, as seen in Figure 2-5. MC carbides may decompose into both M<sub>6</sub>C and M<sub>23</sub>C<sub>6</sub> at the grain boundaries during thermal processing or under high temperature service.

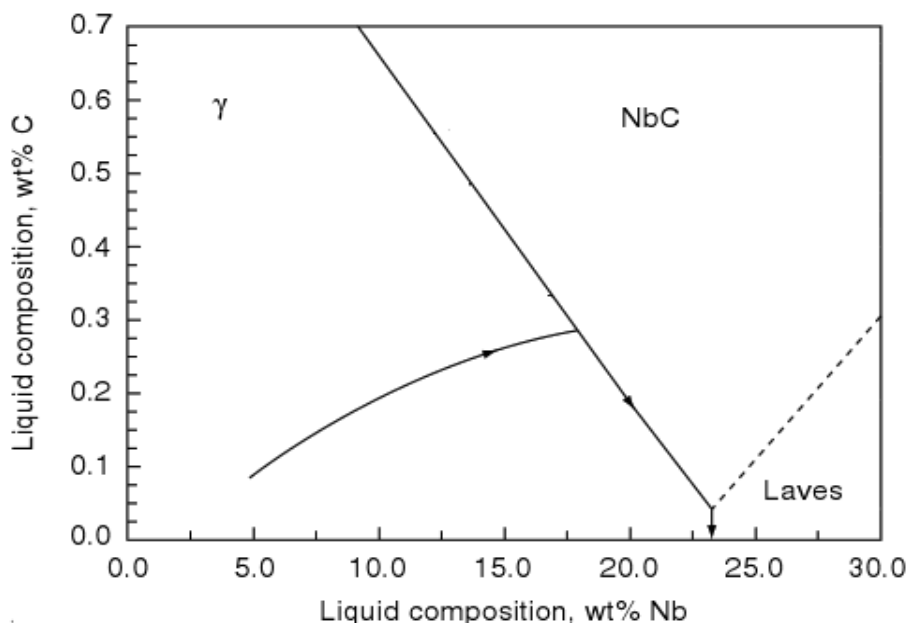
Figure 2-6: Solidification diagram of superalloys [2].

As alloying elements such as Nb and C is rejected from dendritic regions during solidification, the remaining liquid becomes progressively enriched with these elements until it reaches the line between  $\gamma$  and NbC, as seen in Figure 2-6. Solidification of the interdendritic regions ensues with the eutectic-like reaction  $L \rightarrow \gamma + \text{NbC}$ , when the solid solubility of the liquid is reached. The liquid composition continues to be depleted of C as  $\gamma/\text{NbC}$  solidifies, until the chemical composition of the liquid area consists of approximately 19.1 wt% Nb and 0.03 wt% C. At this point the remaining liquid in the interdendritic region solidifies into eutectic  $\gamma$  and stoichiometric Laves phase in the reaction  $L \rightarrow \gamma + \text{Laves}$ . Higher volume fractions of Laves phase in the  $\gamma/\text{Laves}$  eutectic constituents is associated with an increase of segregation of Nb to the interdendritic areas [2, 13].

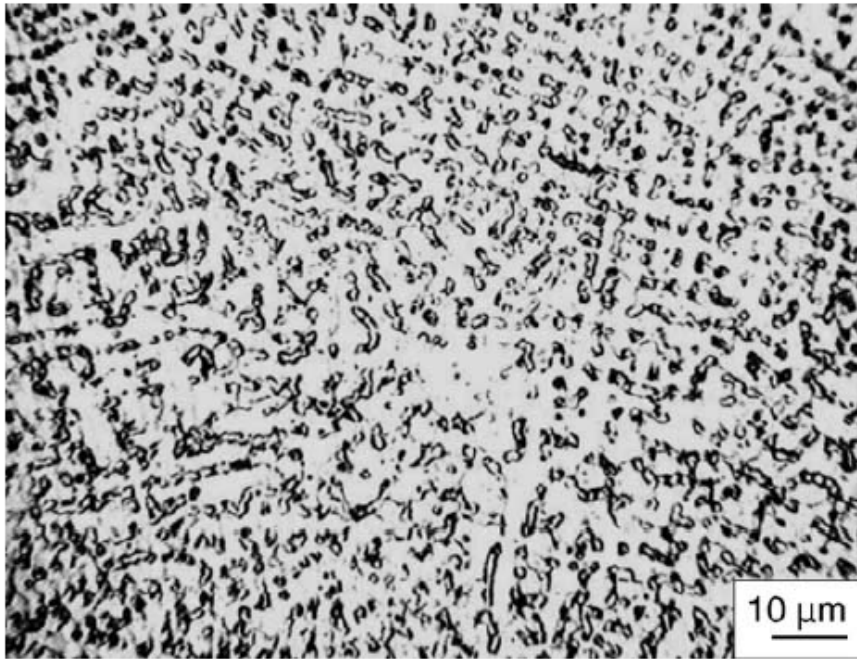
Previous investigations on the microstructural evolution of fusion welds [2, 6] found that  $\gamma$ /Laves was the major interdendritic constituent in both Inconel 718 and 625 PLUS, because of the alloys low C levels. NbC was only found in small quantities. This is associated with the low carbon levels of both alloys. **Feil! Fant ikke referansebildet.** shows an image of the typical interdendritic structure of the dark appearing  $\gamma$ /Laves constituents in the smooth appearing  $\gamma$  dendrites.

*Figure 2-7: Interdendritic structure containing eutectic  $\gamma$ /Laves in the weld metal of Inconel 718 [12].*

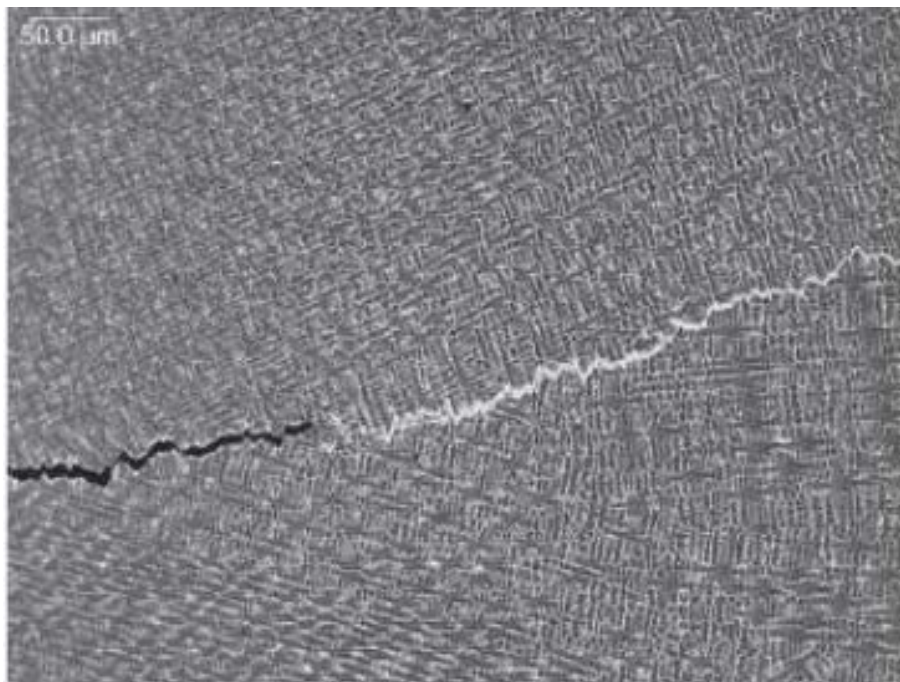
A previous investigation [6] found that Inconel 718 was more susceptible to solidification cracking than 625 PLUS. Figure 2-8 shows the appearance of a solidification crack in an optical light microscopy.

*Figure 2-8: Solidification crack in the weld metal of a superalloy [2].*

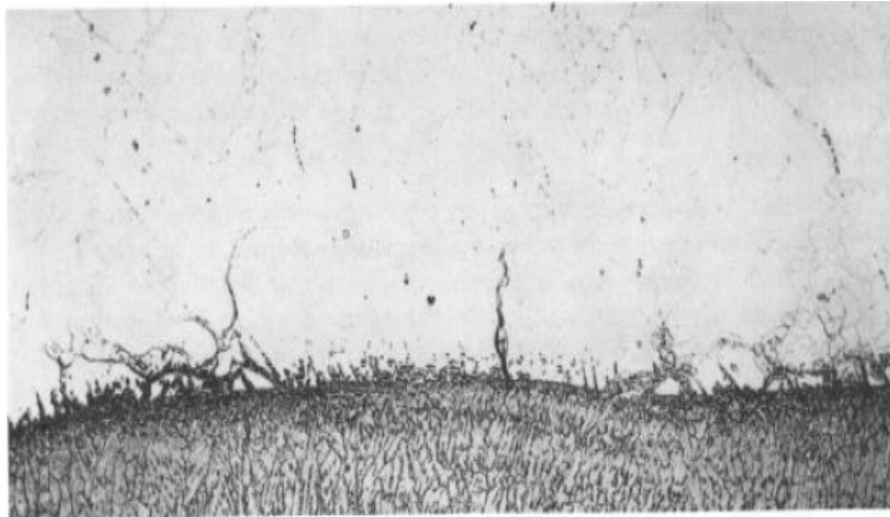
A general problem with Inconel 718 is the solidification of liquid films along grain boundaries in the HAZ, resulting in detrimental Laves sheets at the grain boundaries [2, 3]. Heat exposure from welding procedures causes the formation of the liquid films along the grain boundaries in the area of HAZ closest to the weld metal, which solidifies in a eutectic reaction. The formation of these microfissures is known as HAZ liquation cracking. An example of the microstructure associated with the liquation cracking is found in Figure 2-9.

Figure 2-9: Liquation cracks in the grain boundaries in the HAZ of gas-tungsten-arc welded Inconel 718 [4].

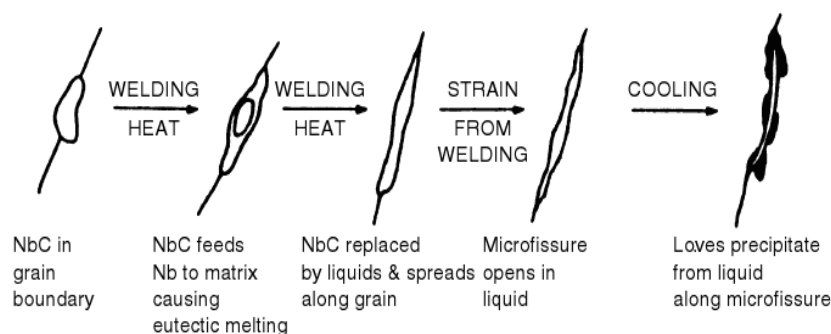
R.G Thompson and S. Genculu [15] postulated that HAZ liquation cracking in Inconel 718 is associated with the liquation of NbC on the grain boundaries during welding. The postulated mechanism is illustrated in Figure 2-10. The intergranular liquid films solidified in eutectic Laves constituents in the HAZ adjacent to the weld metal.

Figure 2-10: HAZ liquation cracking mechanism in Inconel 718 [2].

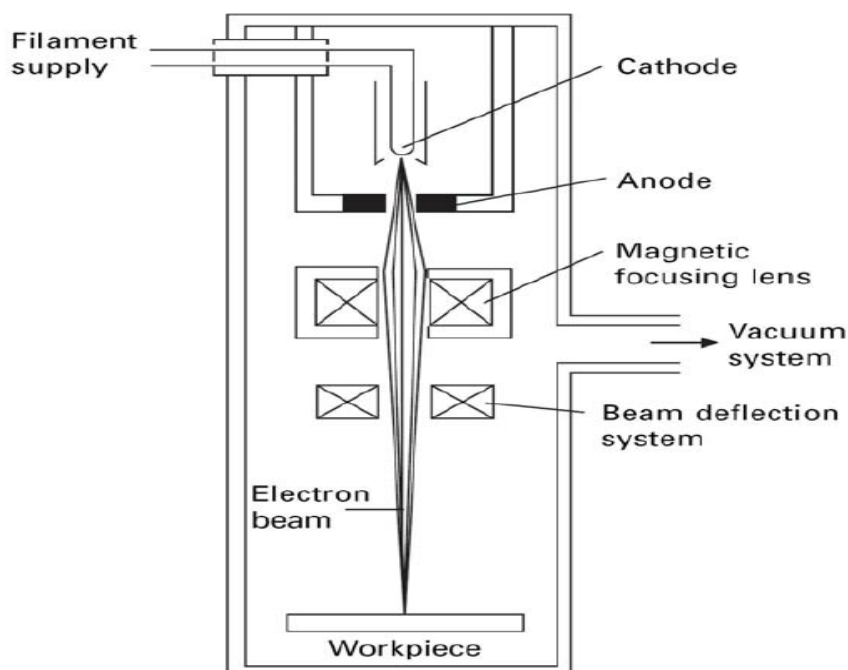
Electrons are accelerated from the cathode to the anode by a difference in electric potential, known as the *accelerating voltage*. Electrons are focused through a hole in the anode. Both magnetic and electrostatic lenses are used for further focus of the beam towards the workpiece [22]. A schematic drawing of an electron gun is shown in Figure 2-11.

Figure 2-11: Schematic view of the electron gun [22].

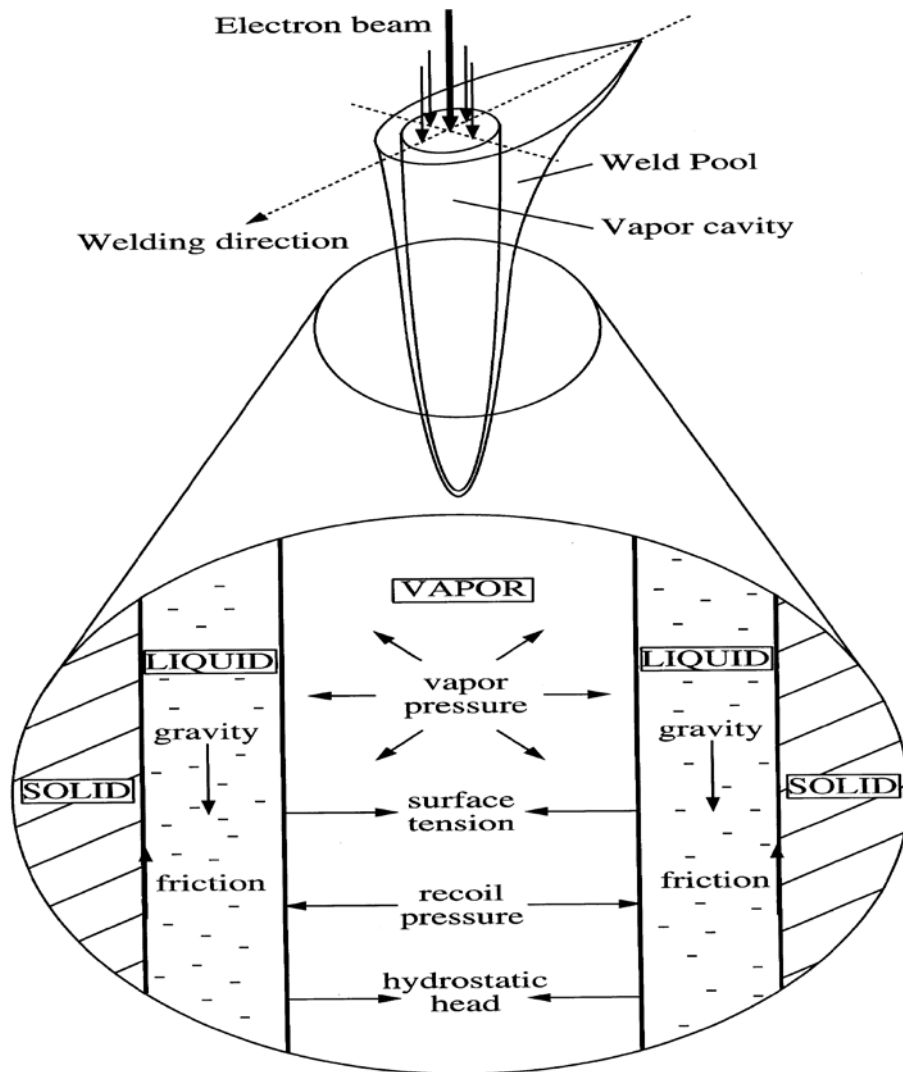
Because of the high temperature and vaporization of metal, a welding technique known as *keyhole welding* is used in EBW. As the high energy electron beam moves over the surface, a cavity of vaporized metal is formed directly under the heat source. This cavity of metal vapor is known as the *keyhole*. It is vital to maintain the keyhole during the welding process to ensure the quality of the weld [22].

Figure 2-12: Forces maintaining the shape of the keyhole [18].

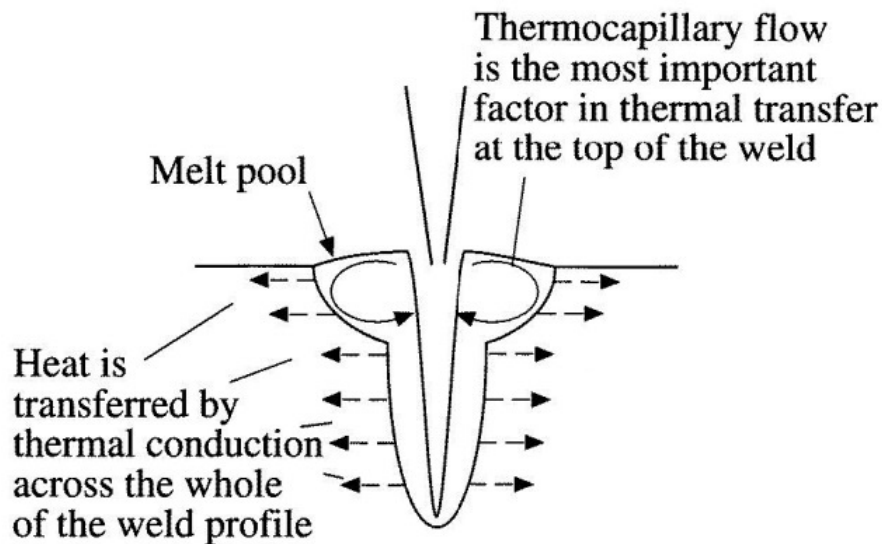
A reservoir of molten metal fills the weld from behind, where it solidifies and forms the weld bead. Figure 2-13 illustrates the thermocapillary flow seen from the cross section of the weld bead.

Figure 2-13: Thermocapillary flow around keyhole [23].

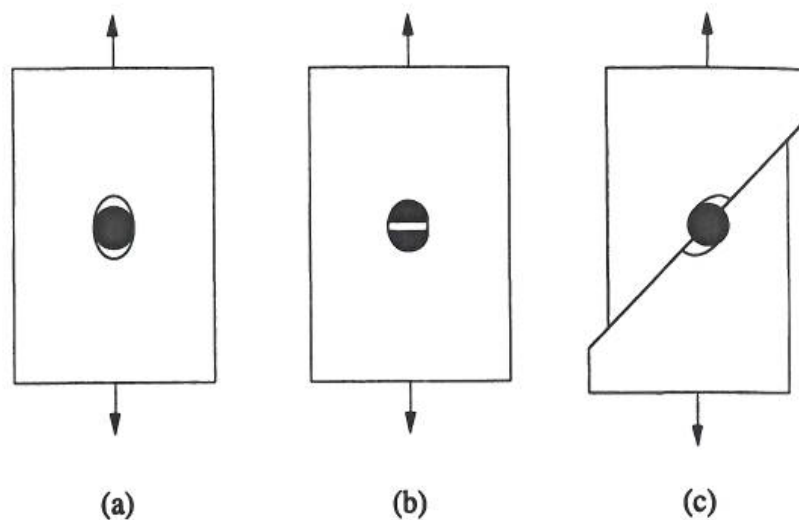
Voids form around inclusions or second phase particles when sufficient stress is applied to break the interfacial bonds between the particles and the matrix [25]. Void nucleation develops either by a) decohesion at the interface between the particle and matrix, b) fracture of the particle or c) decohesion of an interface as a result of shear deformation or grain boundary sliding [26], as seen in Figure 2-14. Larger particles are more likely to crack when plastic strain is applied, because they are more likely to contain small defects [25].

*Figure 2-14: Void nucleation by a) decohesion in the particle-matrix interface, b) cracking of particle, c) decohesion of an interface associated with shear deformation or grain boundary sliding [26].*

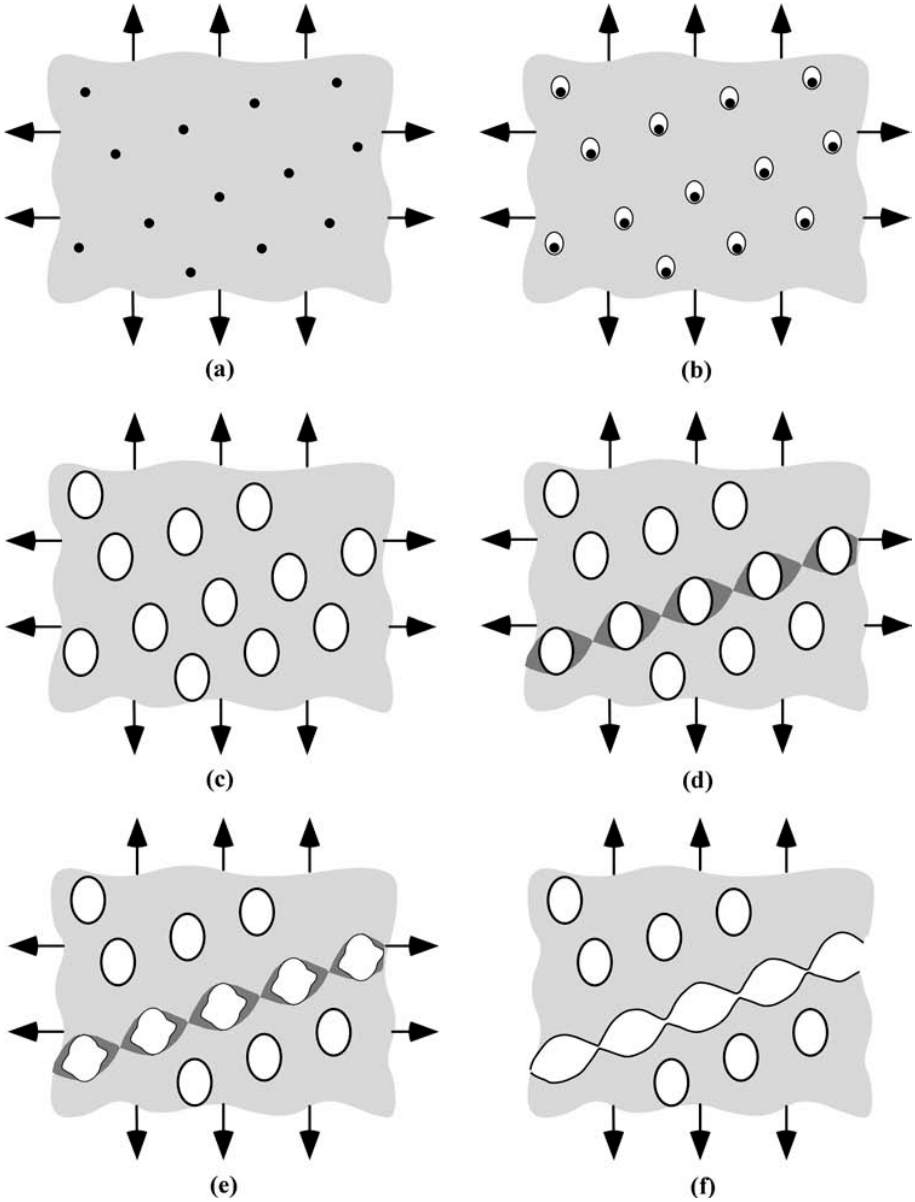
A descriptive expression of ductile fracture is “hole-joining fracture”. Plastic strain and hydrostatic stress cause the formed voids to grow. The applied tensile stress causes deformation of the intervoid material. The voids coalesce with adjacent voids to form a crack [26]. This mechanism is illustrated in Figure 2-15.

*Figure 2-15: Mechanism of ductile fracture via a) inclusions, b) void nucleation, c) void growth, d) strain on the material between voids, e) necking in the intervoid material and f) coalescence of voids leading to fracture [25].*

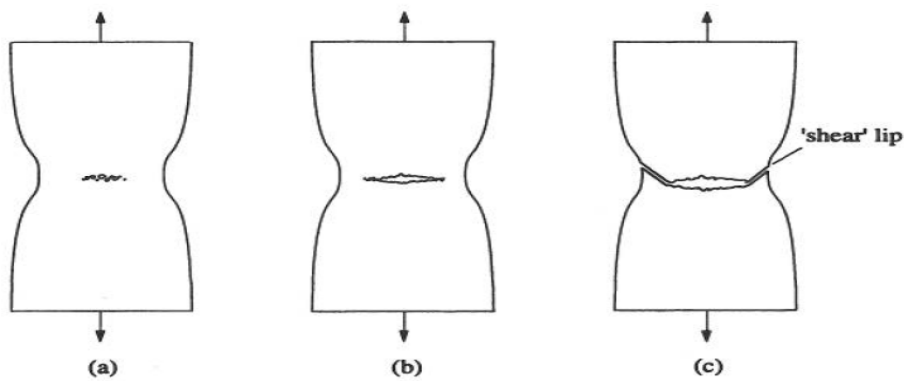
The final fracture ensues by rapid propagation of the crack around the un-fractured outer area of the fracture surface. It is dominated by plane stress which is at its highest  $45^\circ$  to the applied pressure, and so the fracture surface is  $45^\circ$  to the tensile axis. This sloped material at the outer edge is known as the *shear lip* [24]. The mechanism is illustrated in Figure 2-16.

*Figure 2-16: Mechanism leading to cup-and-cone fracture in a tensile specimen in steps of a) void nucleation, b) void coalescence and c) fracture by separation of the “shear lips” [26].*

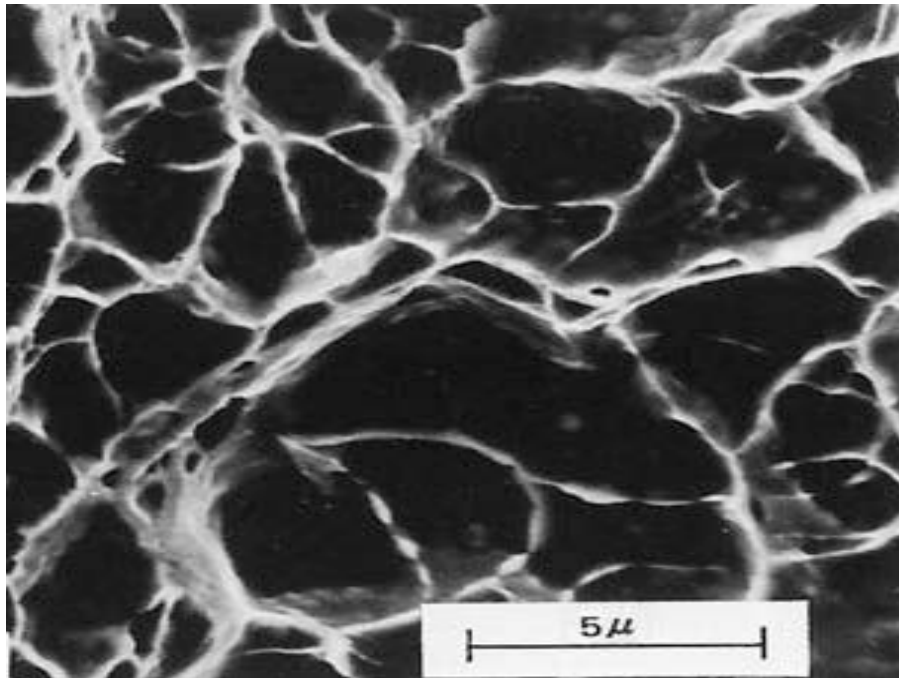
Formations known as dimples can be observed upon high magnification fractographic examination in SEM microscopes. The dimples are half of a void that formed before final fracture. The preferential fracture paths of dimples are usually in the direction parallel to the tensile axis in the initial crack area. An image of dimples showing a preferential fracture path is found in Figure 2-17.

*Figure 2-17: Fractograph showing spherical dimples characteristic of ductile fracture [24].*

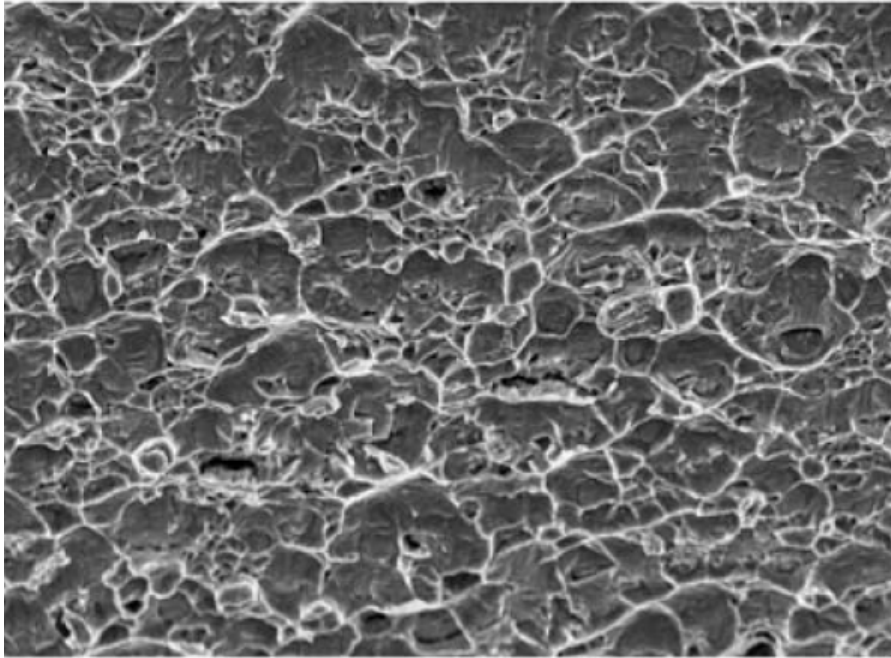
Previous fractographic examinations of Inconel 718 [12, 17] resulted in ductile fractures with relatively small amounts of plastic deformation. Fractographs revealed a fracture surface with a distinct dendritic structure as a result of the solidification behavior of the alloy. The shallow dimples showed no preferential fracture path, as seen in Figure 2-18.

*Figure 2-18: Fractograph of weld metal in Inconel 718 showing a dendritic fracture pattern [17].*

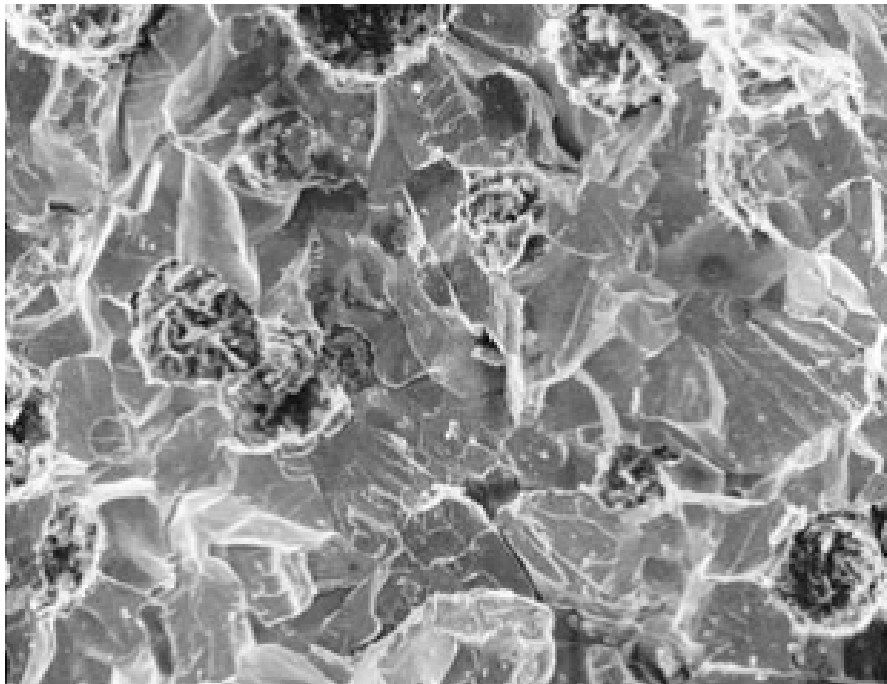
Macroscopically the cleavage surface appears grainy or faceted. Fractographic examinations also reveal the faceted nature of the surface, where each facet corresponds to a single grain. Lines known as “river patterns” can be seen as thin bright lines on each facet. These lines are caused as the crack encounters a grain boundary, and the nearest cleavage plane is located at a slight twist angle from the current cleavage plane [24, 25]. The faceted nature and formed “river patterns” associated with cleavage fracture can be seen in Figure 2-19.

*Figure 2-19: Fractographic image of a cleavage fracture [24].*

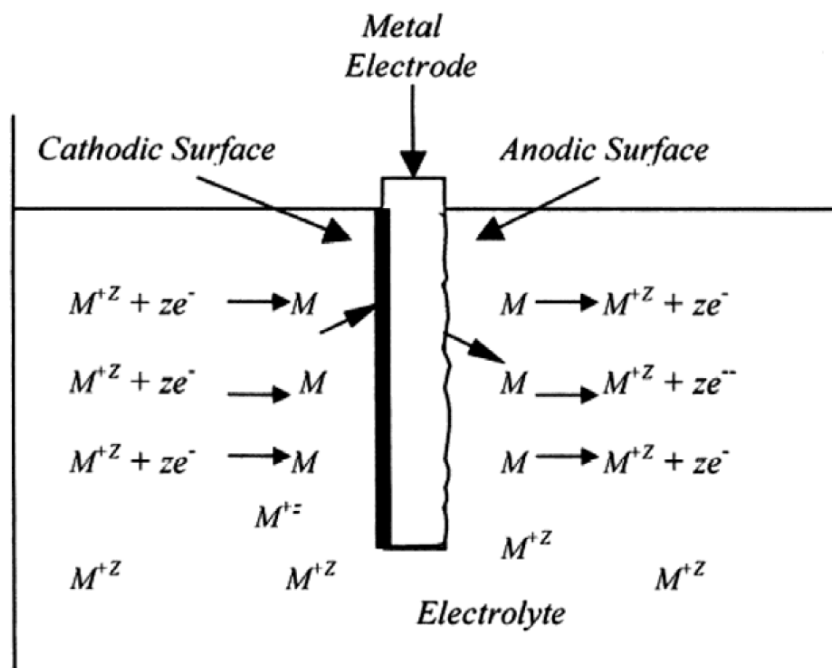
A full electrochemical cell needs to be established for corrosion to occur. A complete cell is dependent on three elements: 1) an anode to provide electrons 2) a cathode to consume electrons and 3) an electrically conductive electrolyte often referred to as the environment. The illustrative drawing of a hypothetical cell is shown in Figure 2-20. Cathodic and anodic areas are established in various places on the metal surface, depending on the corrosion form.

Figure 2-20: Illustrating a full electrochemical cell [27].

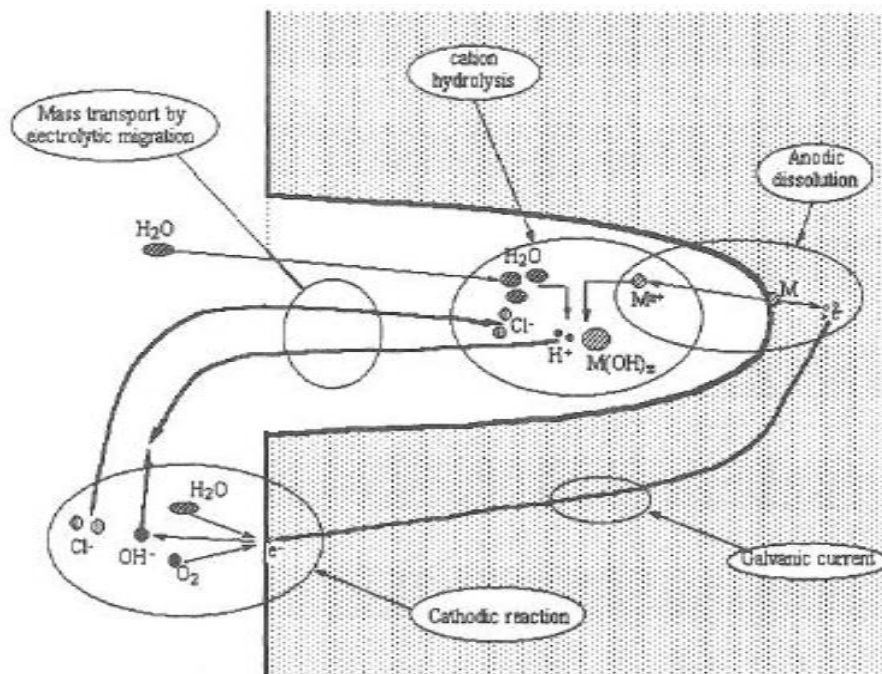
Crevice corrosion is a localized form of corrosion occurring in gaps of the material containing a stagnant solution environment. The size of the gap plays a significant role. The gap has to be narrow enough for the solution to become stagnant, yet wide enough for the solution to enter [24, 28]. A practical example of a typical crevice corrosion site is the gap between washers and bolts. The mechanism of crevice corrosion is illustrated in Figure 2-21.

Figure 2-21: Crevice corrosion[28].

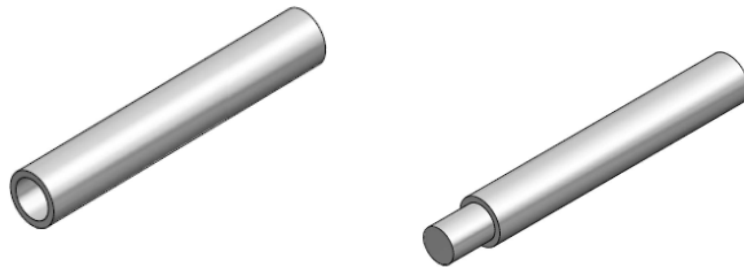
Each specimen consisted of two cylindrical components; a solid axle with a stepped end made to fit inside a hollow tube. Four tensile specimens and four corrosion specimens was electron beam welded, two of each of the alloys investigated.

*Figure 3-1: Tensile specimen components.*

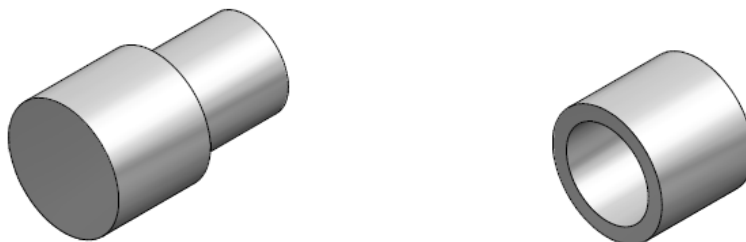
*Figure 3-2: Corrosion specimen components.*

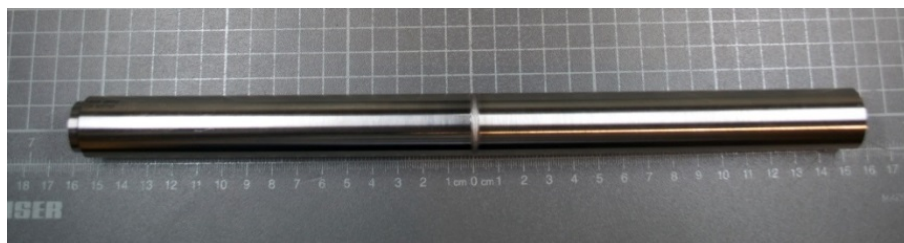
*Figure 3-3: Tensile specimen after electron beam welding and drilling of the weld root. The metal plug is inserted into the hollow end.*

A custom made metal plug was placed inside the hollow ends as structural support to avoid deformation of the tensile specimens from the grips of the tensile testing machine.

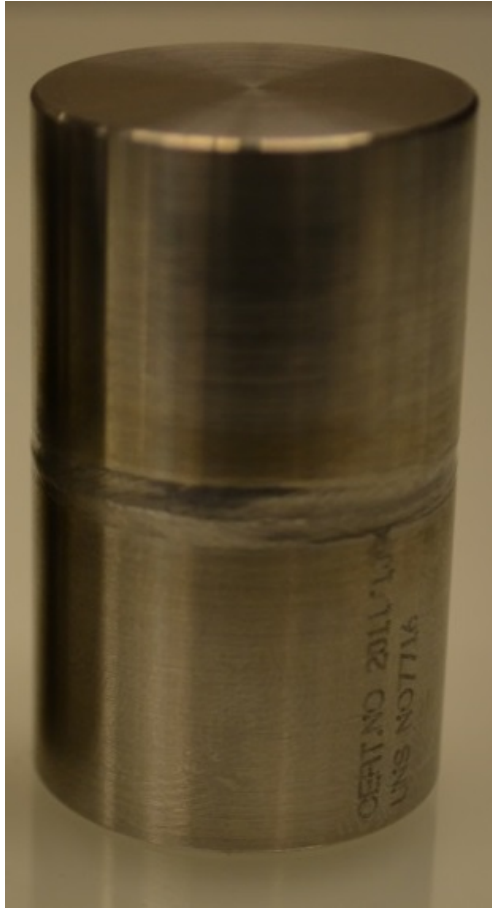
*Figure 3-4: Corrosion specimen after electron beam welding.*

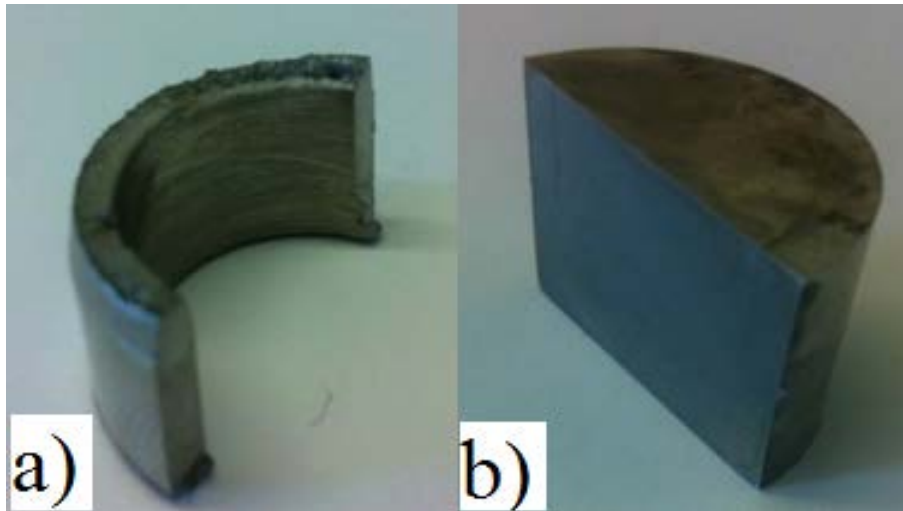
*Figure 3-5: Image of a) Fractographic specimen and b) Microstructure specimen.*

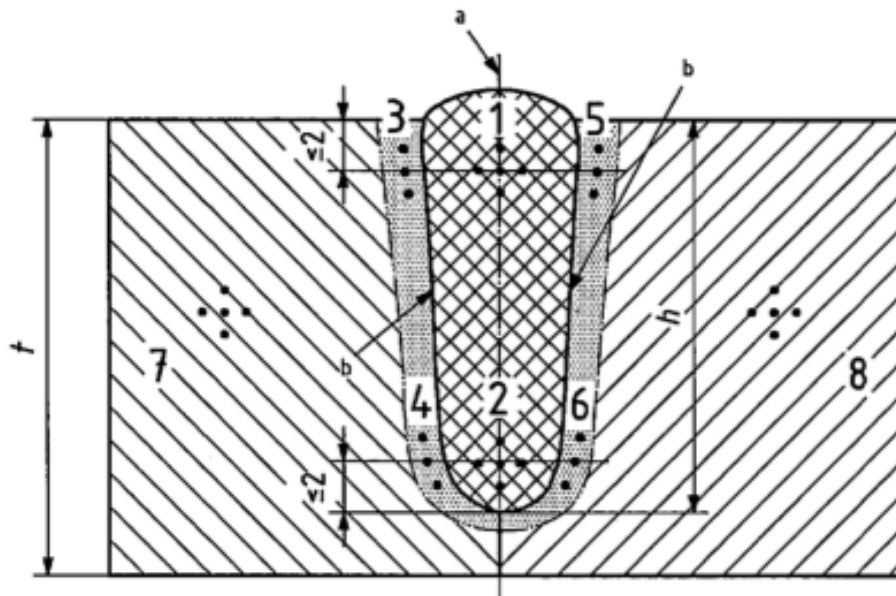
Hardness was measured using the Vickers hardness test before and after post-weld heat treatments. Hardness measurements were performed in accordance with ISO 22826 – “Hardness testing of narrow joints welded by laser or electron beam”[33]. Relevant for this dissertation is test type E of the standard. The points of indentation specified in the test type are illustrated in Figure 3-6.

Figure 3-6: Zones and points of indentations for Vickers hardness tests.

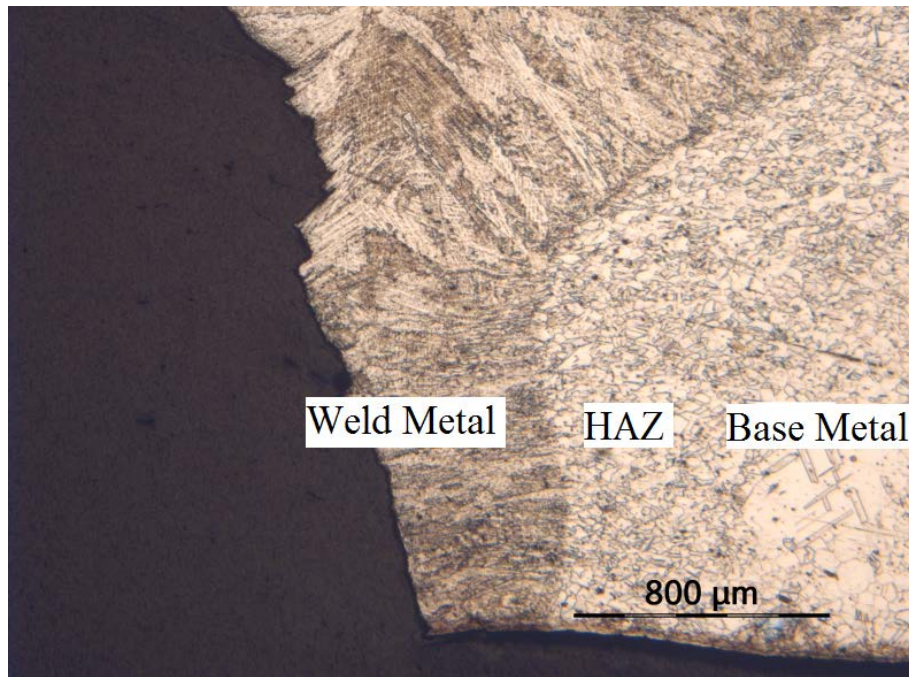
The fracture path was investigated from both fragments of each fractured tensile specimen. The fracture initiated and passed through the weld metal for all specimens. Figure 4-1 shows the typical fracture path of a tensile specimen after etching to expose the weld metal, HAZ and base metal. Typical fracture paths from all specimens are found in the first part of Appendix C.

*Figure 4-1: Fracture path of 625 PLUS No. 1.*

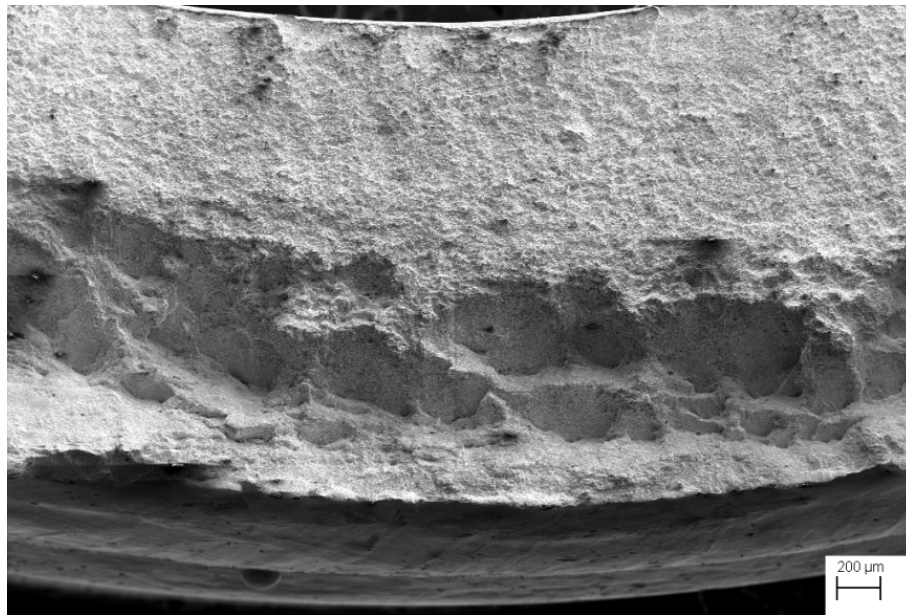
The fractographic specimens were investigated using the secondary electron detector of the SEM. Cup-and-cone fractures characteristic of ductile fracture mode was observed for all specimens. The initial fracture initiated on the inner diameter of the specimen and the fracture surface severed perpendicular to the applied tension. This can be seen in Figure 4-2 where the initial fracture appears as a relatively flat surface on the inner diameter visible in the upper end of the figure. Shear lips were visible close to the outer edge of the specimen, where the final separation left a fracture surface 45° to the applied tension, as seen in Figure 4-3.

*Figure 4-2: Cup-and-cone fracture of 625 PLUS No. 2.*

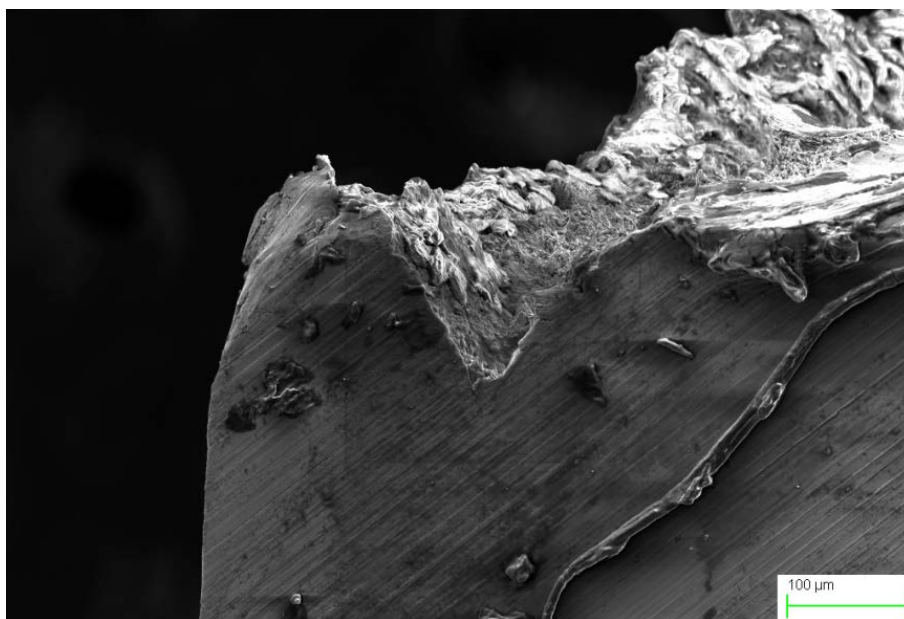
*Figure 4-3: Fraction of shear lips 45° to applied tension in Inconel 718 No. 2.*

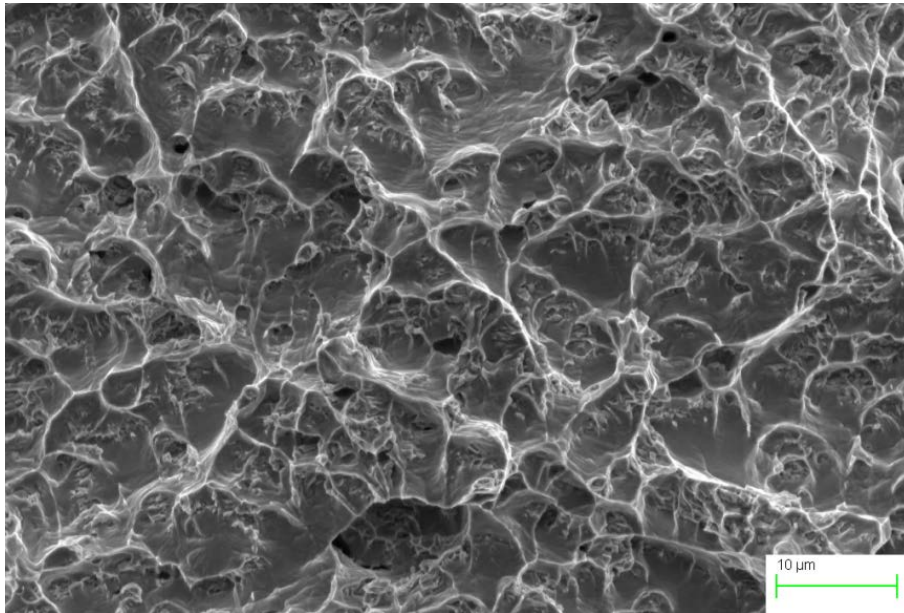
The formation of a cup-and-cone fracture and separation of the shear lips typical for all tensile specimens confirmed a ductile fracture mode for the specimens. However, the amount of plastic deformation seen in the fractographs was low, as seen in Figure 4-4 and Figure 4-5. No preferential fracture path of the intervoid material was seen. The dendritic fracture pattern associated with fracture of as-welded superalloys was common in all fractographs. The amount of plastic deformation in the intervoid material seemed higher in the 625 PLUS specimens.

*Figure 4-4: Fractograph of Inconel 718 No. 2.*

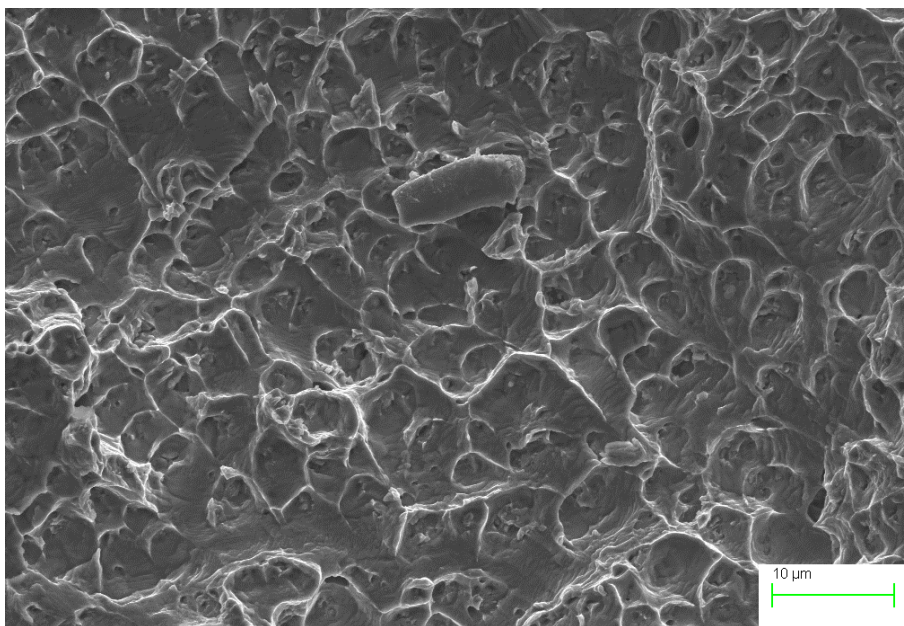
*Figure 4-5: Fractograph of 625 PLUS No. 1.*

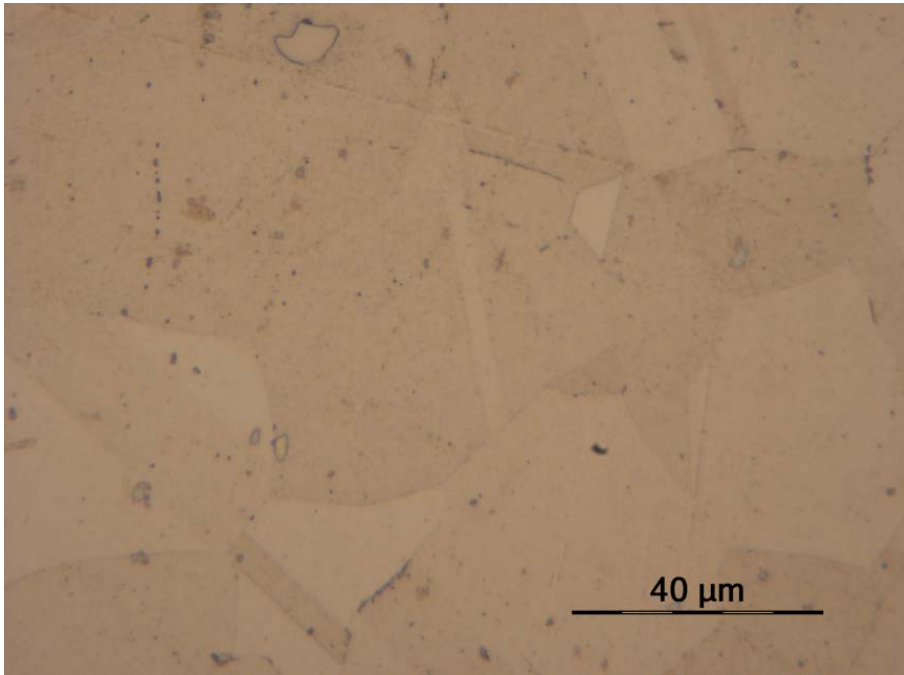
*Figure 4-6: Base metal of Inconel 718 No. 3.*
