University of  
Stavanger

## MASTER'S THESIS

**“Effect of Electron Beam Welding on the  
Microstructure and Mechanical Properties of Nickel Alloys”**

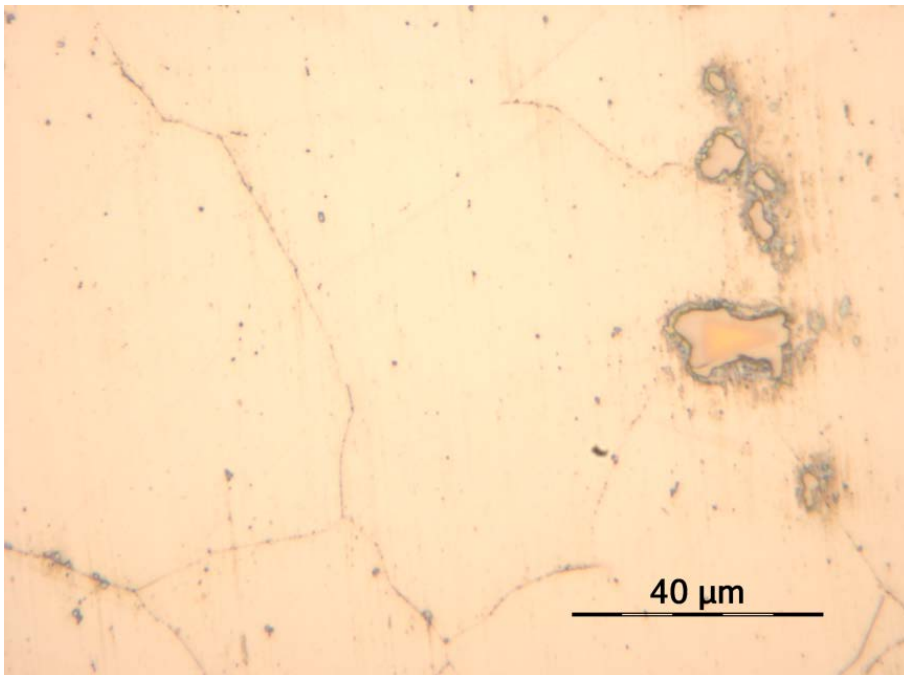
*Figure 4-7: Base metal of 625 PLUS No. 3.*

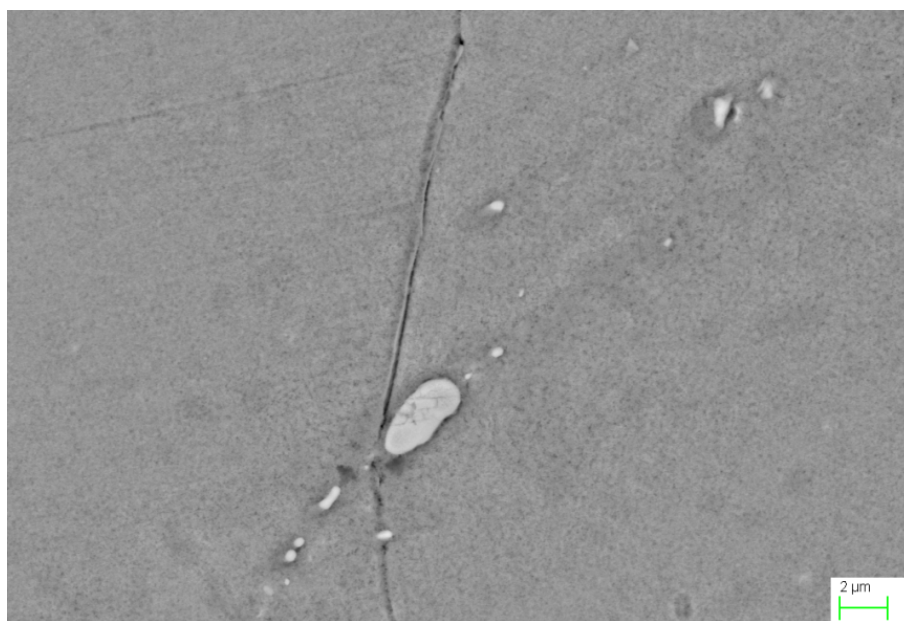
*Figure 4-8: Nb-rich MC carbide in 718 Inconel No. 3.*

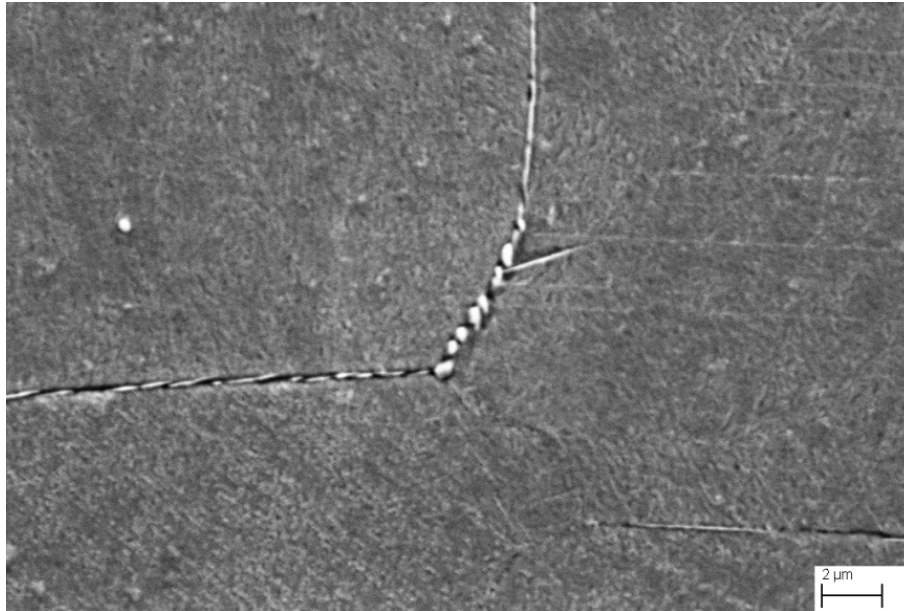
*Figure 4-9: Fine globular  $\delta$ -phase at grain boundary in Inconel 718 No. 3.*

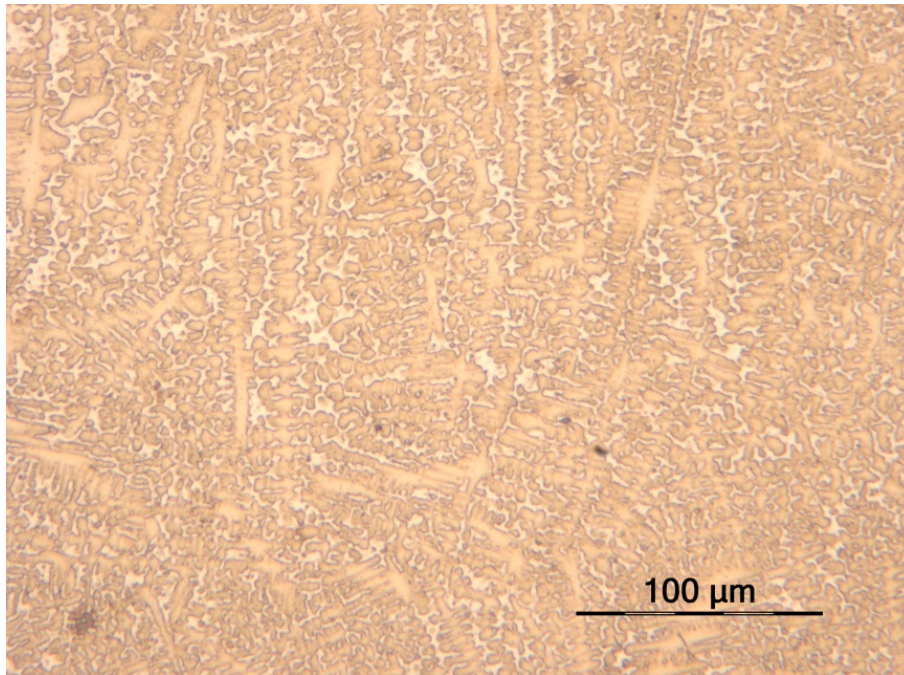
*Figure 4-10: Weld metal of Inconel 718 No. 4.*

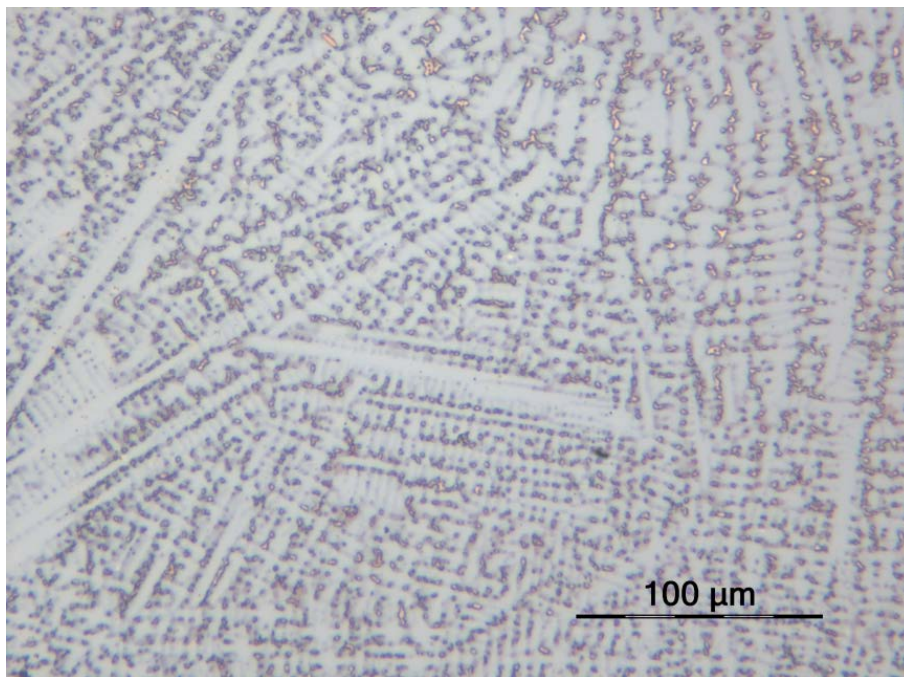
*Figure 4-11: Weld metal of 625 PLUS No. 4.*

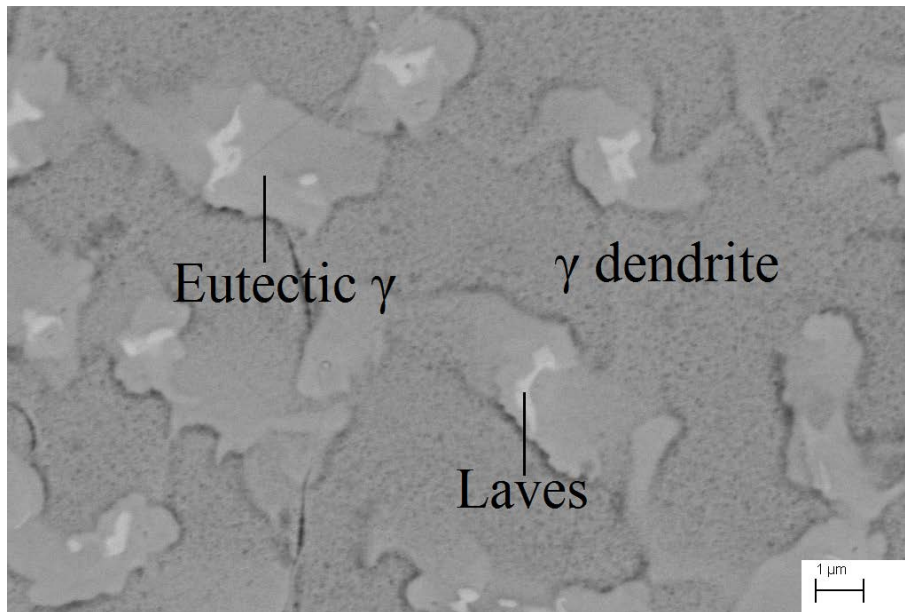
Figure 4-12: Constituents found in the weld metal of Inconel 718 No. 4.

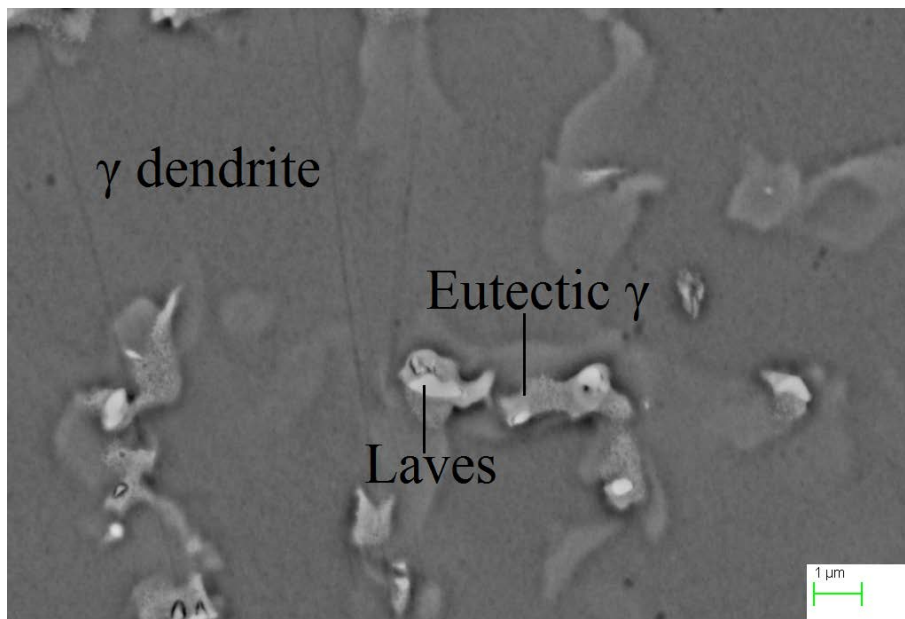
Figure 4-13: Constituents found in the weld metal of 625 PLUS No. 4.

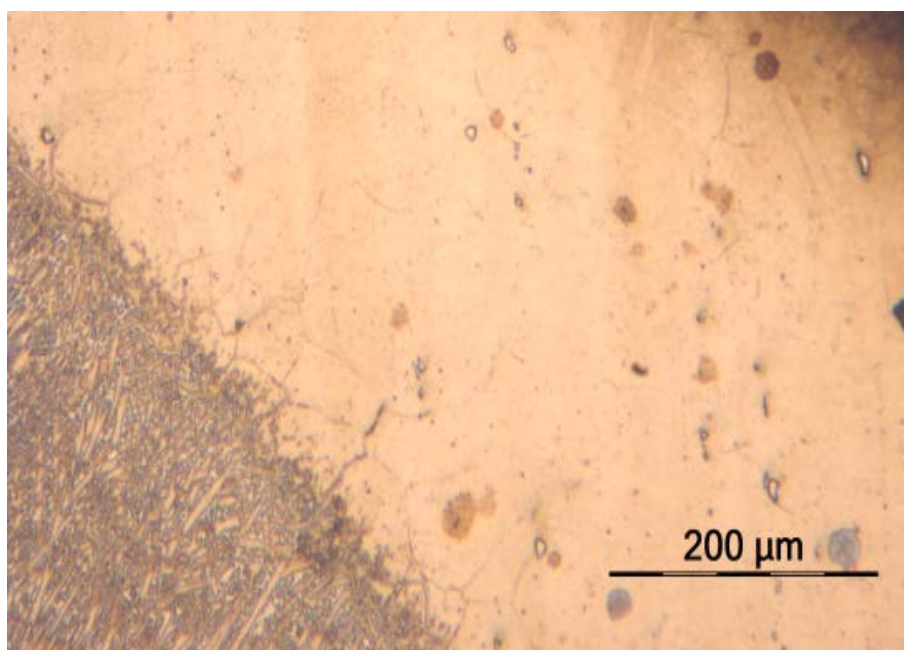
*Figure 4-14: HAZ liquation cracks in Inconel 718 No. 4.*

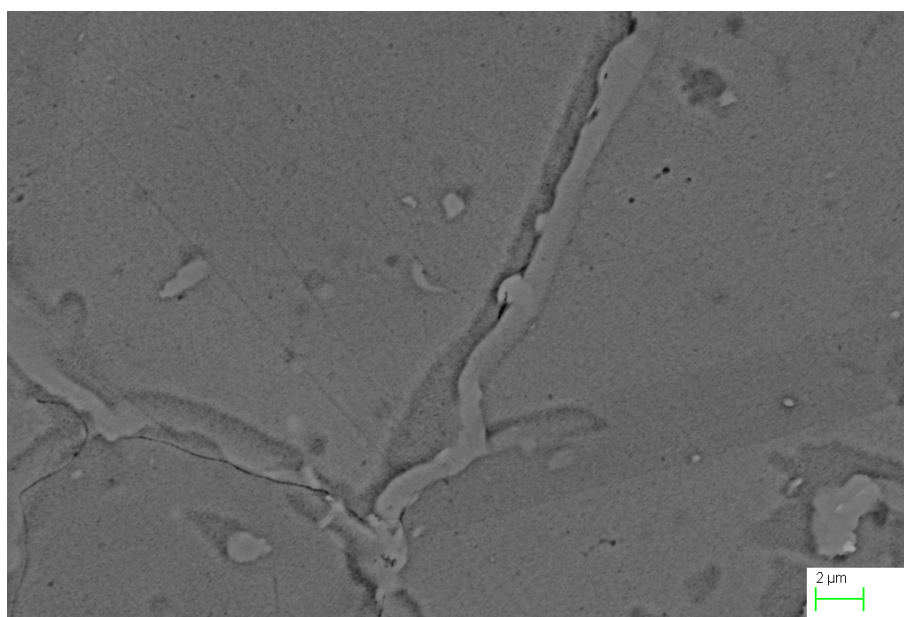
*Figure 4-15: HAZ liquation cracks in Inconel 718 No. 4.*

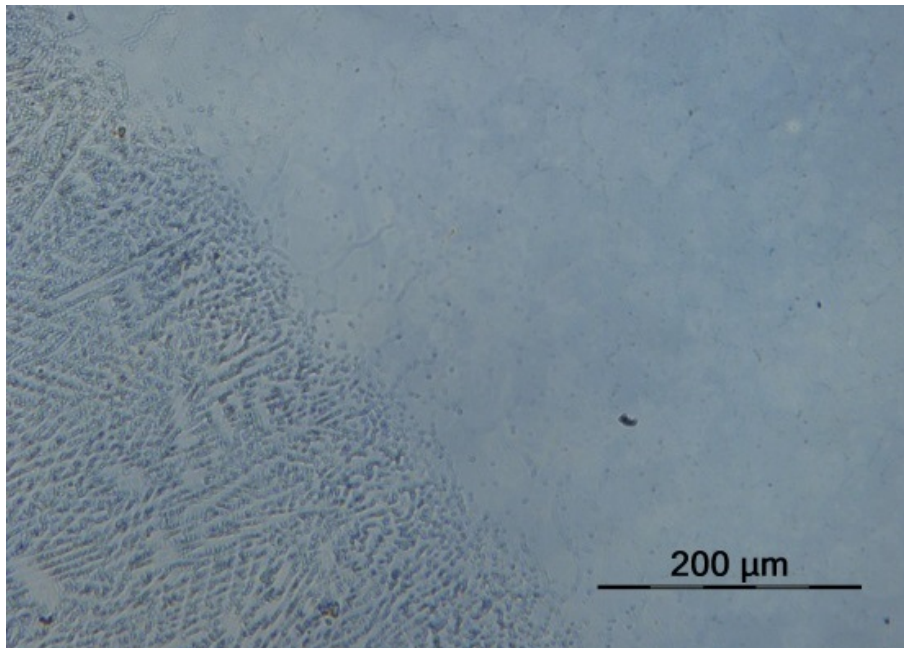
*Figure 4-16: HAZ/weld metal interface of 625 PLUS No. 4.*

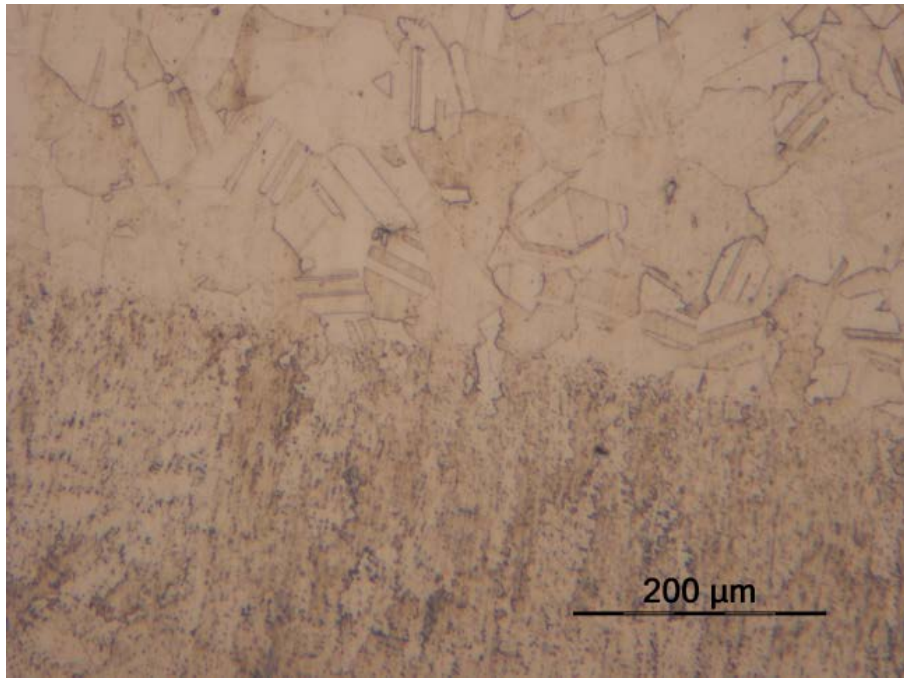
*Figure 4-17: Inconel 718 No. 3 weld metal before post-weld heat treatments.*

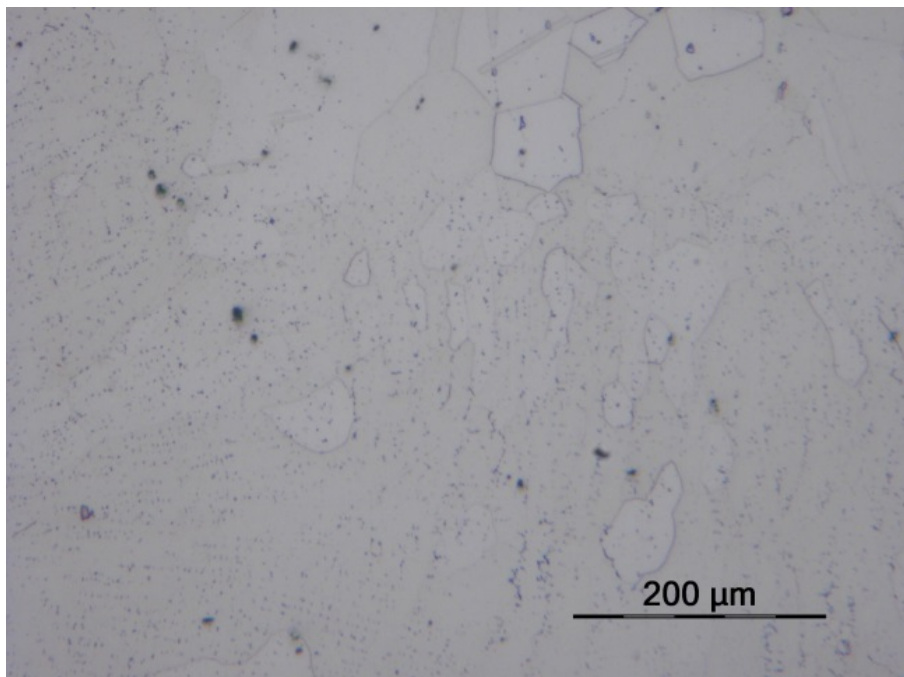
*Figure 4-18: Inconel 718 No. 3 weld metal after post-weld heat treatments.*

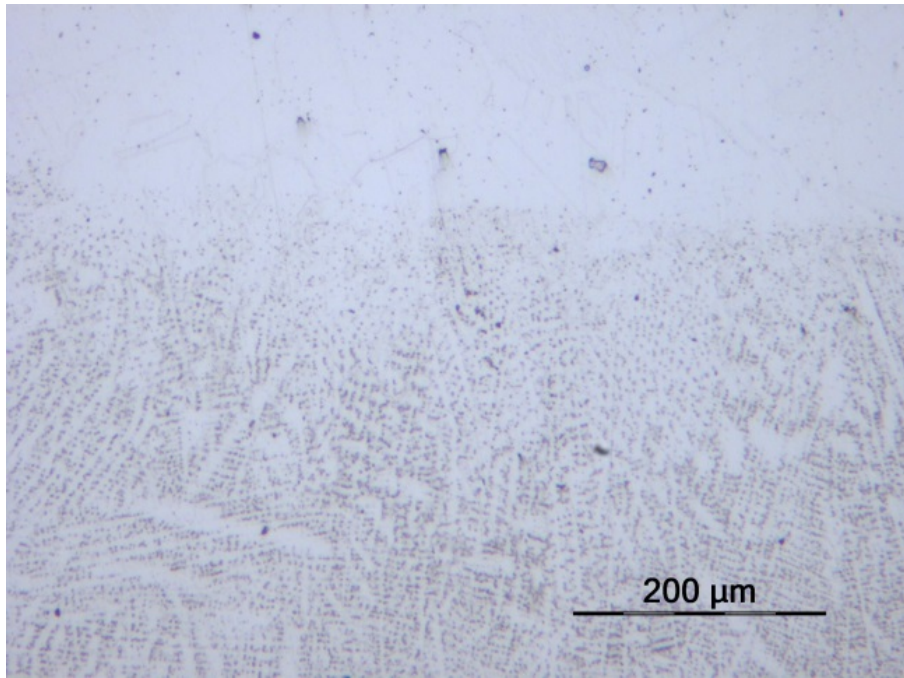
*Figure 4-19: 625 PLUS No. 3 weld metal before post-weld heat treatments.*

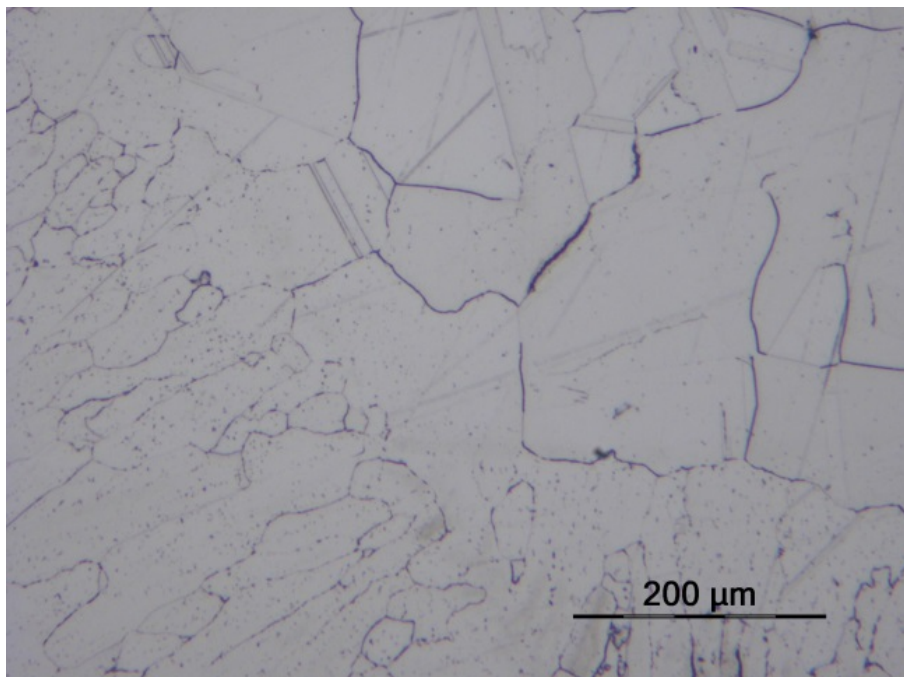
*Figure 4-20: 625 PLUS No. 3 weld metal after post-weld heat treatments.*

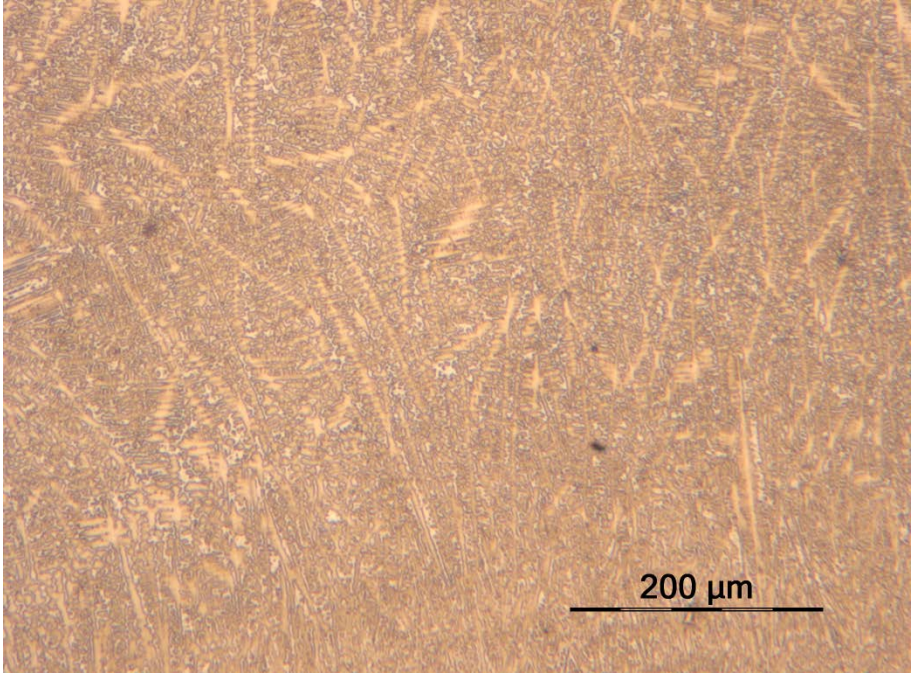
*Figure D-1: Inconel 718 No. 4 weld metal. 10% Chromic Acid.*

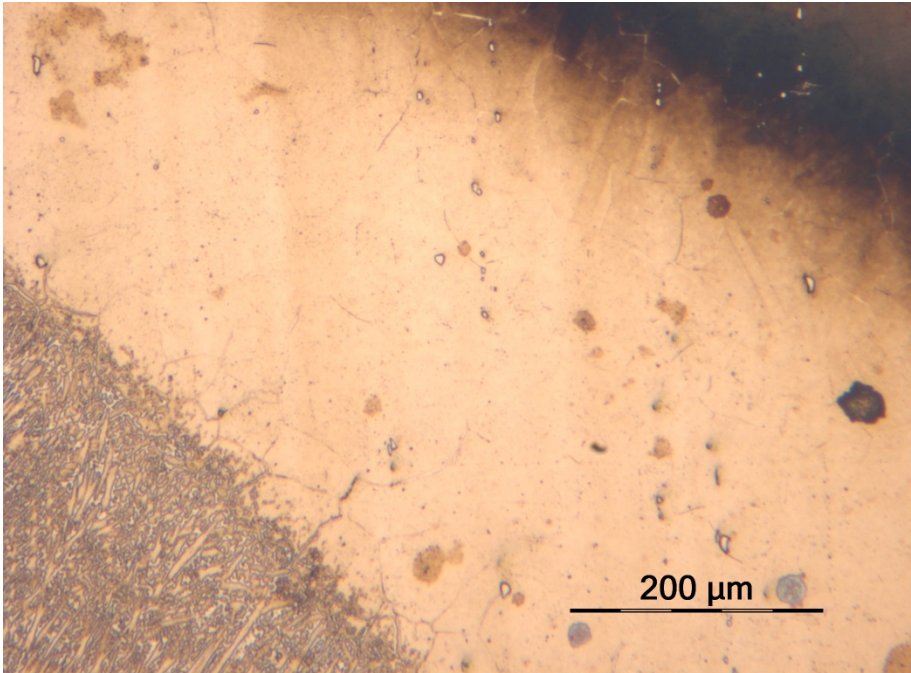
*Figure D-2: Inconel 718 No. 4 HAZ. 10% Chromic Acid.*

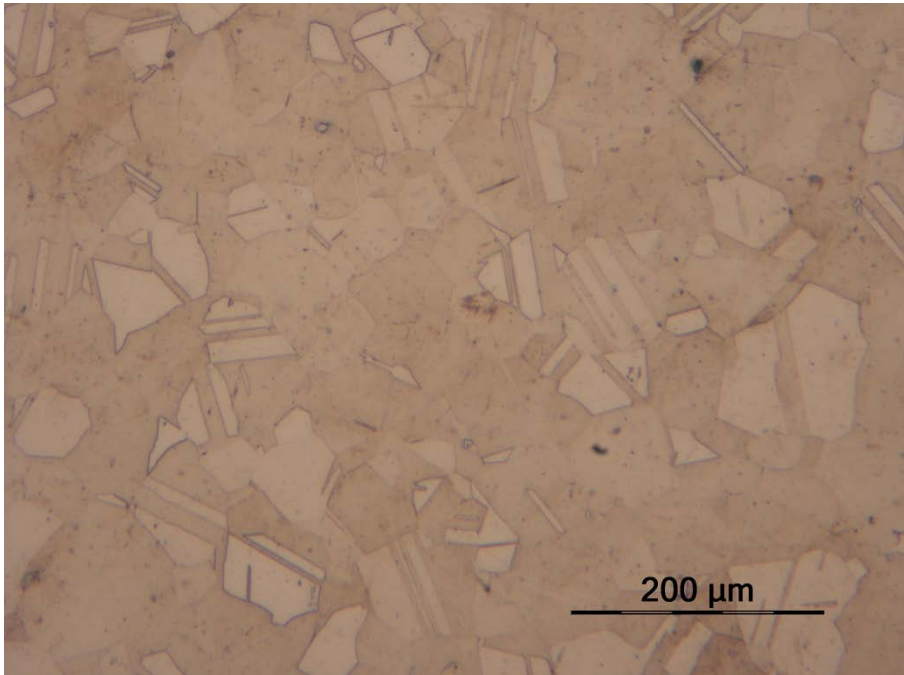
*Figure D-3: Inconel 718 No. 3 base metal. Kalling's No. 2.*

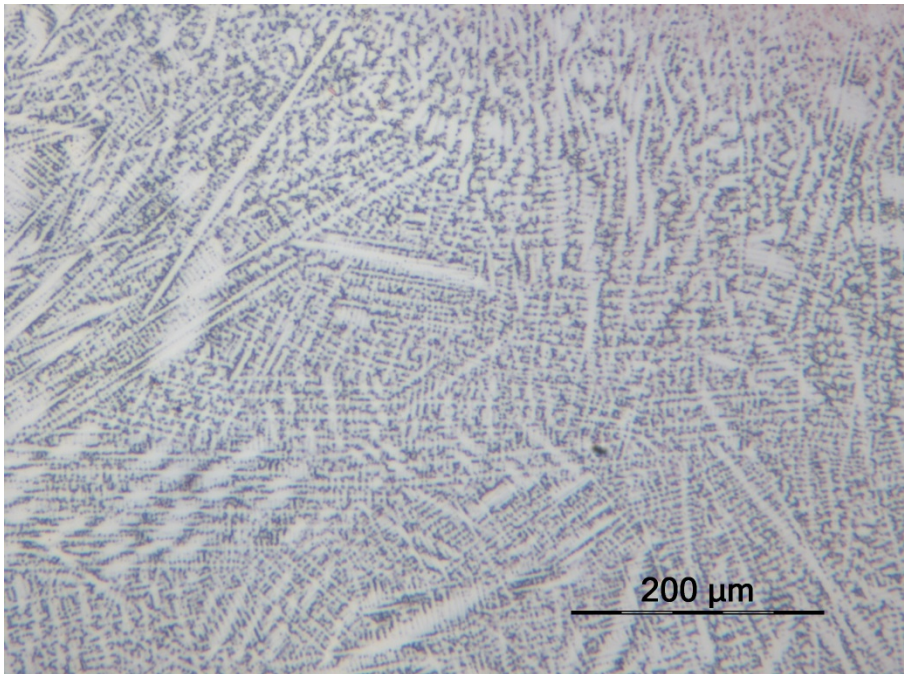
*Figure D-4: 625 PLUS No. 4 weld metal. 10% Chromic Acid.*

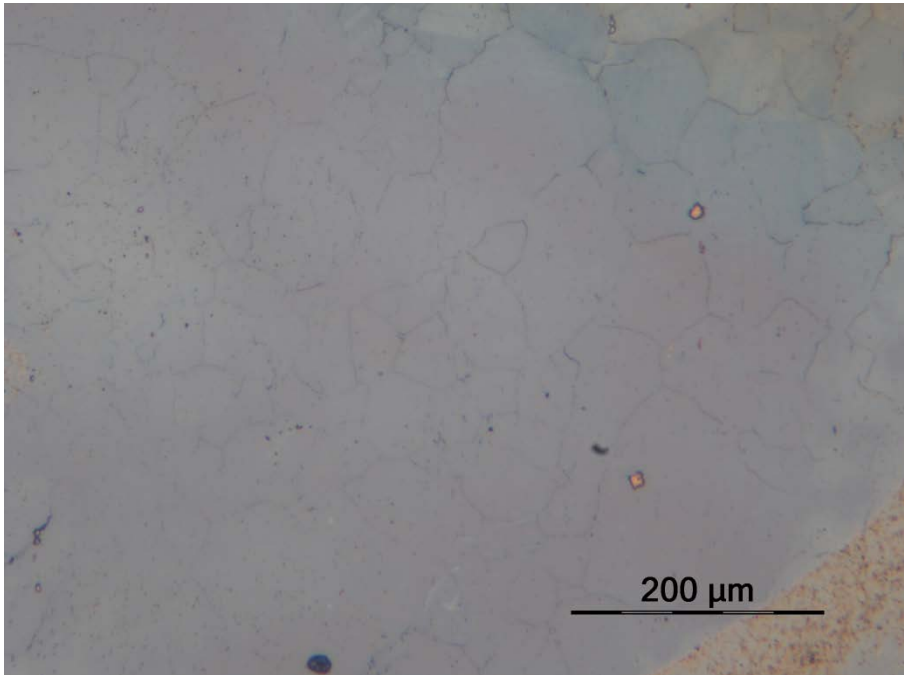
*Figure D-5: 625 PLUS No. 4 HAZ. 10% Chromic Acid.*

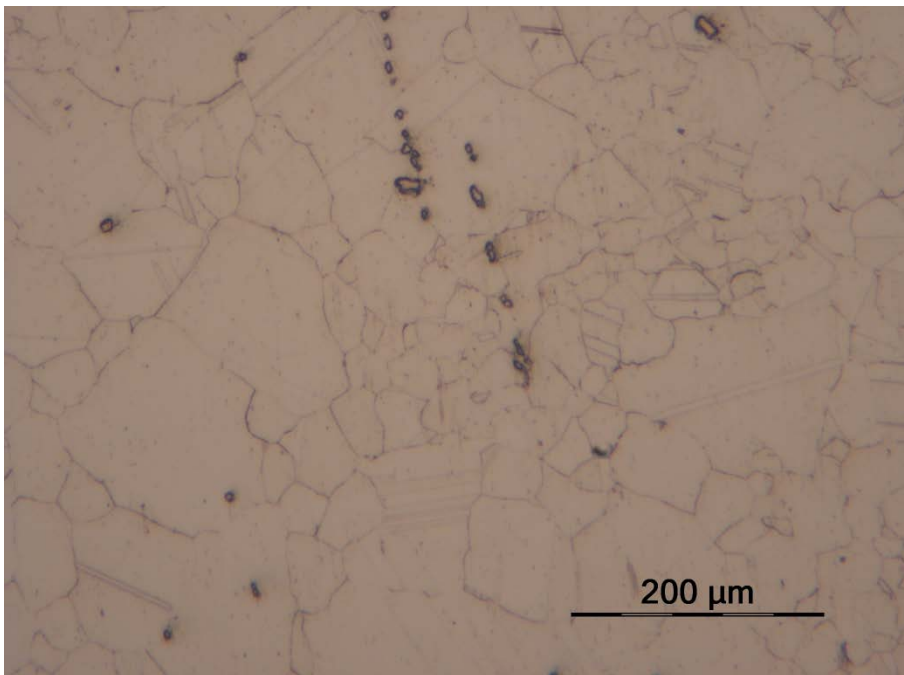
*Figure D-6: 625 PLUS No. 3. Kalling's No. 2.*
