BACHELOR'S THESIS

Study program/Specialization: Petroleum Technology	Spring semester, 2021 Open
Writer: Christian Høie	<i>Christian Høie</i> (Writer's signature)
Faculty supervisor: Hans Joakim Skadsem	
Thesis title: Permeability of Cement Plugs In Steel Pipes and Effects of Treatment Material Injection	
Credits (ECTS): 20	
Key words: Aperture Microannuli ThermaSet Resin Remedial Treatment	Pages: 53 Stavanger, 26 th of June 2021

This thesis studied the permeability of cement plugs cast in steel casings and the effects of treatment material injection in an attempt to reduce the permeability, which was higher than what is considered for bulk cement due to leakage pathways. Five steel casings were filled with API Neat class G cement, the samples were leakage tested to establish the permeability. At the conclusion of the permeability measurements, the samples were subject to lab-scale treatment experiments using two different recipes of ThermaSet. The permeability measurements before and after the treatment was compared. Three out of five samples experienced a reduction in permeability.

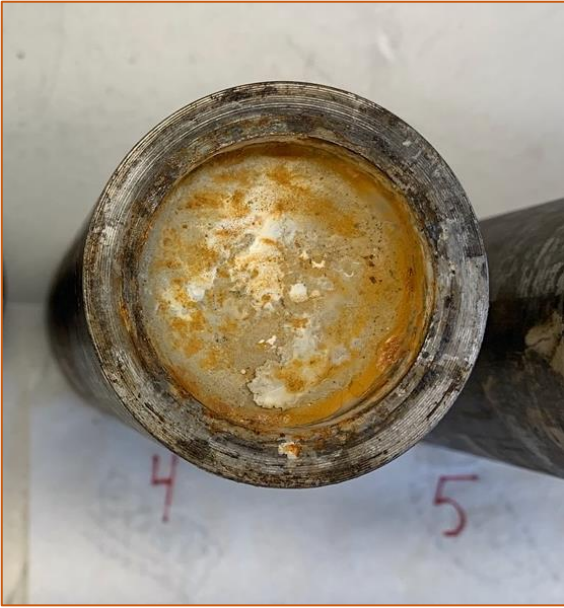
Figure 9.2 – Sample 4 after finished testing, the resin has cured into yellow/white. For illustration purposes.

N-heptane Sudan Blue II dye was mixed into the ThermaSet upon injection. The ThermaSet cures into yellow/white as seen in Figure 9.2, the dye was mixed into the resin in an attempt to make the color more vibrant for a later study. It is important to note that the dye was not recommended by the manufacturer of the resin nor was it said to be compatible with the resin by the manufacturer. The dye was readily available and was thus used in the study. The dye was believed to be relatively new, however, after further investigation the dye is between 30 and 40 years old. It is uncertain if the chemical composition of the dye is altered after all these years and could cause problems.

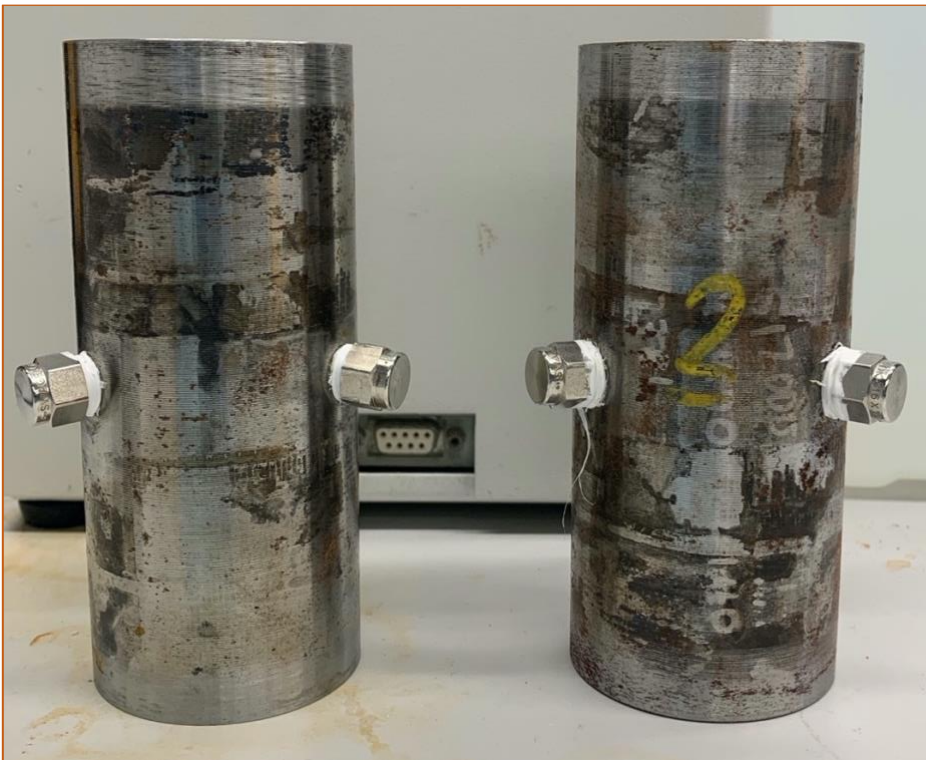
Figure 9.3 – Ports on the side of samples 2 and 3, here fitted with blinds for testing

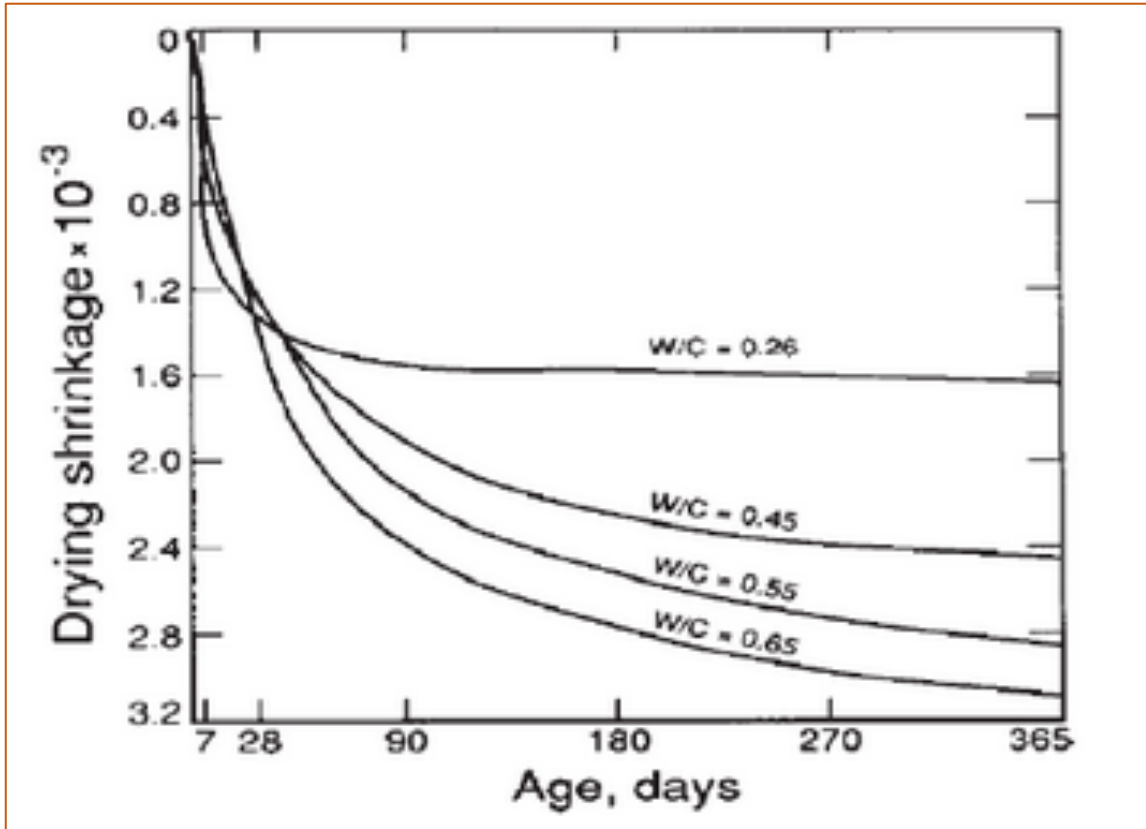
Figure 10.1 – Effect of w/c ratio on the drying shrinkage of concrete as a function of time. Sample 6 would experience a stronger shrinkage due to it being “older” when tested. Data by Hallar (from Soroka, 1993 cited in Idiart, 2009)

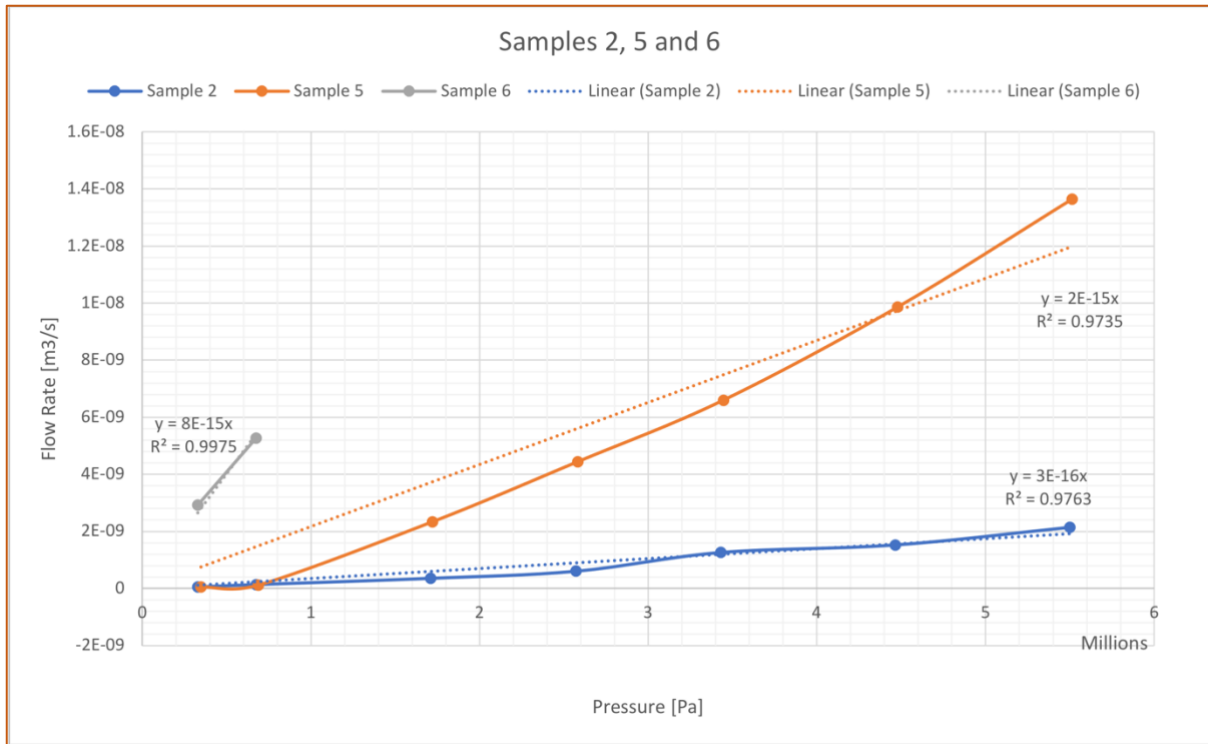
Figure 10.3 – Flow measurements of the most permeable samples 2, 5 and 6.

The flow measurements are summarized in Table 10.1.1; Figure 10.3; Figure 10.4. It is clear from Table 10.1.1 that all samples experience leakage as the permeability are several orders higher than what is considered for intact cement. However, the degree of leakage varies considerably for all samples. What is interesting to note is that Samples 2 and 3 are of the same origin, and Samples 4, 5 and 6 are of the same origin. For Sample 4, 5 and 6 the permeability ranges from $3.498 \mu D$ to $708.663 \mu D$. From section 6 Zonal Isolation, the typical permeability value of an intact cement matrix is as little as $0.01 \mu D$ for water. This indicates that the samples experience some form of flaw within the cement sheath itself or the cement-steel interface, a microannuli. Stormont et al., 2018 concluded that one of the most important mechanisms for microannuli creation was cement hydration. Given the experimental methodology of the samples, cement hydration appears to be the source of leakage through microannuli and/or any flaw in the sheath itself.

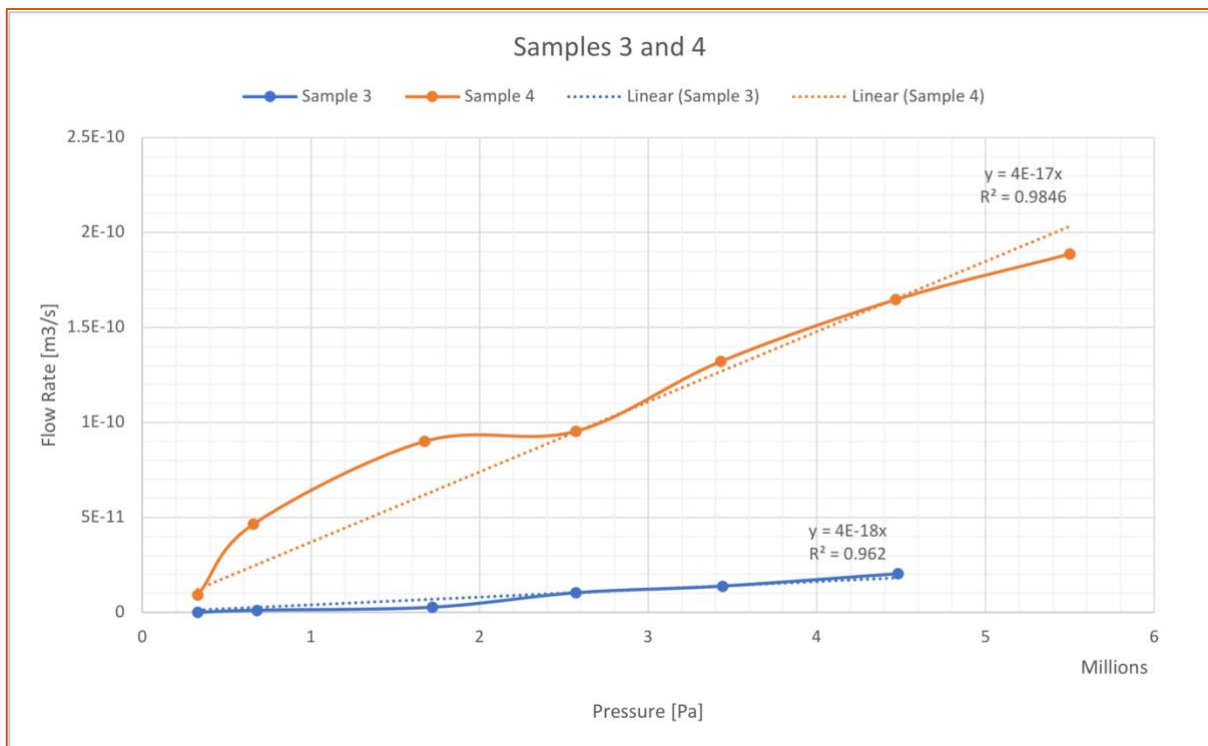
Figure 10.4 – Flow measurements of the least permeable samples 3 and 4.

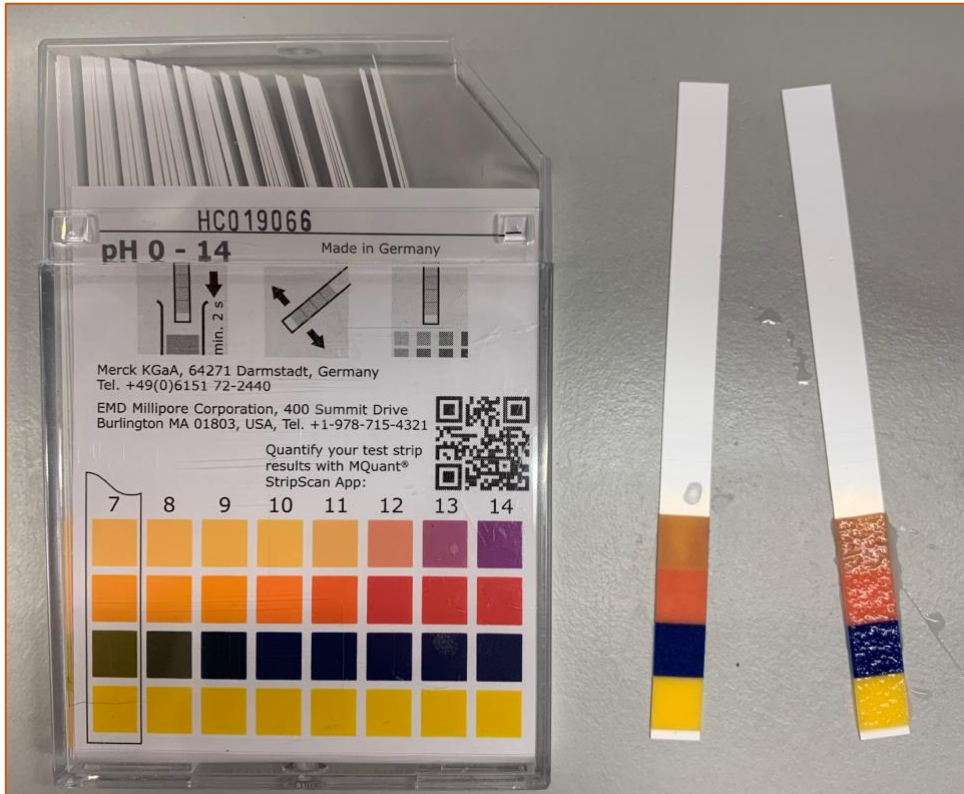
Figure 10.5 – Distilled water experienced an increase in pH after flowing through the samples

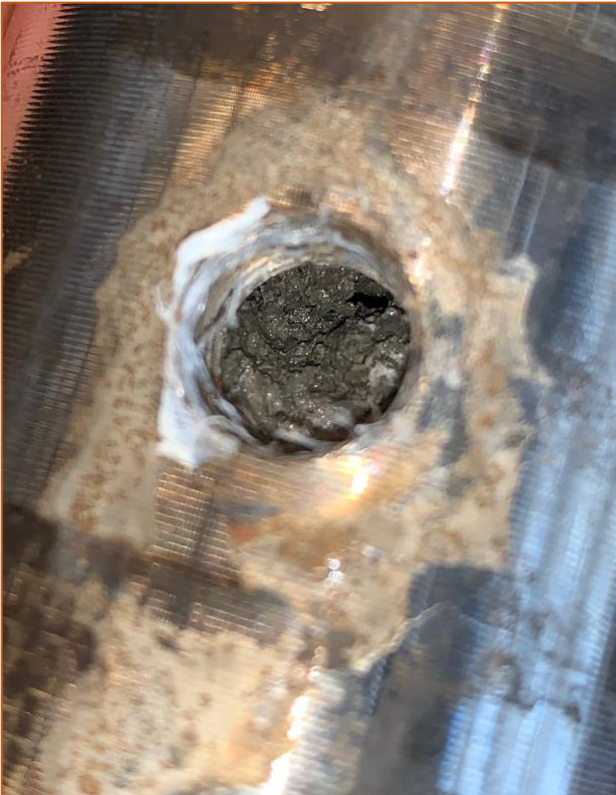
Figure 10.8 - Sample 2, the cement core appears to have collapsed from the pressure exerted by the blind plugs which was used during flow measurements.

Samples 2 and 3 were subjected to a permeability test using the ports on the side prior to this experiment. The flow measurements from that test were not finished and are mostly not of interest. However, sample 2 sheared at 500psi (34.47 bar), dislodging parts of the cement core, Figure 10.9. Approximately 1 cm of the core protruded outside the casing, the protrusion was cut flush with the casing as to fit with the new setup. Upon re-plugging the side port due to leakage through the port, the cement core appears to have collapsed as a result of the force exerted on the cement from the plug and the void, Figure 10.8.

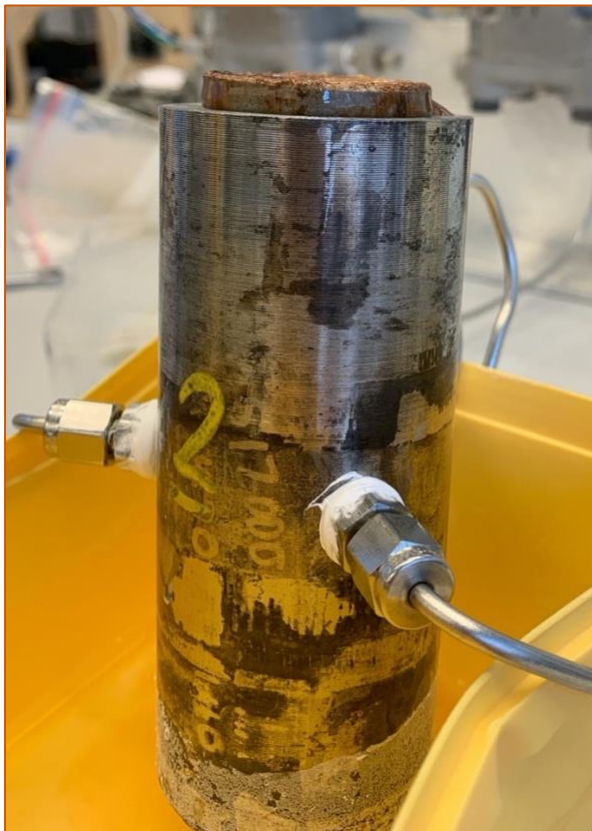
Figure 10.9 – Sample 2. Water injection through the sides. The cement core sheared at 34.47 bar. The sample is in the process of dislodging the core.

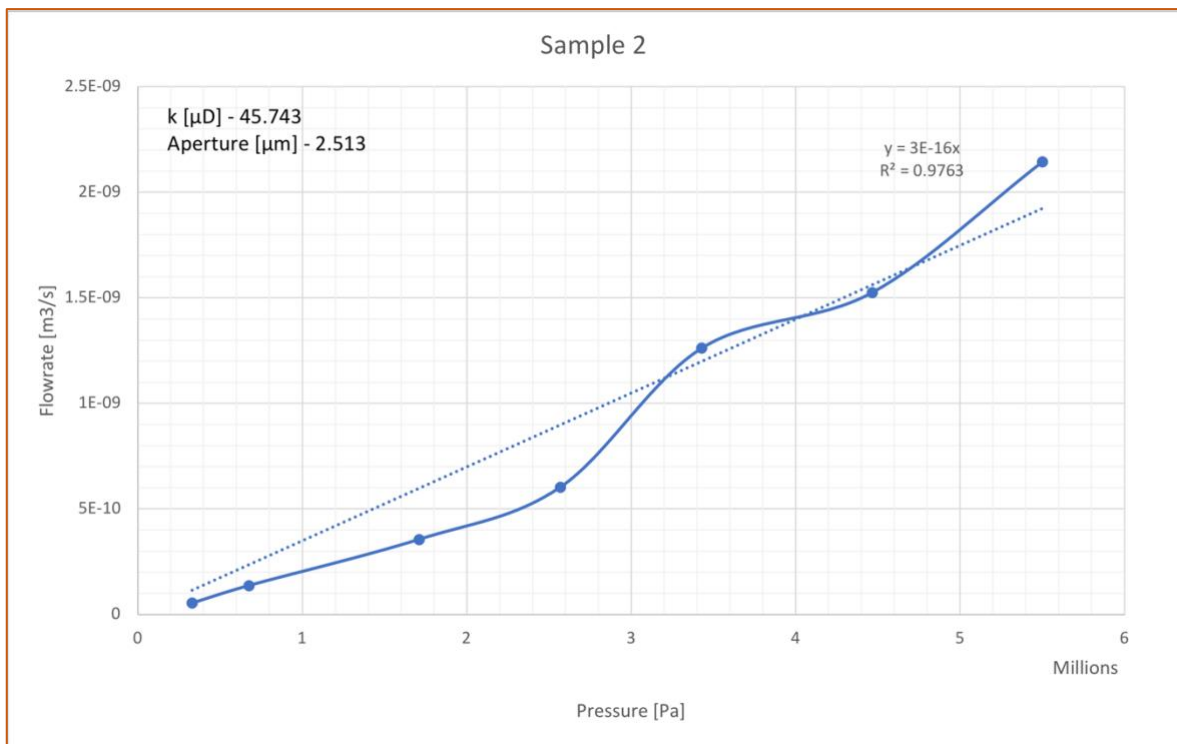
Figure 10.10 – Flow measurements of sample 2

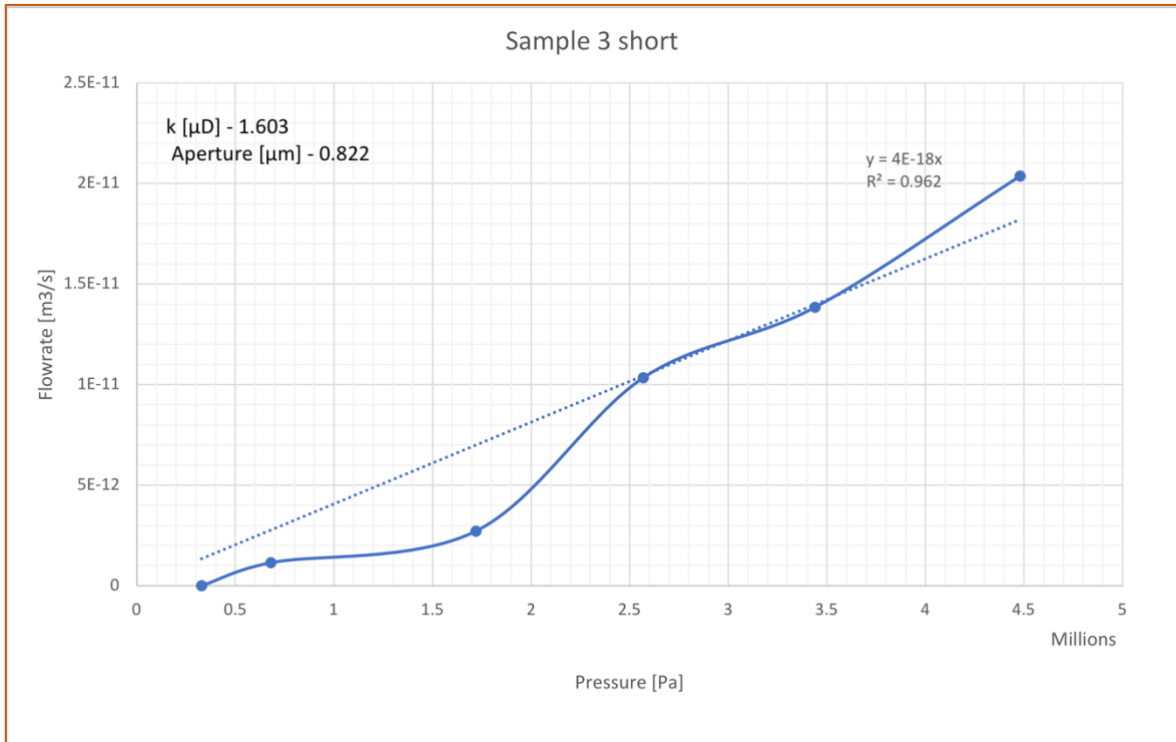
Figure 10.11 – Flow measurements of sample 3 – without 55 bar measurement, clearly this is linear flow.

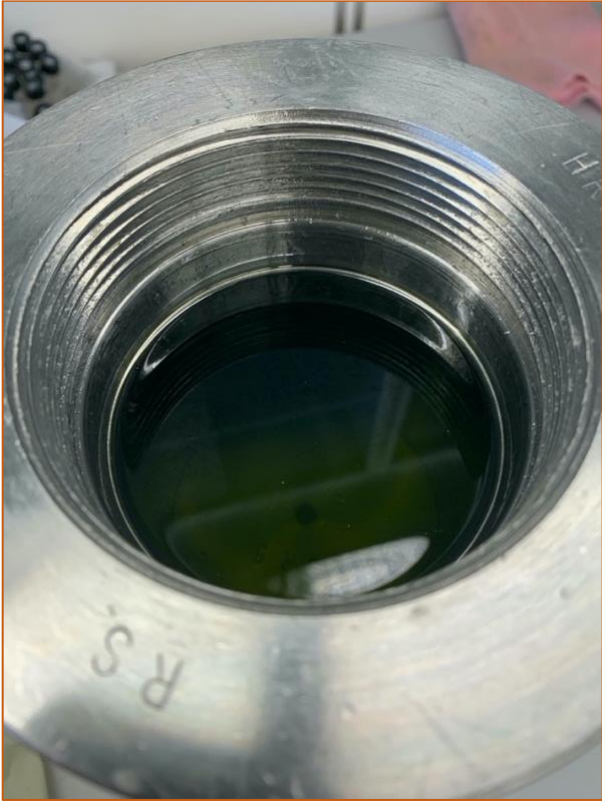
Figure 10.17 – Dyed resin used in treatment experiment, for color comparison.

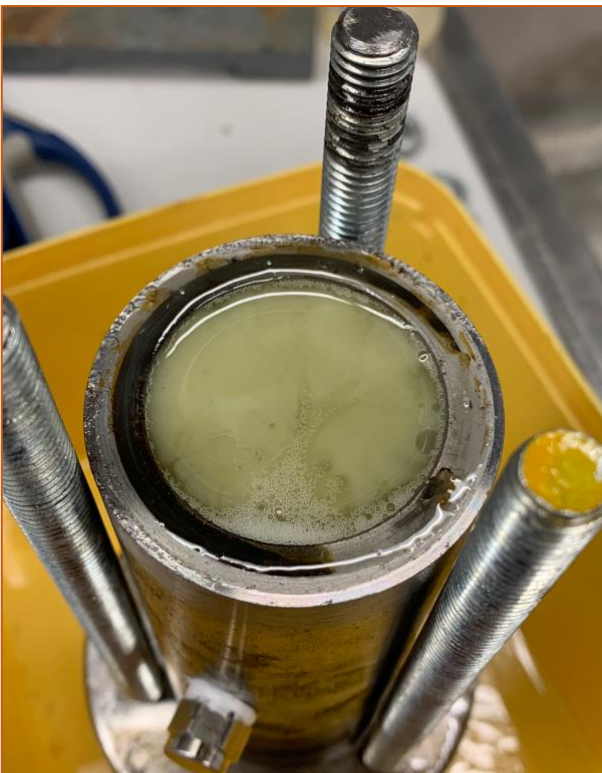
Figure 10.18 – Sample 3 disconnected after failed injection. The color of the resin is altered and there are visible bubbles in the resin.

Samples 2 and 3 were tried injected with the resin optimized for squeezing, containing dye. Neither of the injections rendered successful. Sample 3 did inject for some time before the flowrate went to zero. The sample experienced backpressure in the process of disconnecting the sample, resin shot out of the inlet. In Figure 10.17 the color of the dyed resin that would be injected is green. However, in Figure 10.18 the color of the residual resin in Sample 3 is altered. Bubbles are also visible within the residual resin on Sample 3.

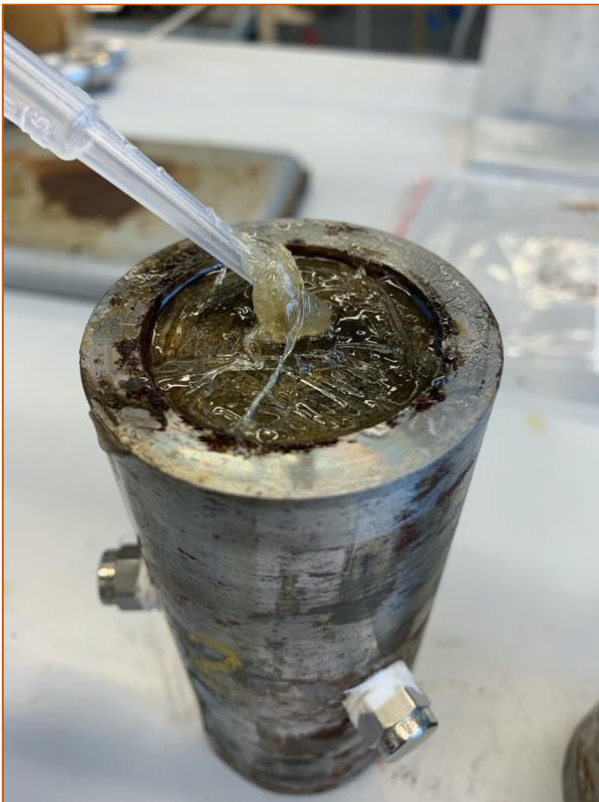
Figure 10.20 – Sample 2, residual resin is altered. It turned gel-like and highly viscous

Sample 2 did not inject; however, it has a larger permeability than Sample 3. From Figure 10.19 it appears as though the dye has colored the cement matrix. Looking at Figure 10.20, the residual resin after disconnecting the sample from the test cell is a very thick gel-like substance. The reason for this is uncertain and was not answered by the manufacturer. Sample 2 experienced a collapse of the cement core (Figure 10.8), as the viscosity of the squeeze ThermaSet is 40 times that of water, it is possible the resin has plugged the apertures and/or microannuli using the cement particles from the collapsed area and is part of the reason for the unsuccessful injection.

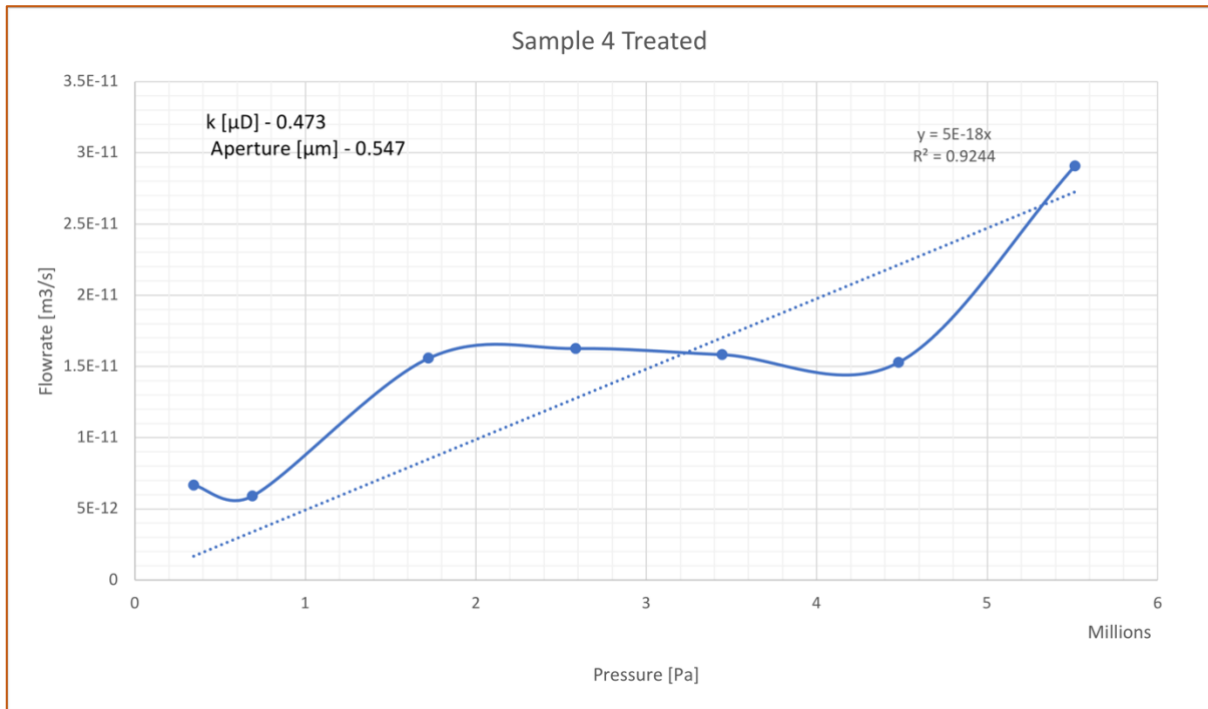
Figure 10.21 – Flow measurements of Sample 4 after treatment
