This study outlines a medieval stone repair technique involving wood tar. In the process of condition assessment, an unusual adhesive was identified used for repairs and indents on Stavanger Cathedral, a medieval Norwegian soapstone structure. Based on appearance and context, an initial hypothesis was formulated that tar may have been used as a historic repair method. This hypothesis was subsequently tested and confirmed through analysis. Samples of the adhesive were investigated using light microscopy, scanning electron microscopy with energy-dispersive spectroscopy, Fourier-transform infrared spectroscopy and gas chromatography–mass spectrometry. The material was radiocarbon dated and the date found to coincide with the reconstruction of the choir following a fire in the latter quarter of the 13th century. Several hundred findings of tar repairs have so far been identified on the cathedral, indicating comprehensive use of tar as a medieval adhesive for soapstone. These findings have implications for the development of an alternative conservation adhesive based on traditional materials.

**MURALS, STONE, AND ROCK ART**

Stuck like glue: Wood tar as a medieval stone adhesive

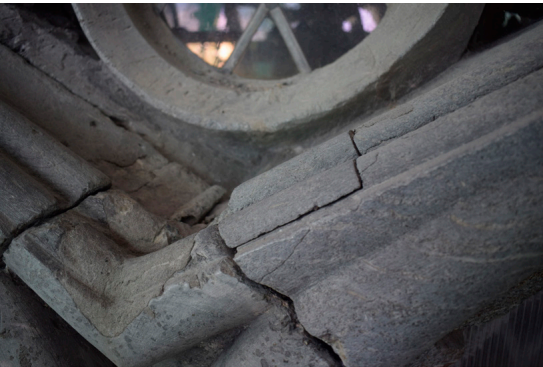
**Figure 2.** Medieval stone repair on Stavanger Cathedral. Photo: Bettina Ebert, Museum of Archaeology, UiS

During a recent condition assessment of the cathedral façades, an unusual attachment method for a stone indent was uncovered by the conservators (Figure 2). The stone in question was located in the window tracery in one of the bays on the south façade of the choir (Figure 3). The adhesive used on this indent was revealed because the stone had come loose during removal of the cement mortar from the surrounding joints as part of the repointing process. The method of attachment consisted of a black adhesive layer, a sample of which was taken for investigation. This adhesive sample has formed the basis of the current study. The black material had been neatly applied in an even layer a few millimetres in thickness, with a small

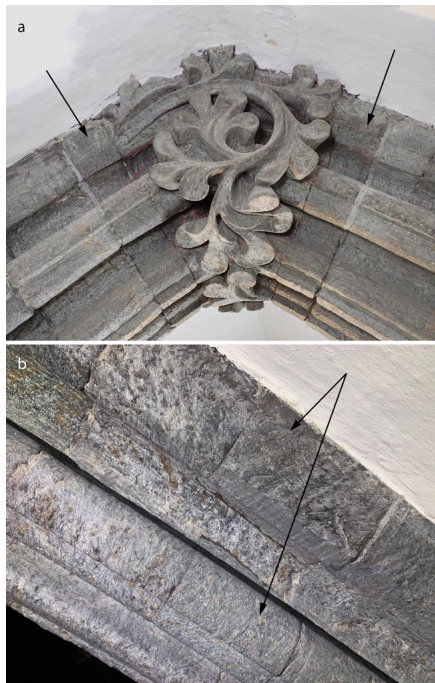
**Figure 6.** Tar used as an adhesive for large blocks of soapstone in the choir's vaulted ceiling. Arrows indicate stones adhered with tar. Photo: Bettina Ebert, Museum of Archaeology, UiS

Following the initial find of the adhered stone investigated in this paper, nearly 250 additional indents, stones and repairs have since been identified that employ the same method of adhesion (Figures 6–8). These repairs range in size from a few centimetres to entire stone blocks making up the vaulted choir. They have been identified on structures linked to the Gothic rebuilding of the cathedral, both on the interior and exterior, with no such evidence on the Romanesque elements. Since the investigation of these finds on Stavanger Cathedral is as yet incomplete, it may be estimated that several hundred such instances remain to be documented, before expanding the research to other medieval stone structures in the region
