MASTER THESIS

Industrial Asset Management

Computer Vision in Wind Turbine Blade Inspections: An Analysis of Resolution Impact on Detection and Classification of Leading-Edge Erosion

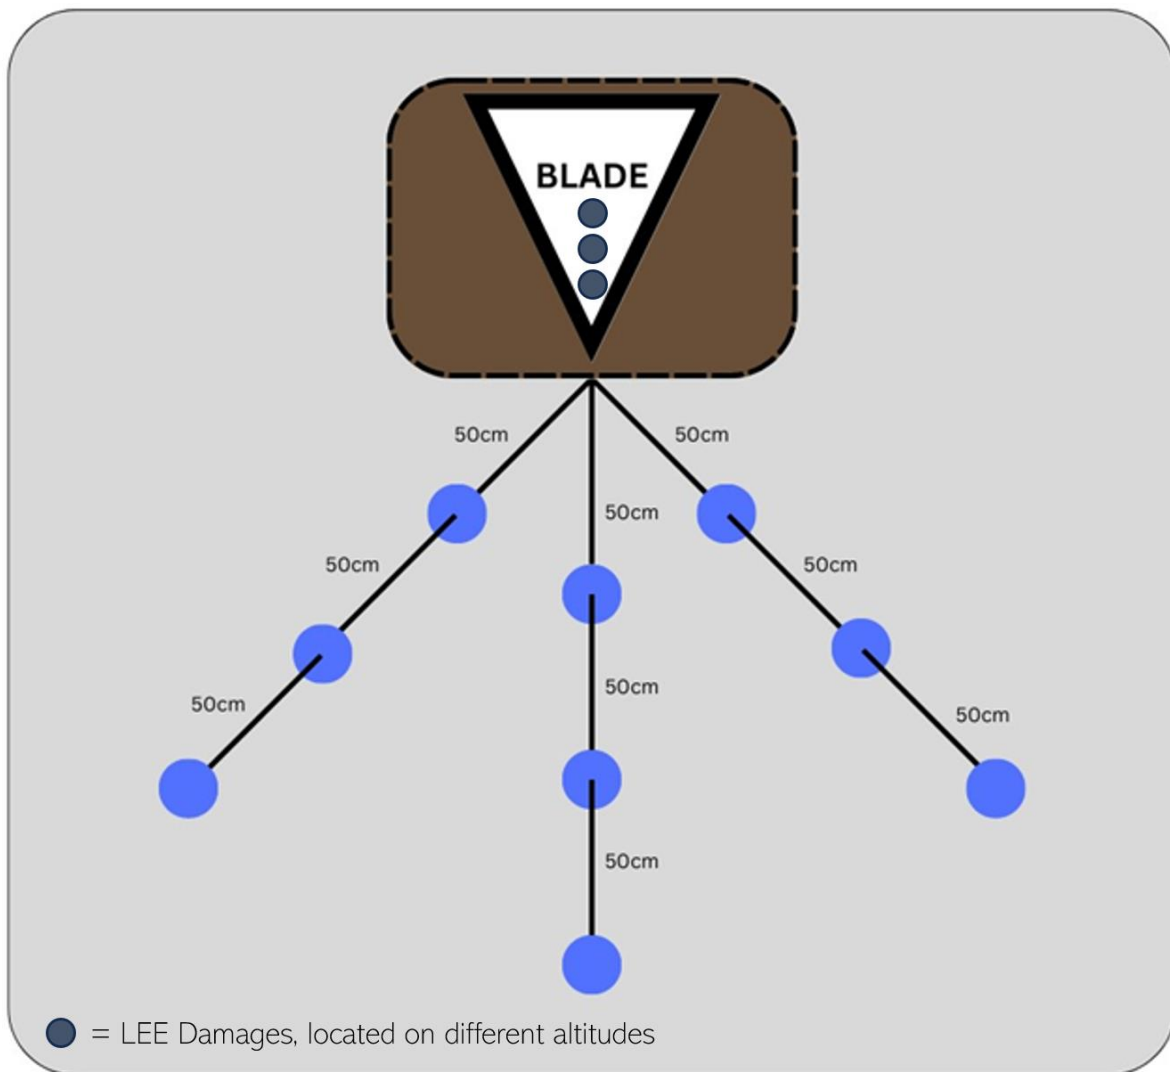
Figure 3.2 – Image Collection Layout

In order to standardize the photography process and ensure the images were comparable across different erosion categories and devices, a structured process was carefully devised and followed throughout the image acquisition activity. This protocol required each erosion category to be photographed from three specified distances: 50cm, 100cm, and 150cm. At each distance, five images were taken while facing the leading edge directly (0 degrees), then again at an angle of 45 degrees, and finally at an angle of -45 degrees relative to the blade's leading edge. This was repeated for each damage instance located on the blade, and with each unique imaging device. Figure 3.2 visualizes the imaging layout of the process. This systematic approach provided a comprehensive visual dataset of each erosion category from multiple perspectives, resulting in an initial pool of 405 images.

The capturing of images through the smartphone and the digital camera was conducted manually, however the capabilities of the drone allowed for a “mission” to be programmed for this process. The mission was coded in Python and sequentially commanded the drone to assume its position on image capture points and commence capturing pictures of the damages. The initial mission included one complete cycle for the drone to capture images at all dedicated points, however, this process consumed excessive power from the already limited capacity of the drone’s battery, therefore was deemed infeasible. Following this discovery, the mission was adjusted so that in a single execution, the drone would only capture images at points lying on individual angle lines. This modification required the drone to be placed at 50 centimeters distance from the blade’s leading edge as the takeoff position, and the mission to be executed thrice. The modified mission code can be found in Appendix A.

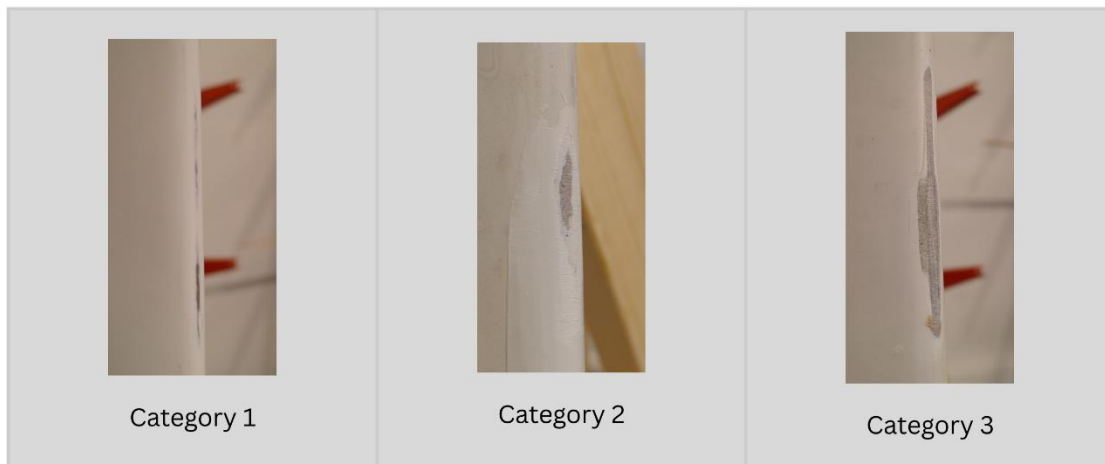
Figure 4.1.1 – Artificial LEE on Blade Section

In accordance with the experimental procedures outlined in the methodology, the section of the wind turbine blade was intentionally subjected to damage in three separate locations along its leading edge. The purpose was to simulate distinct categories of leading edge erosion that could occur in a real-world scenario. The types of damage ranged from the initial stages of cosmetic erosion, characterized by minor surface wear and tear, to the severe end of the spectrum where the structural material of the blade is completely exposed, necessitating urgent intervention. The damages inflicted on the blade are visually represented in Figure 4.1.1.

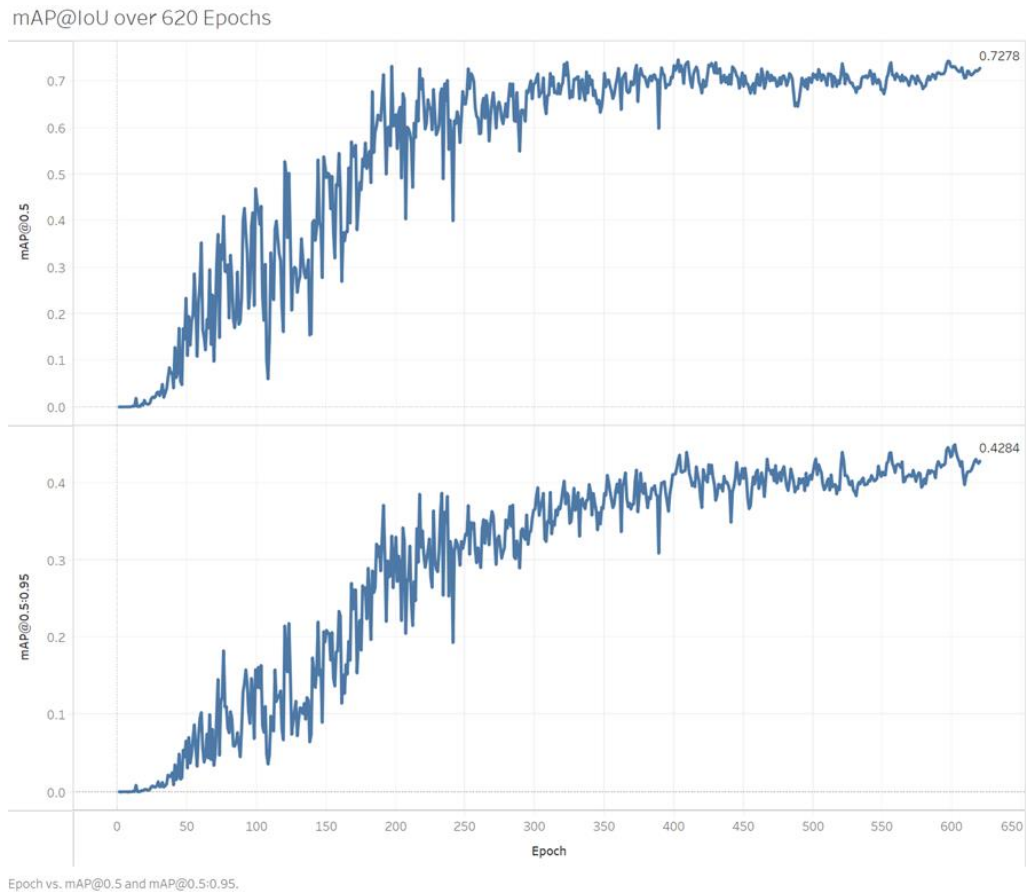
Figure 4.3.3 – mAP over Training

Next, the Mean Average Precision (mAP) is inspected, both at an Intersection over Union (IoU) threshold of 0.5 (mAP@0.5) and over a range of IoU values from 0.5 to 0.95 (mAP@0.5:0.95). Figure 4.3.3 displays the evolution of mAP over the course of 620 training epochs.

The mAP is a popular metric in measuring the accuracy of object detectors like YOLOv7. Specifically, mAP@0.5 means the model is evaluated at a single IoU threshold of 0.5, and mAP@0.5:0.95 means the model is evaluated at multiple IoU thresholds from 0.5 to 0.95. Recalling the definition, Intersection over Union (IoU) is a measure used in object detection to determine the accuracy of the bounding boxes predicted by the model. It is essentially the ratio of the area of overlap and the area of union of the predicted and actual bounding boxes.

After a thorough iterative approach, which will be further detailed in section 4.3 Performance Analysis & Reparameterization, it was decided to train the model for 620 epochs, using an NVIDIA A100 GPU on Google Colab, which took roughly 1.5 hours to conclude. This number was decided based on the observation that mAP@0.5:0.95 converged into its optimal value around this mark, and any further training could risk overfitting. The mAP@0.5:0.95 was prioritized over mAP@0.5 as it provides a more comprehensive evaluation, taking into account the mAP over a range of IoU values between 0.5 and 0.95. The model achieved mAP@0.5 and mAP@0.5:0.95 of 0.7278 and 0.4284, respectively, at the end of 620 epochs, with their peak values of 0.7458 and 0.4497 achieved at epochs 403 and 602. This confirms that average precision over lower IoU values converges into optimum more quickly, as detections with higher IoU values require further training to improve precision.

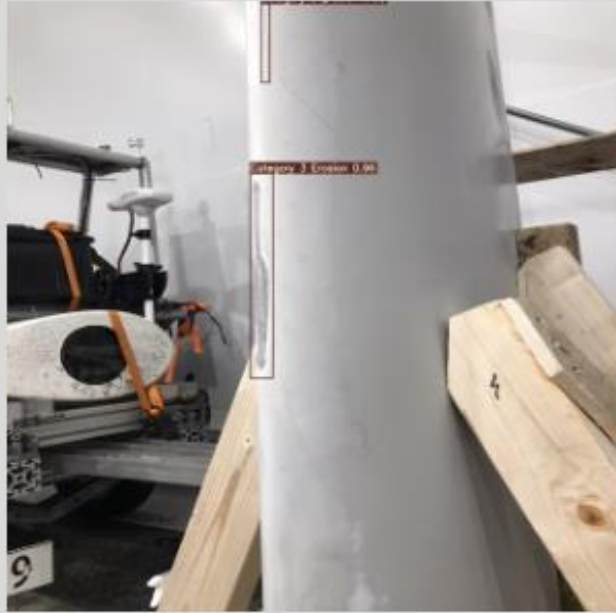
Source: Smartphone

False Positive on Coating

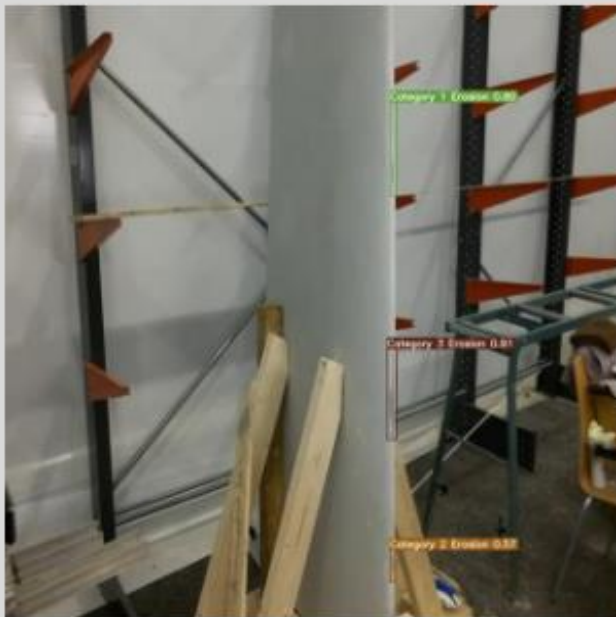
Source: Drone

Correct Detection and Categorization

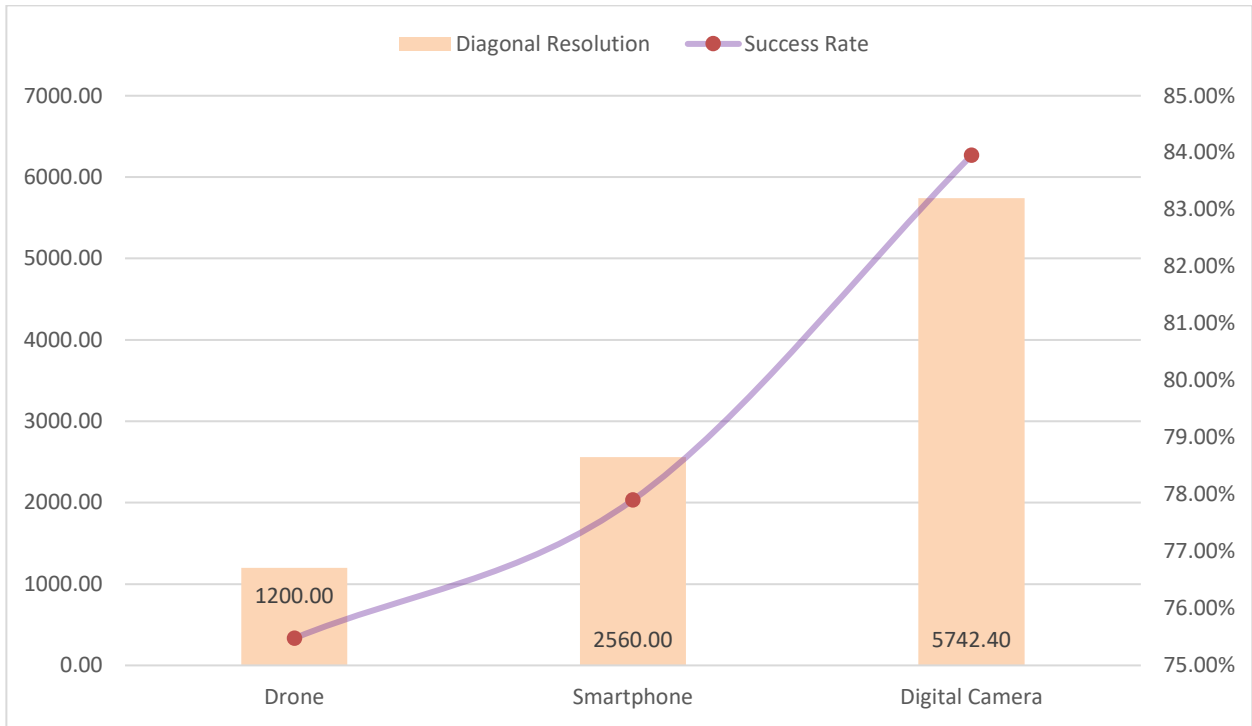
Figure 4.6.2 – Resolution and Success Rate Relation

To put things into perspective, the resolutions of the images from the drone, smartphone, and digital camera were 960x720, 1536x2048, and 4592x3448 pixels, respectively. In order to lay the foundations for an appropriate comparison, diagonal resolution values were used in visuals, instead of length and width resolution values of images. When these values are compared directly with the respective success rates, a clear pattern emerges, suggesting that the resolution of the input images indeed impacts the performance of the custom model. This correlation can be attributed to the fact that higher resolution images are able to represent more detailed and unique characteristics of each damage category, thereby enabling the model to make more confident detections. Indeed, a higher resolution tends to yield sharper images, which in turn allows for more precise and accurate damage detections. This is supported by Figure 4.6.2, illustrating the relationship between the diagonal resolution of each device and their respective success rates.

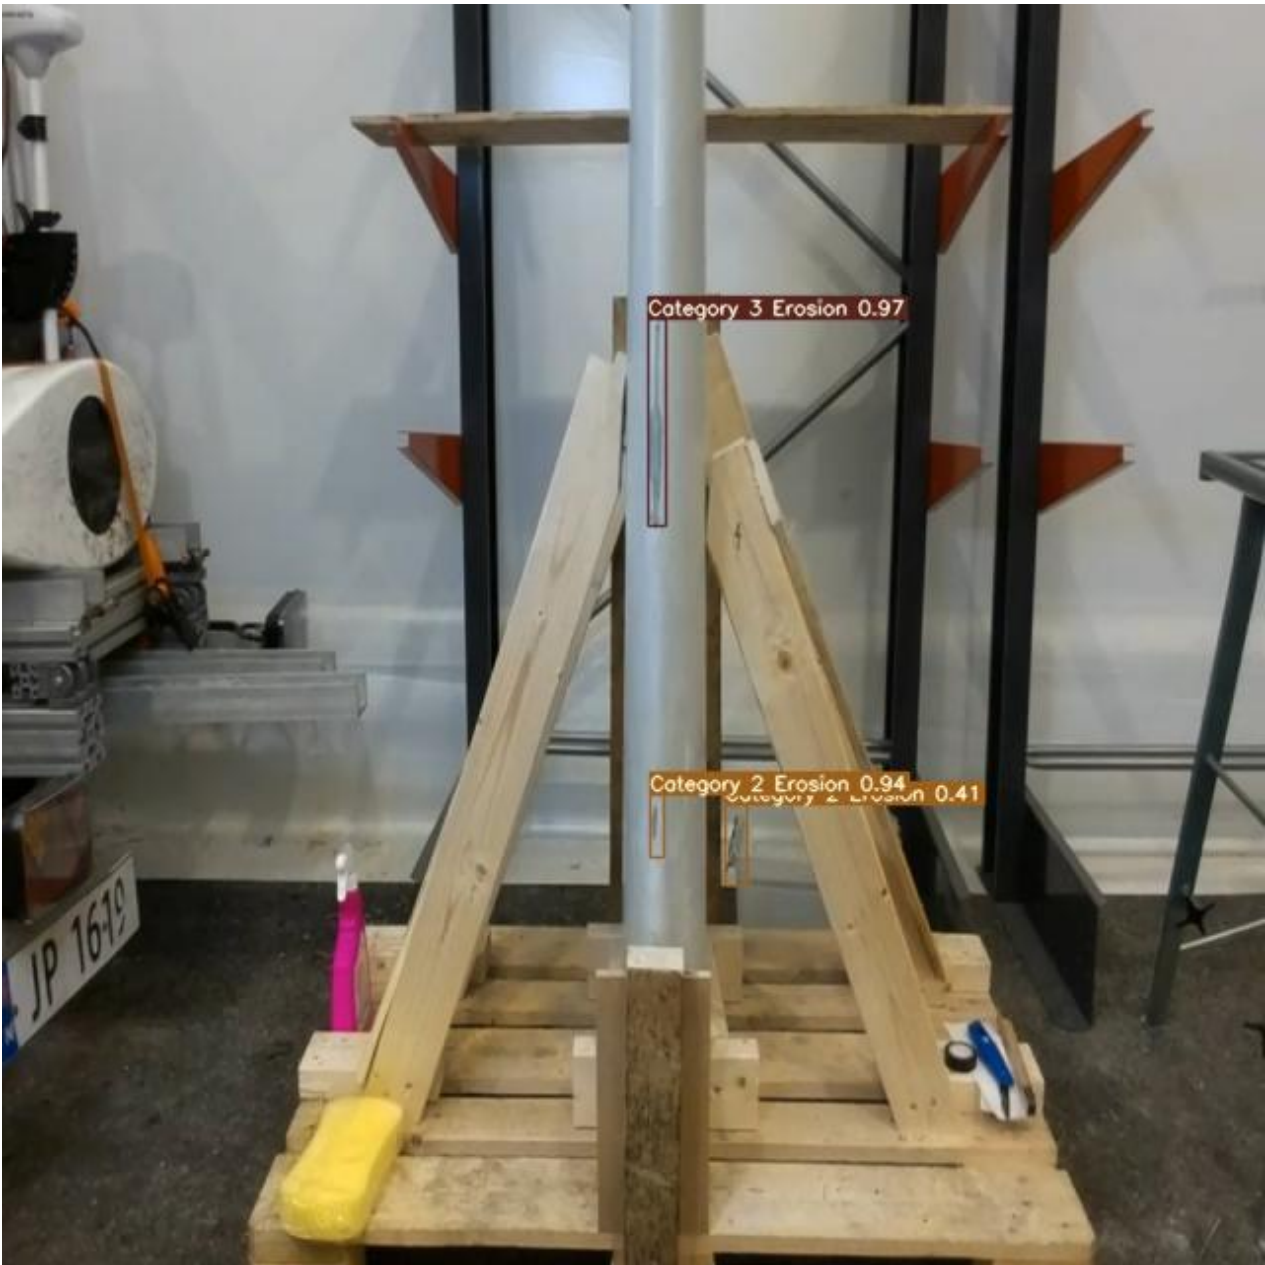
Image Device: Ryze Tello (Drone)
False Positive in Background
