## MASTER'S THESIS

Un-bonded flexible pipelines and risers are an alternative to conventional rigid steel pipes. The use of flexible pipes has enabled development of several offshore fields that seemed unfeasible with the use of rigid pipes due to extensive seabed preparation and large dynamic motions. The lack of knowledge and integrity management tools for flexible pipes is a limiting factor and cause pipelines and risers to be replaced before their service life has been reached. This thesis aims to discover the critical failure modes for flexible pipes and explore conventional and novel techniques for performing inspection and monitoring. By understanding the failures and having access to the necessary technology the remaining lifetime and lifetime extension calculation will be more accurate than to date. Degradations and failure mechanisms will be detected at an early stage giving the operators better time to initiate mitigating and repair measures.

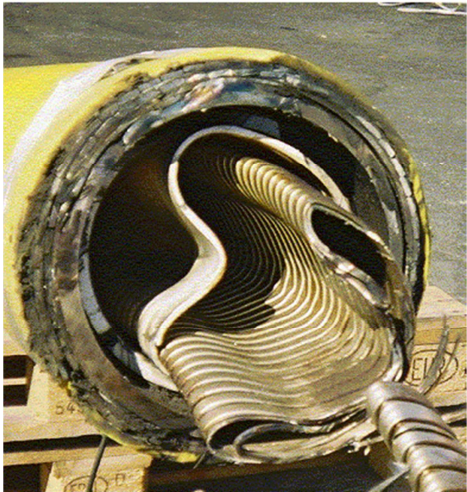
Figure 5 - Carcass collapse [21].

The collected CODAM data presented in Table 3 shows that collapse is the most common reported incident for the NCS. In later years it has been discovered that collapse is especially threatening for double annulus risers. Statoil has had several incidents with flexible risers designed with this configuration. Problems with carcass collapse in flexible risers at Njord A, Visund and Snorre B is described in [21]. This investigation report reveals leakages during shut down activity in three different risers at three different location, all of the with the same double annulus configuration. Figure 5 presents an incident where the carcass has collapsed.

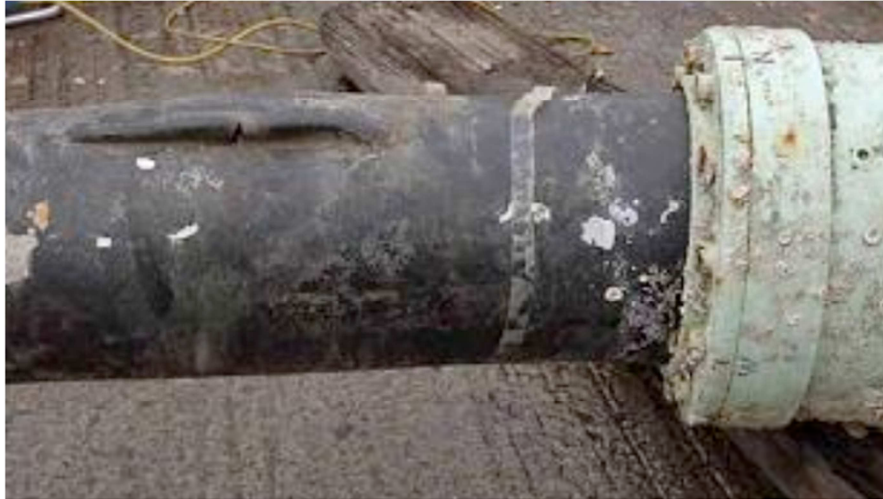
Figure 6 - Rupture of external sheath due to leak in end fitting [11].

The CODAM database includes several reported burst incidents of flexible risers. Figure 6 shows an example of burst of the external sheath near the end fitting. In this case there was a leak across the main seal inside the end fitting. This leak caused the pressure to build up inside the annulus leading to a rupture of the external sheath (ref. [11]).

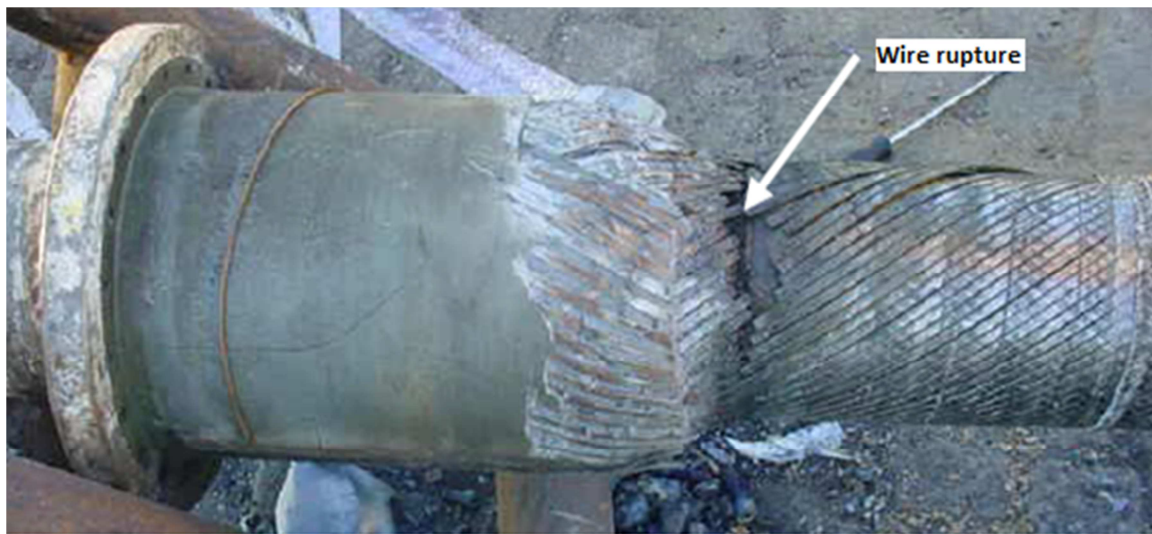
Figure 9 - Tensile armour wire rupture due to fatigue [14].

Figure 8 shows how abrasion can wear down the external sheath and some of the tensile wires risking the entire pipeline to rupture. Figure 9 is an example of how tensile wires can rupture due to fatigue, this time near the end fitting.

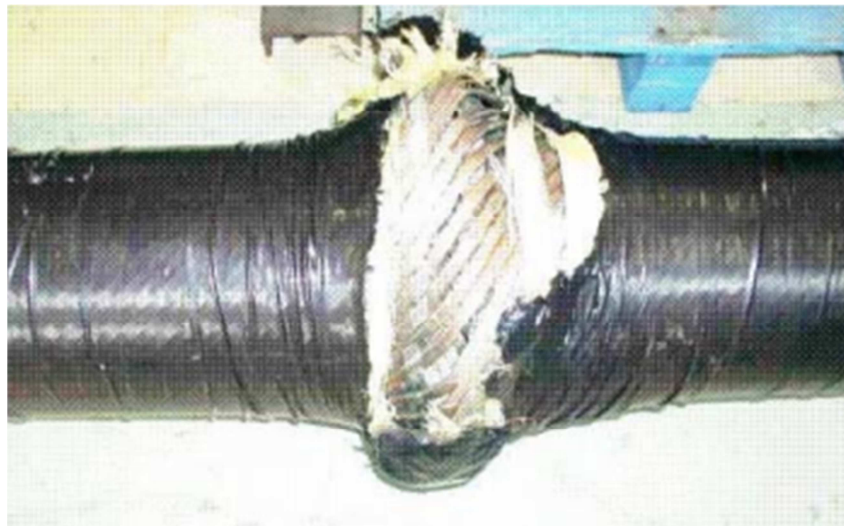
Figure 11 - Example of birdcaging [23].

From SureFlex' incident report we see that birdcaging is a failure to be aware of, with 5% of the reported incidents worldwide (2010) being categorised as bird caging. Also overbending and upheaval buckling are represented on the incident chart, both being a result of compressive forces (among other reasons). Figure 11 shows a small example of birdcaging.

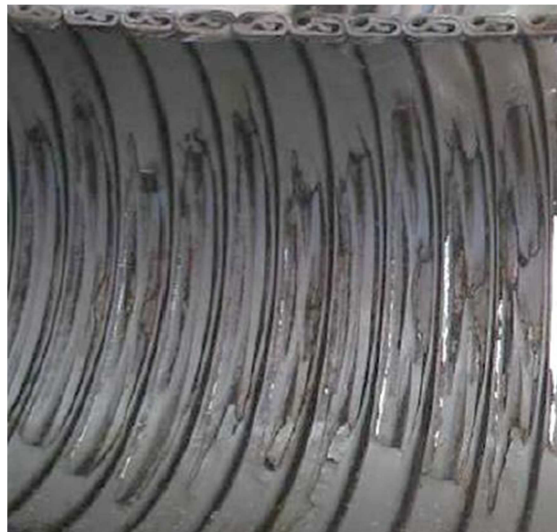
Figure 13 - Internal erosion of carcass [1].

Erosion alone does not usually cause failure of the pipe, but the erosion process wears down the corrosion protecting layer of the internal carcass wall. If erosion and corrosion act together the thinning of the carcass may be sufficient enough to cause collapse or rupture. Figure 13 shows an example of internal erosion of a carcass.

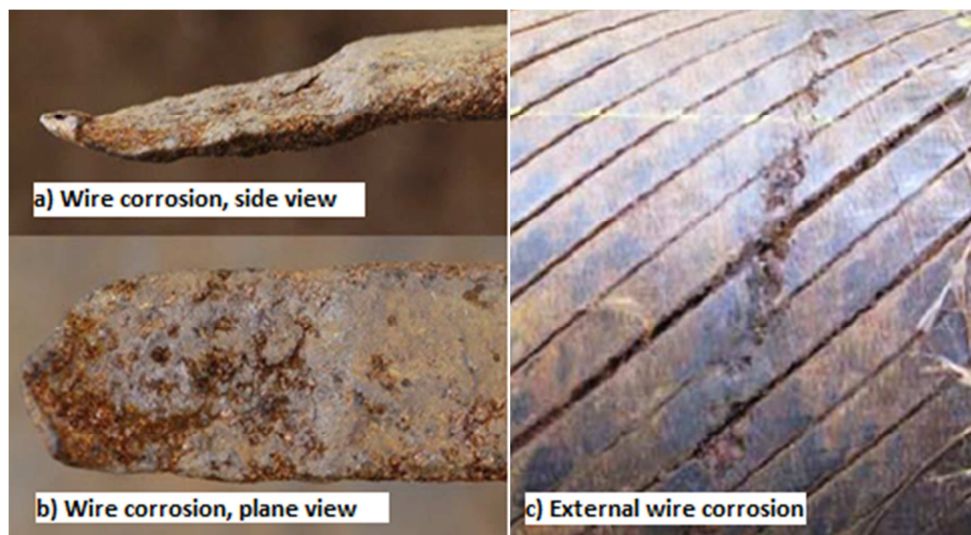
Figure 14 - Corroded tensile armour wires due to breach of outer sheath [1].

Corrosion is not by itself a normal cause to pipe failure, but together with high loadings or fatigue loads this is a serious threat of integrity. Figure 14 shows two different cases of corrosion of the tensile armour wires. Figure 14 a) and b) presents a fully corroded single tensile armour wire, while c) presents local corrosion on multiple tensile armour wires.

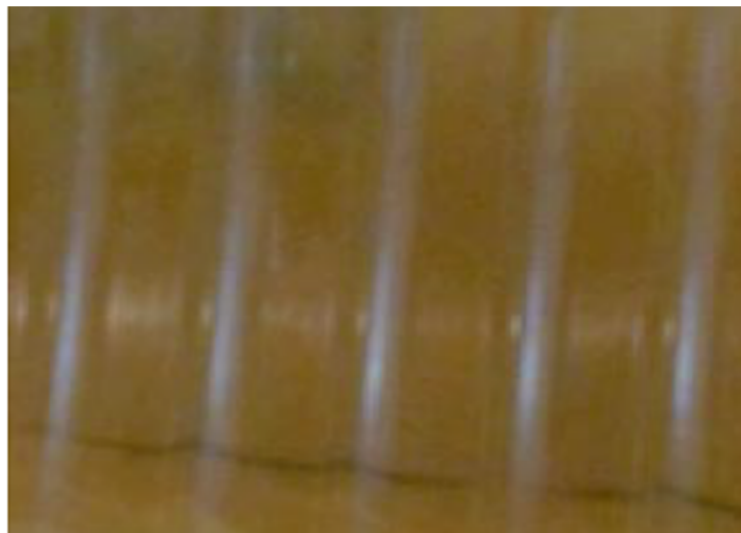
Figure 15 – Example of internal pressure sheath cracking [1].

The use of polymer sheaths in flexible pipelines is one of the elements that make this technology possible. Without these materials the pipeline would not be able to contain the produced hydrocarbons or keep the seawater out of the pipe annulus. However the materials used have very different properties compared to steel. One of the consequences of the different properties is the increase or decrease in volume. For example the expansion coefficient for some polymer materials are more than 10 times higher than steel. For rapid cool down of pipelines, i.e. installation and shut-down scenarios, this causes the polymer sheaths to reduce in volume much faster than steel. This can result in large stresses in the pressure sheath that can cause cracks or transfer the loads to the carcass, and in worst case cause carcass collapse or end fitting pull-out.

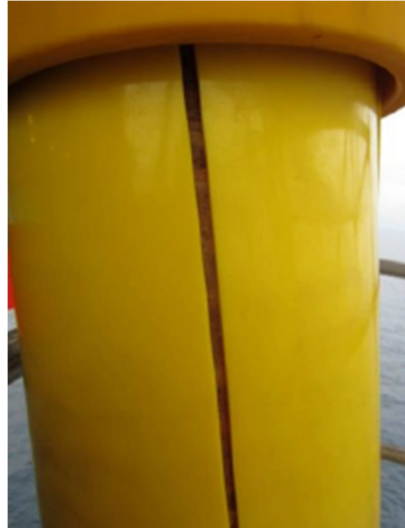
Figure 16 – Example of outer sheath cracking [1].

To give the polymer layers its flexibility they contain an additive called plasticiser. When in contact with production fluids this additive will migrate out of the polymeric sheath causing it to reduce in volume and become more brittle. Figure 15 shows the cracking of the internal pressure sheath. Figure 16 shows cracking of the outer sheath.

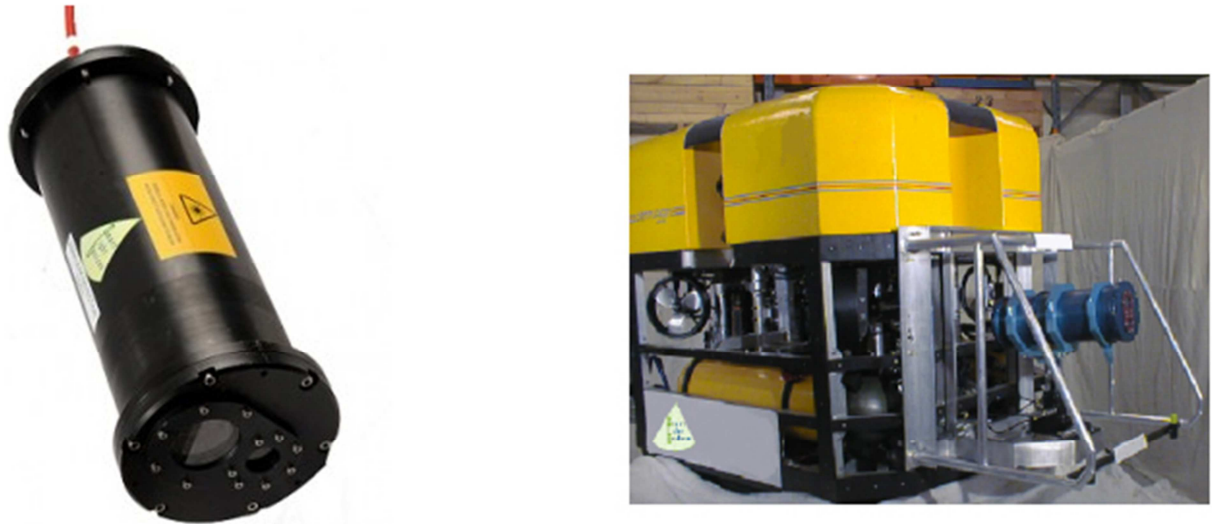
Figure 18 - Laser leak detection device - Smart Light Devices [26].

Laser leak detection is an optical leak detection tool that emits a high intensity light or laser to detect emission of fluids from pipelines, risers or other subsea modules. The wavelength of the light is tuned so that it is reflected of a certain substance of interest, for example hydrocarbons, hydraulic fluids or specially developed injection dyes. The reflected light is detected by an intelligent camera, and the system is connected in real time to a computer located on the intervention vessel/host facility. Software is developed to analyse the data and sound an alarm when a leak is detected. The injection dye may be injected into the object that is being inspected (e.g. a water injection pipe) to give a clear result.

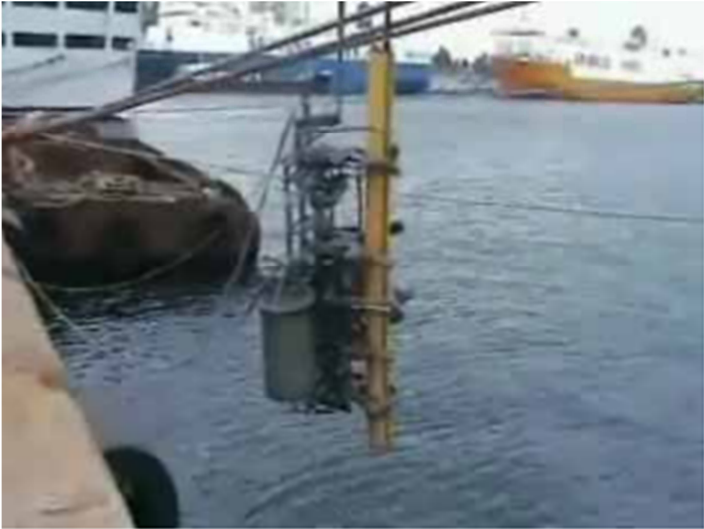
Figure 20 - Robot crawler with DR inspection tool [28].

the basics of DR together with specially developed algorithms for digital recognition. The system uses an external gamma ray source and an opposite positioned digital flat panel used for detection. Images that are detected on the flat panel are sent to a computer topside via an umbilical. The software developed for this system will filter out the most valuable images to be inspected and highlight anomalies such as unlocking of pressure armour, wire cracking, breaking and buckling and reduction of wall thickness (due to corrosion or erosion). The condition of the internal pressure sheath can to an extent also be inspected through radiographic images. The inspection system is mounted onto a robot crawler (see Figure 20), which can be attached to the riser either above or below the splash zone.

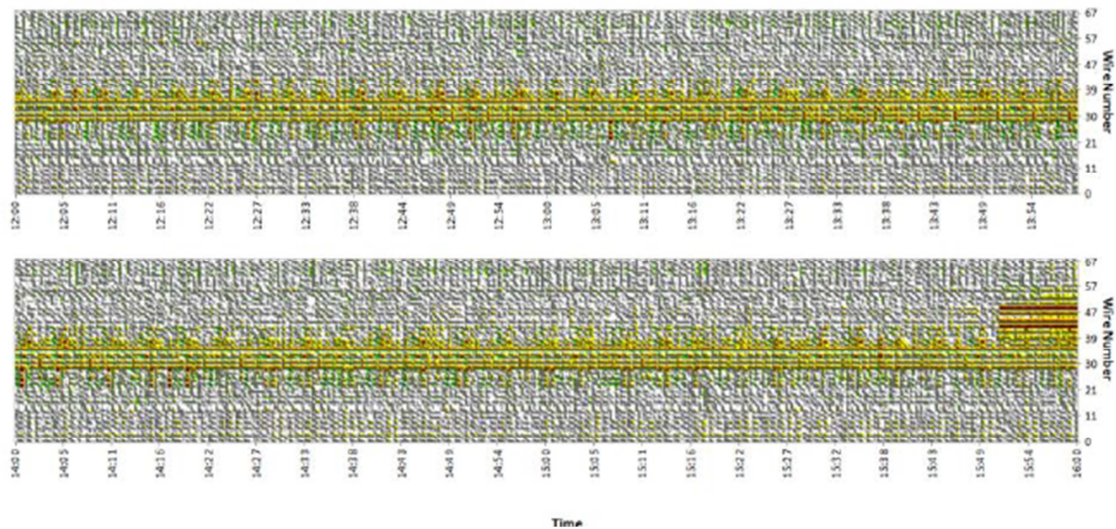
Figure 27 - Results of the stress test done by MAPS prototype in 2011 [15].

Prototypes of the system have been designed with emphasis on standard components used in the offshore sector and tested in laboratory and on a full scale riser (ref. [12, 15]). Though these tests verify that armour wire breakage can be determined with this system there are several difficulties that still has to be looked into. Mechanical hardness, grain size, texture and other material properties affects the magnetic parameters, along with movement of the armour wires this causes distortions in the measurements done. To cope with problems like this testing with different frequencies are done to recognise and determine the results. A software is designed to manage the frequencies and to give an interface where the results can be displayed.

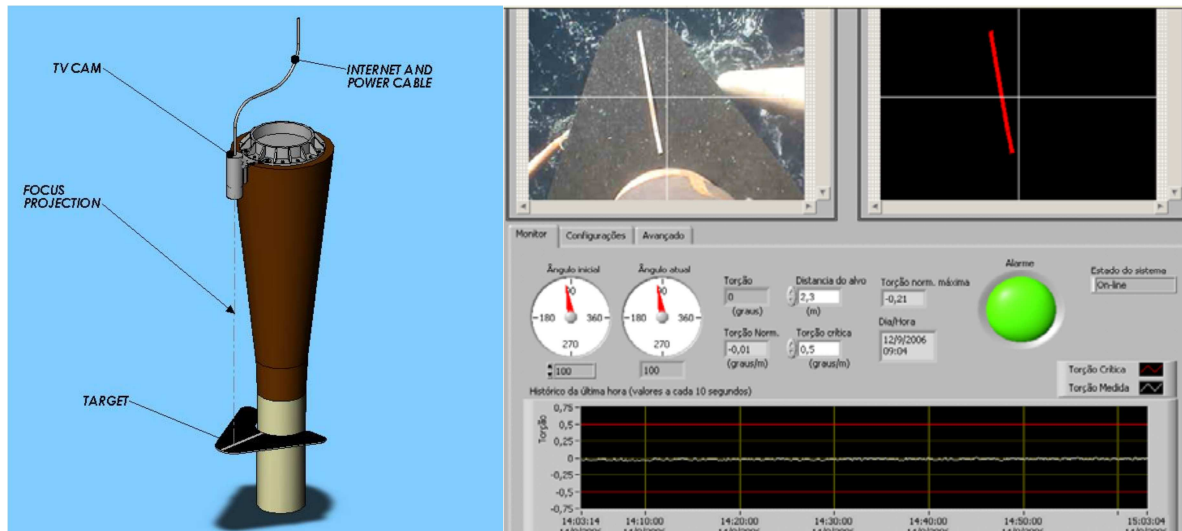
Figure 28 - Torsion monitoring configuration and monitoring software interface [14].

Another a bit more advanced method is the torsion monitoring method using a fixed camera directed to a fixed plate with a clear straight line painted on it. The camera is installed over the end fitting and the target plate is installed on the riser a distance below the bend restrictor. The video signal is digitalised and sent to a computer where the angle deformation can be measured with a precision of 0.3 degrees. The supporting software gives a continuous digital feed and the video is recorded to monitor historical movement for a defined period.

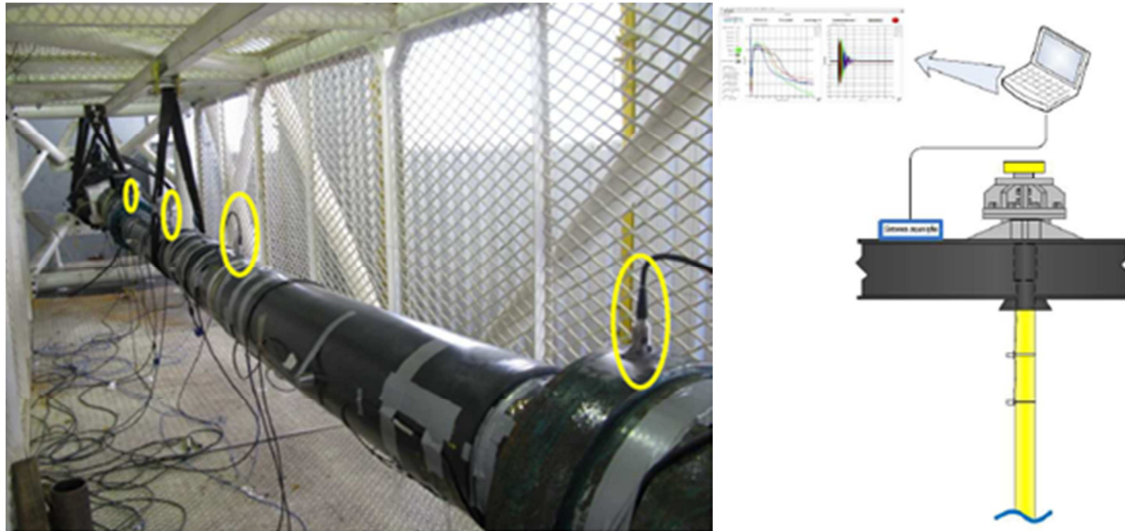
Figure 34 - Vibration monitoring laboratory test and field configuration [5].

Petrobras has performed a laboratory test (ref. [5]) comprising a flexible riser segment with 6” internal diameter. Four separate accelerometers was mounted onto the riser, two on the external sheath and two on the end fittings, the test setup is shown in Figure 34. The system has not yet been field proven, and there are some questions around the distortion of the signals in an operational environment.
