MASTER THESIS

Walkability along the Bussvei

WALKABILITY ALONG THE BUSSVEI

Perspectives from the stretch in Mariero, Stavanger

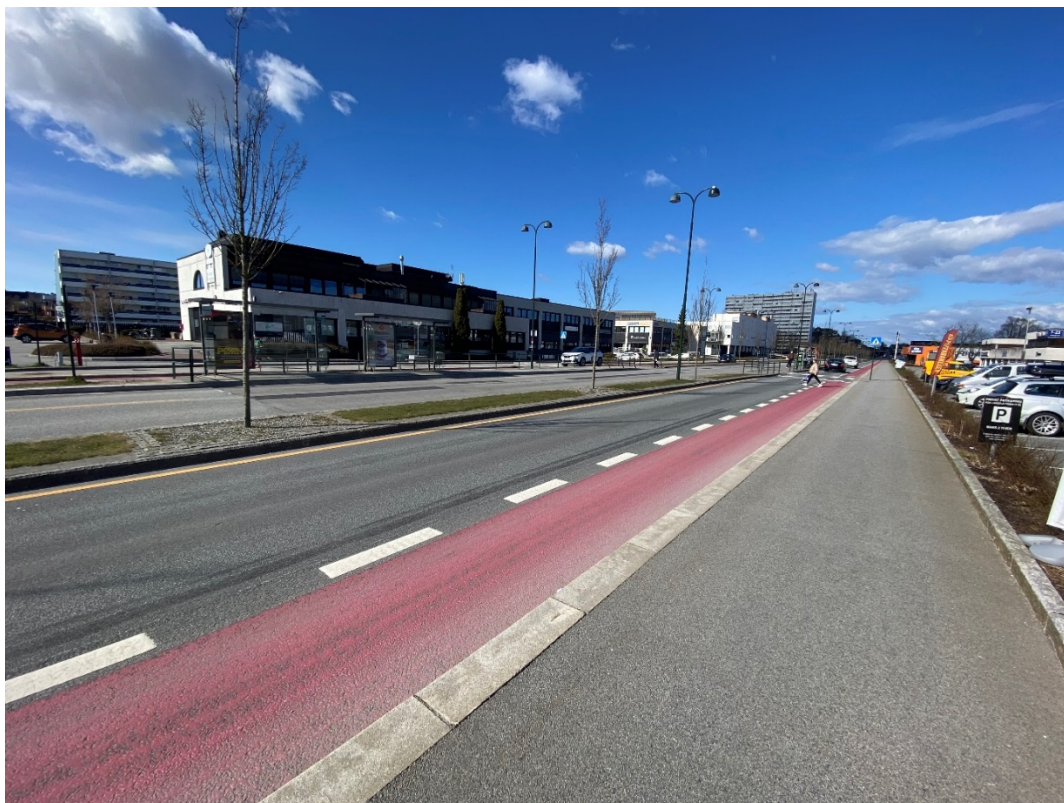
Picture 1: Urbanscape observed by Mariero, in Stavanger. Photo by Vieira (2021c).

Implied by the criticism over the Bussvei and the potential to deteriorate the urban landscape where it crosses, this thesis copes with the attempt to study how people use and experiences the urban structures that make up the Bussvei. These structures (e.g., sidewalks, crossings, bus stops, underpasses) serve those who are going to access or leave the public transport and people who cross the area by walk. Picture 1 shows the urbanscape of the Bussvei in Mariero. That stretch of the Bussvei consists of central lanes exclusive to bus traffic. Trees, light poles, and bus stops lie in intermediate areas between bus and common traffic lanes. Cycling lanes were delimited between common traffic lanes and sidewalks. Through this picture, one can reflect if the features of this urbanscape looks attractive for pedestrians.

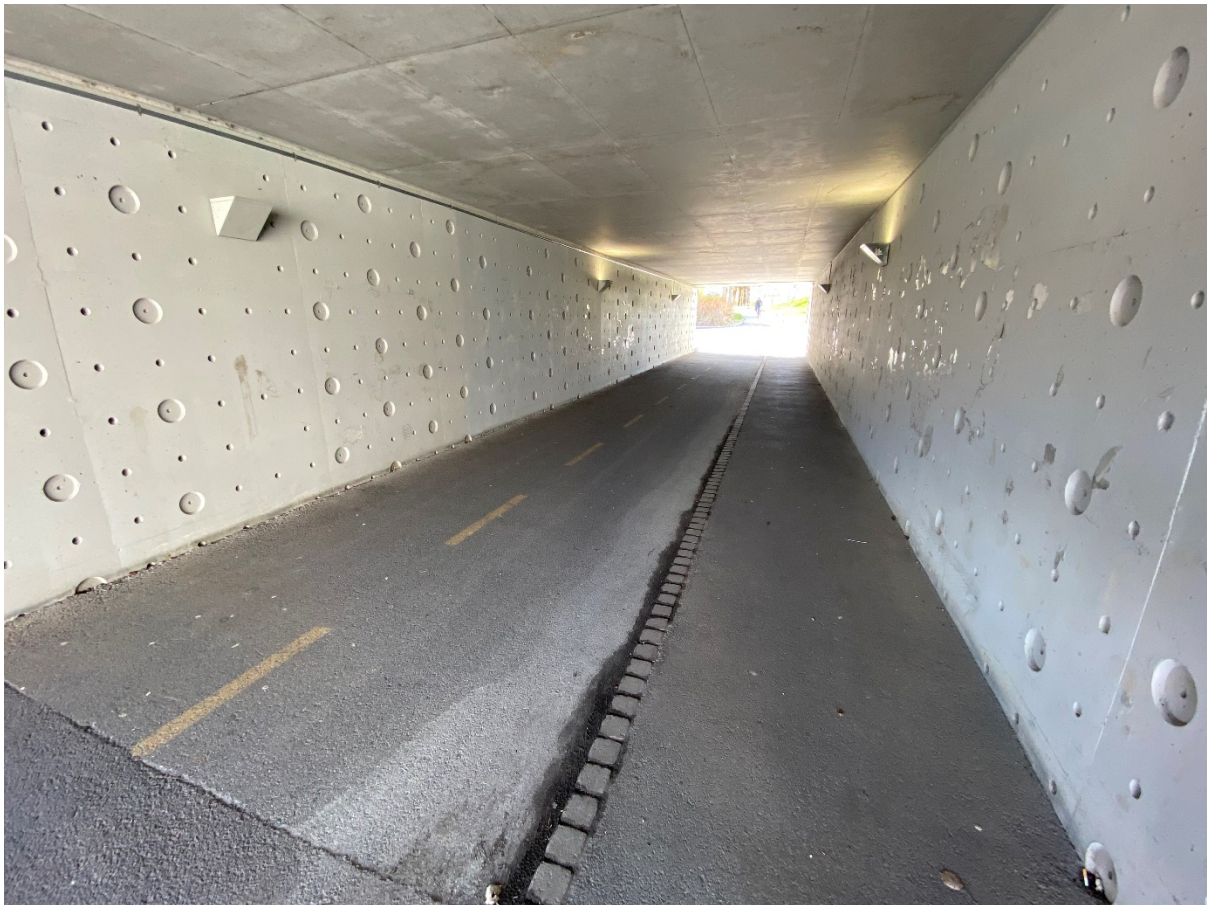
Picture 2: Interior of Eikeberg underpass. Photo by Vieira (2021c).

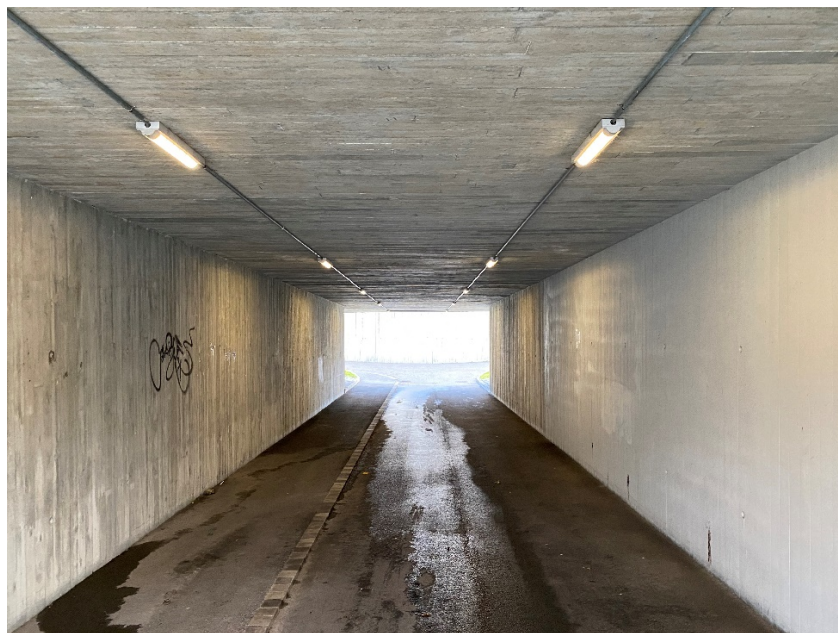
Picture 3: View of the interior of the underpass near the Mariero bus stop. Photo by Vieira (2021c).

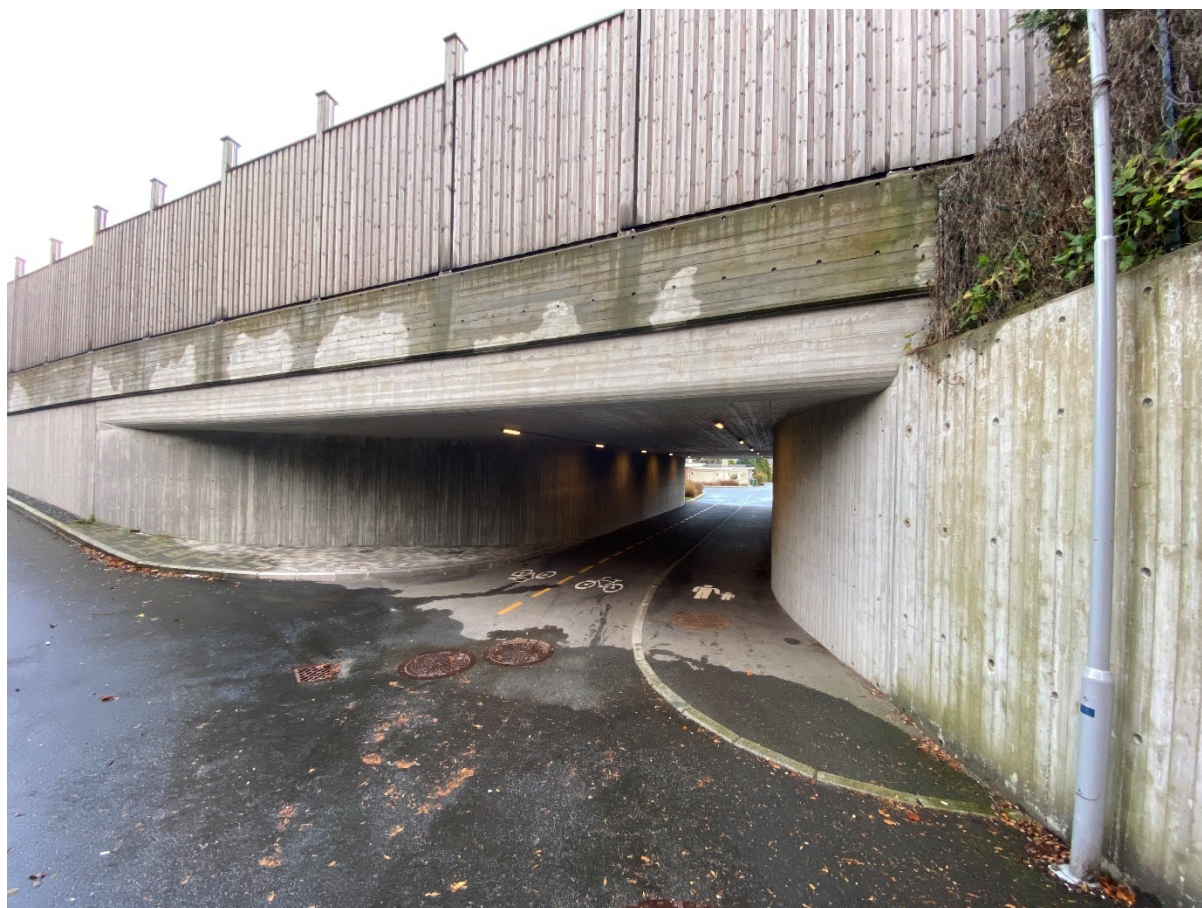
Picture 4: Internal aspect of Lyngnesveien underpass. Photo by Vieira (2021c).

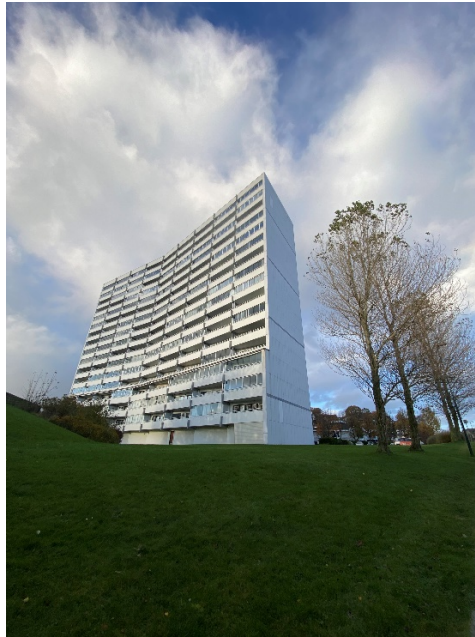
Picture 5: Gullaksveien 2 building near Eikeberg bus stop, the highest structure within the study area. Photo by Vieira (2021c)

Figure 18 shows the Floor Area Ratio of Mariero. Where it is possible to see that enclosure is not much of a problem in Mariero. The sole building that reaches 70 m is the residential Gullaksveien 2 (Picture 5). However, it results in a low floor area ratio as most of the property is covered by a lawn. The other buildings have few floors and therefore do not feel tight enclosures.

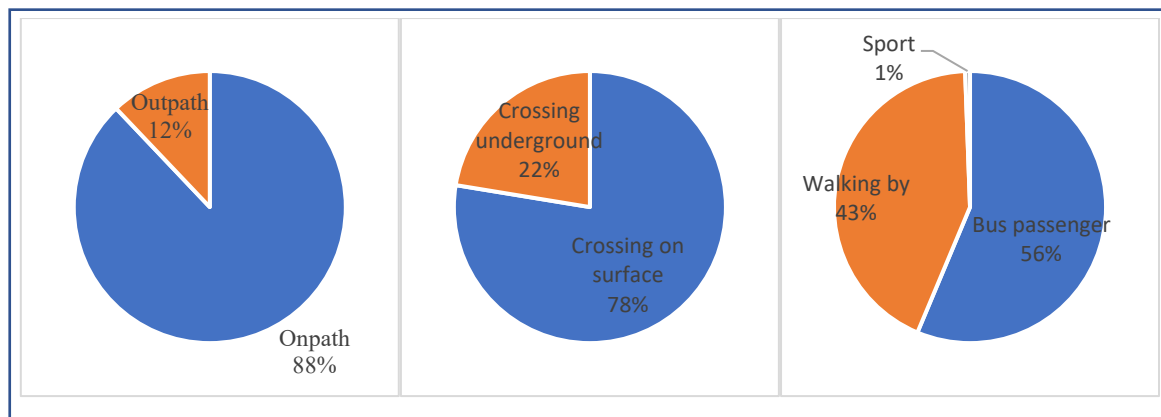
Figure 22: Profile of pedestrian usage of Bussvei pedestrian structures near Mariero.

Figure 22 shows the profile established by analyzing other data gathered during the mapping at the Mariero bus stop. 88% of pedestrians near the Mariero bus stop used the structures developed to them, and 12% crossed outside zebra crossings. Among those crossing the Marieroveien, 78% crossed on the surface and 22% using the underpass, the lowest percentage of all the three bus stops. This result, in particular, is not surprising given the unattractive aspects of the underpass near the Mariero bus stop. 56% of the pedestrians observed near the Mariero bus stop were in the area as a part of their public transportation travel. Moreover, 43% of pedestrians observed in this area were walking by, perhaps due to the concentration of shops and services near the Mariero bus stop. Only 1% were observed jogging.

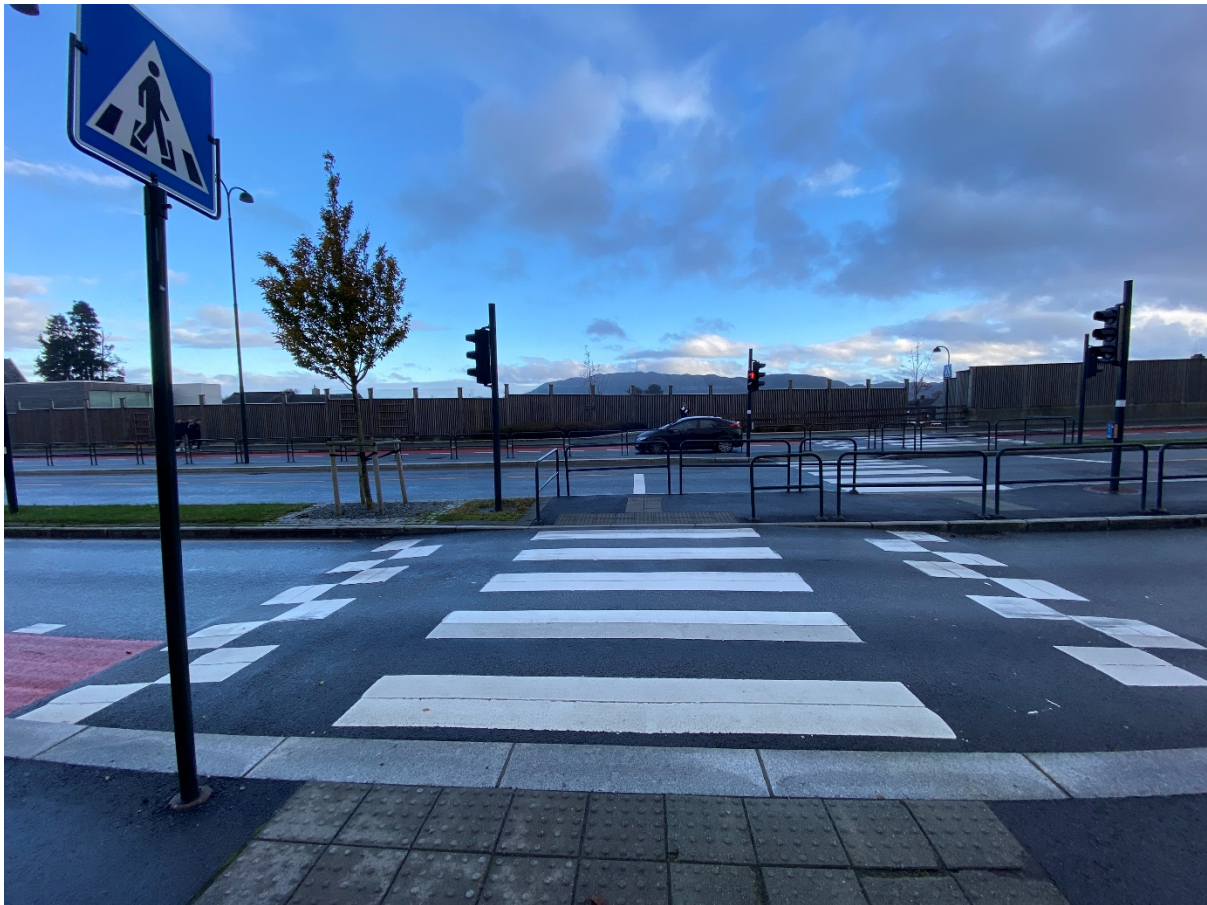
Picture 6: Zebra-crossing near the Lyngnesveien bus stop. Photo by Vieira (2021).

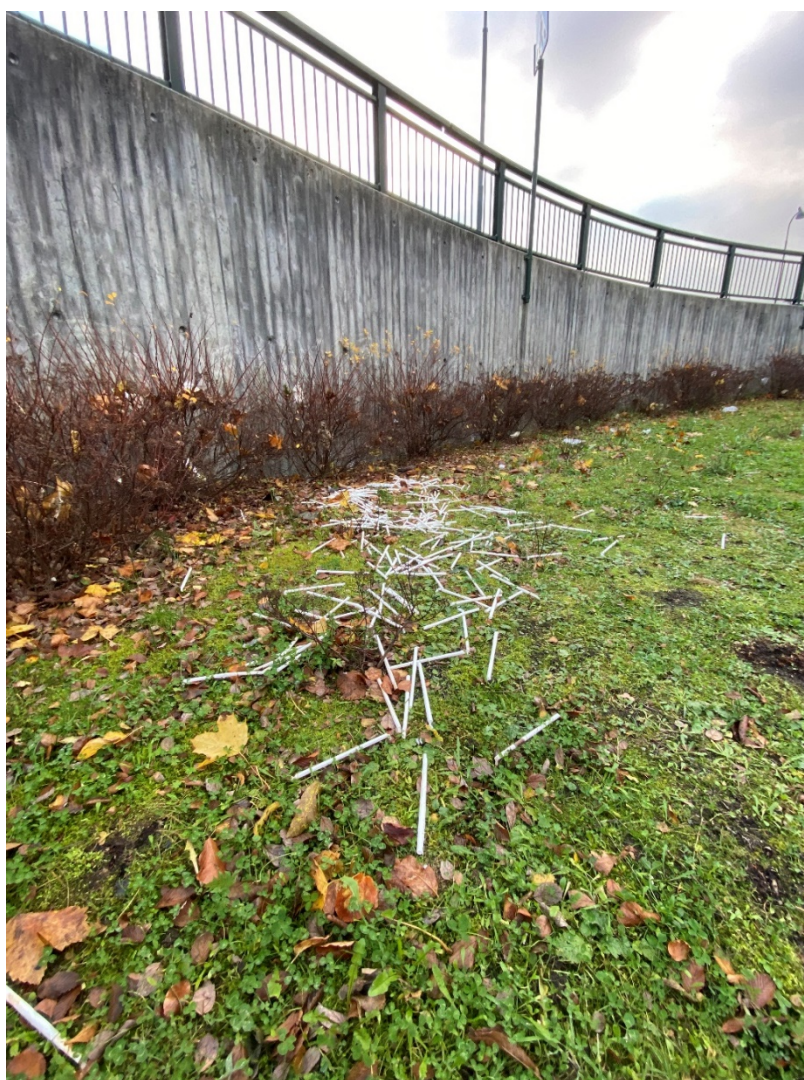
Picture 7: Disposable straws lying in a green corner of Mariero underpass. Photo by Vieira (2021c).

The underpasses, as predicted through the work of Hass-Klau (2015), are indeed problematic in the study area. The one built near the bus stop of Mariero is steep over the recommended by the guidelines of Statens Vegvesen (2019). Also, the green corners of this specific underpass are often filled with garbage (Picture 3), which confers very low quality to the urban landscape.

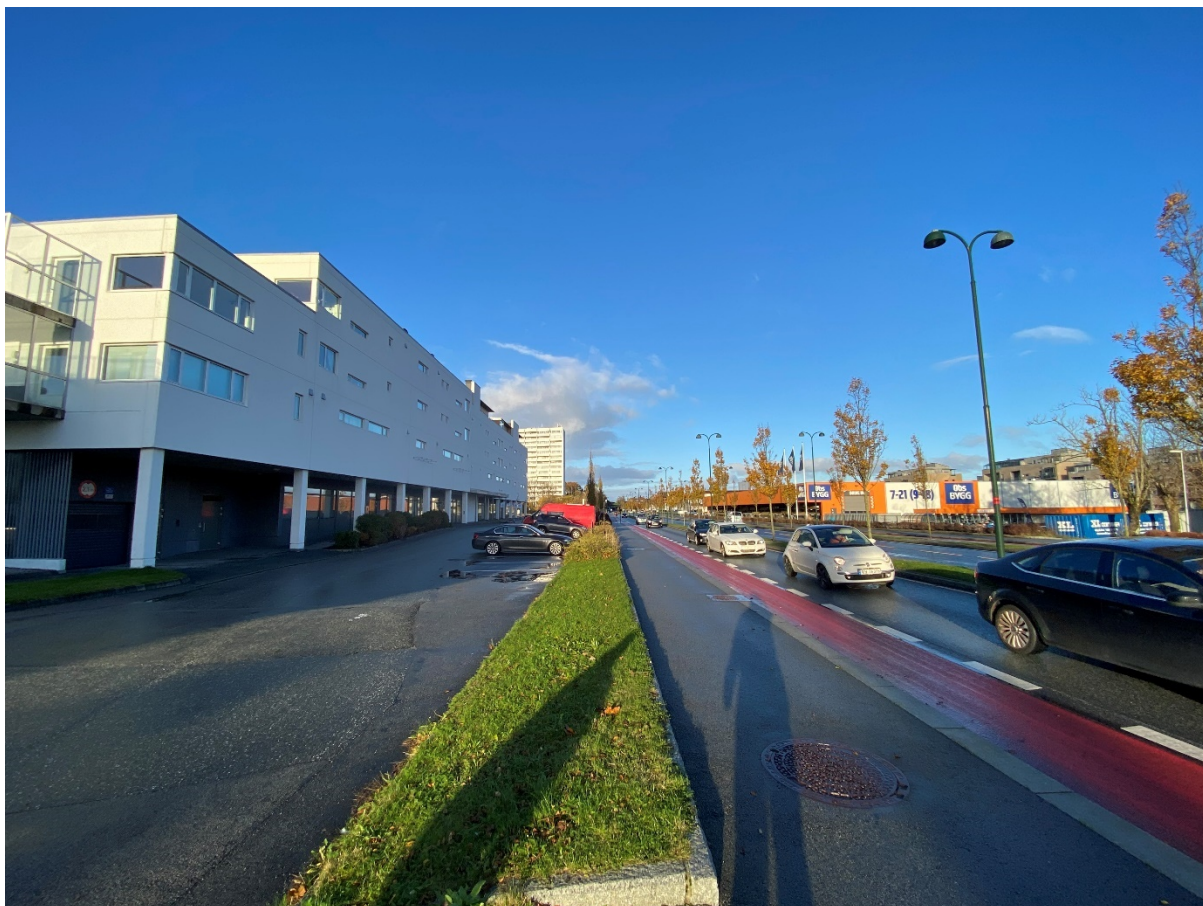
Picture 8: Parking lots and inactive façades near Mariero bus stop. Photo by Vieira (2021c).

In addition to the large offer of parking places, the façades lying behind them are not attractive either. They do not expose products that pedestrians would like to browse and look. They can be made by glass, but often covered with sticks. Picture 4 show an example of a building with inactive façade with parking lots in front of them.

Other element that is present in very low abundance on Picture 4 is trees and bushes near the sidewalk. Only a narrow strip of lawn exists, separating public (sidewalk) and private spaces (parking lot). Perhaps this frontal parking lots could give place to more trees to improve the aesthetic aspect of Mariero, besides serving as abatement for traffic noise and contribute to the carbon balance. Figure 15 shows that more parking lots exist behind these buildings, which can compensate the loss of the parking possibilities by Marieroveien.

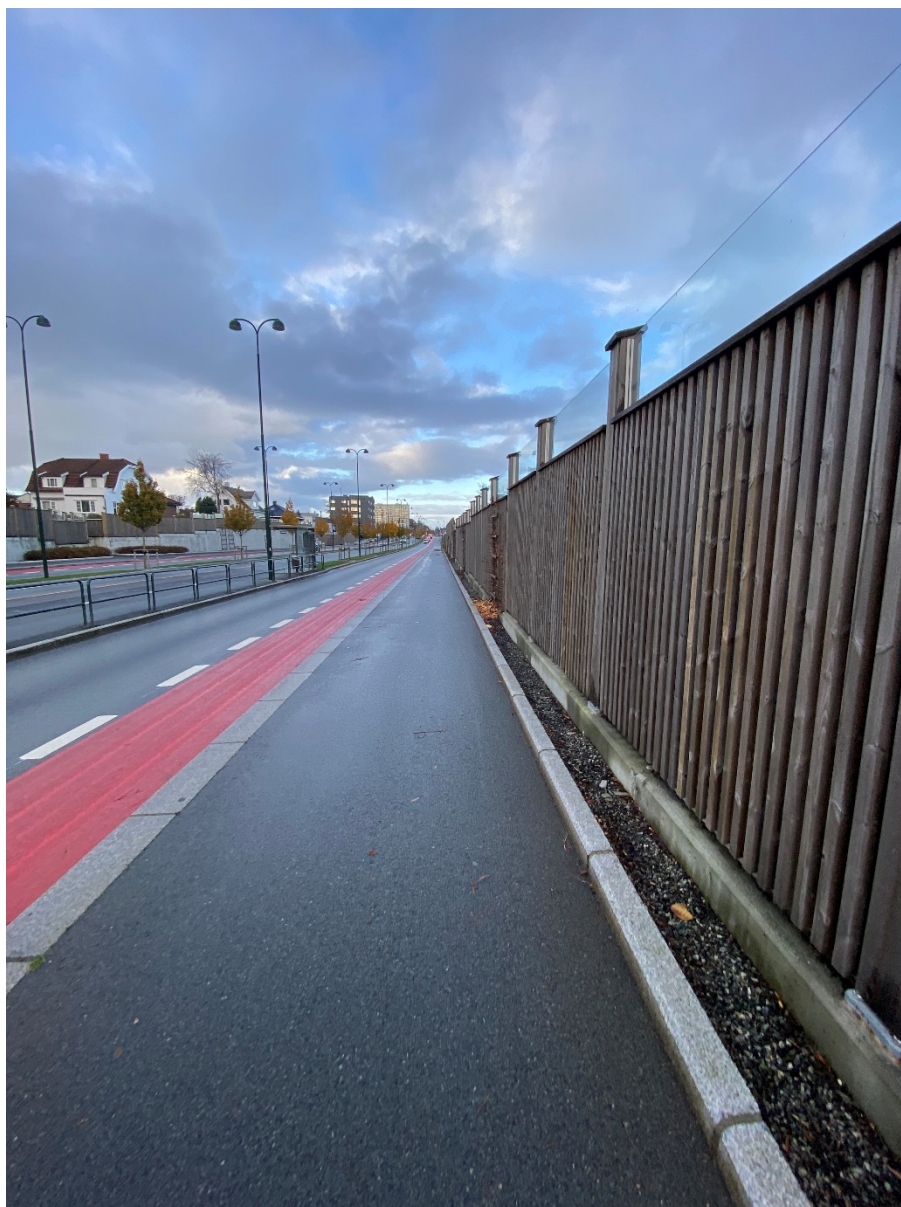
Picture 9: Noise abatements near Lyngnesveien bus stop. Vieira (2021c)

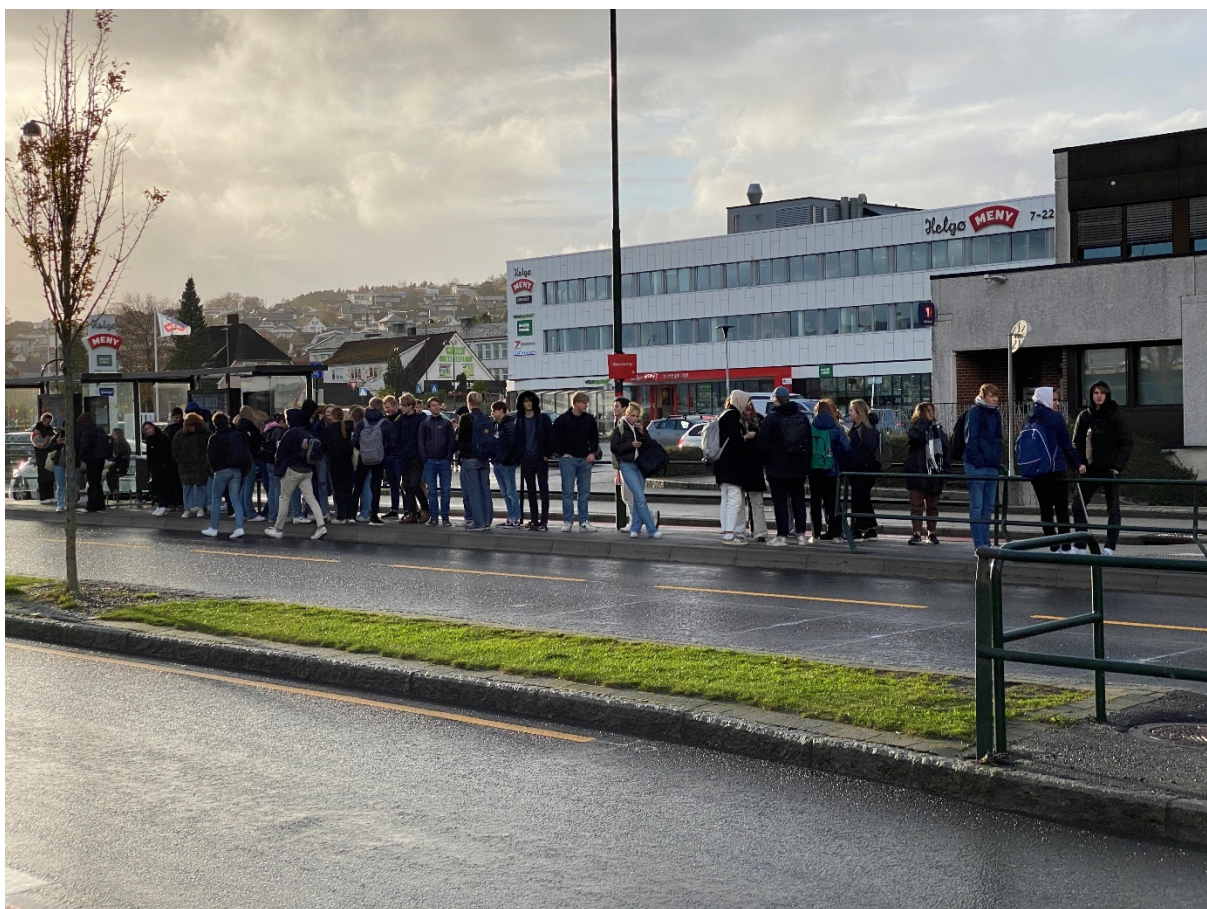
Picture 10: Overcrowding of Mariero bus stop in the afternoon. Photo by Vieira (2021c).
