MASTER'S THESIS

(Writer's signature)
Faculty supervisor: Professor Srividya Ajit, UiS External supervisor(s): Kenneth Olsen, Statoil ASA	
Thesis title: Non-Intrusive Inspection (NII) of pressure vessels	
Credits (ECTS): 30	
Key words: Non-Intrusive Inspection analysis Decision process Corrosion Risk Assessment Inspection plan Cost benefit analysis Offshore Survey	Pages: 48 + enclosure: 51 Stavanger, 01.06/2015 Date/year

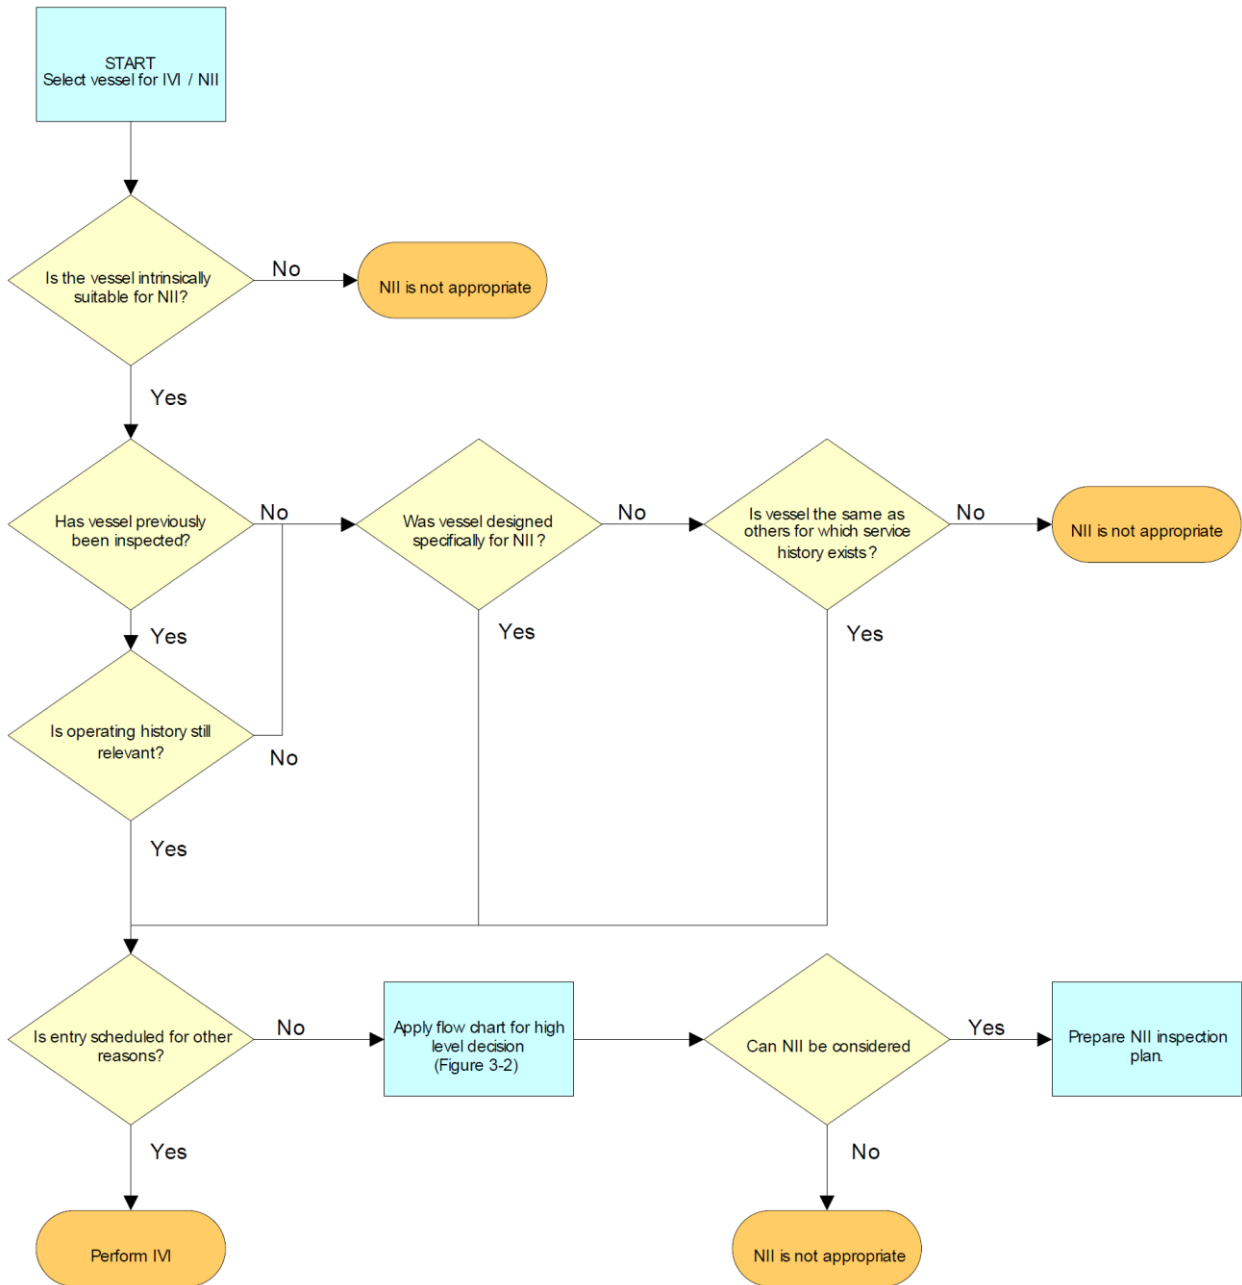
Figure 2-2: The NII preliminary screening procedure, where each questions answered leads to the final recommended decision (DNV, 2011).

The main purpose in this section is to rapidly identify which vessels that is not recommended, this could for example be due to that the vessel is not designed to perform NDT externally or it is not possible to attain the required information. The questions to be answered are shown in the flow diagram in Figure 2-2.

It is chosen to explain the definition of the first question “*Is the vessel intrinsically suitable for NII?*” It means that if there are any obstacles for the NII being performed. This may for example be; no access to surface, constraints in geometry, extremely high temperatures, or other relevant obstacles prohibiting the externally NDT. The rest of the questions answer themselves.

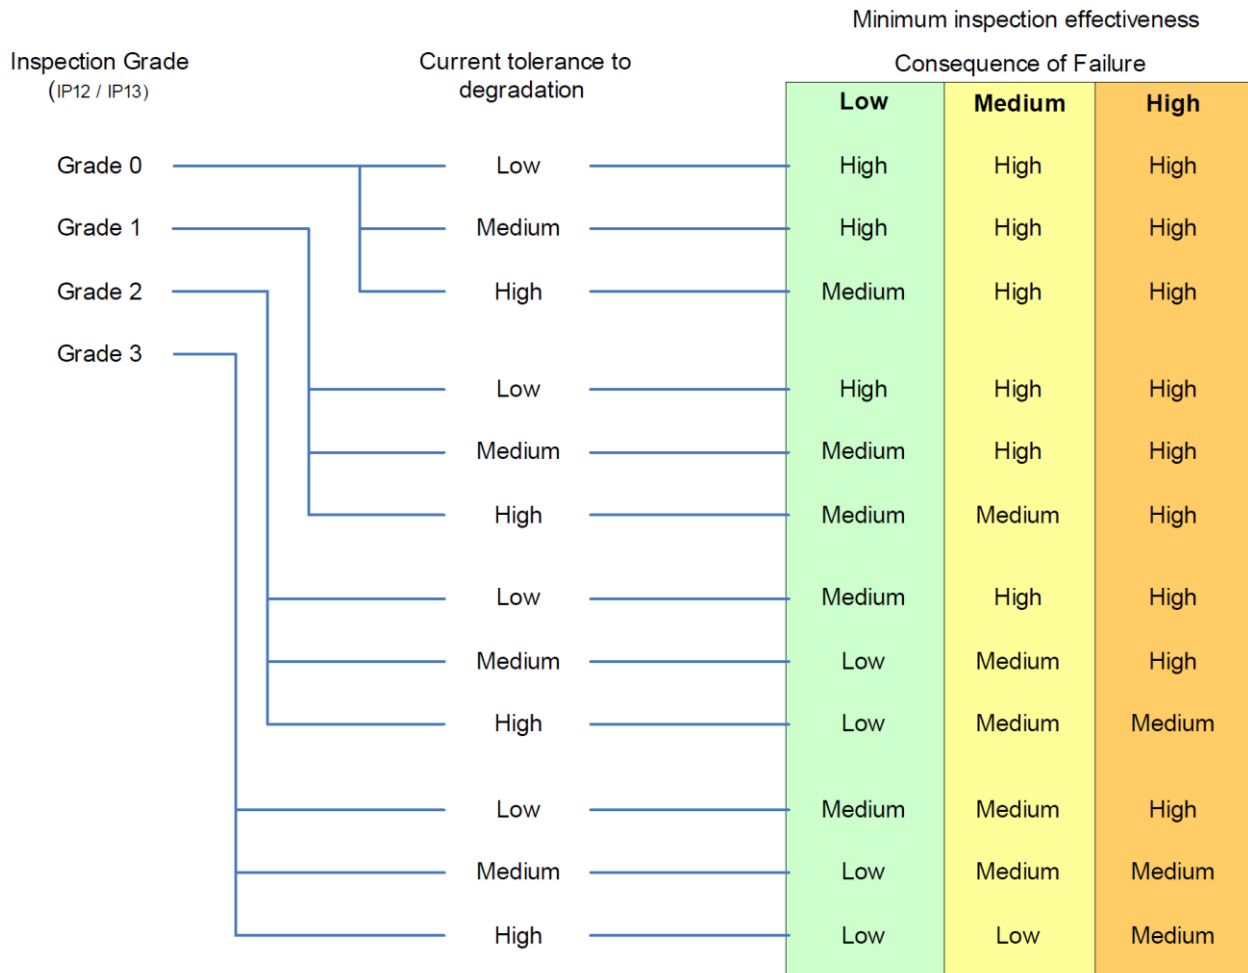
Figure 2-7: Inspection minimum effectiveness flow chart (DNV, 2011).

The flow chart provides the minimum required effectiveness for each zone, and the effectiveness is based on a qualitative measure of the probability of detecting flaws, including the coverage. The effectiveness is a function of the POD and coverage (Effectiveness=f(POD,xCoverage). There are given three categories, where high implies higher effectiveness than for IVI, medium similar to IVI, and low lower than IVI.

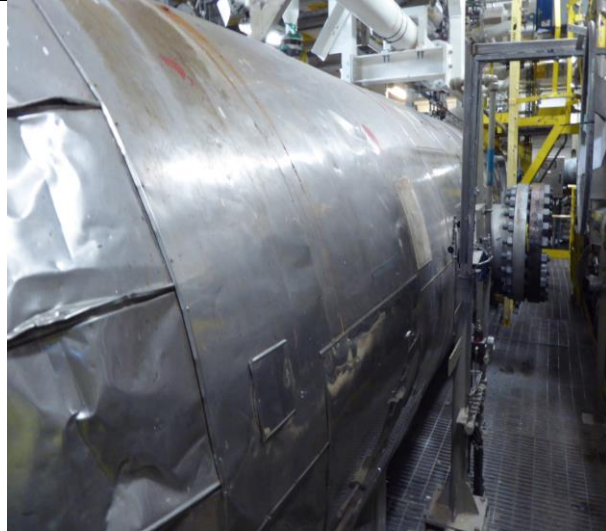
Picture 1. Separator insulated, picture taken from manhole side.

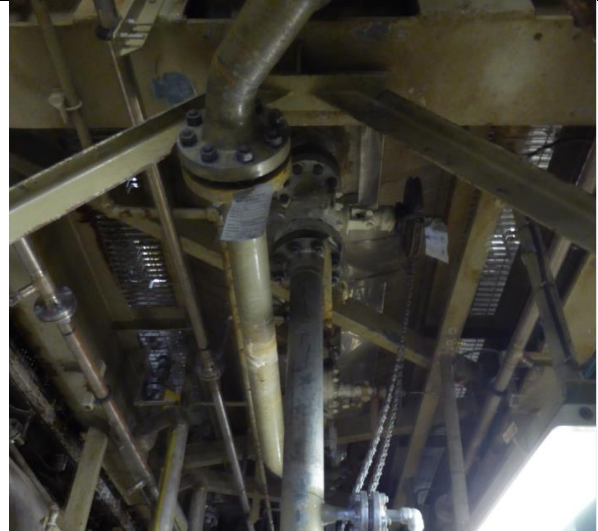
Picture 2. Separator insulated, picture taken from the bottom part. Lack of access due to supporting structure.

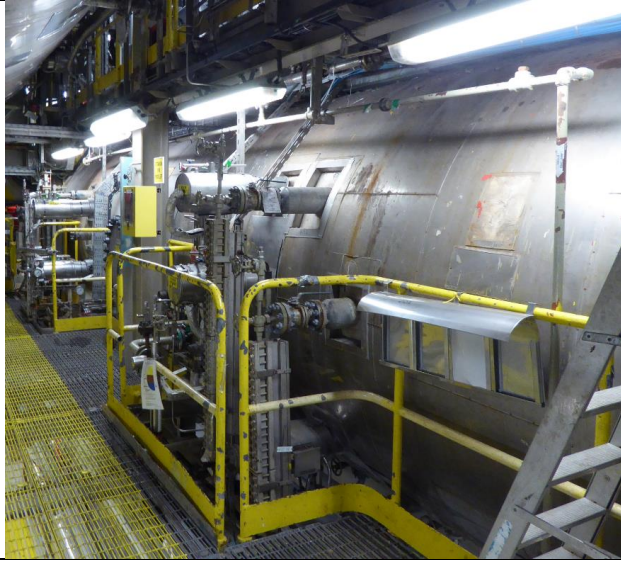
Picture 5. Separator insulated, picture taken from manhole side.

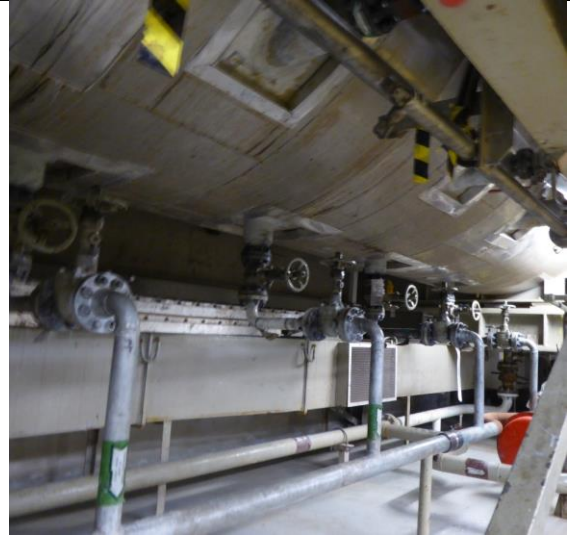
Picture 6. Separator insulated, picture taken from the bottom part. Easy access from floor.

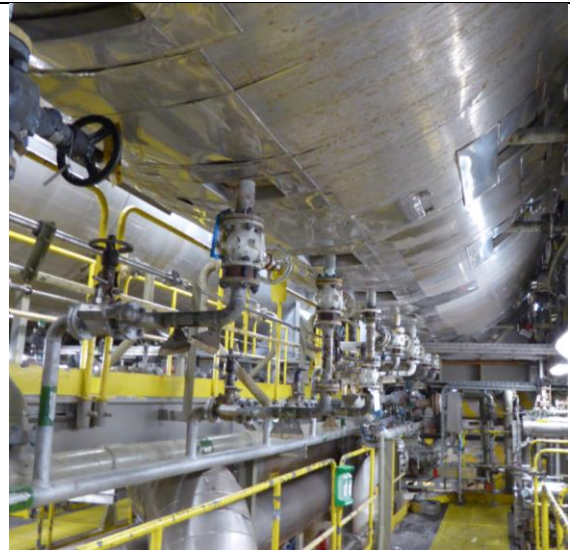
Picture 8. Separator insulated, picture taken from the bottom part. Easy access from deck.

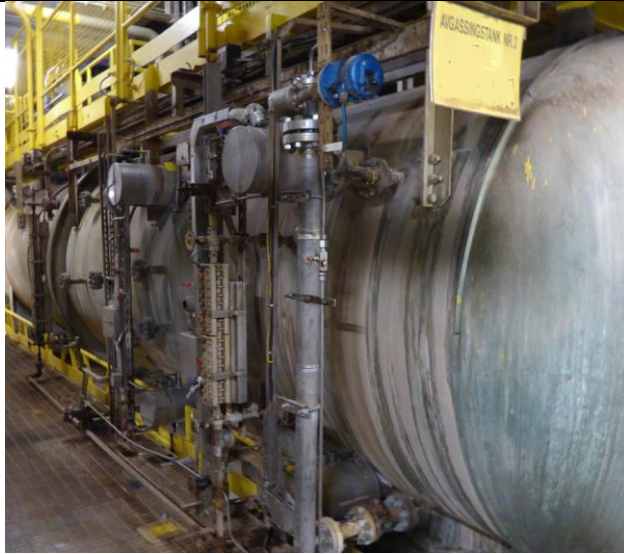
Picture 9. Separator not insulated, picture taken from manhole side.

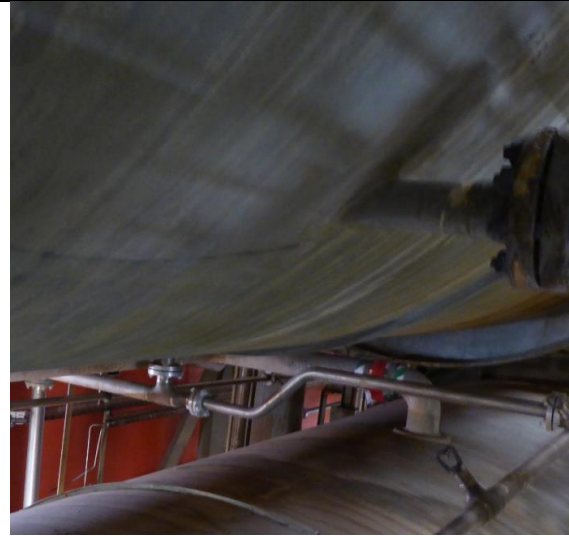
Picture 10. Separator not insulated, picture taken from the bottom part. Easy access from lower vessel.

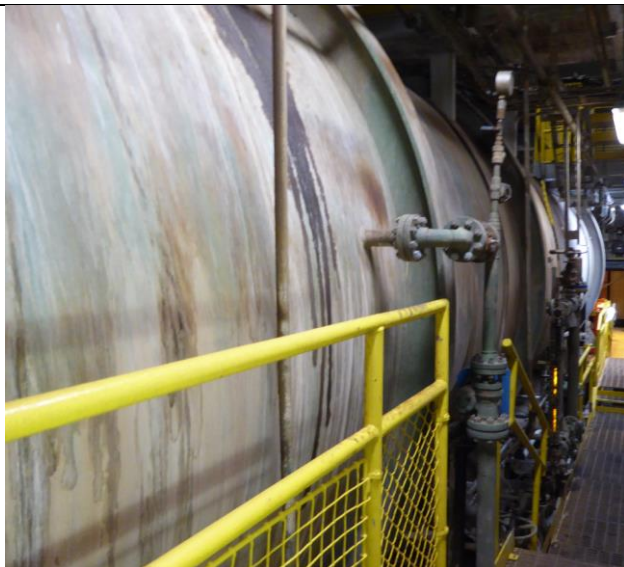
Picture 11. Vessel not insulated, picture taken from south side.

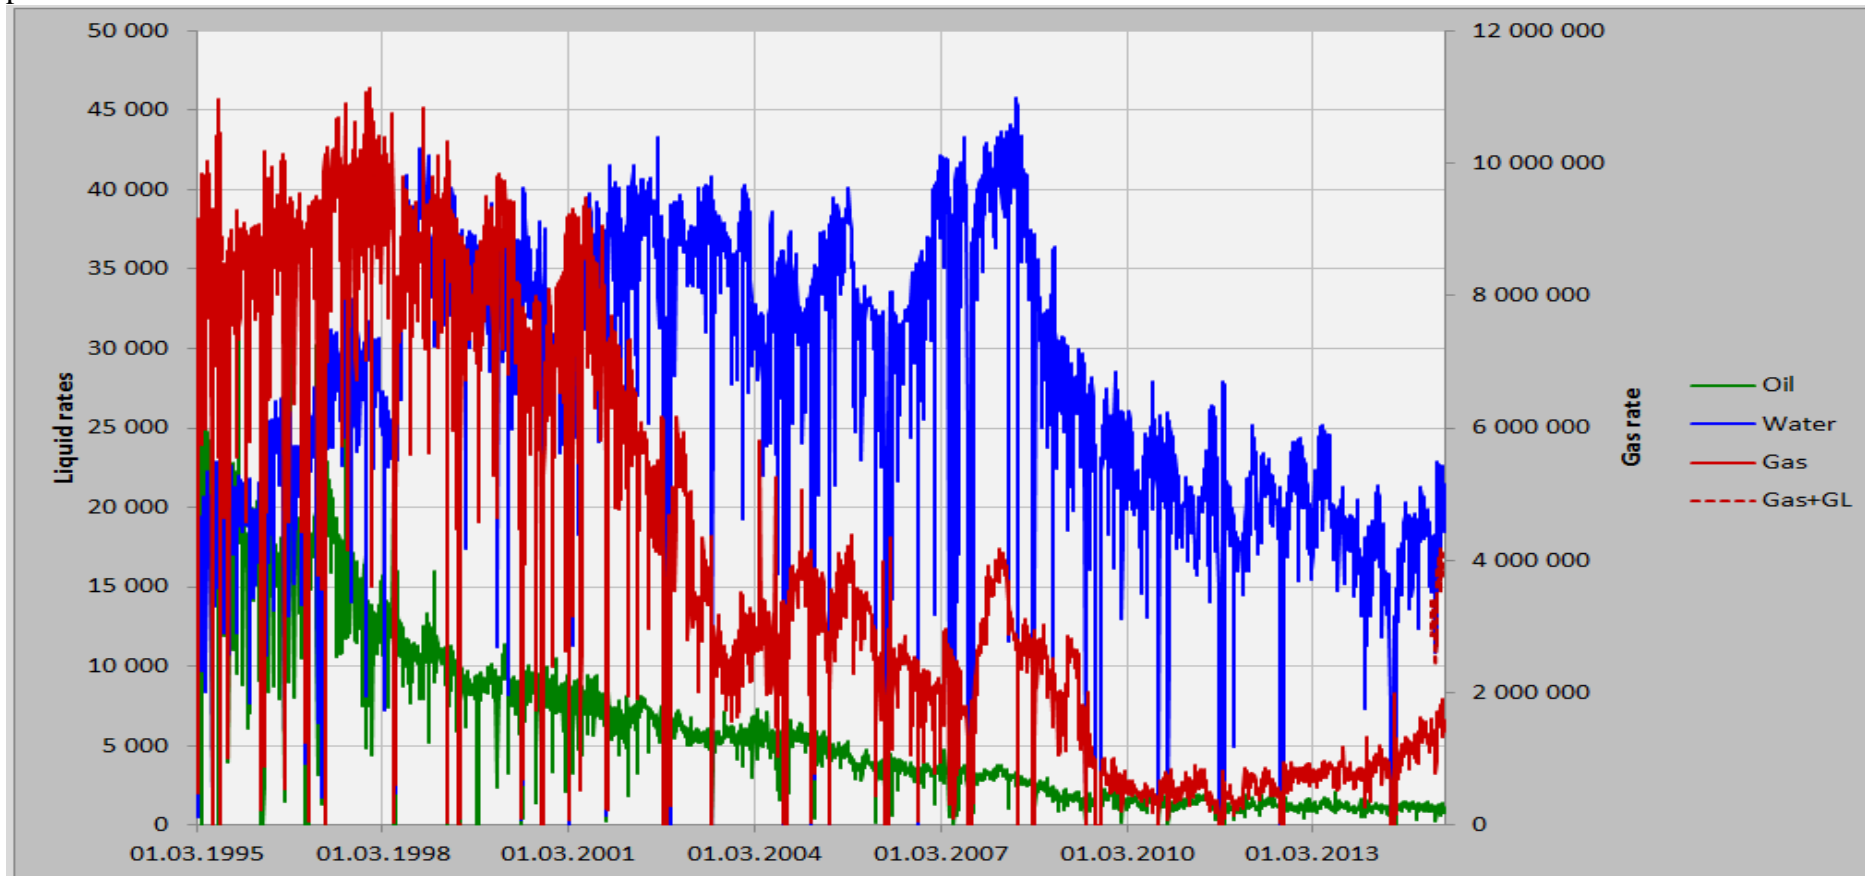
Chart C-1: Production profile since 1995 to 2014. Oil and gas production has decreased, and the water rate is dominating the total production (PI Processbook, 2015; Specialist 3, 2015).

The water level is at a peak now, and the prediction is that it should decrease in the future. The gas would increase until 2017/18, but due to limitations of the topside compressors it would be more or less constant gas production. The oil level is predicted to decrease each year, and drop to about no oil production at 2021.

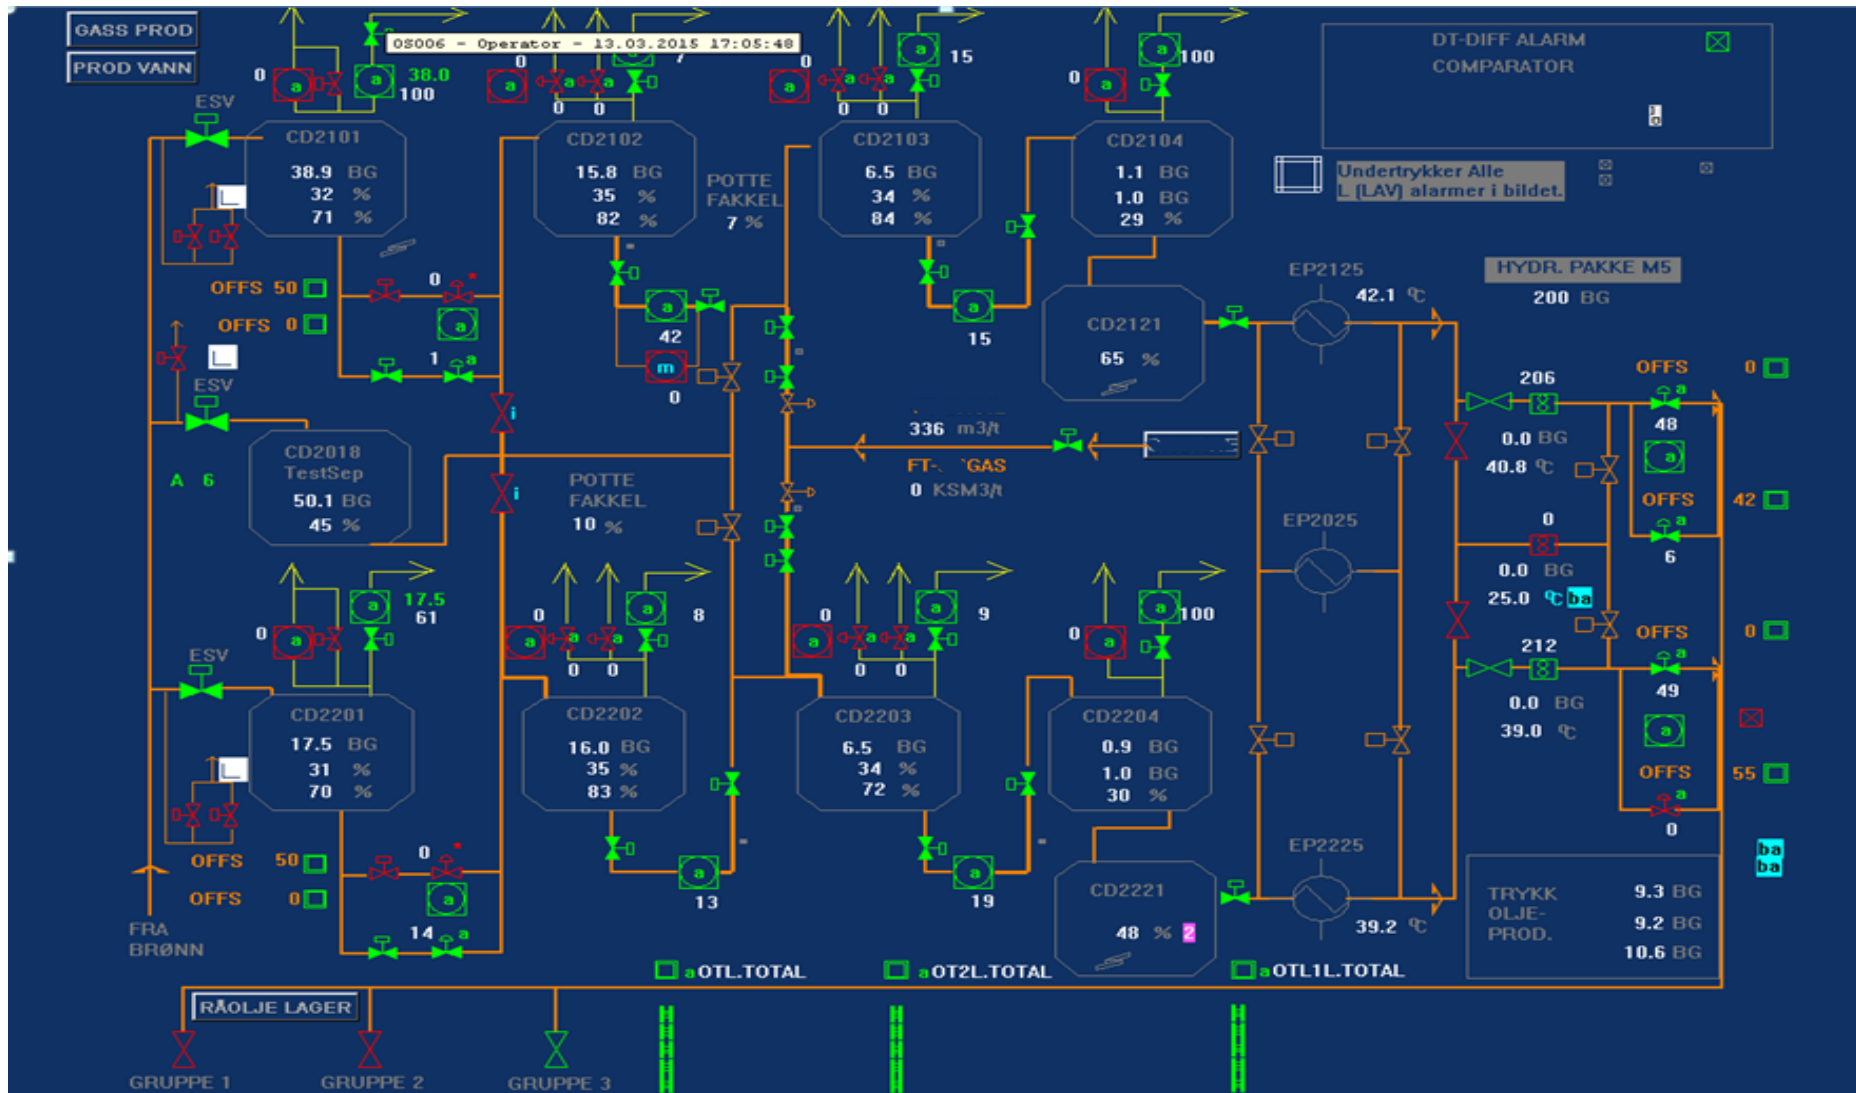
Chart C-2: Production layout. A snap shot of the oil and gas production system, which includes both separation trains (PI Processbook, 2015, Specialist 3, 2015).

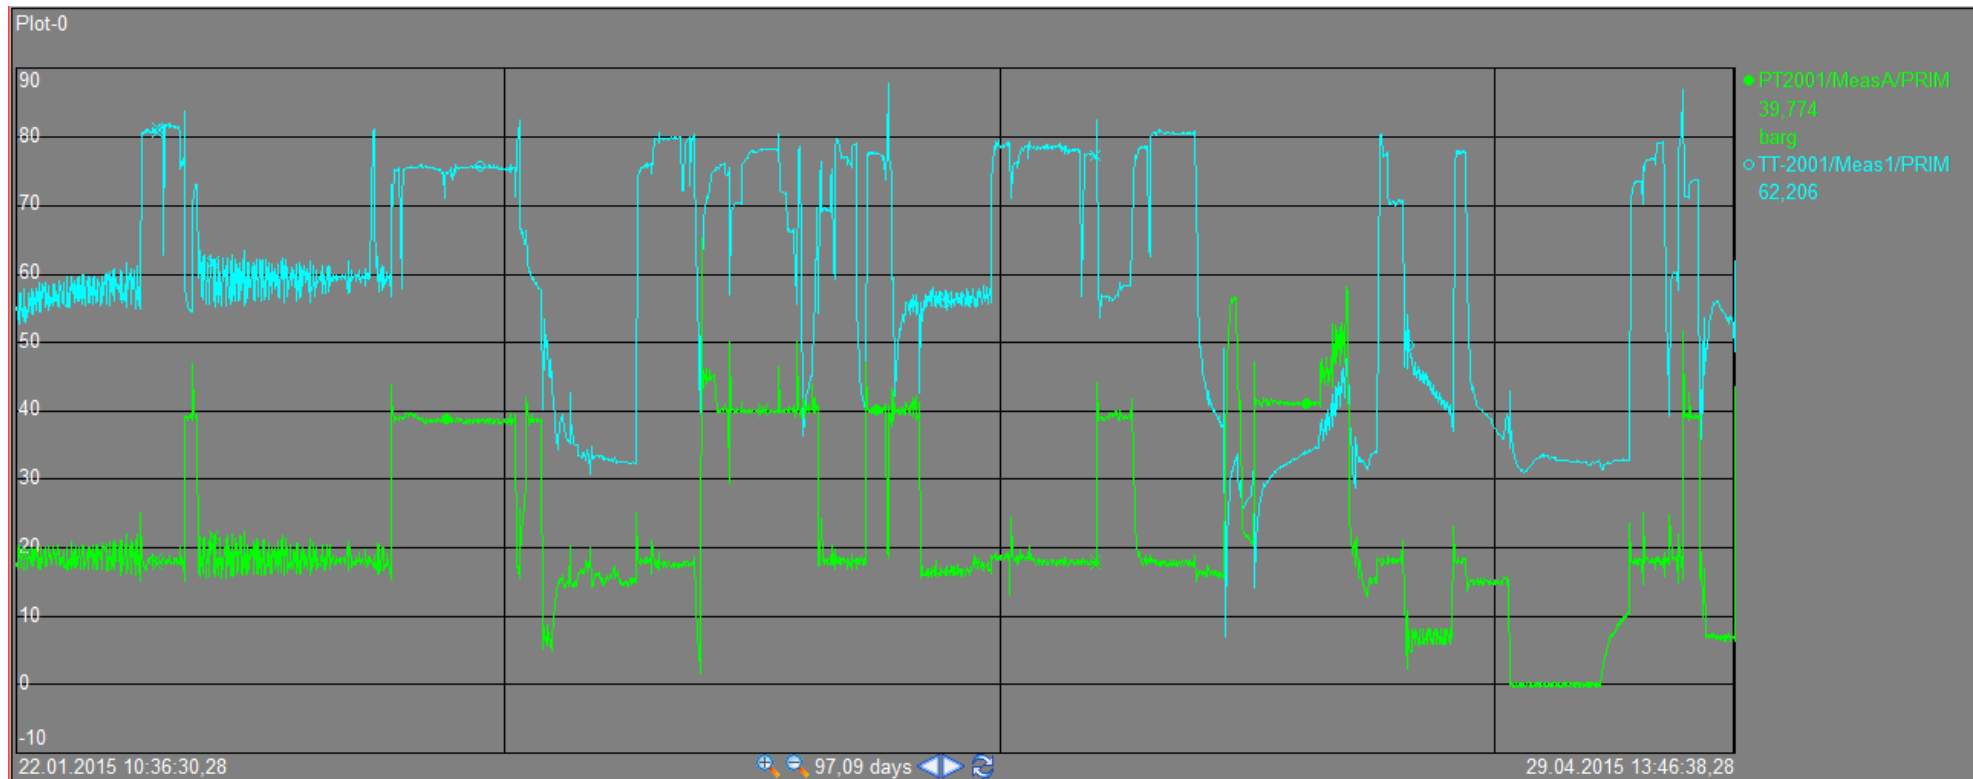
Chart C-3: Trending of the temperature and pressure in the test separator (CD2018) in a period of 97 days. The light blue line indicates the temperature in degrees of Celsius, and the green line the pressure in barg (PI Processbook, 2015).

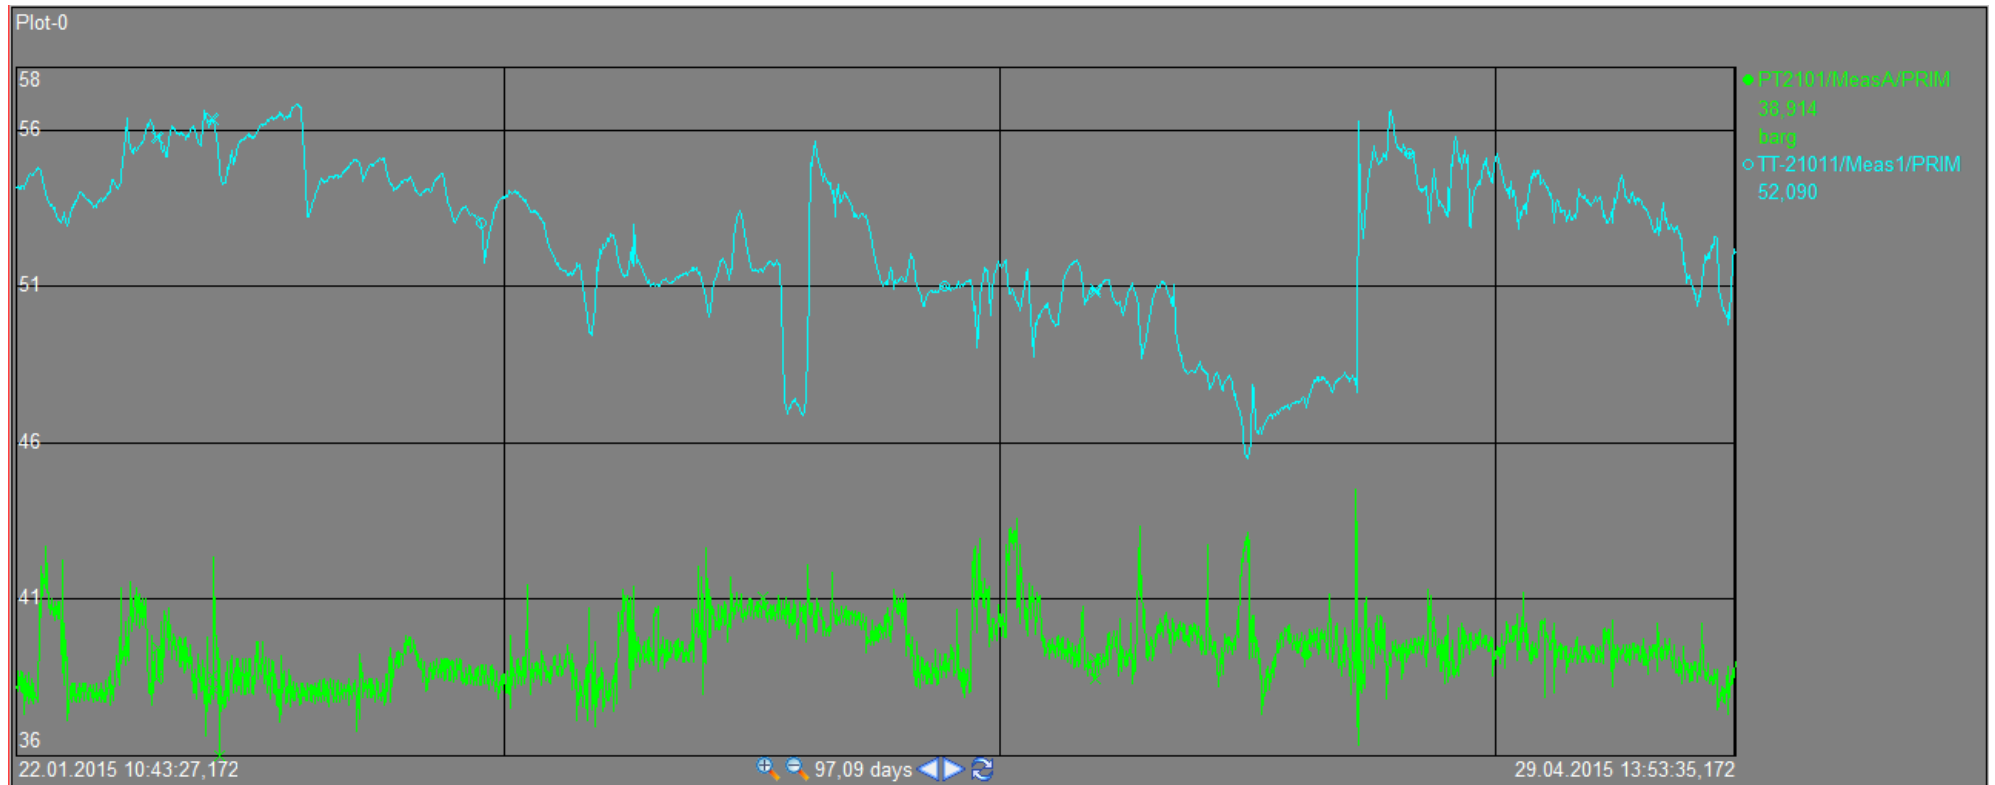
Chart C-4: Trending of the temperature and pressure in the inlet separator (CD2101) in a period of 97 days. The light blue line indicates the temperature in degrees of Celsius, and the green line the pressure in barg (PI Processbook, 2015).

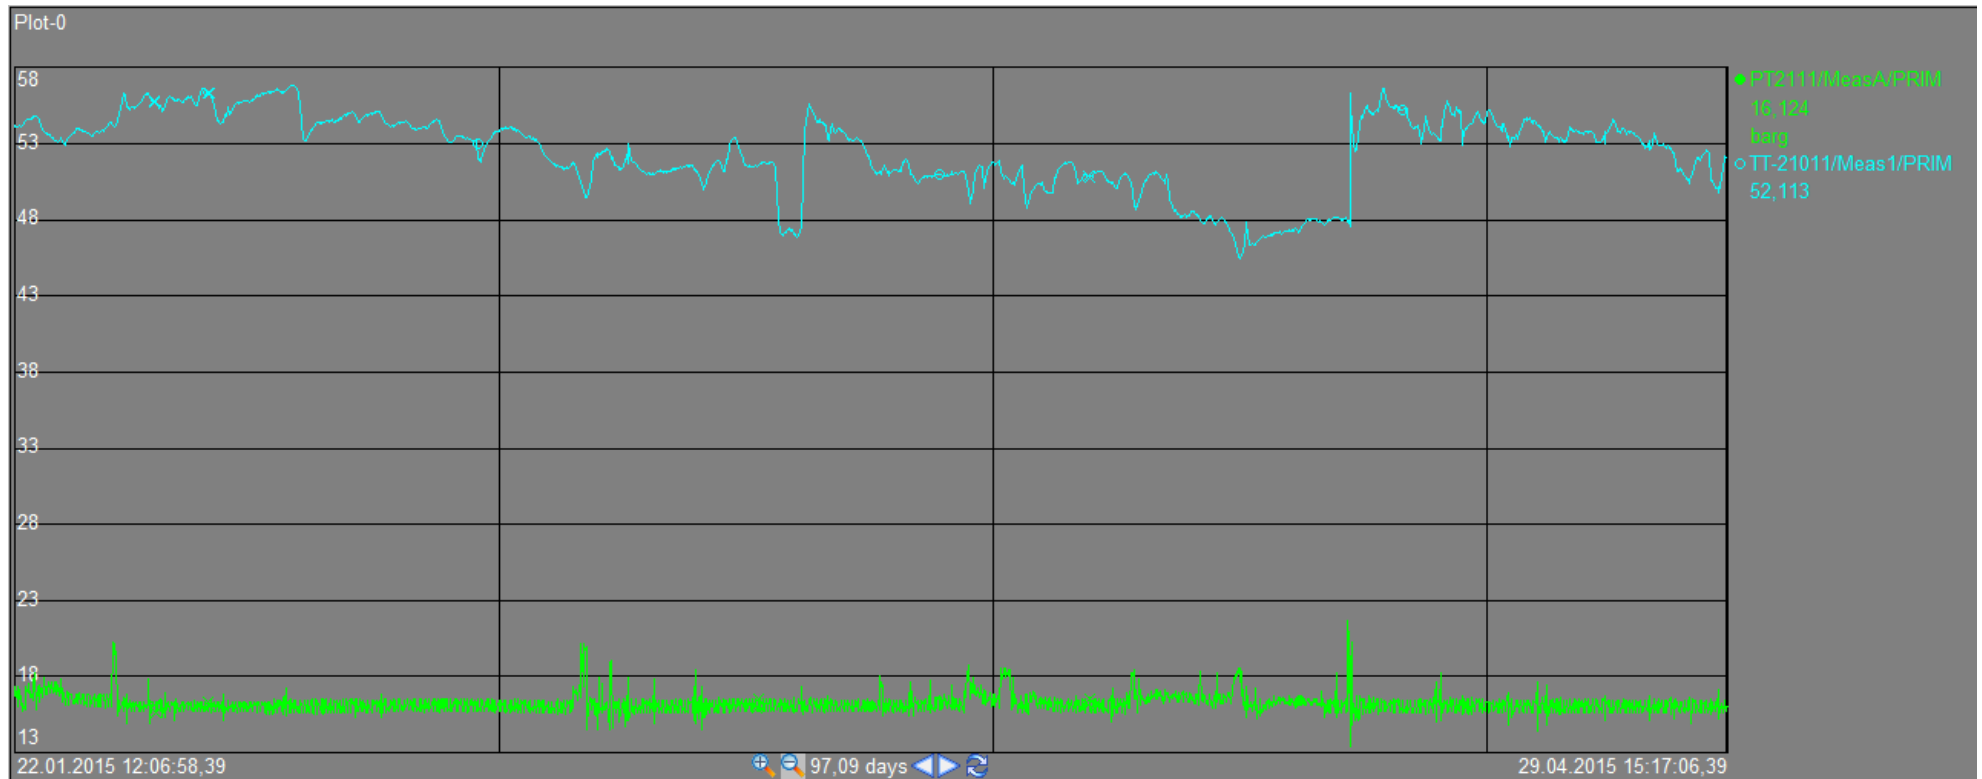
Chart C-5: Trending of the temperature and pressure in the crude flash drum No.1 (CD2102) in a period of 97 days. The light blue line indicates the temperature in degrees of Celsius, and the green line the pressure in barg (PI Processbook, 2015).

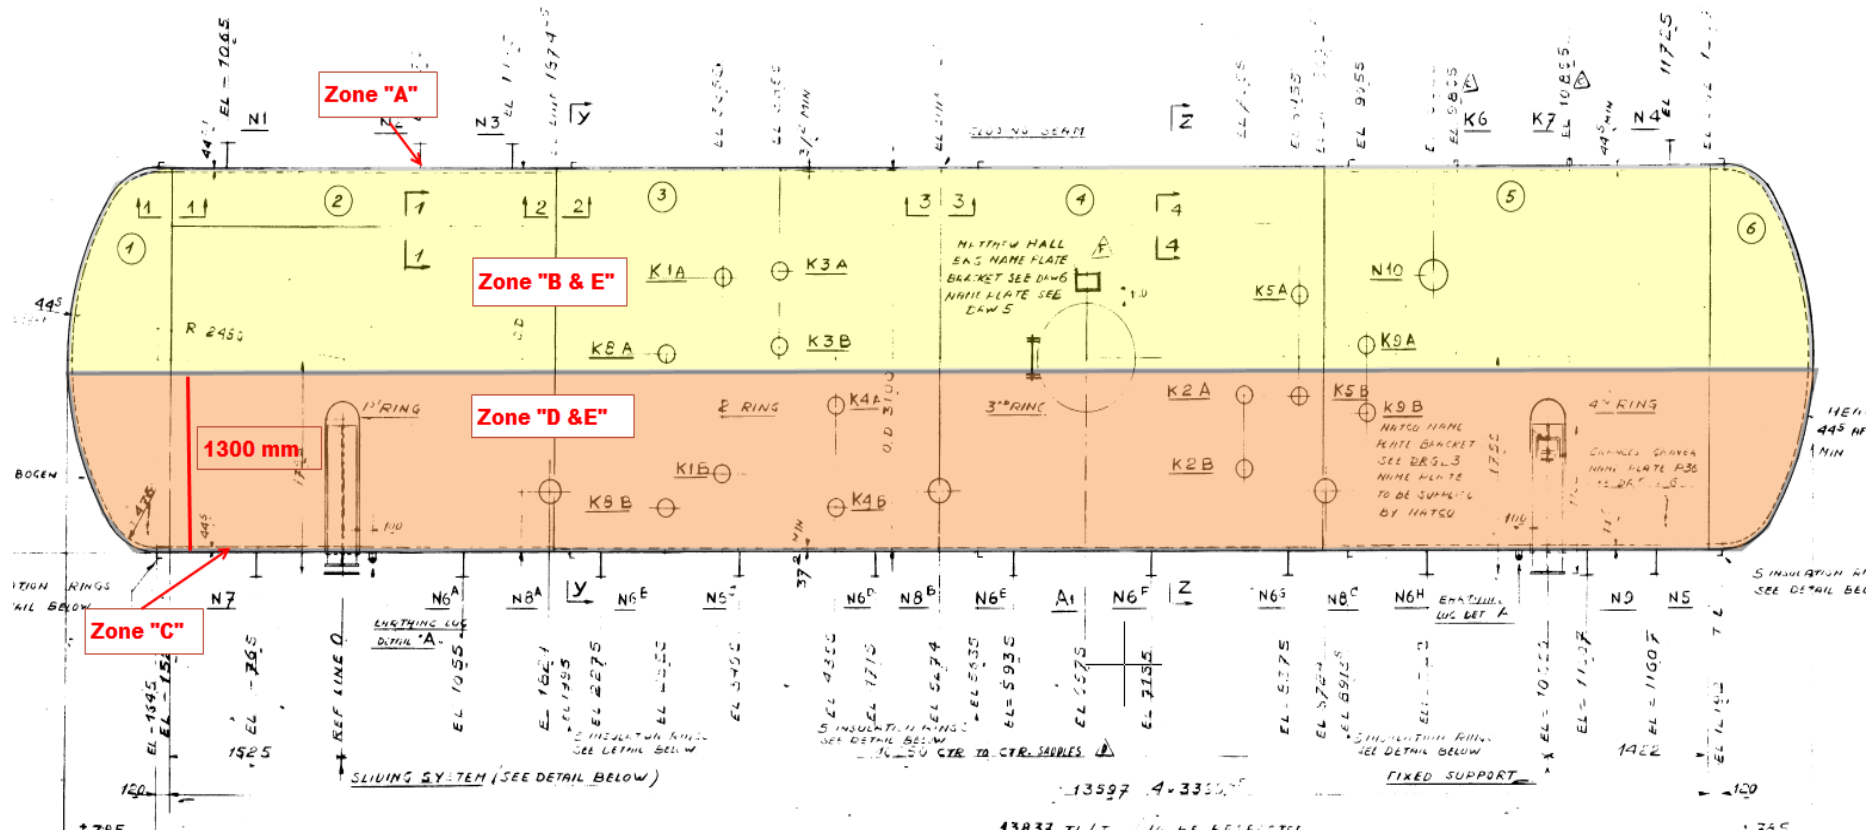
Drawing E-2: General arrangement drawing of crude flash drum No. 1 (CD2102), each inspection zone and location is marked with a suffix (From A-Z). Brown are marks out the area with liquid (oil and water), and the yellow area the gas level (STIDtips, 2015).

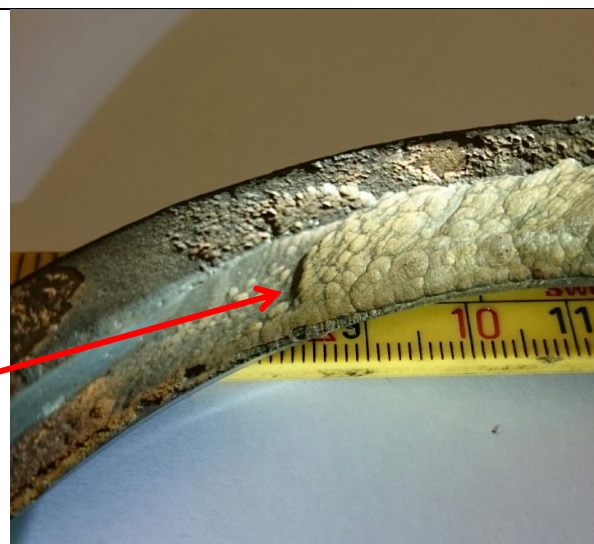
2. Separator – Corrosion of RTJ sealing surface.

Drawing G-2: Corroded RTJ-sealing surface at nozzle N10.

Picture G-2: RTJ - primary sealing surface 100% corroded and 50% of RTJ - secondary sealing surface after 3 years in service.
