Buckling capacity of simulated patch corroded tubular columns – laboratory tests

T Vo¹, K Hestholm¹, G Ersdal^{1,2,*}, N Oma² and M Sivertsvik³

¹ University of Stavanger, Norway

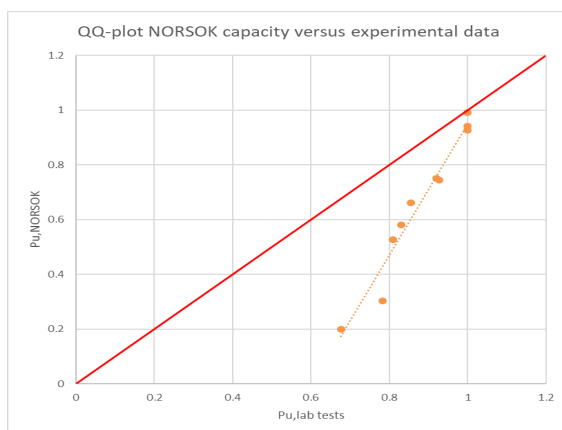
Figure 3. A comparison of the results of the tests performed by Hebor [9] and calculations according to NORSOK N-004 [3].

A comparison of the results from Hebor [1] and the calculated capacities according to NORSOK N-004 [3] for patch corroded columns in compression are shown in Figure 3. The tests performed by Hebor [1] included specimens with a diameter of 218 mm and a thickness ranging from 3.4 to 6.5 mm with thickness loss ranging from 0% to 100%. As can be seen in Figure 3 the results from Hebor [1] indicate significantly larger capacity compared to the calculation formulae in NORSOK N-004.

Due to the lack of similarity in the comparison with the tests performed by Hebor [9] and NORSOK N-004 calculations for patch corroded columns it was decided to perform more tests of tubular columns with simulated corrosion damage to provide more data for the validation of the NORSOK N-004 formulae.

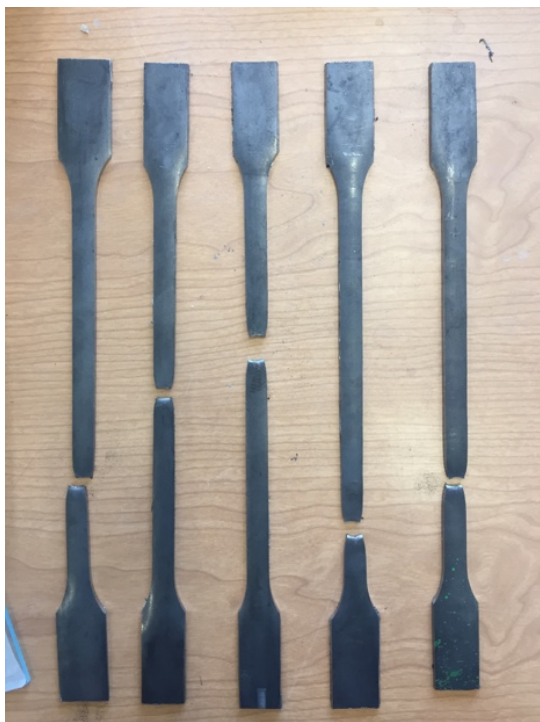
Figure 5. Test specimens from the yield strength test.

The material certificate of the longitudinal welded steel tubes specified a $R_{e\ min.}$ of 235 MPa, mechanical test value R_e of 280.4 MPa and a corresponding tensile strength R_m of 391.7 MPa. Five (5) independent mechanical tension tests were performed in the UiS test laboratory from test specimens taken directly from the received tubulars as shown in Figure 5. These tests indicated a mean value of the yield strength of 340 MPa.

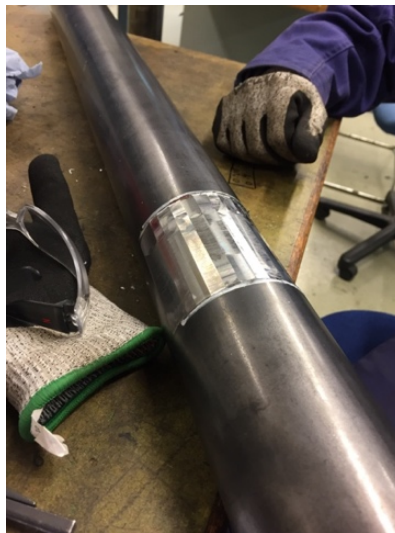
Figure 7. Example of tubular column with simulated corrosion damage by grinding.

The damage area simulating patch corrosion was selected to be 70mm in height and 70mm along the arc length of the pipe giving an angle of damaged area to be 114.6 degrees. The background for the chosen amount of corrosion damage (wastage) inflicted on the tubulars was based on an attempt to achieve results for a range as wide as possible of capacity reductions (ratio between damaged and undamaged columns). A range from 1.0 down to approximately 0.4 was achieved in the tests. This was achieved by removing 0.9mm, 1.9mm and 2.9mm by grinding in order to simulate corrosion damage (wastage).

In order to distinguish between the different columns, they were named with the following particulars: *Pipe diameter, wall thickness, damage extent as a percentage of thickness, chronological test number within their group*. As an example, a tube with 1mm remaining thickness is marked as 70-29-34-4, where 70 is outer diameter, 2.9 is material thickness, 34 is percent of remaining thickness and 4 would be the test number within the group. In addition, the tubulars with a simulated through thickness patch corrosion has an "h" or "r" at the end of the identification that indicates whether the corners of the damage are hard or round. Hard corners were cut with angle grinders and round corners were drilled.

The reasoning behind the simulated patch corrosion area was rather pragmatic and an area of $D \times D$ where D is the diameter of the pipe seems a reasonable size to start the investigation. The attempt was to have a uniform thickness reduction in this area. However, as can be seen in Figure 7 the grinding process may have left the specimens with some minor variations in thickness.

Grinding was chosen over other possible methods in order to reduce heat and possible changes to the material properties during the process. However, there is still a possibility that some residual stresses were introduced during the grinding process.

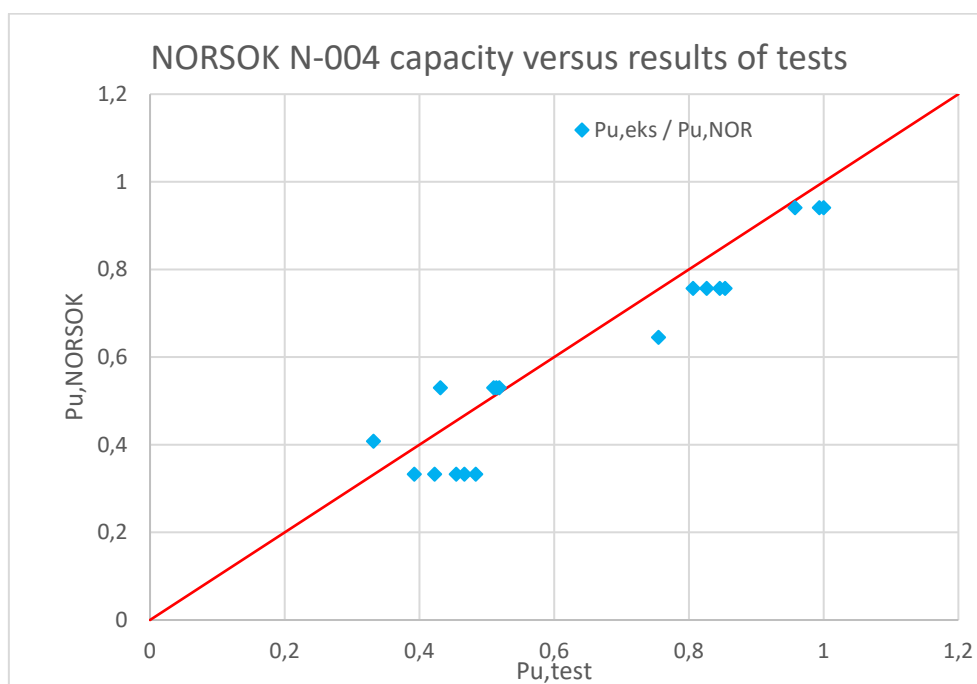
Figure 9. Q-Q plot of results of laboratory tests versus calculated capacities according to NORSOK N-004 [3].
