FACULTY OF SCIENCE AND TECHNOLOGY

MASTER'S THESIS

University of Stavanger was given a pipe consisting of two parts of the duplex stainless steel grade UNS S31803, which had been welded together using TIG welding. The thesis is about examining the weld that goes around the pipe.

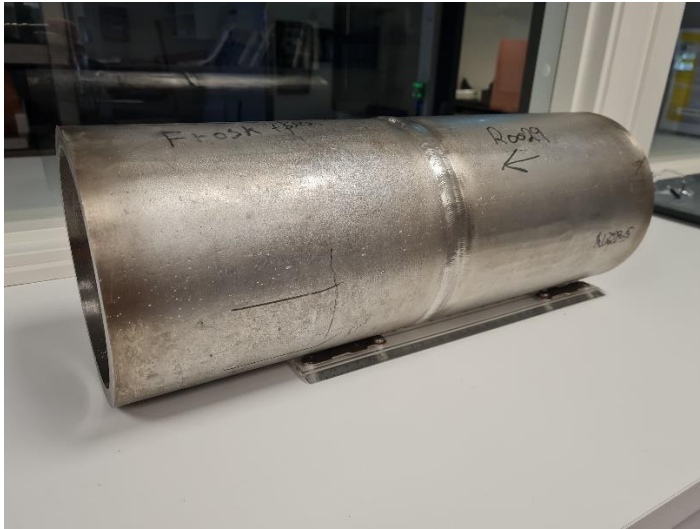
Figure 2 Picture of the pipe the way it looked before machining.

The object that contains the weld and the material is a pipe. The pipe was welded together using TIG welding, as specified in the WPS located in appendix at 8.1.1. Figure 2 shows the pipe before the work on making the specimen began.

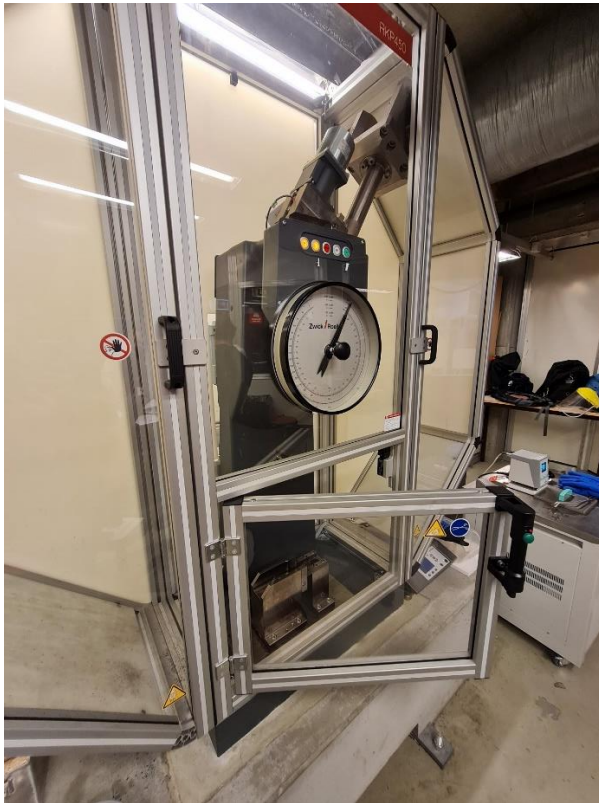
The Charpy tests were tested with the machine showed in Figure 4. The machine is a Zwick/Roell RKP 450. The samples were put into the machine with a tong.

Figure 4 The Charpy test machine.

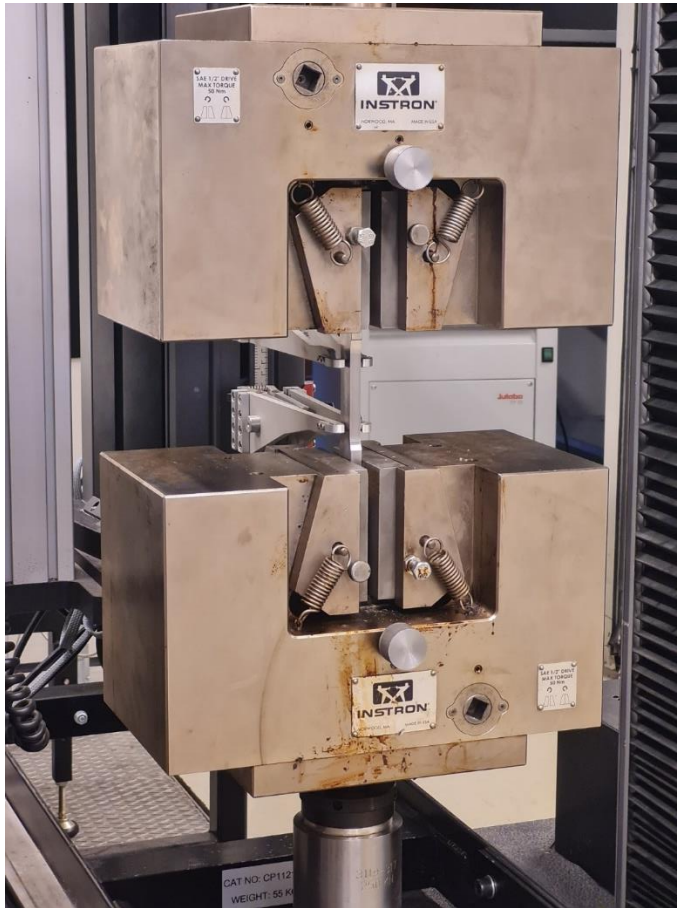
The testing was done with an Instron tensile test machine. Due to there being a weld transverse to the tensile load, the yield strength and Young's modulus were not measured as the material wouldn't be homogeneous. Ultimate tensile strength and the stress against strain was measured.

Figure 7 The clamps of the tension test device.

There was first a dummy test that was stretched by the machine to calibrate it. Then three tests of the material within the tolerances of the drawing above. The tests were held in place as seen in Figure 7. The tensile test device is made by the company Instron.

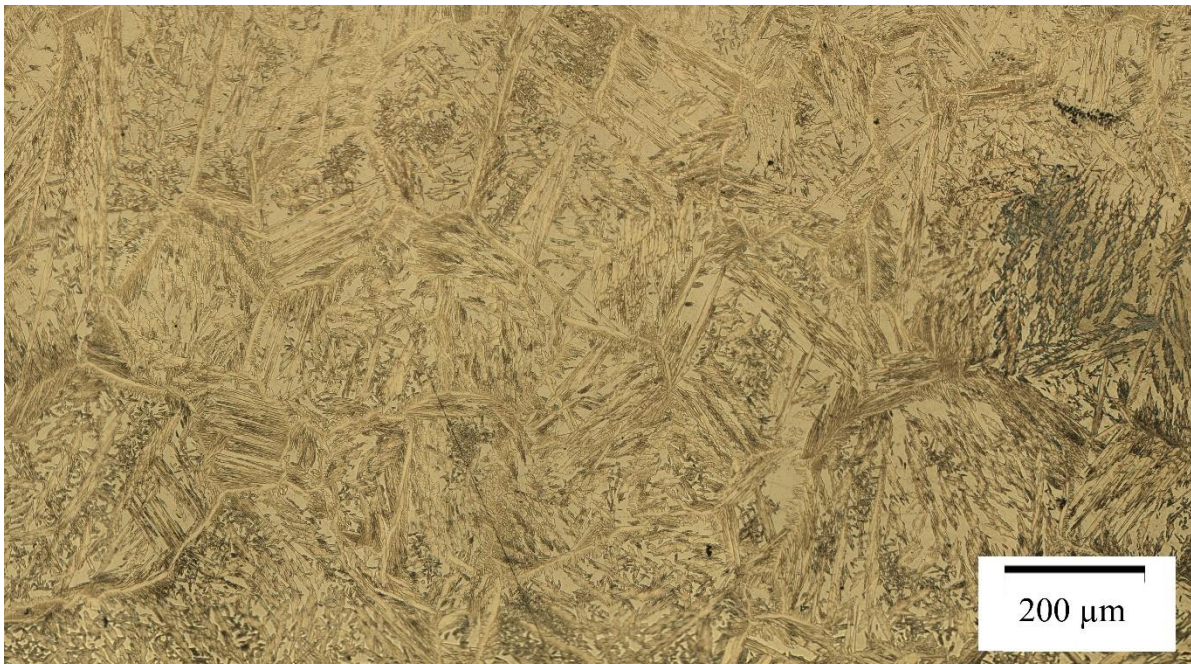
Figure 13 Closer look at the microstructure in the root pass.

Figure 13 is a screenshot of a zoomed in and cropped version of Figure 12, where the scale bar is the same size compared to sample and only moved as to not be cropped out. Figure 13 shows Widmanstätten structures and allotriomorphic structures. Figure 13 also shows some darker areas. The blue rectangle in Figure 12 shows where Figure 13 is taken from.

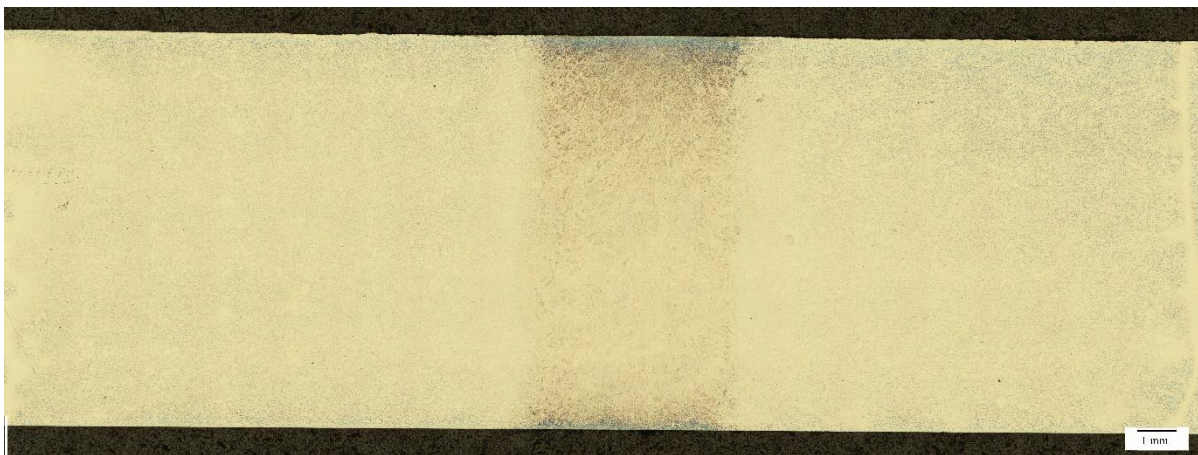
Figure 16 is a picture from when the Bottom-view sample was only etched with oxalic acid. Figure 17 is a zoomed in and cropped image of Figure 16, focusing on the edge of the weld. Both show a gradient from lighter color in the middle to darker color at the edge of the weld/sample. Figure 17 shows what appears to be brighter area on the grain boundaries — allotriomorphic austenite. Possibly some Widmanstätten austenite can be seen as well.

Figure 16 Overview of the Bottom-view sample. The edges of the sample at the weld is darker.

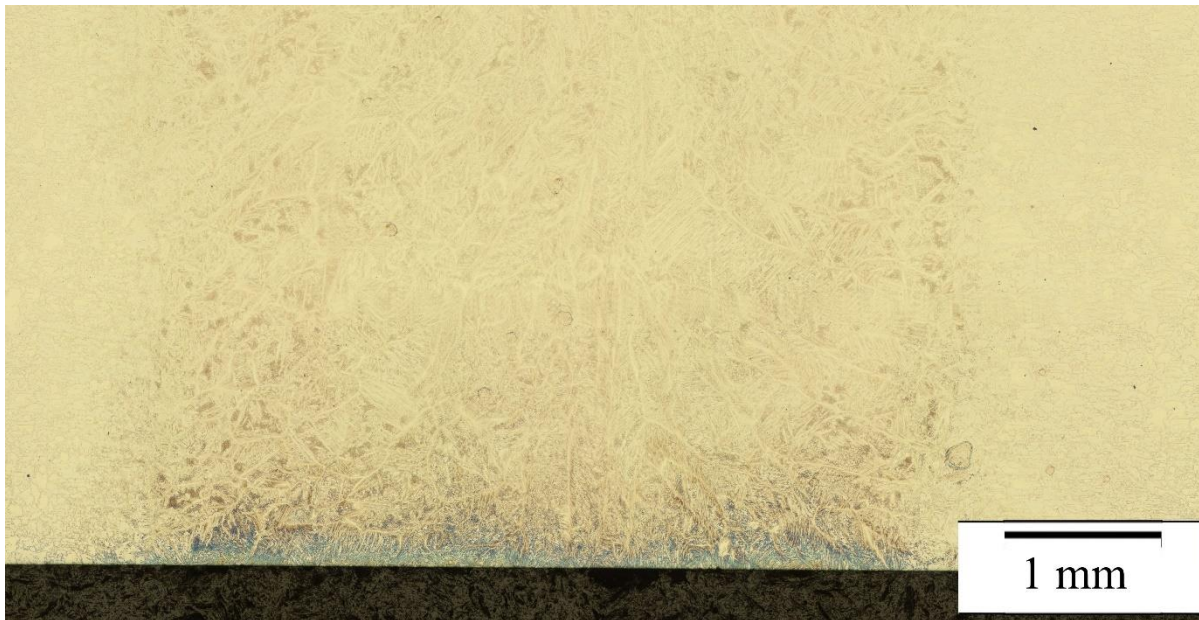
Figure 17 Zoomed in version Figure 16 showing the edge of the sample. It shows some allotriomorphic austenite.

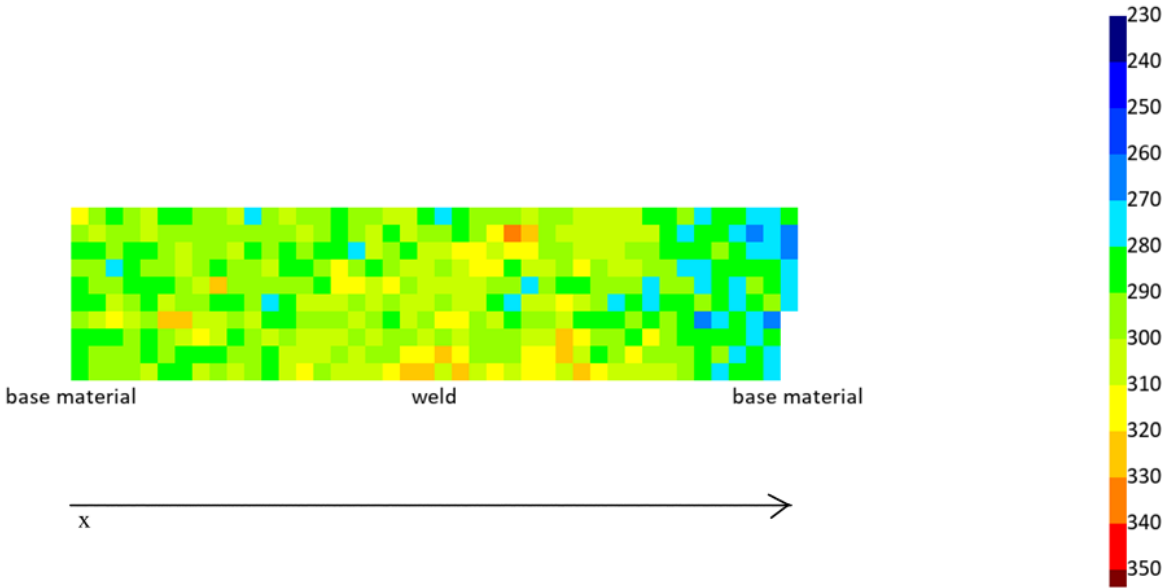
Figure 24 Area map of the hardness results for the Bottom-view sample.

Figure 24 shows the area map of the hardness values. The values on the right side of the weld are lower than the values on the left side of the weld for this sample.

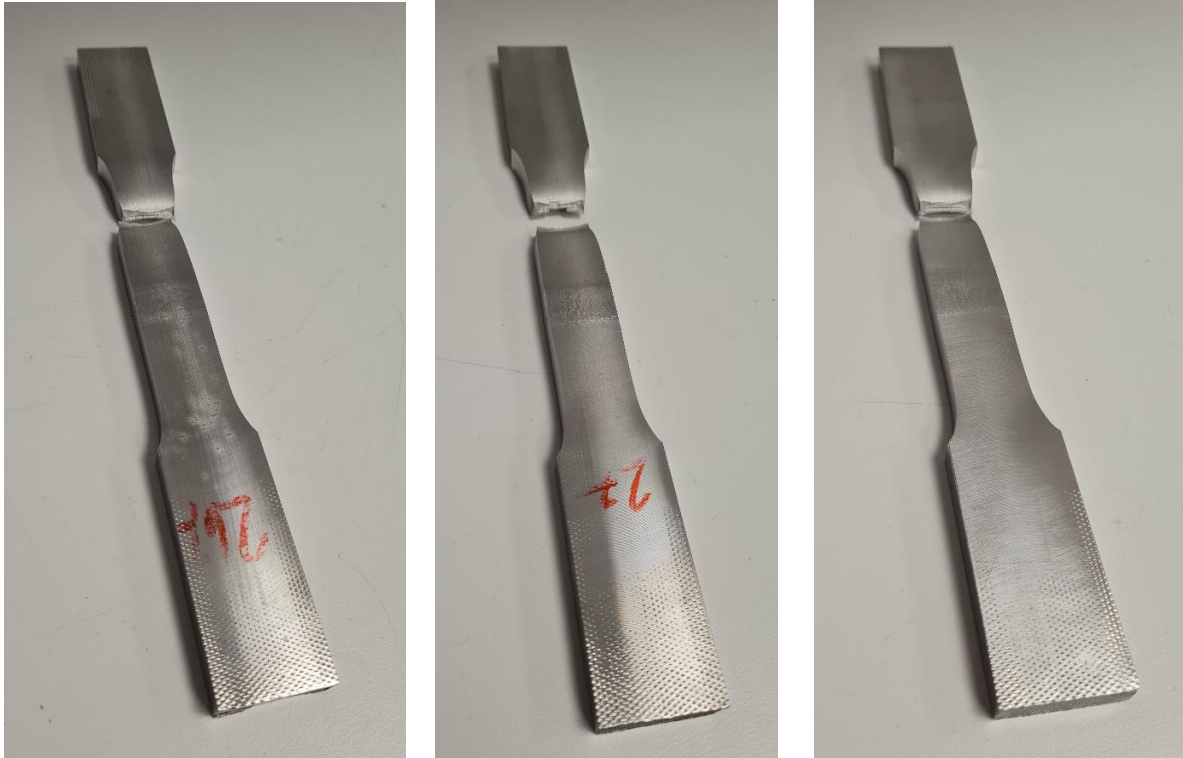
Figure 30 shows the specimen after the tension test was done. The fusion zone looks like it has “expanded” in the area because the surrounding material have gotten a reduced thickness. The fracture appears to be ductile and happened some distance from the weld. The fusion zone also has some kind of pattern within its surface that emerged during the tensile test.

Figure 30 The tension specimens after the tests were done.

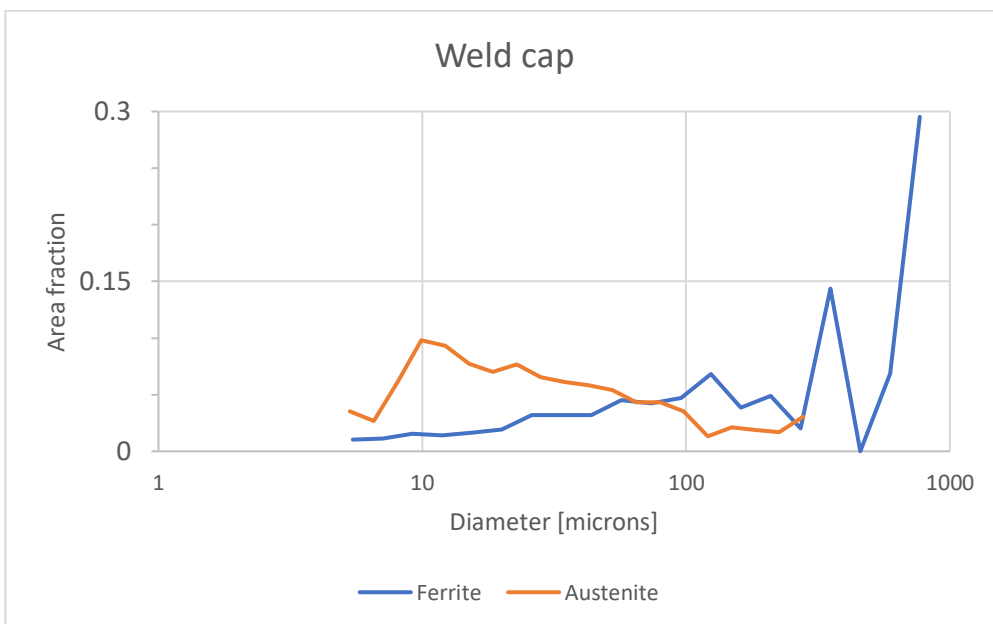
Figure 35 Grain size ferrite in weld cap.

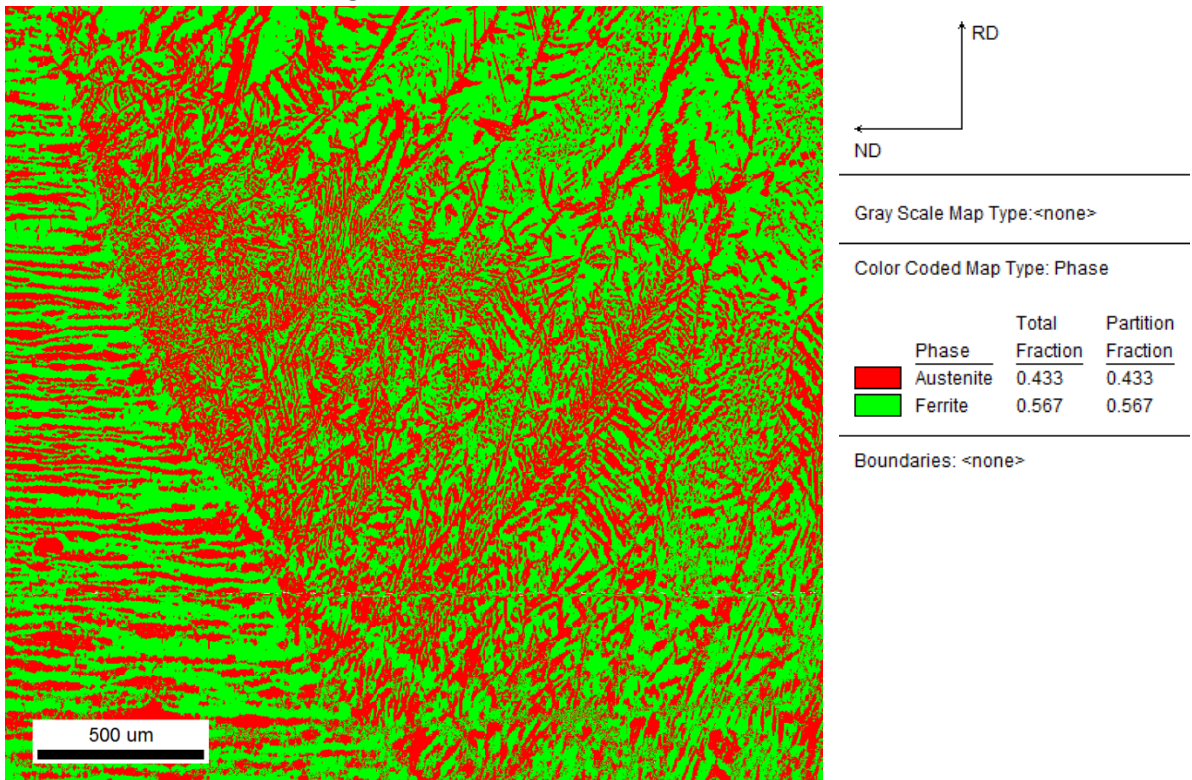
Figure 38 Phase map for the left HAZ.

There is an area of higher austenite amount near the HAZ or at the HAZ than further into the weld pool.

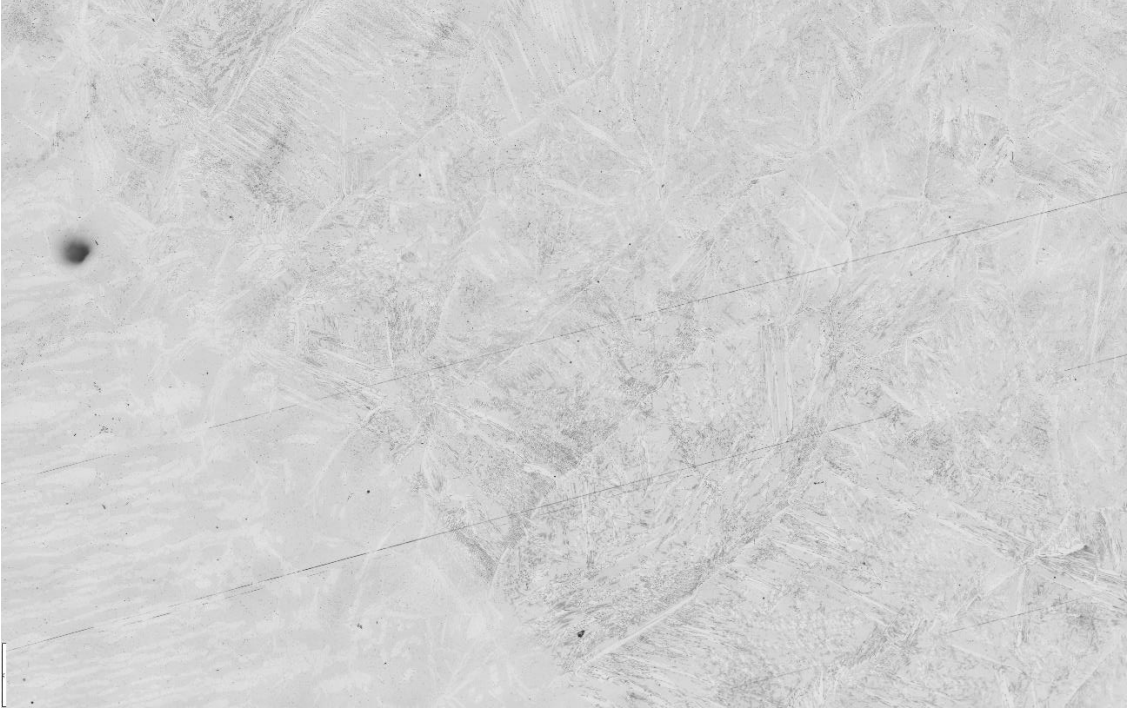
Figure 44 Overview of Side-view sample showing transition from weld to base material.

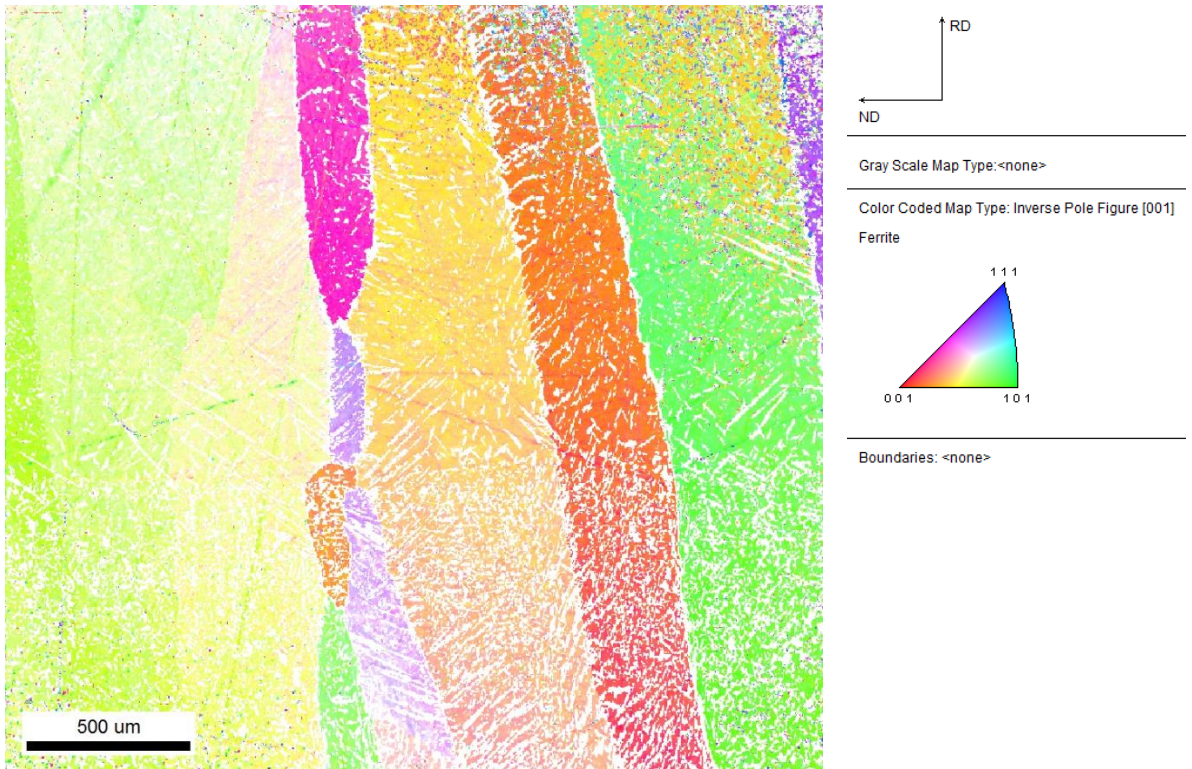
Figure 53 IPF showing ferritic structures in the upper weld cap.

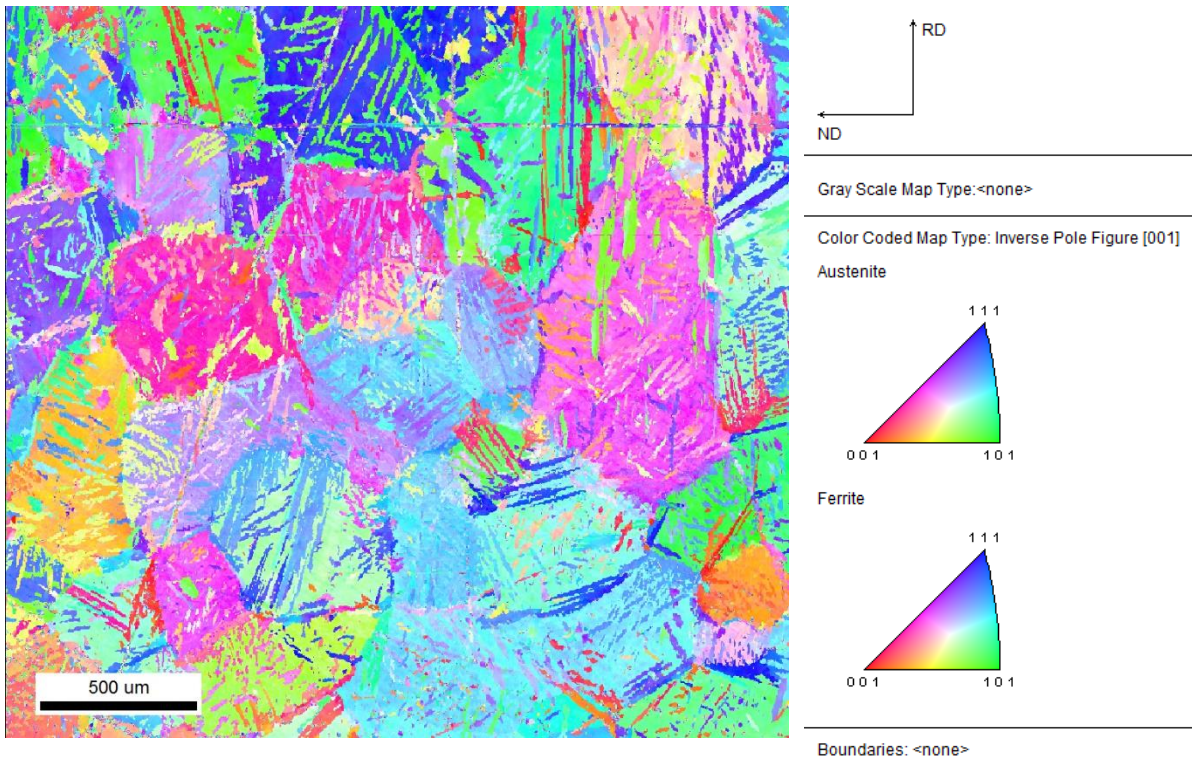
Figure 63 IPF for Root Weld.
