MASTER'S THESIS

Study programme / specialisation: Engineering Structures and Materials - Master's Degree / Structural Engineering	The spring semester, 2023 Open / Confidential
Author: Simen Riise	
Supervisor at UiS: Gerhard Ersdal External supervisor: Mostafa Ahmed Atteya	
Thesis title: Experimental assessment of cracked tubular joints repaired with crack-deflecting holes and weld-toe grinding	
Credits (ECTS): 30	
Keywords: Tubular joints Fatigue cracks Life extension Crack deflecting holes Weld-toe grinding Experimental assessment Numerical analysis Stress concentration factors	Pages: 64 + appendix: 38 Stavanger, 15.06.2023

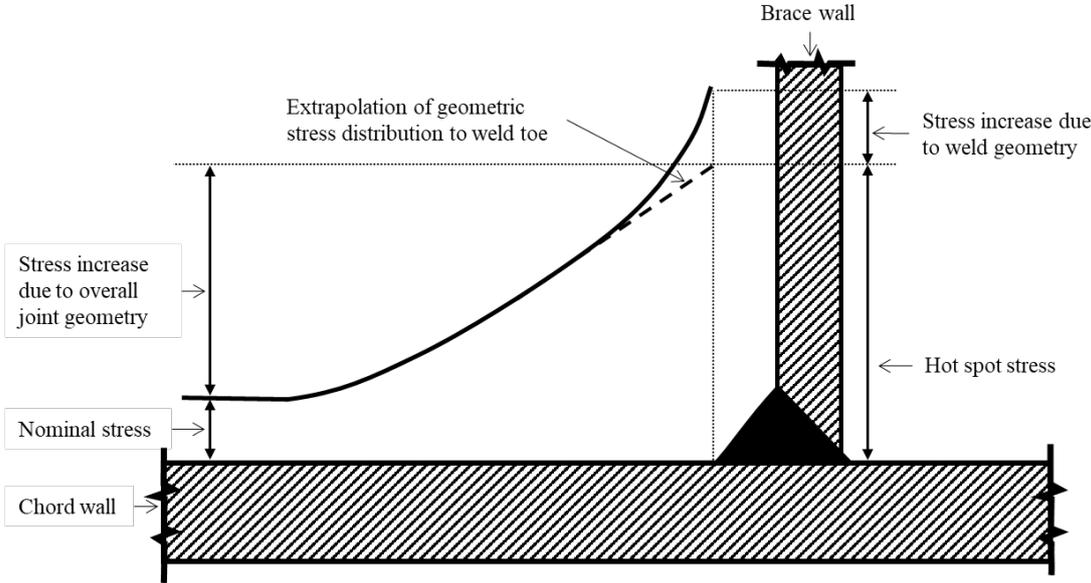
Figure 2-1: Definition of stresses in a welded tubular joint

In fatigue analysis, it is essential to understand the stresses and stress distribution in the particular detail being analysed. The total stresses in a tubular will often be complex with contributions from external forces on the structure, stresses to maintain compatibility between members, stresses arising due to discontinuity at the joint and local stresses at the weld toe (Saini et al., 2016). The total stresses are normally defined as a result of these different stress contributions, as shown in Figure 2-1.

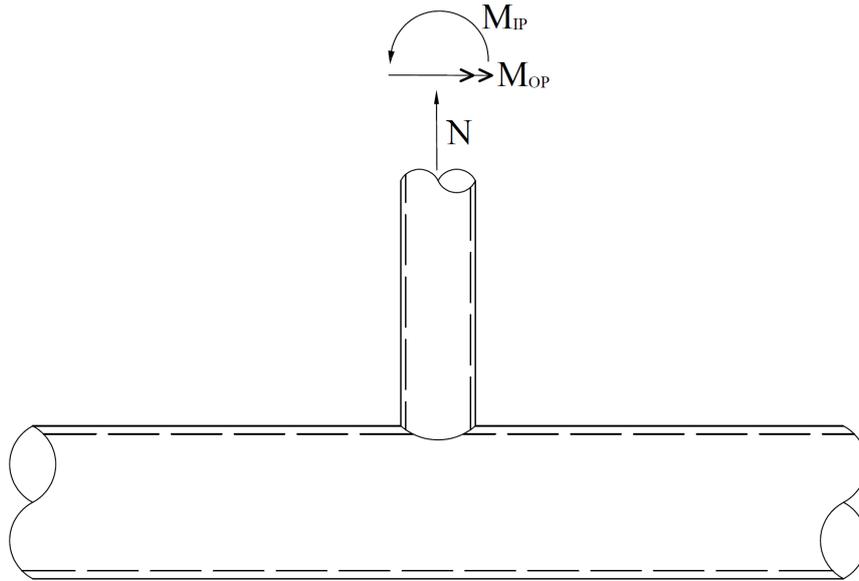
Figure 2-2: The three loading modes in tubular joints, in-plane bending, out-of-plane bending and axial force.

The source of the stresses developed in a tubular joint is mainly from three different loading modes, axial force, in-plane bending and out-of-plane bending, as shown in Figure 2-2. The different stress concepts are further described in the following section.

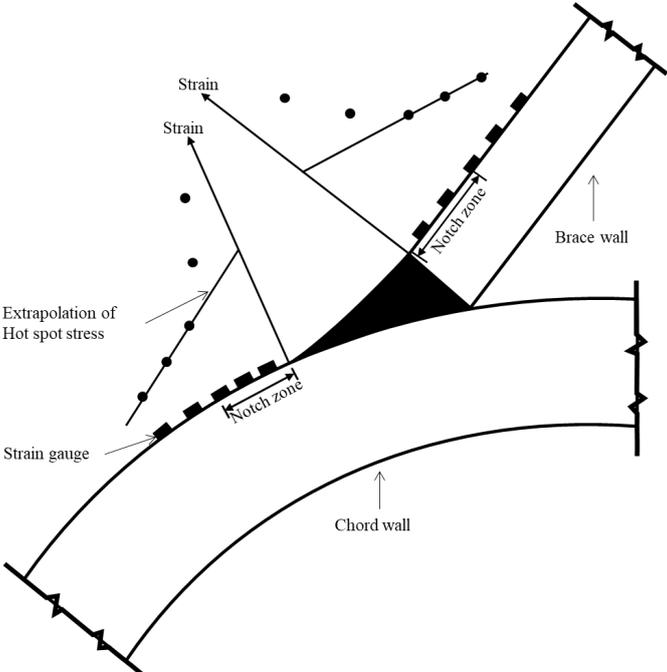
Figure 2-3: Strain development near weld toe and linear extrapolation techniques to determine HSS, as illustrated in (Almar-Næss, 1985)

The local stress at the weld toe, also called notch stresses, is caused by the local notch at the weld toe. In Figure 2-3, the strains close to the weld are illustrated, as shown a rapid non-linear increase in stress occurs very close to the weld toe. This area is referred to as the Notch zone and the localised stress increase is commonly called the local weld notch effect (Saini et al., 2016).

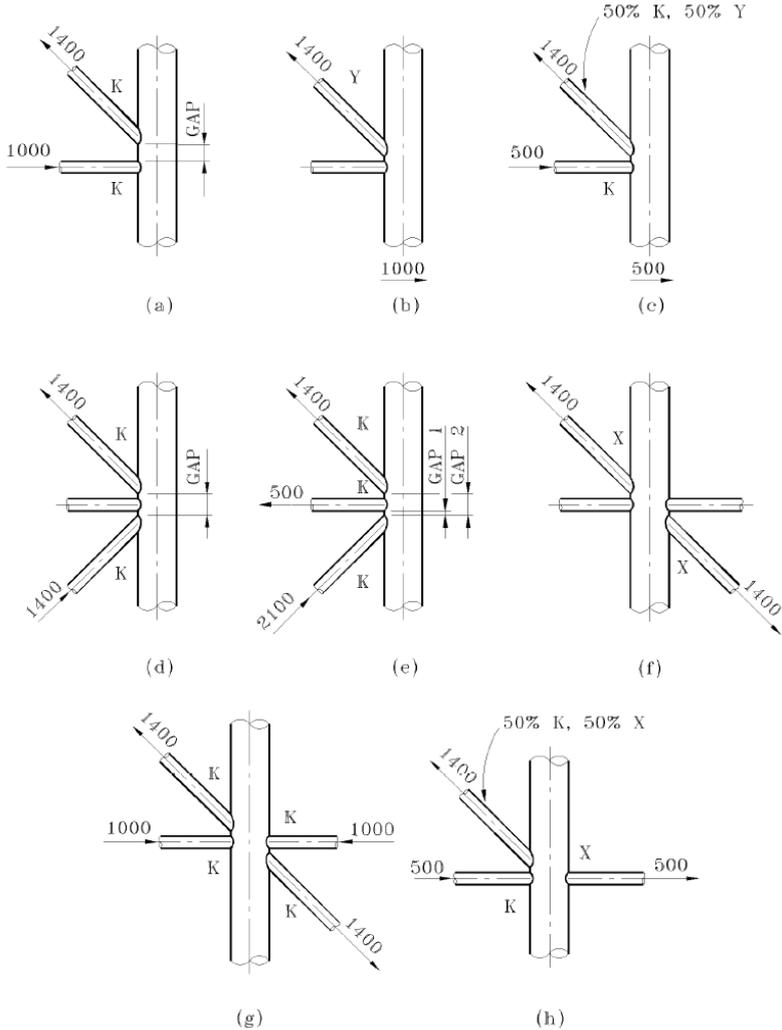
Figure 2-6: Classification of simple joints (DNV, 2019)

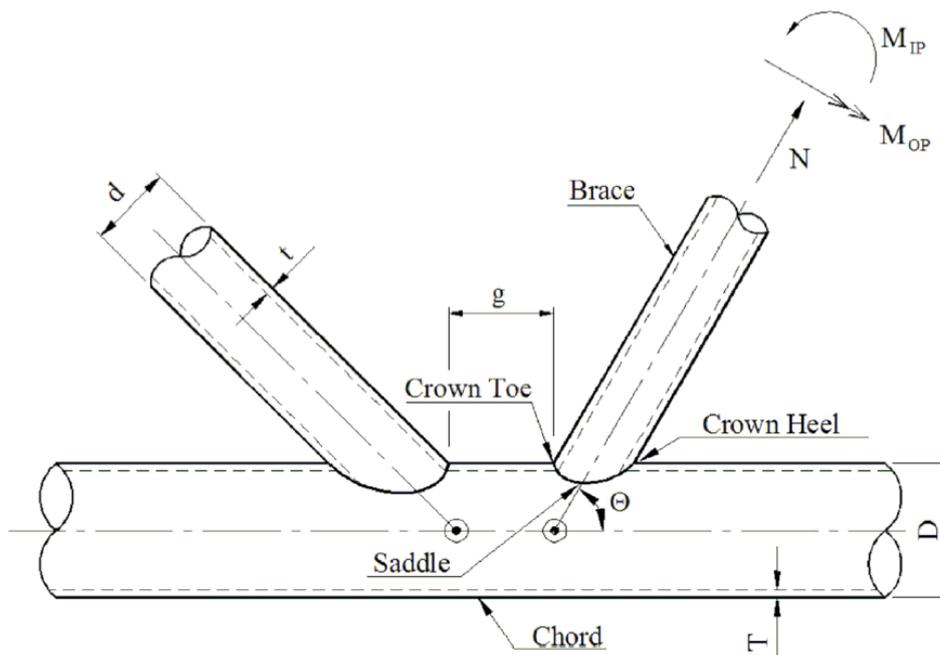
Figure 2-7: Geometrical definitions for tubular joints (DNV, 2019)

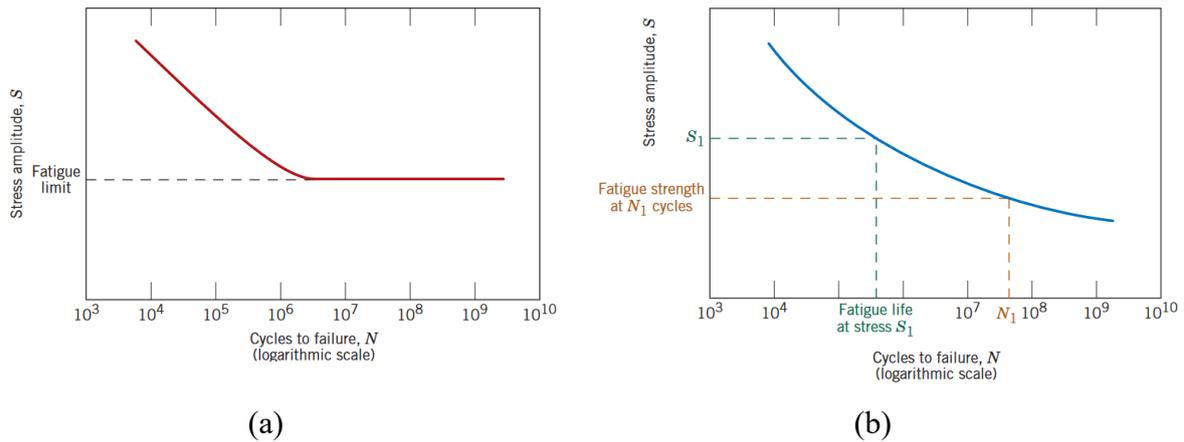
Figure 2-9: S-N curve of material with fatigue limit (a) and without fatigue limit (b) source (Callister & Rethwisch, 2020)

In Figure 2-9, two distinct S-N behaviours are illustrated. In some ferrous and titanium alloys, as shown in Figure 2-9 (a), the S-N curve reaches a horizontal plateau at higher N values. This indicates the existence of a fatigue limit, also known as the endurance limit, which is the maximum stress level below which fatigue failure does not occur. In contrast to ferrous and titanium alloys, such as those made of iron and titanium, most nonferrous alloys (e.g., aluminium, copper) do not exhibit a fatigue limit. As illustrated in Figure 2-9 (b), the S-N curve continues to decline as the number of cycles increases without reaching a horizontal plateau (Callister & Rethwisch, 2020).

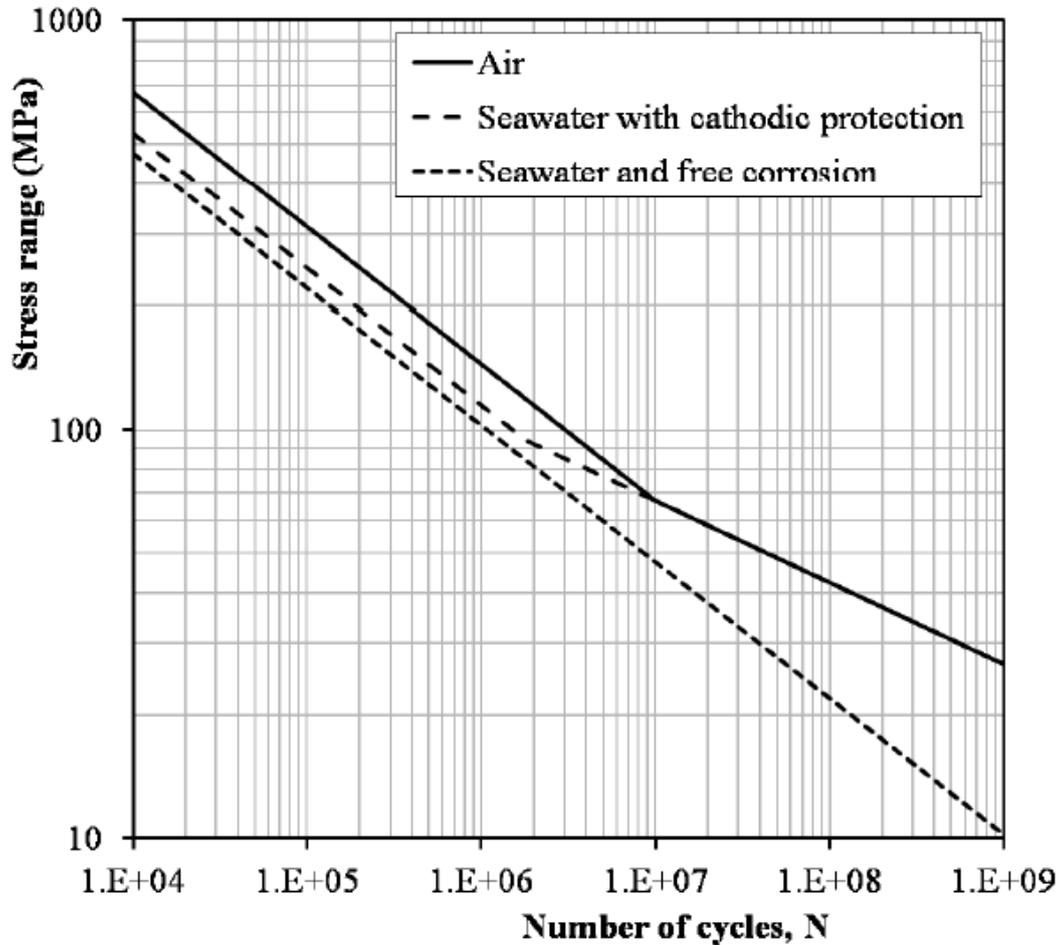
Figure 2-10: S-N curves for tubular joints in air and in seawater with cathodic protection (DNV, 2019)

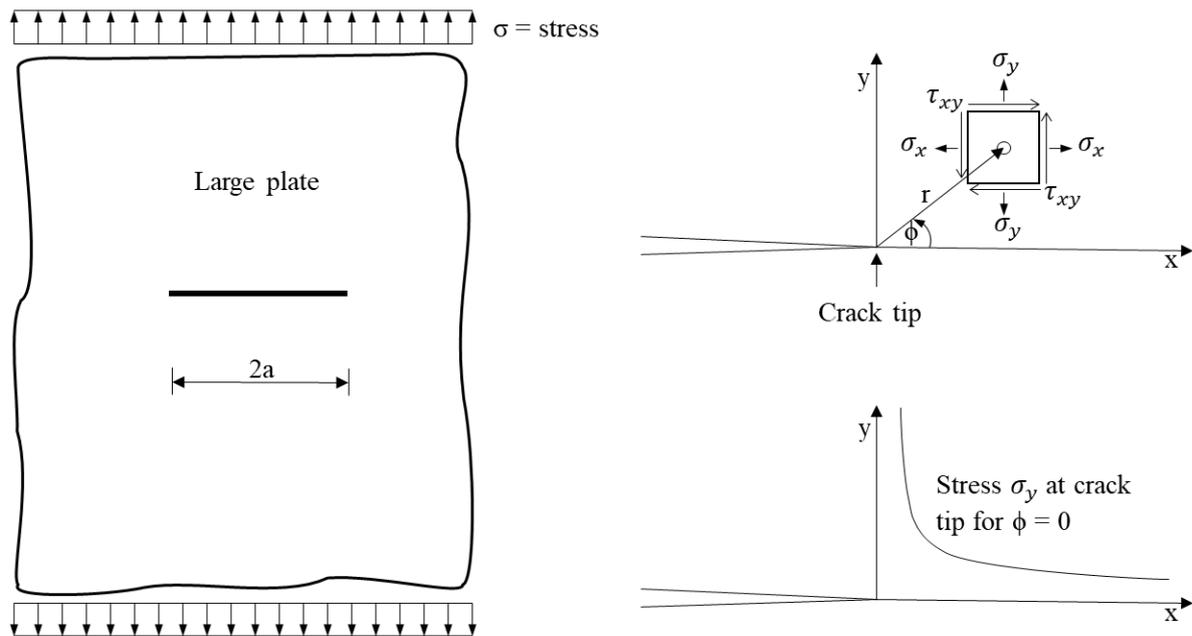
Figure 2-11: Illustration of a stress field in front of a crack tip in a large plate, as illustrated in (Lotsberg, 2016)

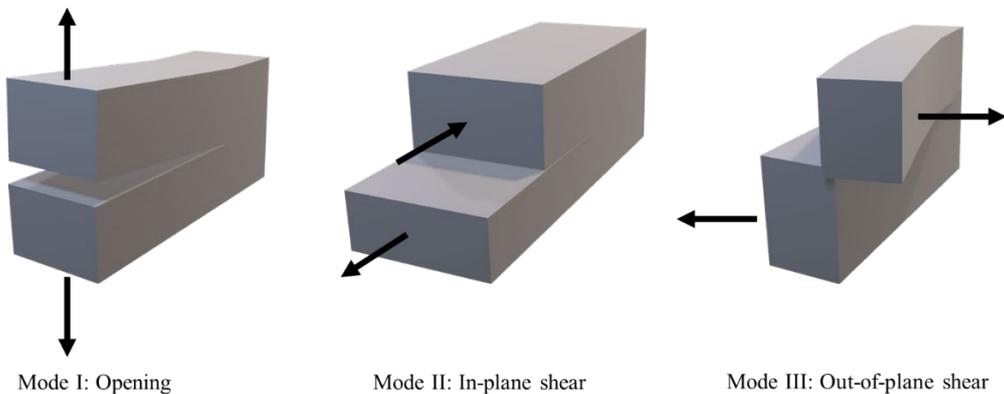
Figure 2-12: Illustration of the three loading modes in fracture mechanics

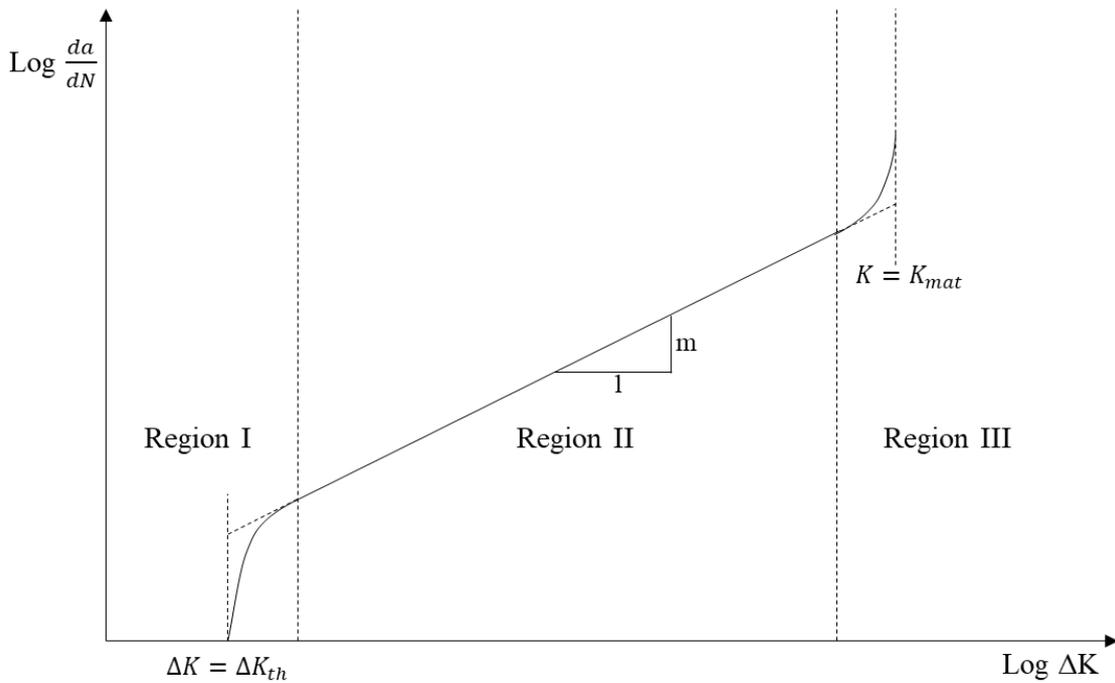
Figure 2-13: Typical fatigue crack growth curve

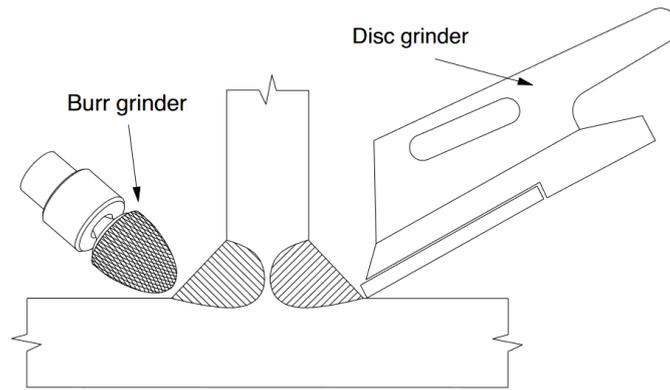
Figure 3-2: Illustration of burr and disc grinding repair of weld, (Braun & Wang, 2021)

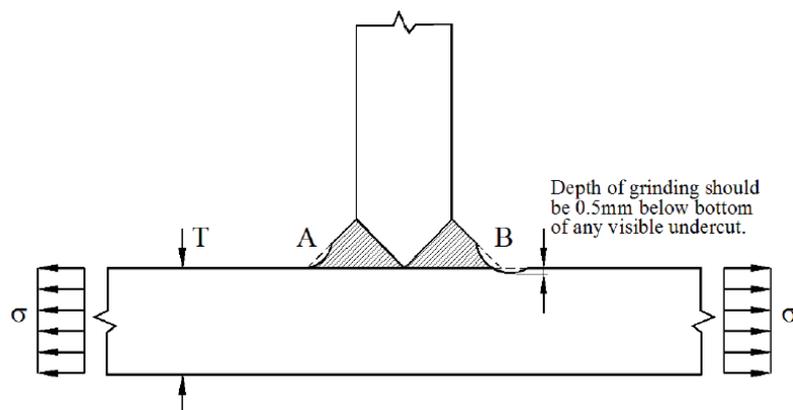
Figure 3-3: Illustration of weld toe improvement (DNV, 2019)

Weld toe grinding is performed by local grinding of the weld toes below any visible undercut. Figure 3-3 illustrates two weld toe improvements, A and B. Grinding the weld toe tangentially to the plate surface, as shown in A, will only slightly improve fatigue endurance. As shown in B, a more efficient improvement is achieved by grinding below the plate surface. The ground concave profile should be 0.5 mm below the bottom of any visible undercut, but not exceed 2 mm or 7% of the plate thickness (DNV, 2019).

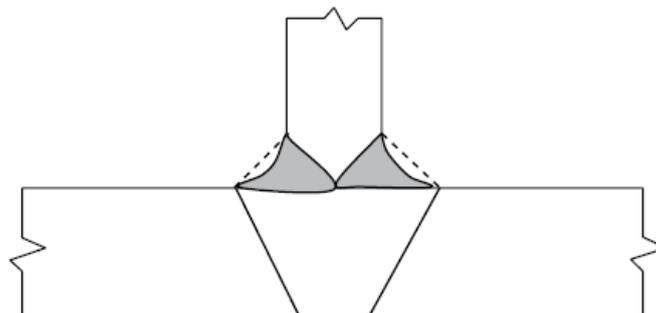
Figure 3-4: Illustration of weld profiling, (DNV, 2019)

Weld profiling is a method for increasing fatigue strength and is accomplished by machining the weld with a given radius, as shown in Figure 3-4. The method is unsuitable for fatigue crack repair but can be combined with weld toe grinding and weld repair.

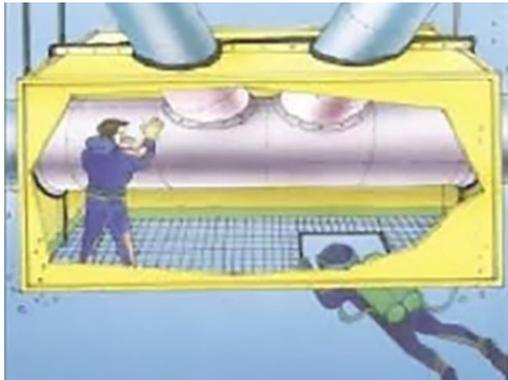
Figure 3-5: Illustration of a waterproof chamber with an open bottom (Profdivers, n.d.)

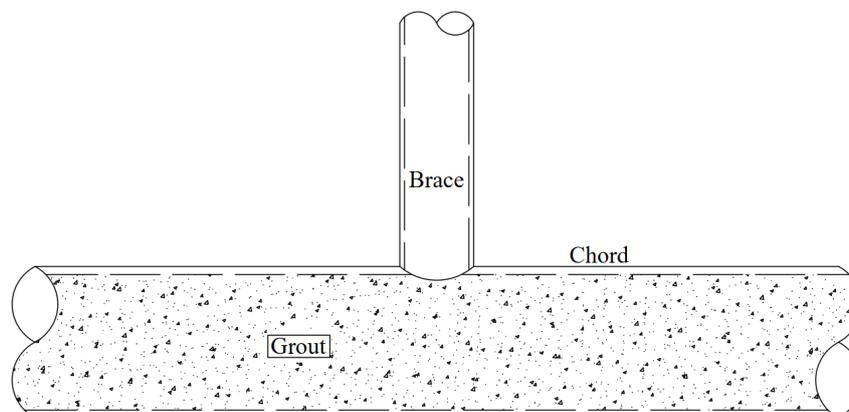
Figure 3-7: Grout-filled joint as illustrated in (Sharp & Ersdal, 2021)

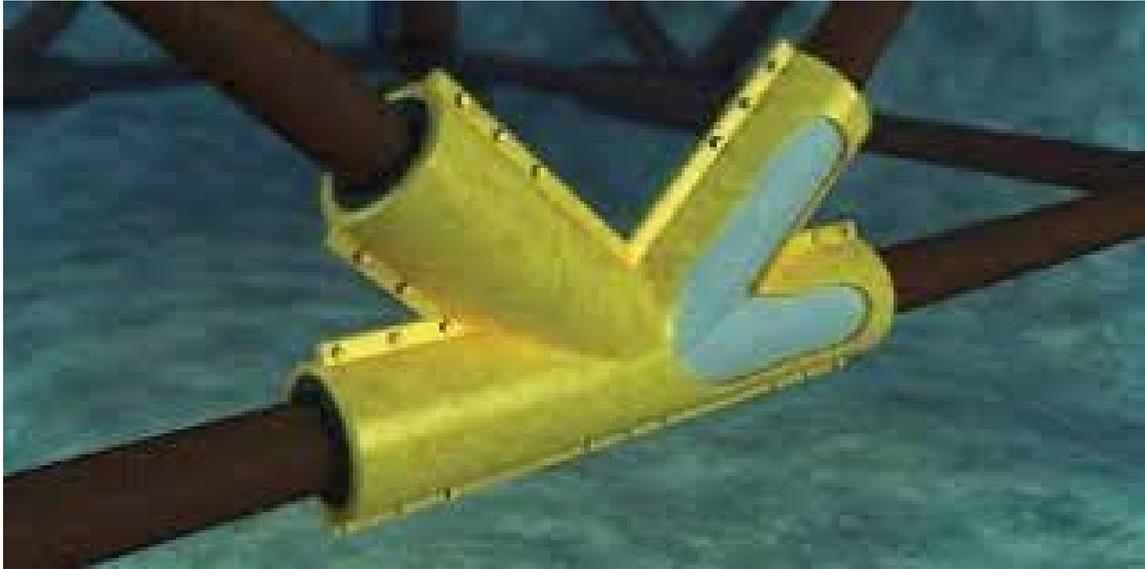
Figure 3-8: Stressed grout-filled clamp (Trident, 2023)

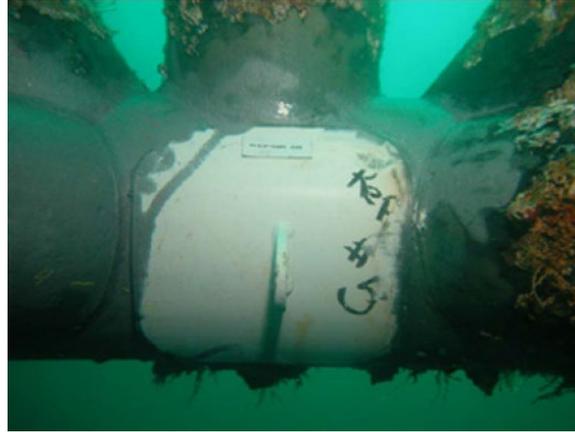
Figure 3-9: Example of doubler plate repair to a jacket structure, source (Sharp & Ersdal, 2021)

Doubler plates can be used to efficiently reinforce a structure by increasing its thickness, but a design analysis is required to ensure effective load-carrying. This repair method is also used in fixed steel offshore structures, as shown in Figure 3-9 (Sharp & Ersdal, 2021).

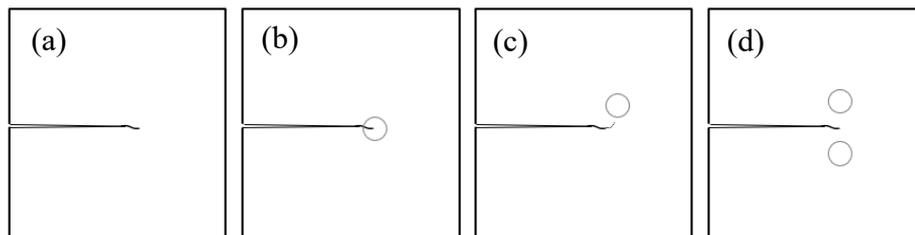
Figure 3-10: (a) crack, (b) stop hole, (c) crack deflecting hole, (d) crack flack holes

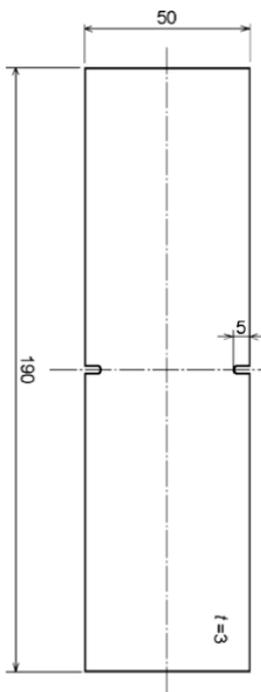
Figure 3-11: Specimen geometry (Makabe et al., 2009)

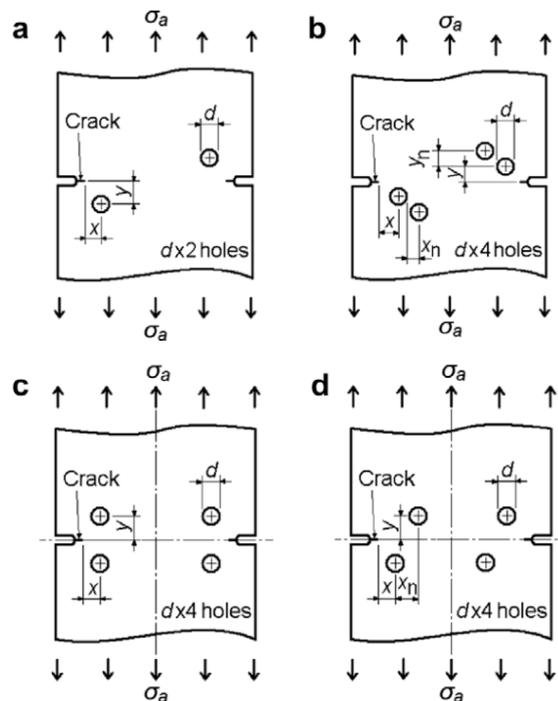
Figure 3-12: Schematic representation of the hole arrangement (Makabe et al., 2009)

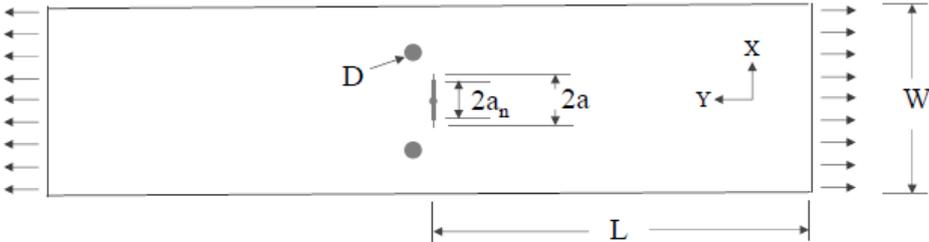
Figure 3-13: Specimen geometry, (Atteya et al., 2020)

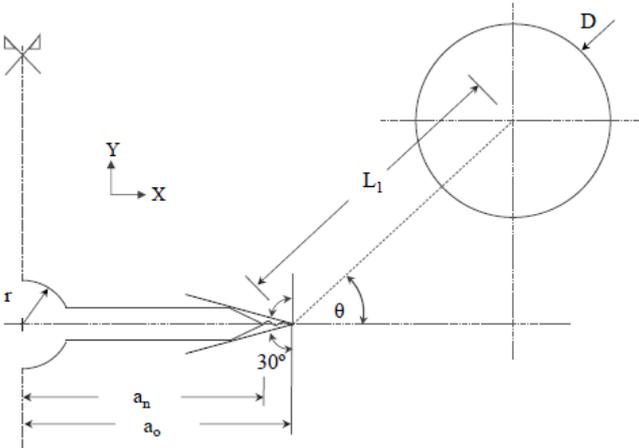
Figure 3-14: Schematic representation of the hole arrangement (Atteya et al., 2020)

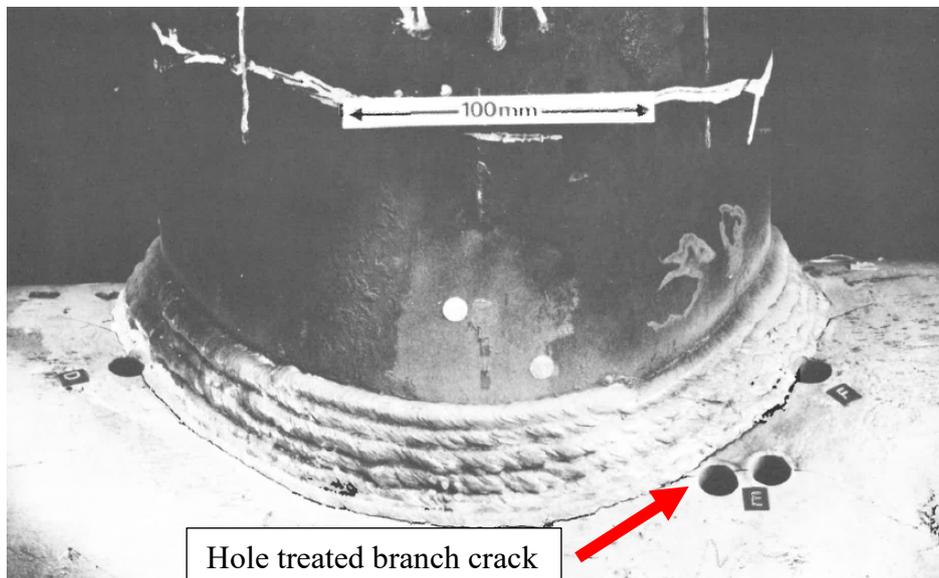
Figure 3-15: Cracked tubular joint with stop hole repair (Tubby, 1989)

The main observation from the test was that the first crack to appear after retesting the repaired joint was a branch from the main toe crack, as shown in Figure 3-15. In practice, it would be difficult to find and sufficiently treat such areas. Consequently, a single untreated branch may be catastrophic. Tubby concluded that hole drilling and cold expansion was not effective repair method in the two specimens investigated.

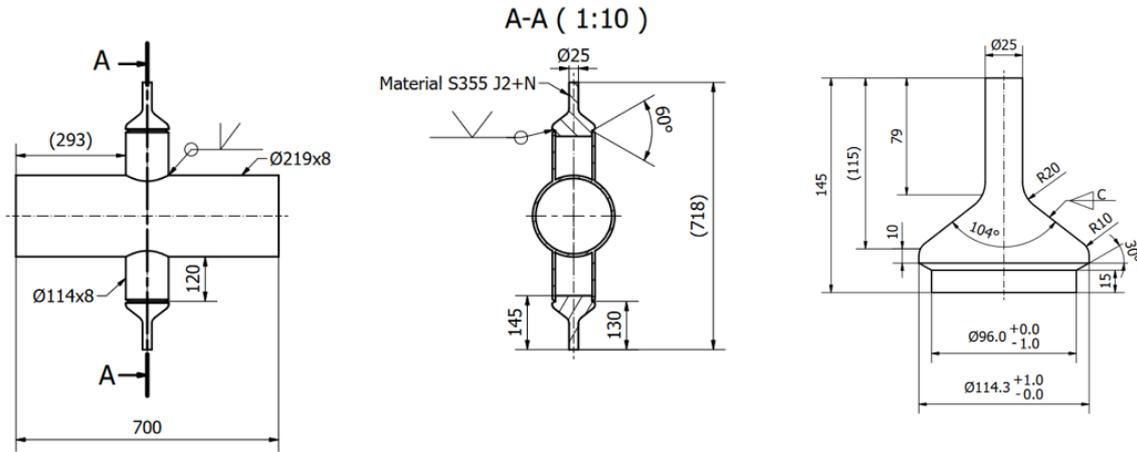
Description	Symbol	Value	Unit
Chord thickness	T	8.20	mm
Chord diameter	D	219.1	mm
Brace thickness	t	8.56	mm
Brace diameter	d	114.3	mm

Figure 4-1: DT-joint Geometry *source* (Atteya, to be published)

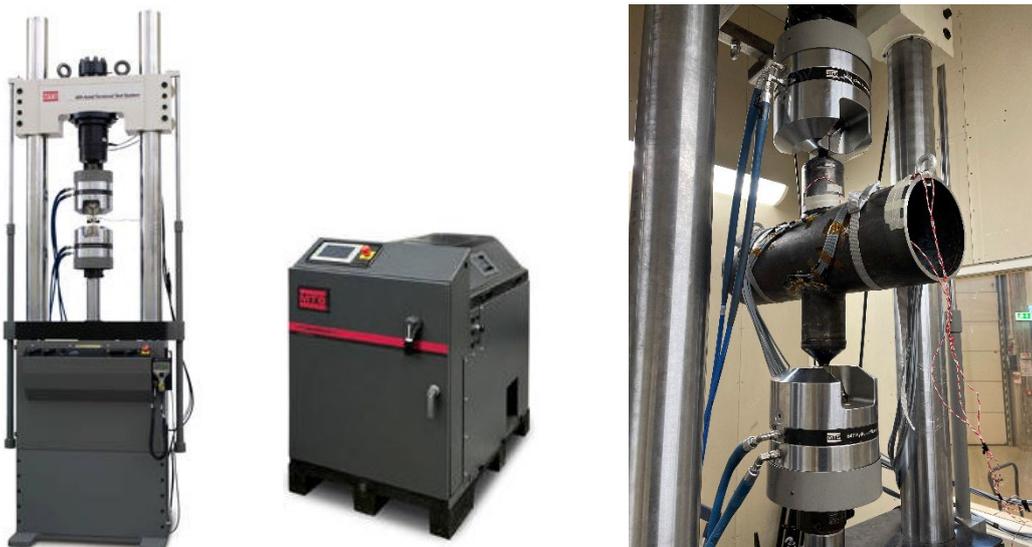
Figure 4-3: Test machine, HPU (MTS, n.d.) and specimen installed in the test system, respectively

The machine employed for the fatigue testing was the MTS 809 Axial/Torsional Test System model 319.25, located in the workshop at the University of Stavanger. The machine can apply axial and torsional load as well as displacement. Moreover, the test system can conduct a wide range of evaluations, spanning from static to multiaxial fatigue testing. Under dynamic loading, the load frame is rated to a maximum axial force of 250kN and 2500Nm torsional force. Furthermore, the system permits a maximum axial displacement of 150 mm and a torsional range of ± 45 degrees. The actuator, connected to the lower gripper, is driven by an external Hydraulic Power Unit (HPU), while the load cell is positioned above the upper gripper. The specimen was vertically positioned in the test machine with the grippers attached to the braces, as shown in Figure 4-3. All testing was performed at room temperature.

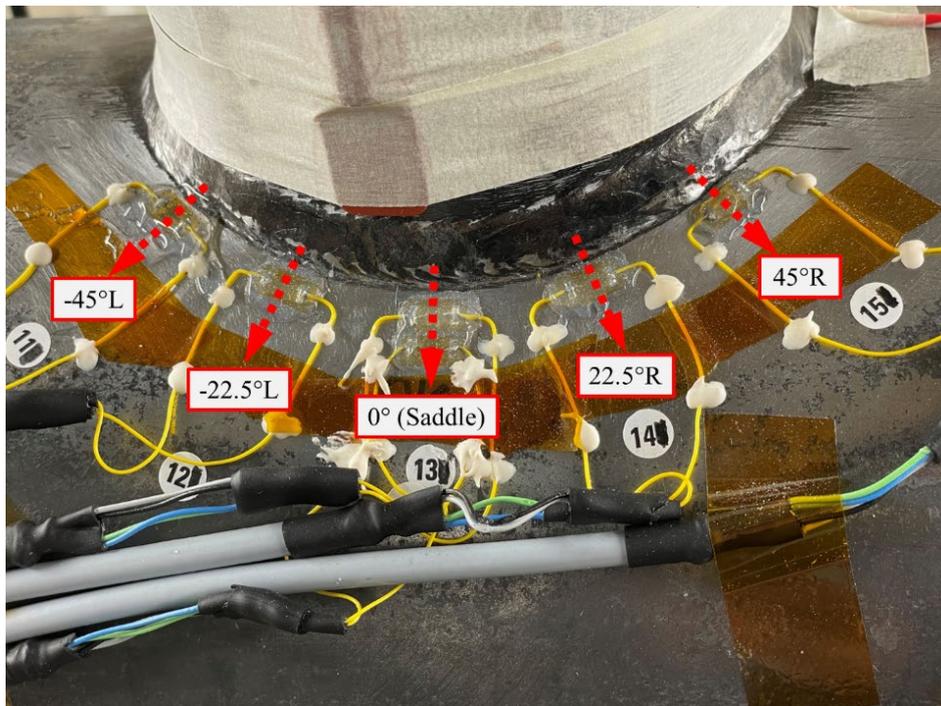
Figure 4-4: Strain gauge layout at quadrant 1

The strain gauges used in the testing were designated 1-LY71-3/120. These gauges exhibit a temperature-responsive characteristic, which allows them to self-compensate within the temperature range of -10°C to 120°C when used on ferrite steel. Moreover, the gauges have a grid length of 3mm, a nominal resistance of 120 ohms and are connected with solder tabs.

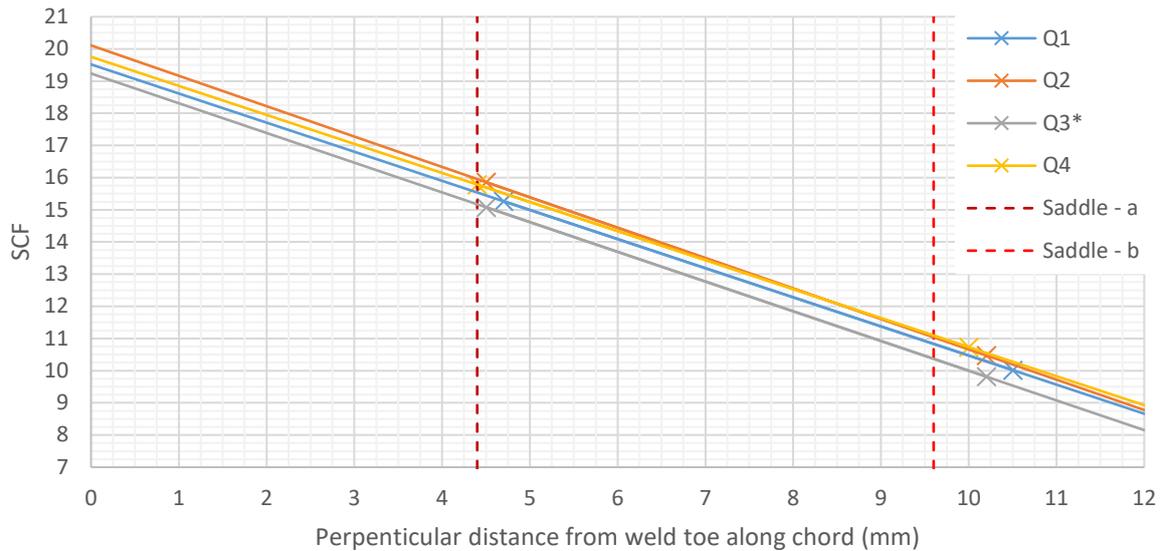
Figure 5-1: SCF at the four quadrants from the experimental work, with $\Delta P=40$ kN. *The SG positioned in saddle-b at Q3 was not measured after installation. Hence, the average SG placement in saddle-b from the other three quadrants is plotted.

The quantification of the HSSs' was accomplished via the linear extrapolation technique described in section 2.3.2, where the strains recorded from the strain gauge at point a and b was linearly extrapolated towards the weld toe. The SCF was then obtained by dividing these HSSs by the brace's corresponding nominal stress level or stress range. The maximum SCF based on the 40 kN load range was 20.45 and located in Q2 and the average SCF of the four saddle positions was 19.89.

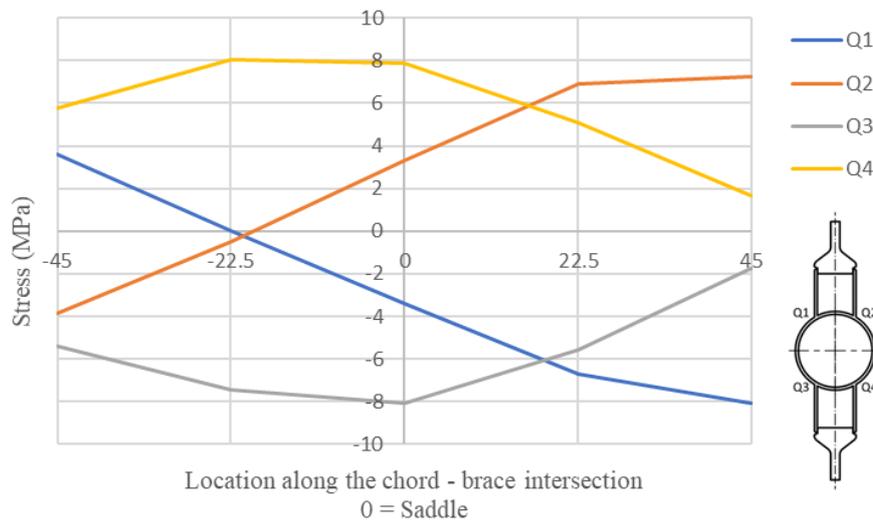
Figure 5-3: Stresses resulting from clamping the specimen in the test rig

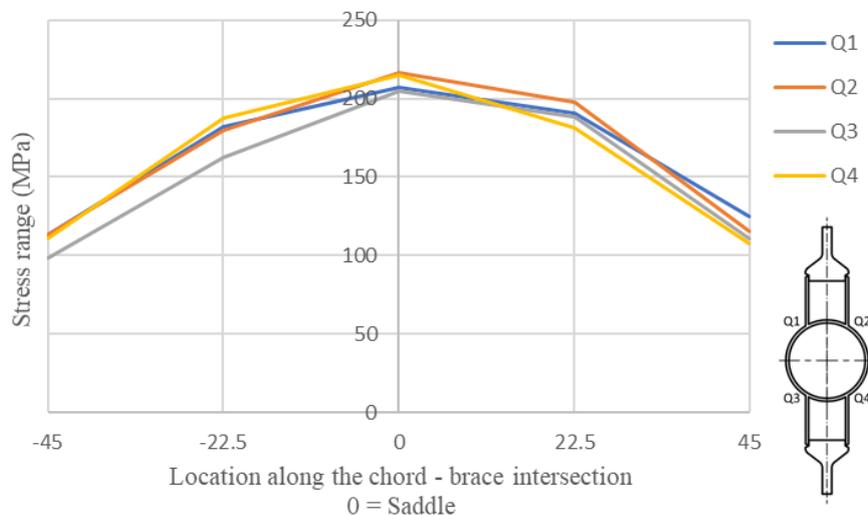
Figure 5-4: Stress range distribution at strain gauge closest to weld along chord-brace intersection ($\Delta P=40\text{kN}$)

As the testing commenced, the stress ranges were recorded and as anticipated for DT joints subjected to axial load, the largest stress ranges were located at the four saddle points. The stresses gradually decreased towards the crown, as shown in Figure 5-4. It is also apparent in Figure 5-4 that stress ranges in all four quadrants are quite similar and symmetric around the saddle. This provides a rough indication of symmetrically placed strain gauges and a lower probability of significant eccentricities in the specimen or test setup. The highest stress range recorded was found in Q2 and Q4.

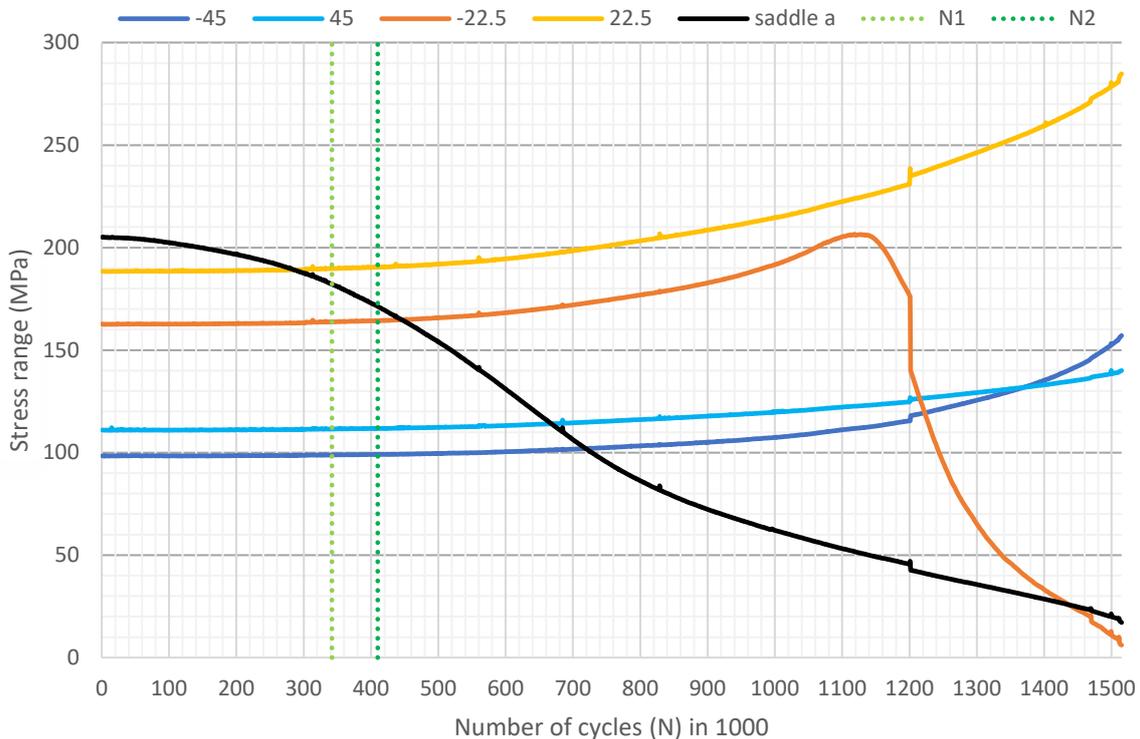
Figure 5-5: Stress range vs number of cycles.

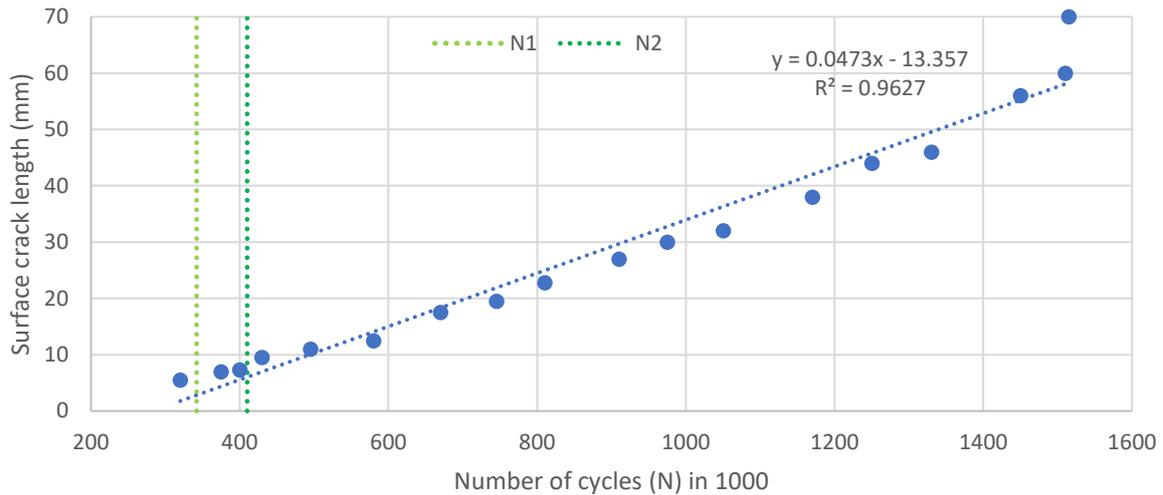
Figure 5-6: Surface crack length vs number of cycles

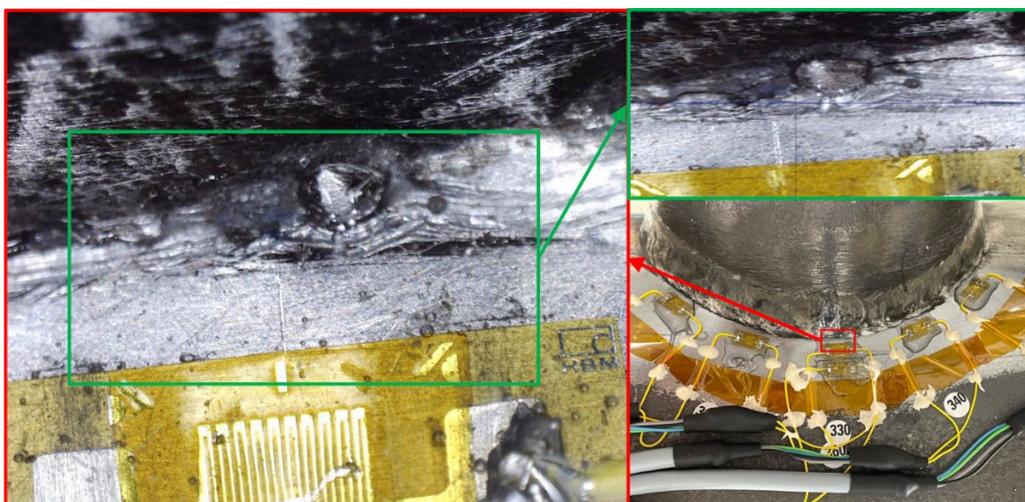
Figure 5-7: Weld scatter at the saddle in Q3

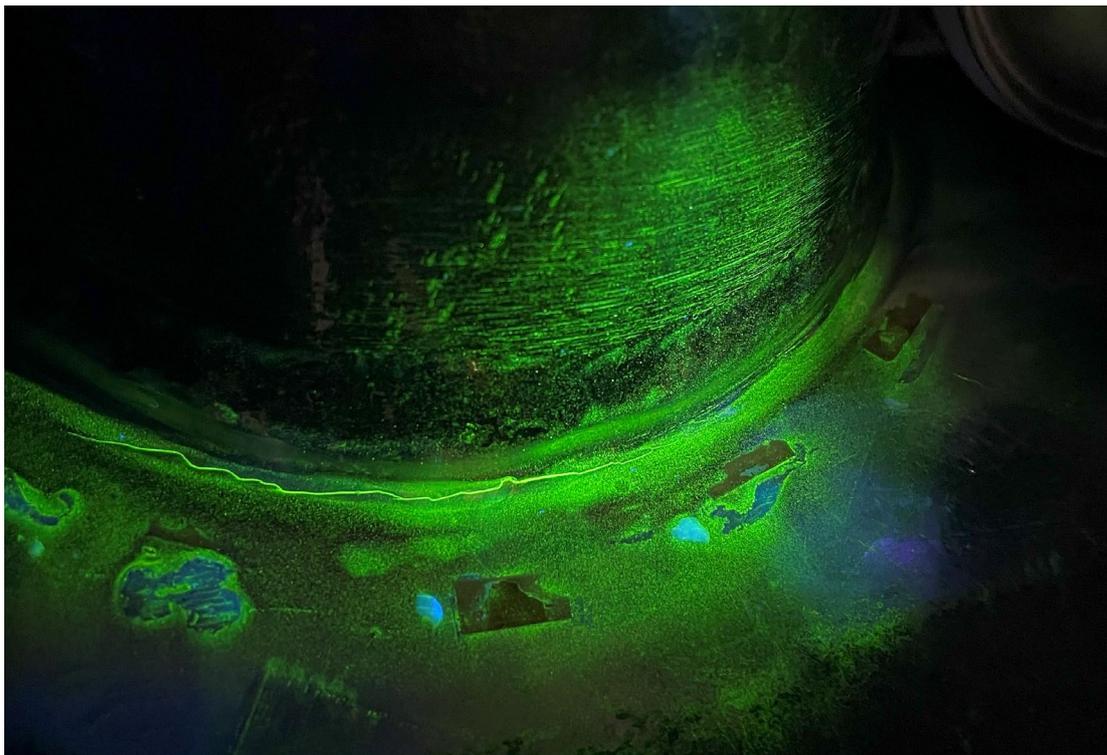
Figure 5-8: MPI of the crack in Q3

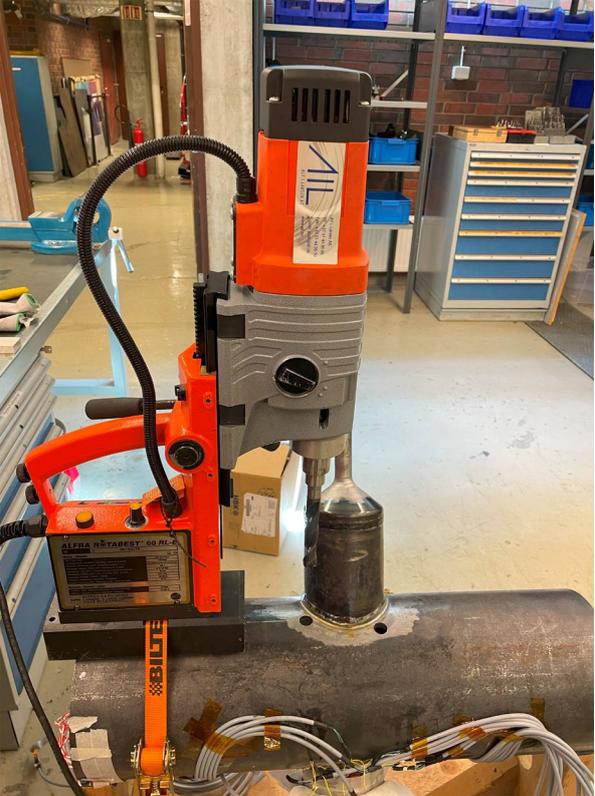
Figure 5-9: Magnetic-based drill

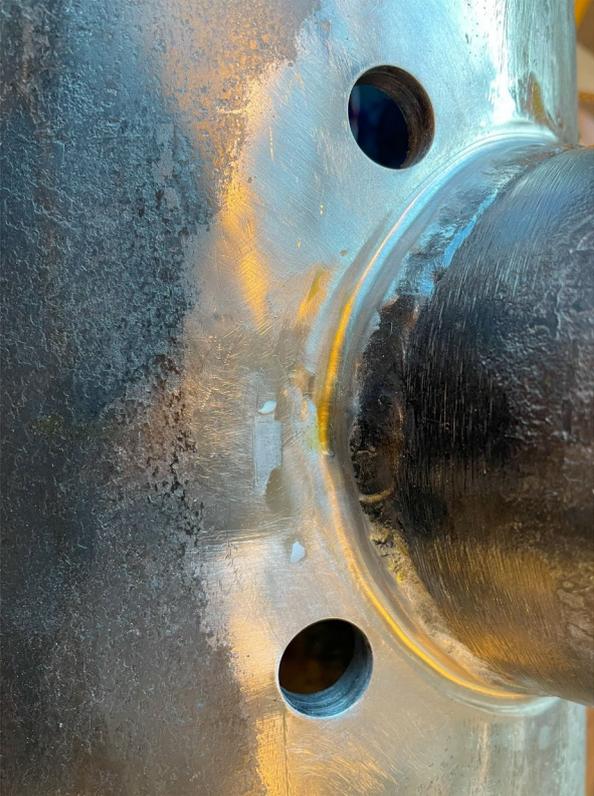
Figure 5-10: Crack deflecting holes

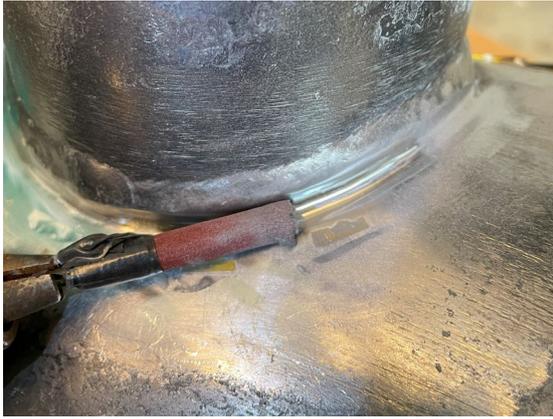
Figure 5-11: Sanding weld toe

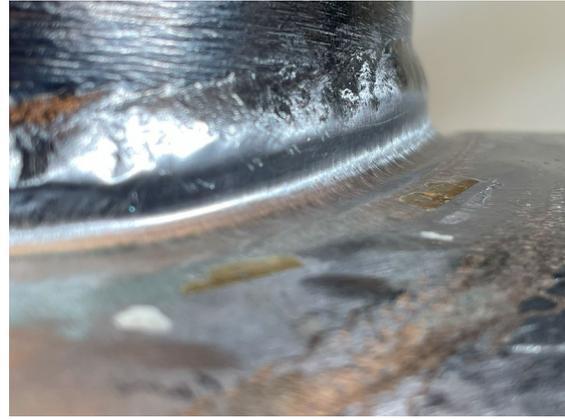
Figure 5-12: Weld profile after weld toe repair

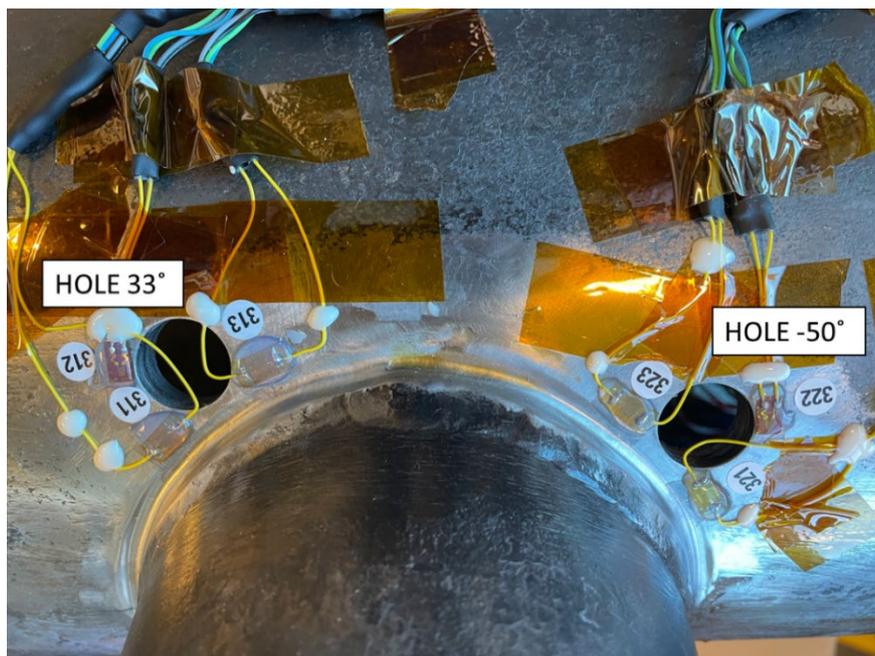
Figure 5-13: Strain gauge layout in repaired quadrant

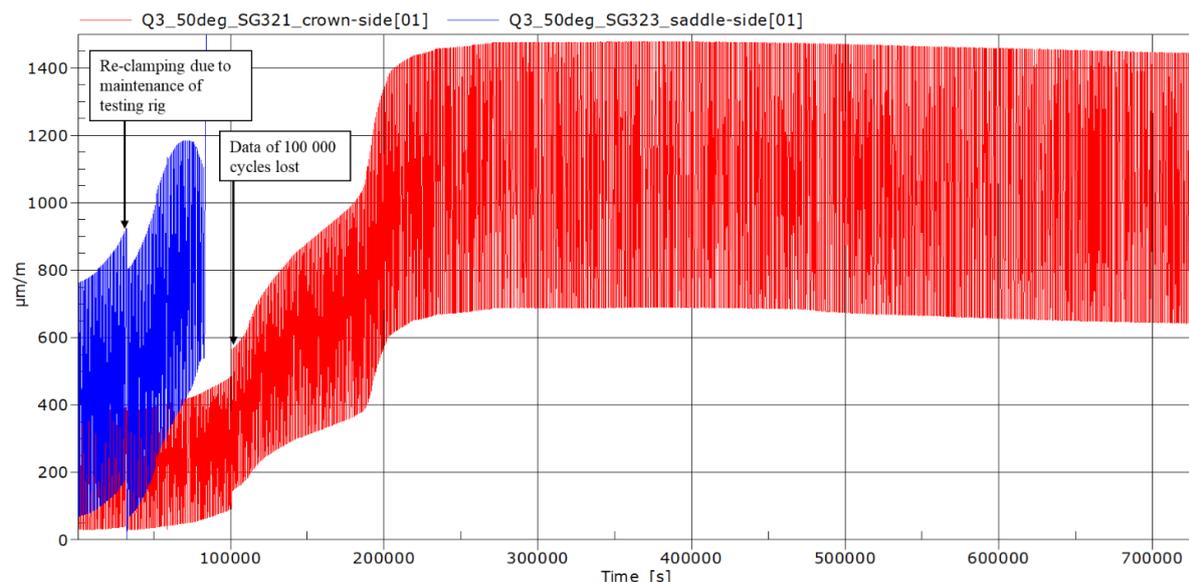
Figure 5-14: Strain evolution diagram -50° hole post-repair testing phase

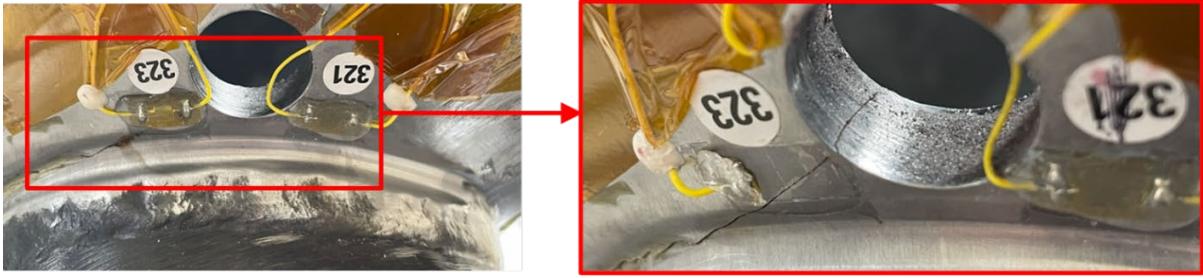
Figure 5-15: Crack propagation into -50° hole

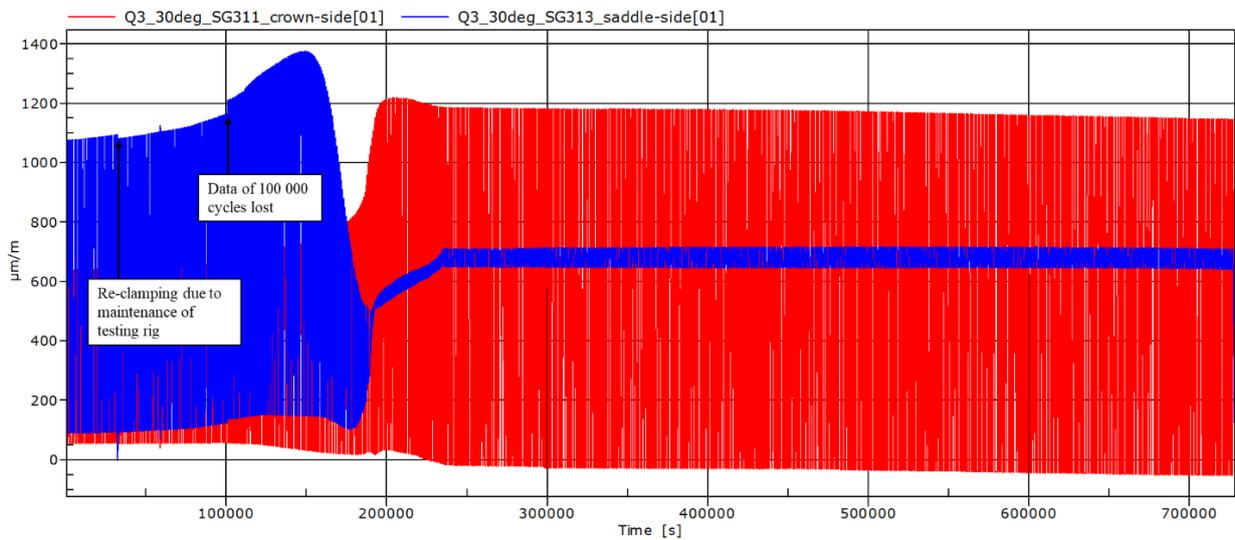
Figure 5-16: Strain evolution diagram +33° hole post-repair testing phase
