MASTER'S THESIS

Study programme / specialisation: Engineering Structures and Materials - Master's Degree / Structural Engineering	The spring semester, 2023 Open / Confidential
Author: Simen Riise	
Supervisor at UiS: Gerhard Ersdal External supervisor: Mostafa Ahmed Atteya	
Thesis title: Experimental assessment of cracked tubular joints repaired with crack-deflecting holes and weld-toe grinding	
Credits (ECTS): 30	
Keywords: Tubular joints Fatigue cracks Life extension Crack deflecting holes Weld-toe grinding Experimental assessment Numerical analysis Stress concentration factors	Pages: 64 + appendix: 38 Stavanger, 15.06.2023

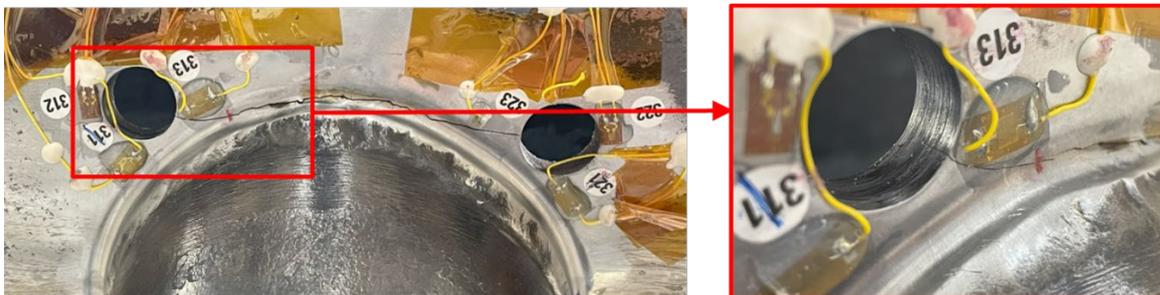
Figure 5-17: Crack propagation into +33° hole

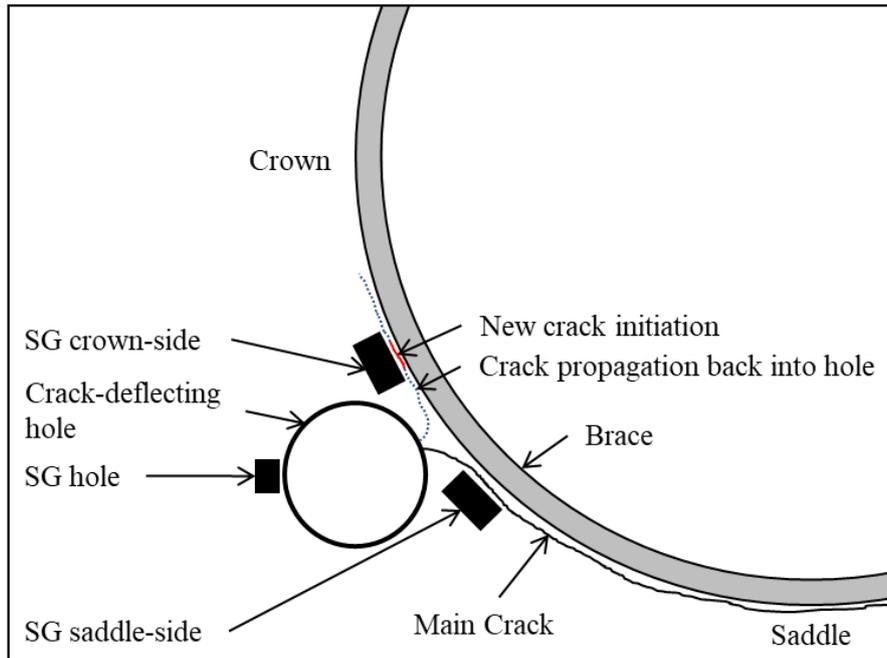
Figure 5-18: Reverse coalescence phenomena and strain gauge naming

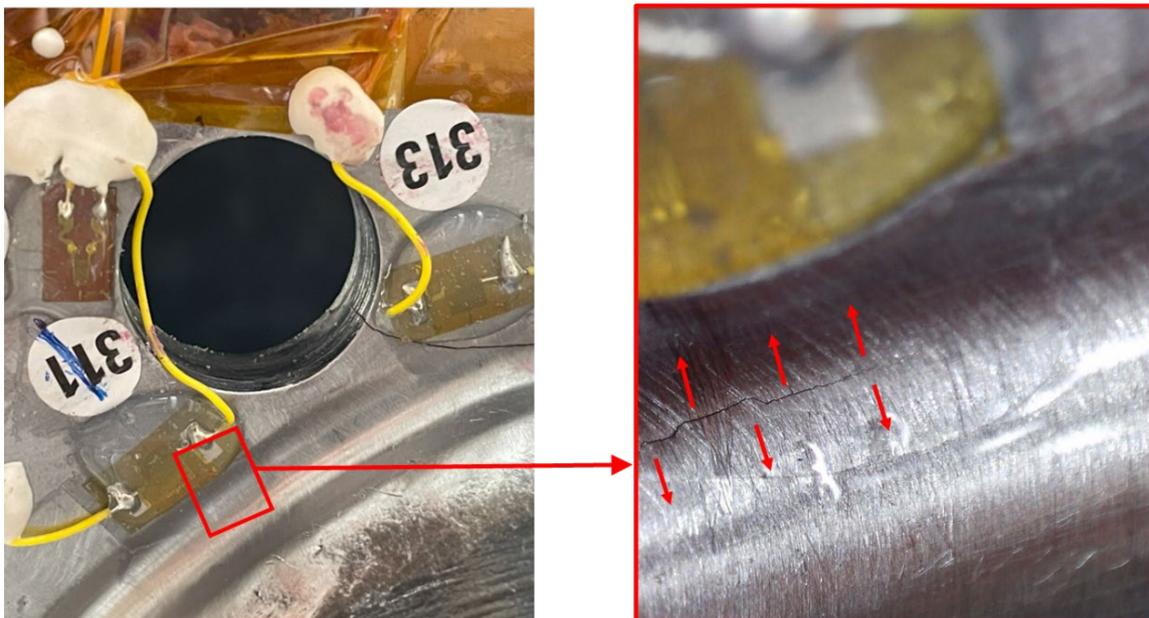
Figure 5-19: Crack initiation in front of SG crown-side at $+33^\circ$ hole

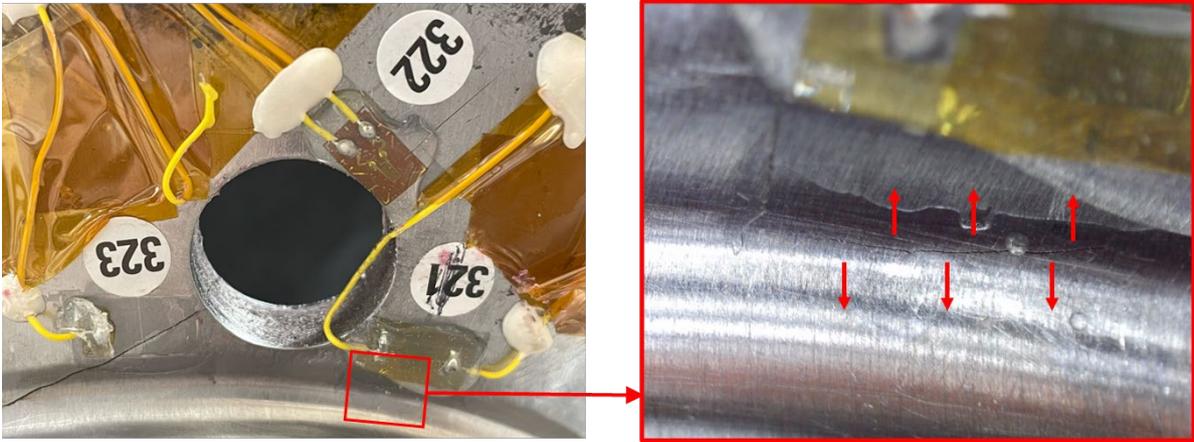
Figure 5-20: Crack initiation in front of SG crown-side at -50° hole

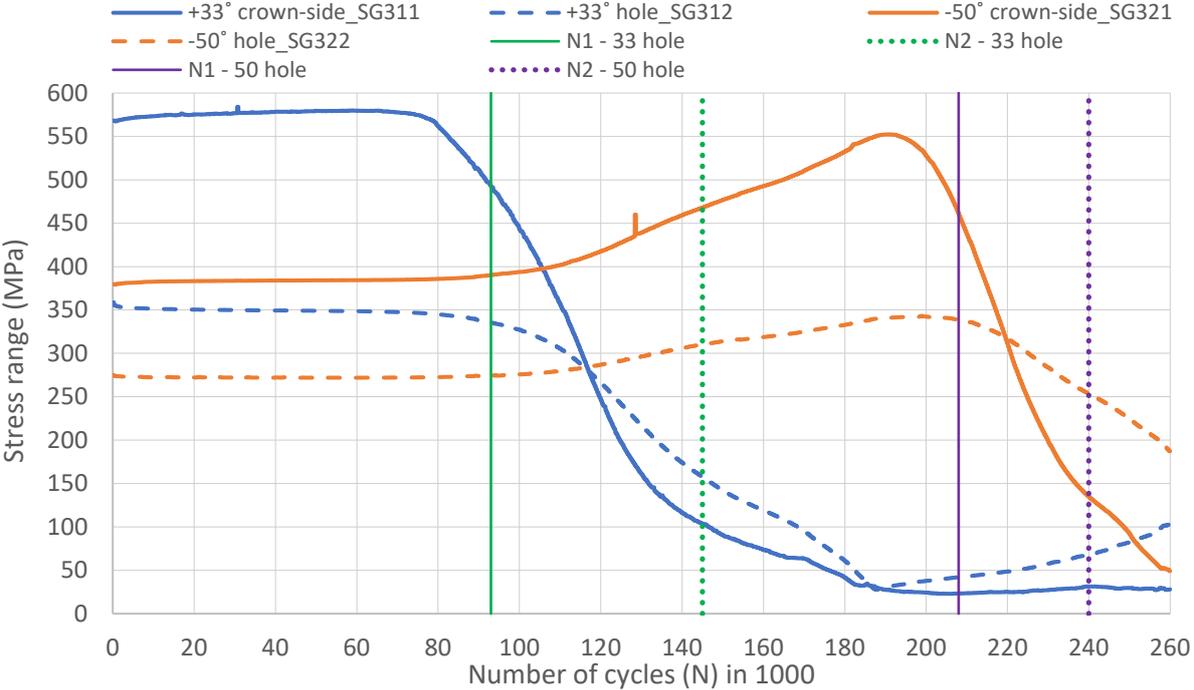
Figure 5-21: Stress range vs number of cycles post-repair

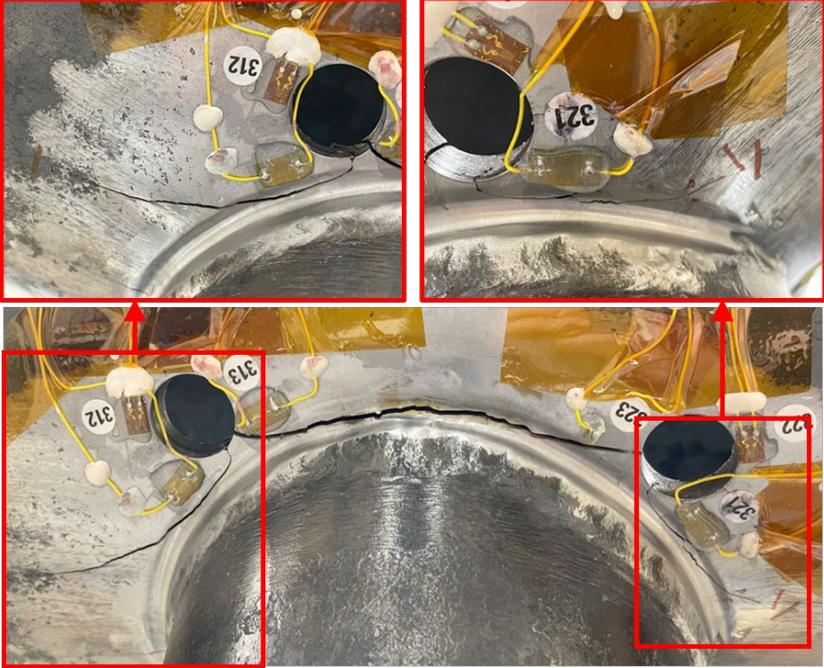
Figure 5-22: Total crack after terminated test

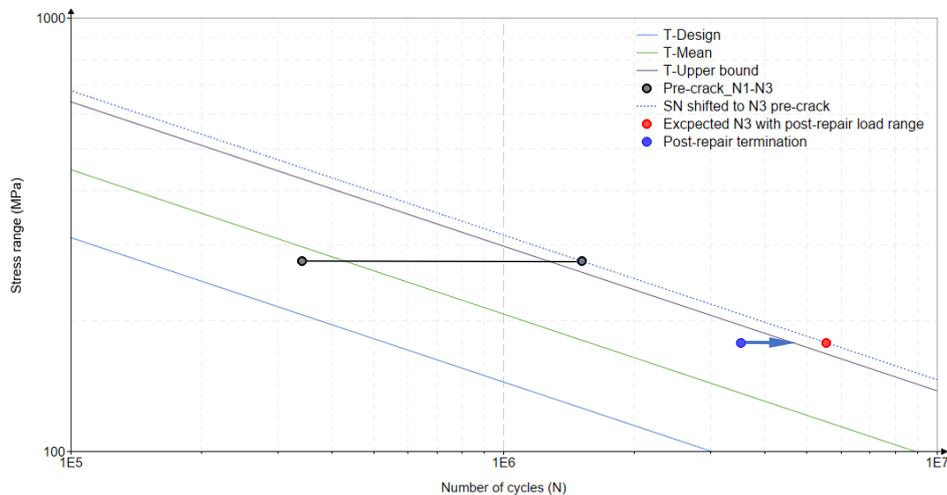
Figure 6-1: Standard SN curve and SN curve shifted to pre-crack result

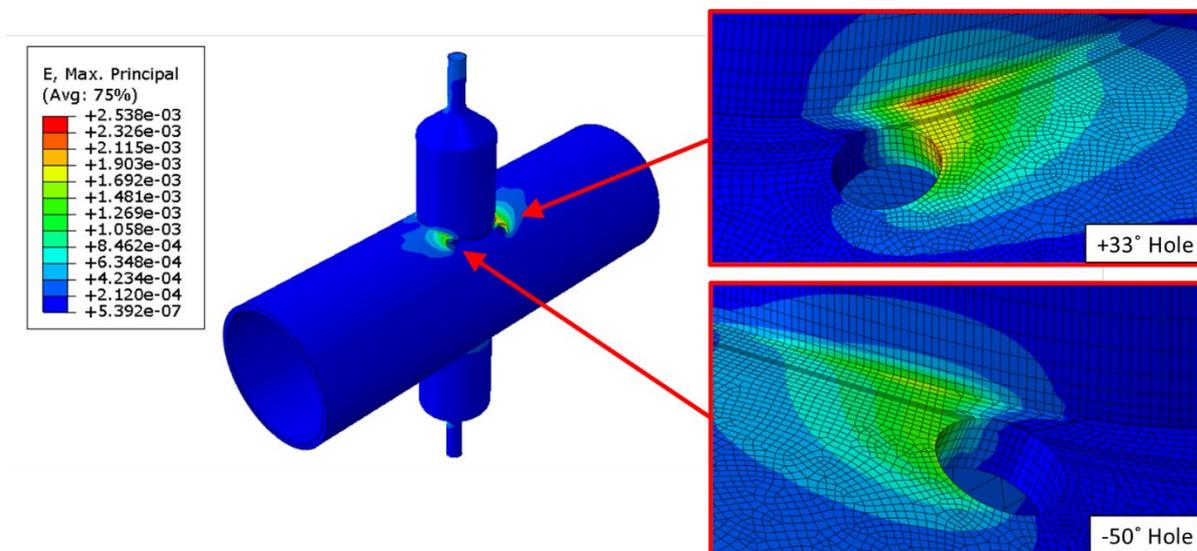
Figure 6-2: FE model of the repaired DT-joint, including the crack

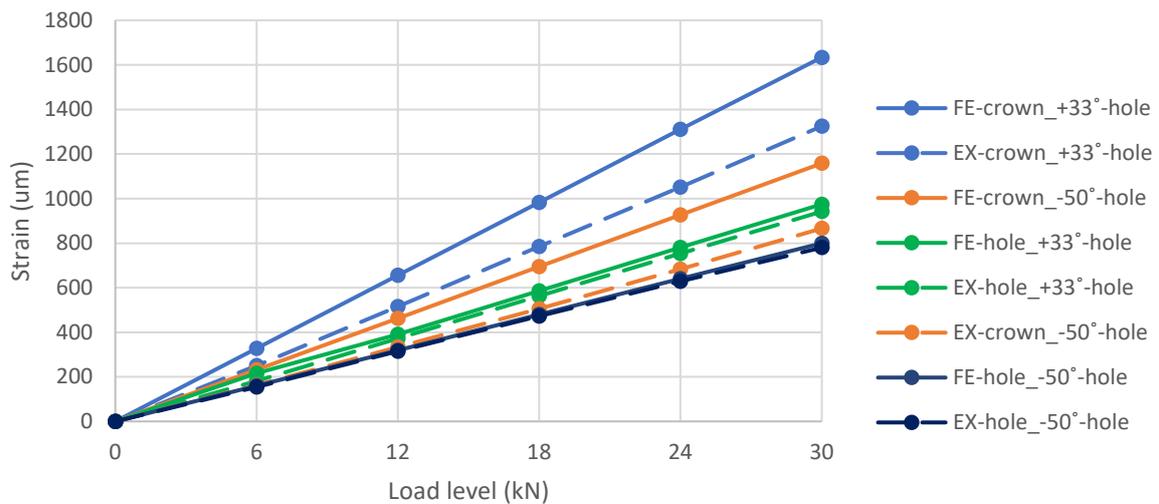
Figure 6-3: Strain readings from the FE model and SG in the experimental work for different load levels

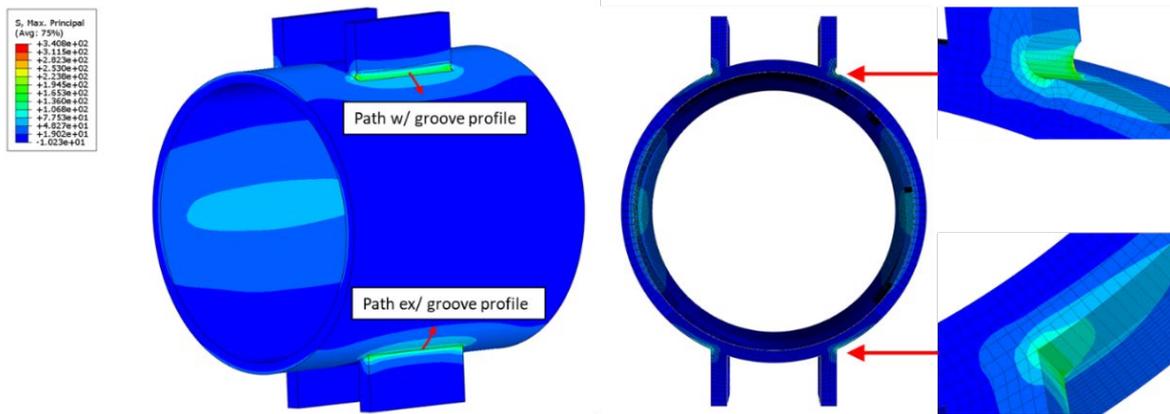
Figure 6-4: FE model of ground weld-toe profile

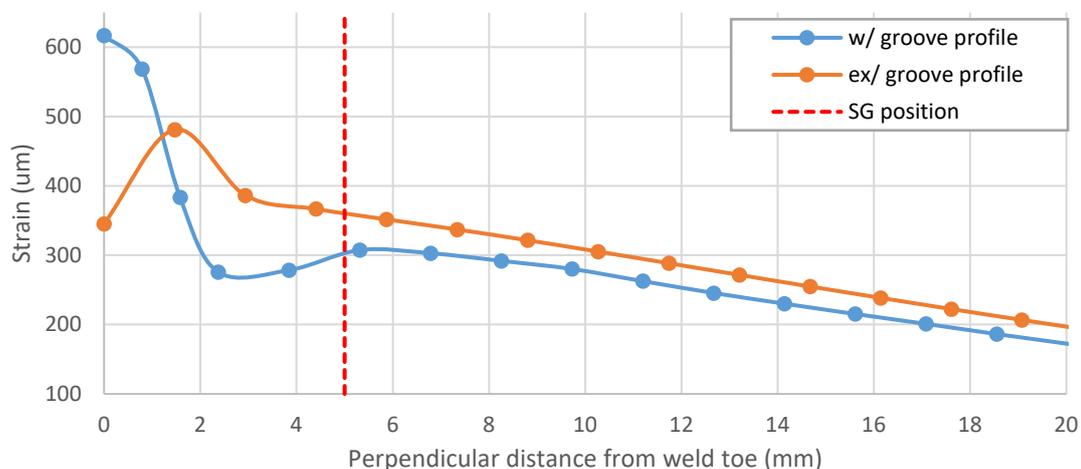
Figure 6-5: Directional strains along paths illustrated in Figure 6-4

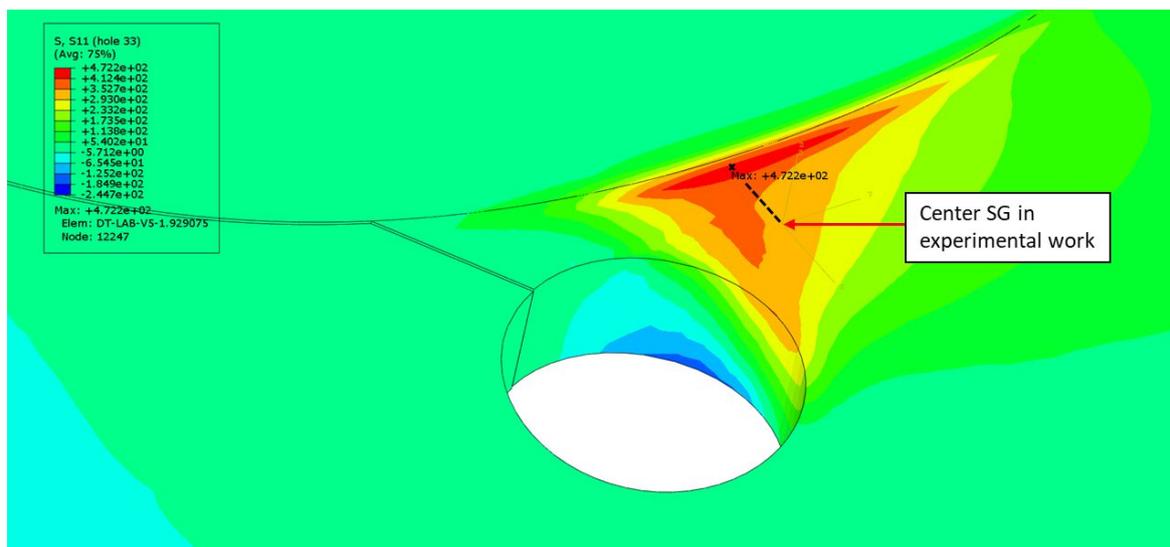
Figure 6-6: Directional stresses around +33° hole

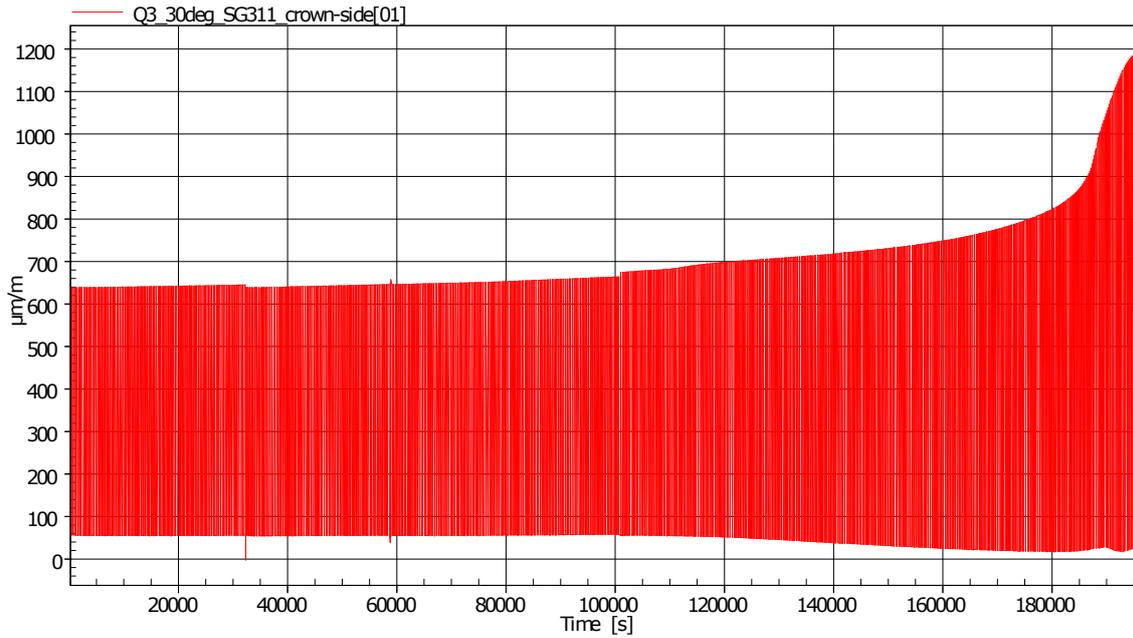
Figure 6-7: Time series of the first 930 000 cycles 1st attempt post-repair SG crown-side +33 hole

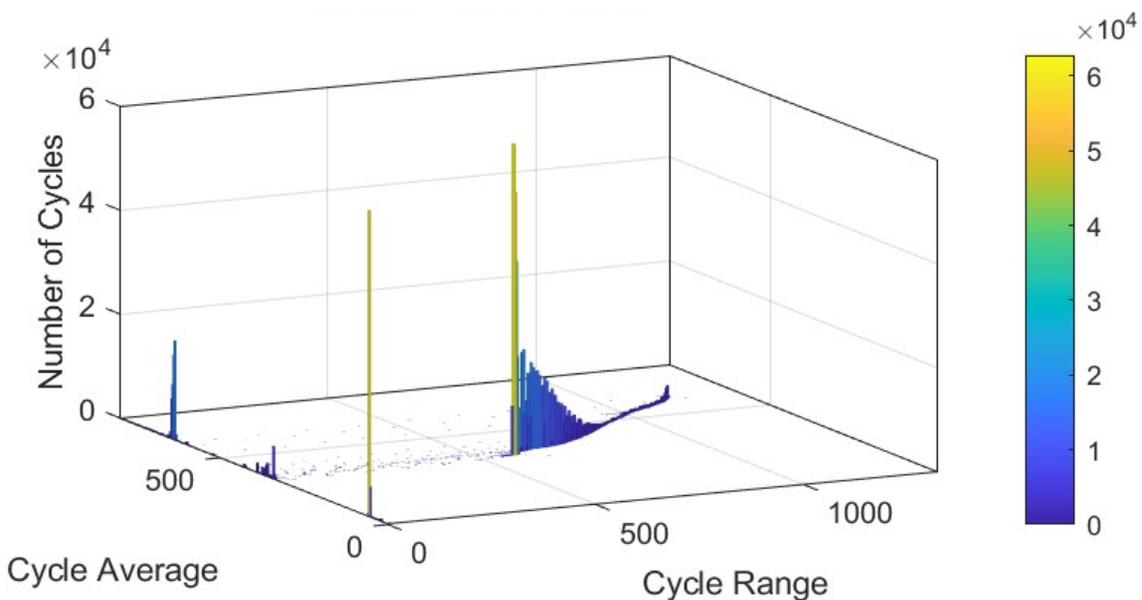
Figure 6-8: Rainflow matrix histogram (w/strain range in μm) of time-series Figure 6-7

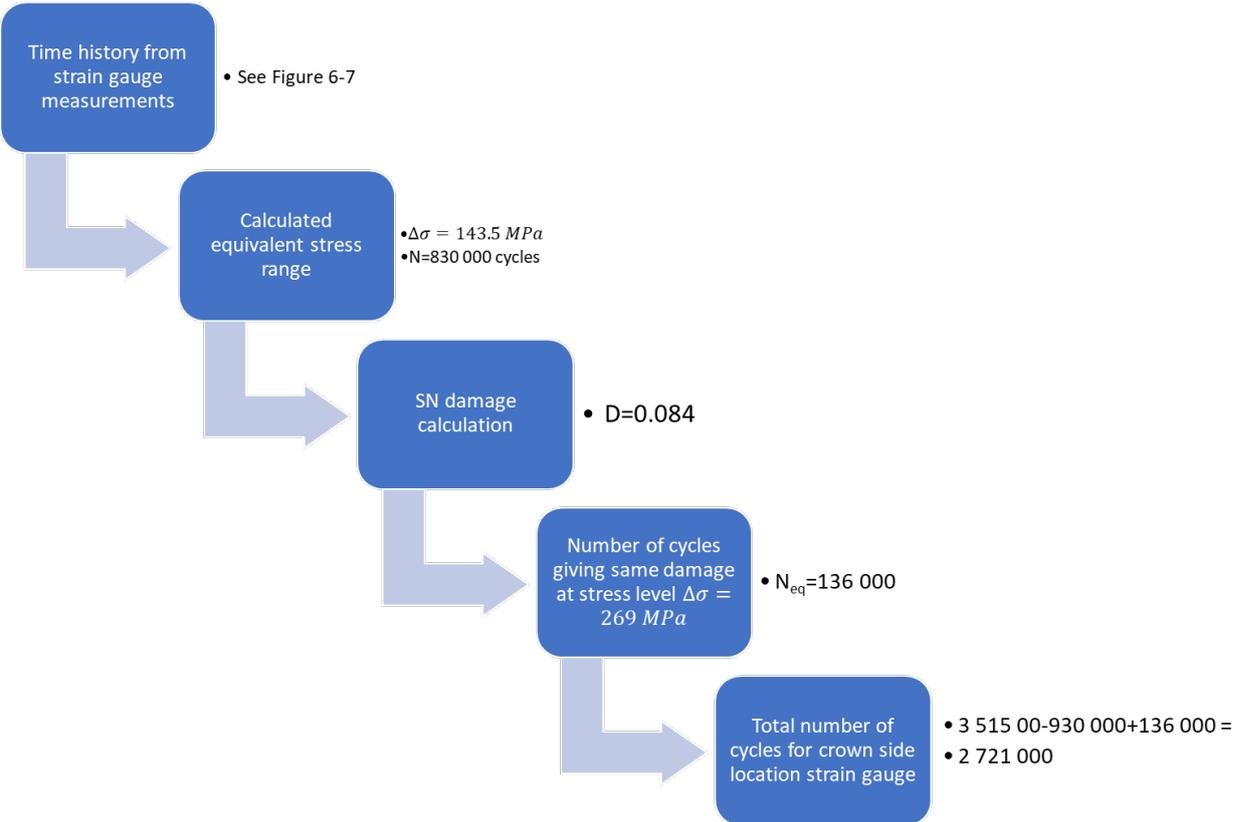
Figure 6-9: Calculation processes to estimate the number of cycles in post-repair testing with $\Delta\sigma = 269$ MPa

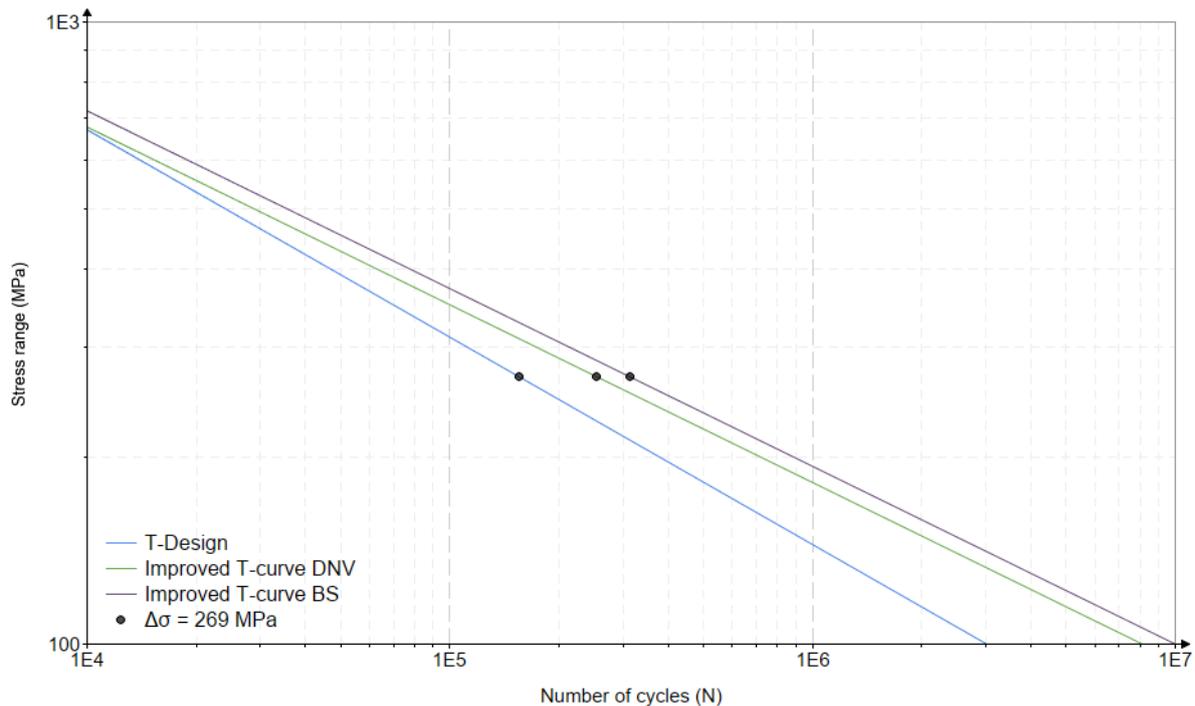
Figure 6-10: Improved SN curve from weld-toe grinding

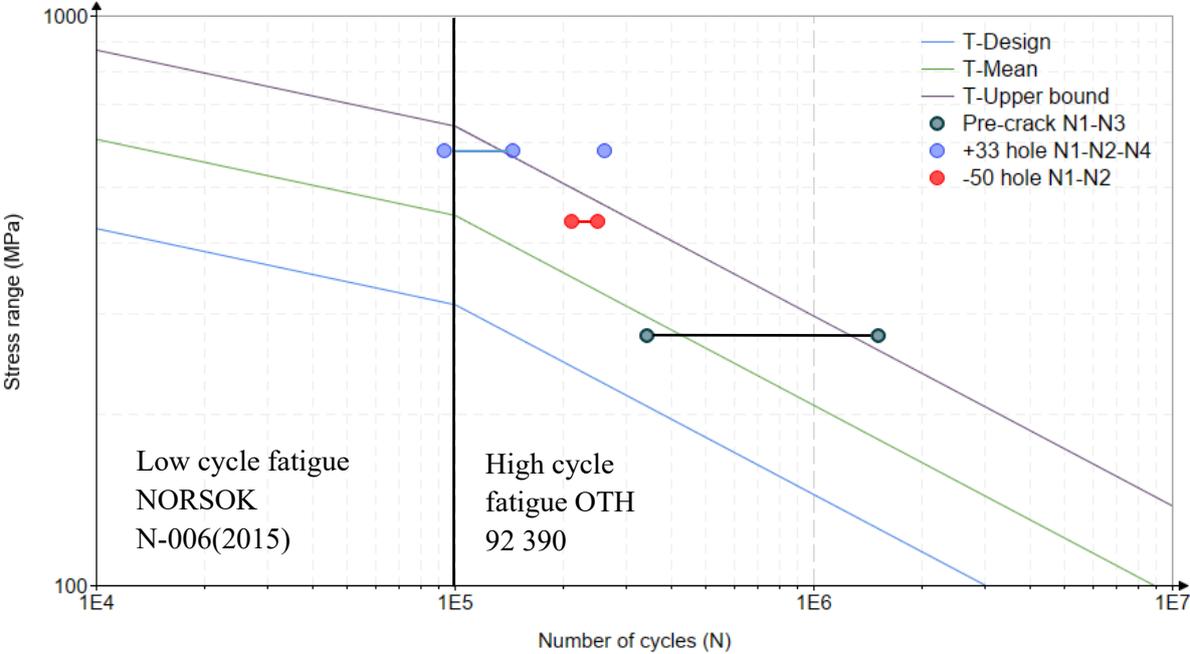
Figure 6-11: Result from testing plotted on standard SN curve

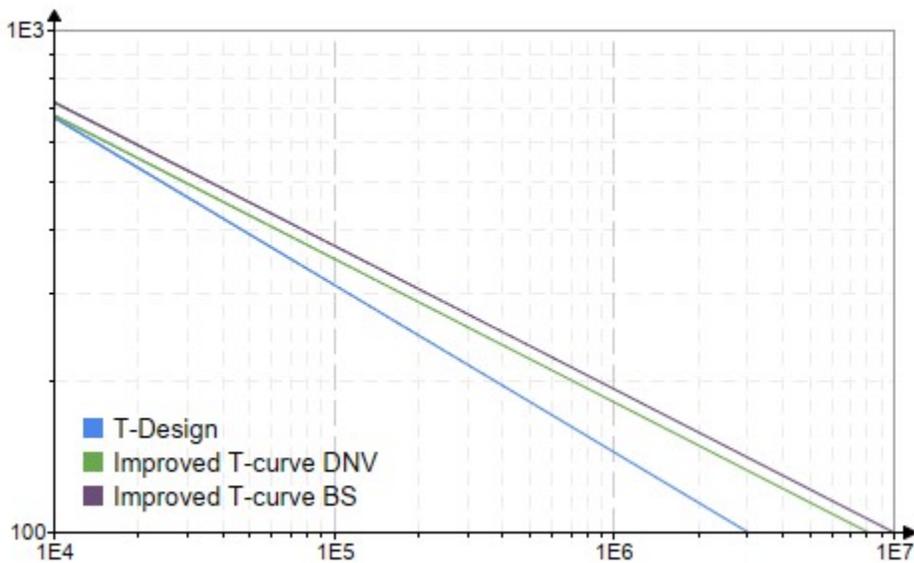
Excepted number of cycles based on DNV and BS for directional and HSS range post-repair:
