# **Structural Integrity of Flange Connection in Onshore Wind Turbine Towers.**

**Investigating Premature Bolt Failures**

**Bachelor Thesis 2024**

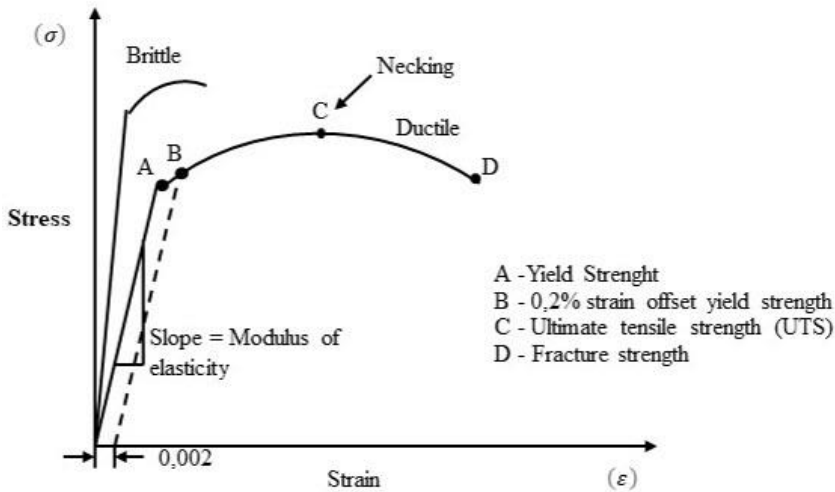
Figure 13 Recreated from [19], Stress-strain curve for a brittle and ductile material.

The transition point from elastic to plastic deformation can be hard to determine for many materials and therefore a convention is established with a linear line drawn parallel to the linear line of the stress-strain curve. This offset is usually 0,2% and is marked as point B in figure 13.

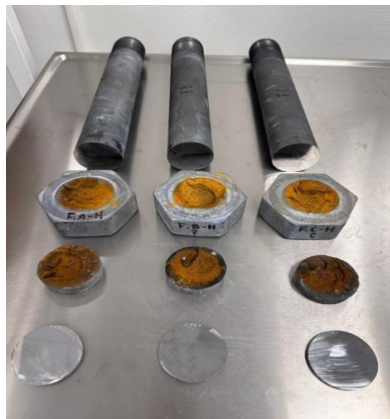
Figure 20 Overview of shanks, bolt heads, fracture surfaces and shank specimens.

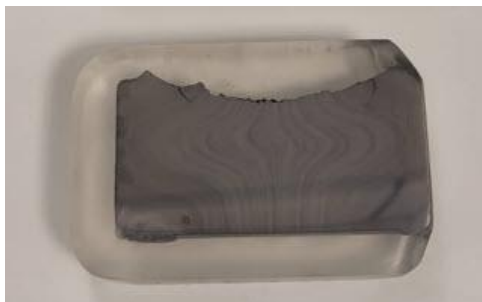
Figure 25 Residual stresses within bolt heads.

Prior to optical microscopy, the parts dipped in 2% Nital solution for 45 seconds. This etching improved the visibility of areas in the micro-structures, enabling one to observe them under a microscope. Etching of specimen from heads revealed residual stress lines inside the heads as shown in figure 25.

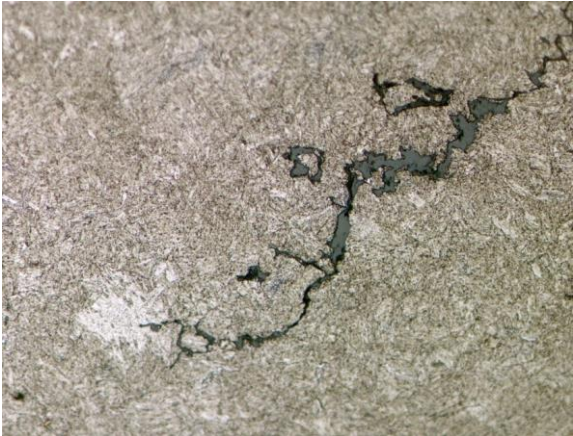
Figure 33 FAH-2 50X possible ductile crack growth.

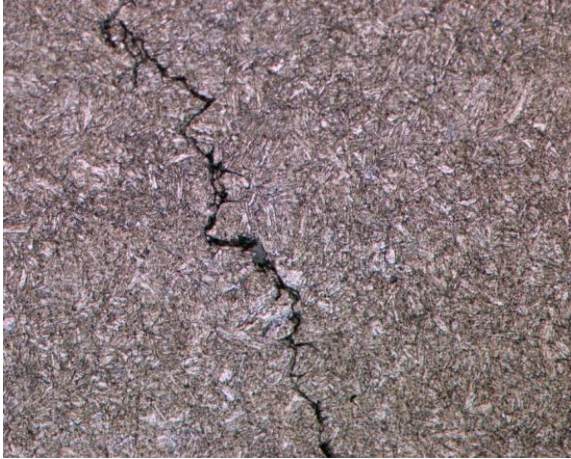
Figure 35 FCH-1 50X possible ductile crack, zig zag pattern.
