## MASTER'S THESIS

Study program/ Specialization: <b>MSc Petroleum Engineering/Drilling Technology</b>	Spring semester, 2014 Open / Restricted access
Writer:  <b>GOKULAKRISHNAN THIYAGARAJAN</b>	..... (Writer's signature)
Faculty supervisor: <b>Mesfin Belayneh, UiS</b>	
Title of thesis:  <b>GAP Analysis of Macondo Blowout incident with their prescribed Standards &amp; Codes</b>	
Credits (ECTS): <b>30</b>	
<b>Key words:</b> GAP Analysis, Macondo Blowout, Deepwater Horizon, Standards and Codes	Pages: 77 + enclosure: 14  <b>Stavanger, June 2014</b>

Macondo blowout also known as the Deep Water Horizon incident has been one of the biggest oil field disaster in history. It has also become an effective case study for the Health Safety and Environmental aspects of the Petroleum Industry.

This thesis deals by exhaustively comparing the GAP between the Macondo blowout with the regulations, recommended practices, guidelines, Industry standards and codes that existed prior to the blowout (Pre-Macondo) and what was actually implemented in case of deep water horizon as well as analyzing it with the current Norwegian / International Standards and codes (Post-Macondo).

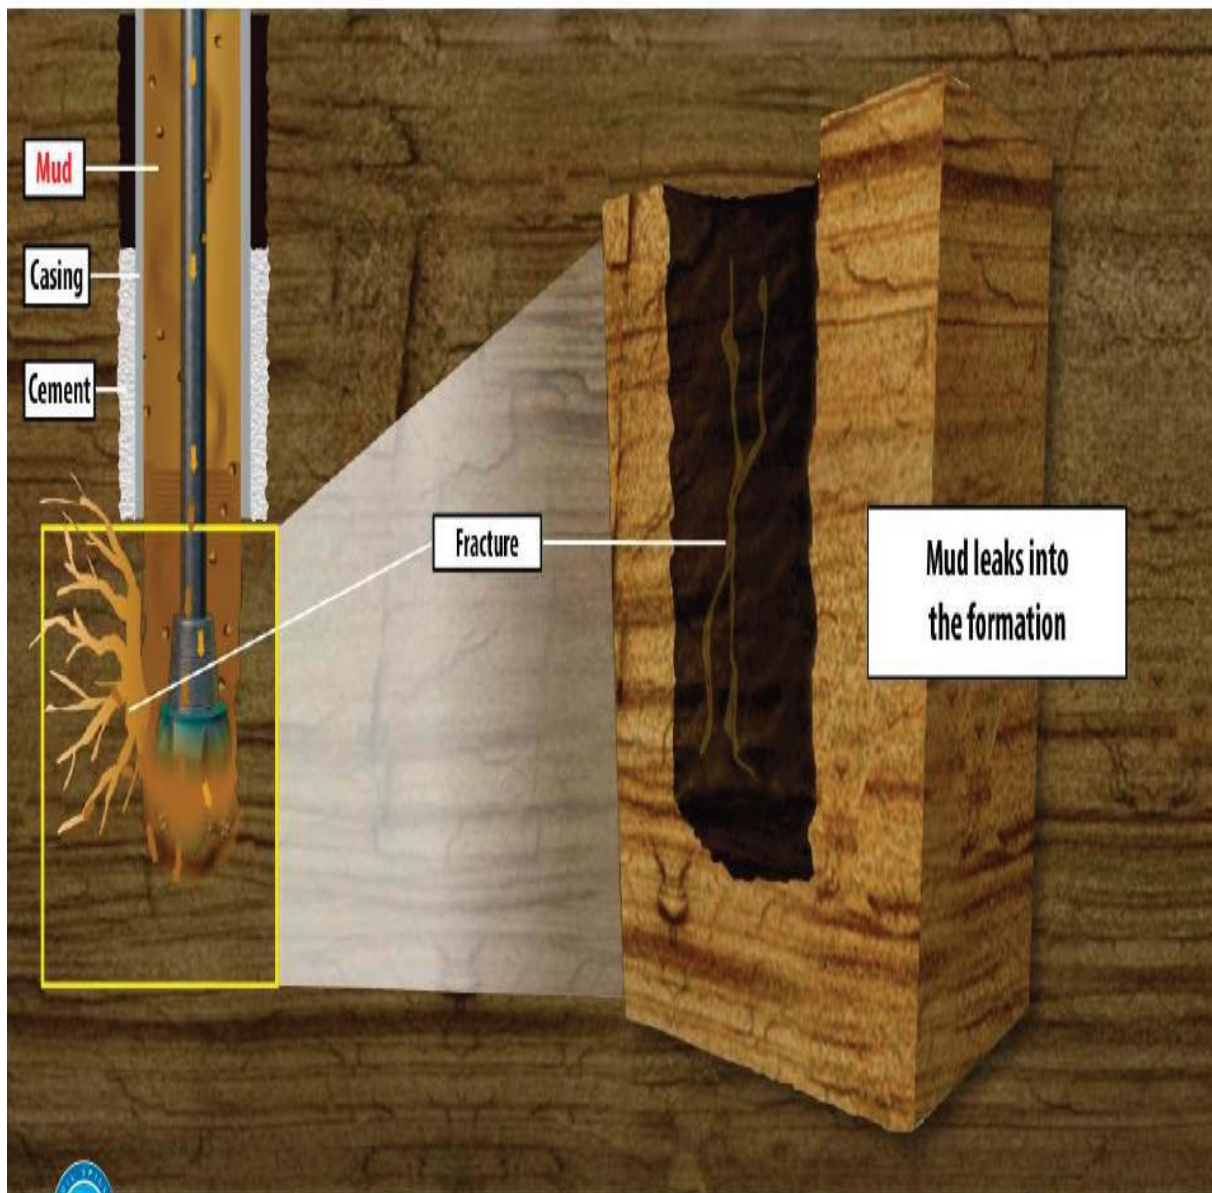
Figure 9-Lost Circulation<sup>11</sup>

Lost circulation is the loss of drilling fluid in to the formation, the drilling mud instead of being circulated up the annulus, flows in to the formation. This could be due to natural fractures in the formation or overbalanced drilling see figure 9.

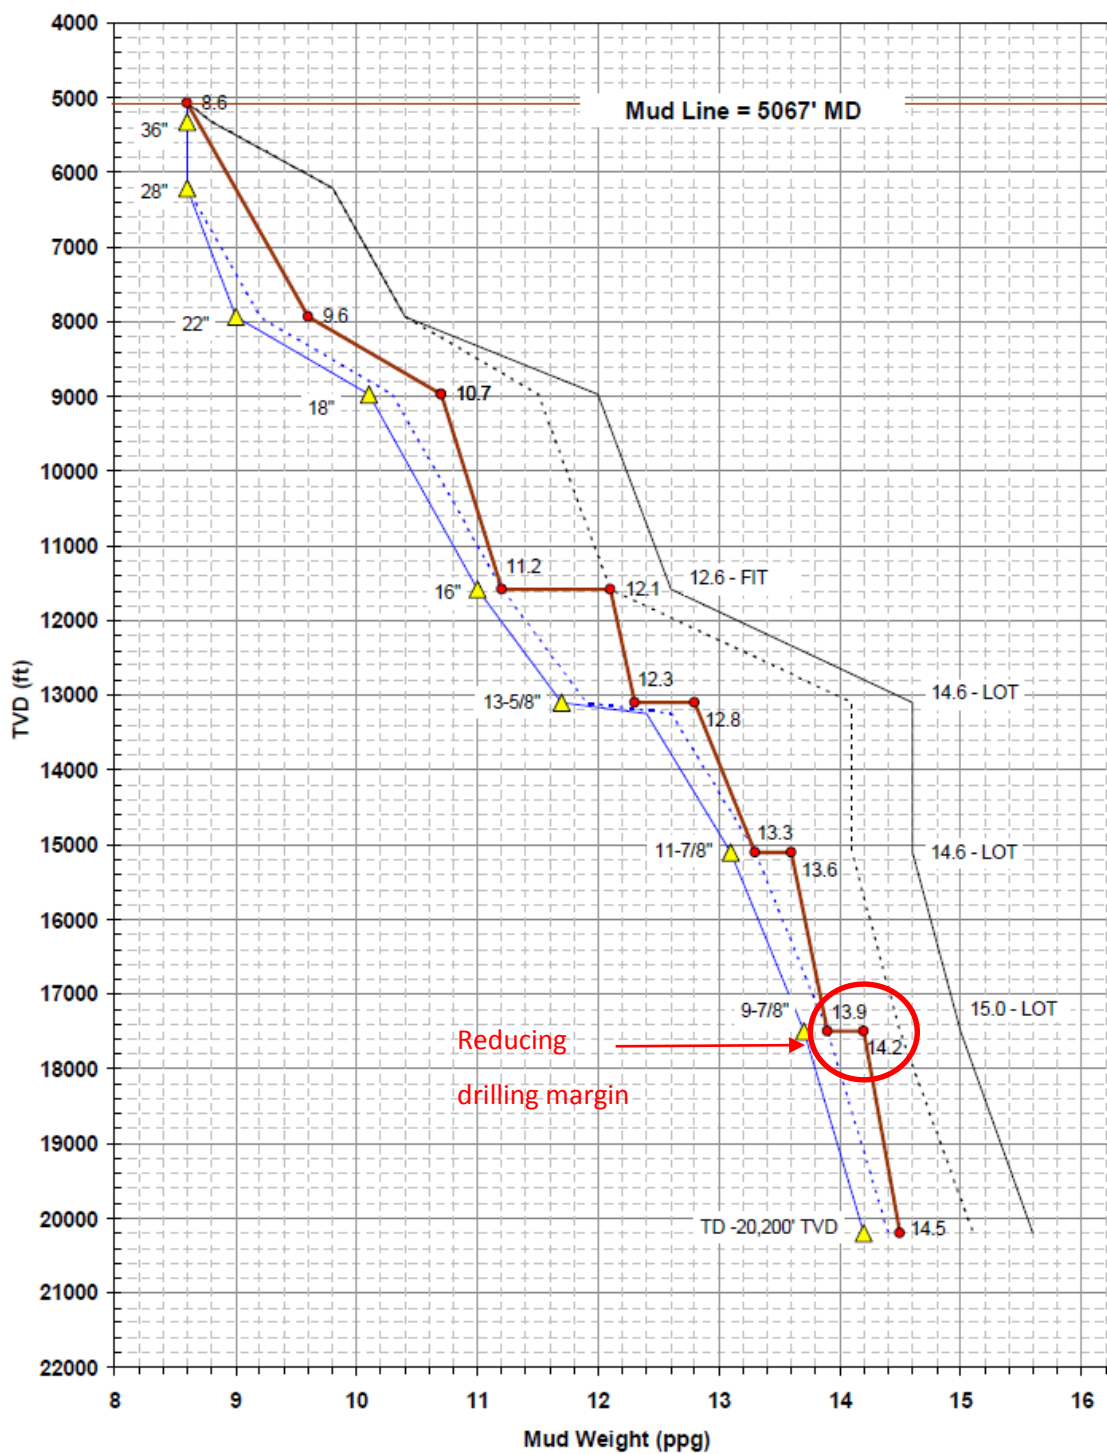
Figure 10-Macondo Well Pore Pressure Fracture Gradient Plot<sup>12</sup>

According to BOEMRE<sup>14</sup> regulations, drilling mud should typically be at least 0.2 ppg (pounds per gallon) above the pore pressure (pp) of the formation to stop the influx of hydrocarbons in to the well and at least 0.5ppg less than the fracture gradient to stop uncontrolled mud loss in to the formation. As seen on figures 10, 11 from 17000 ft. onwards the drilling margin had become very small for BP and from figure 12 BP had lost up to 4000 barrels of drilling mud (between ~17000 feet and ~18000 feet) in to the formation. Therefore this limited the total well depth to 18360 ft. less than the originally planned 20200 ft. This also led BP to change the well casing program.

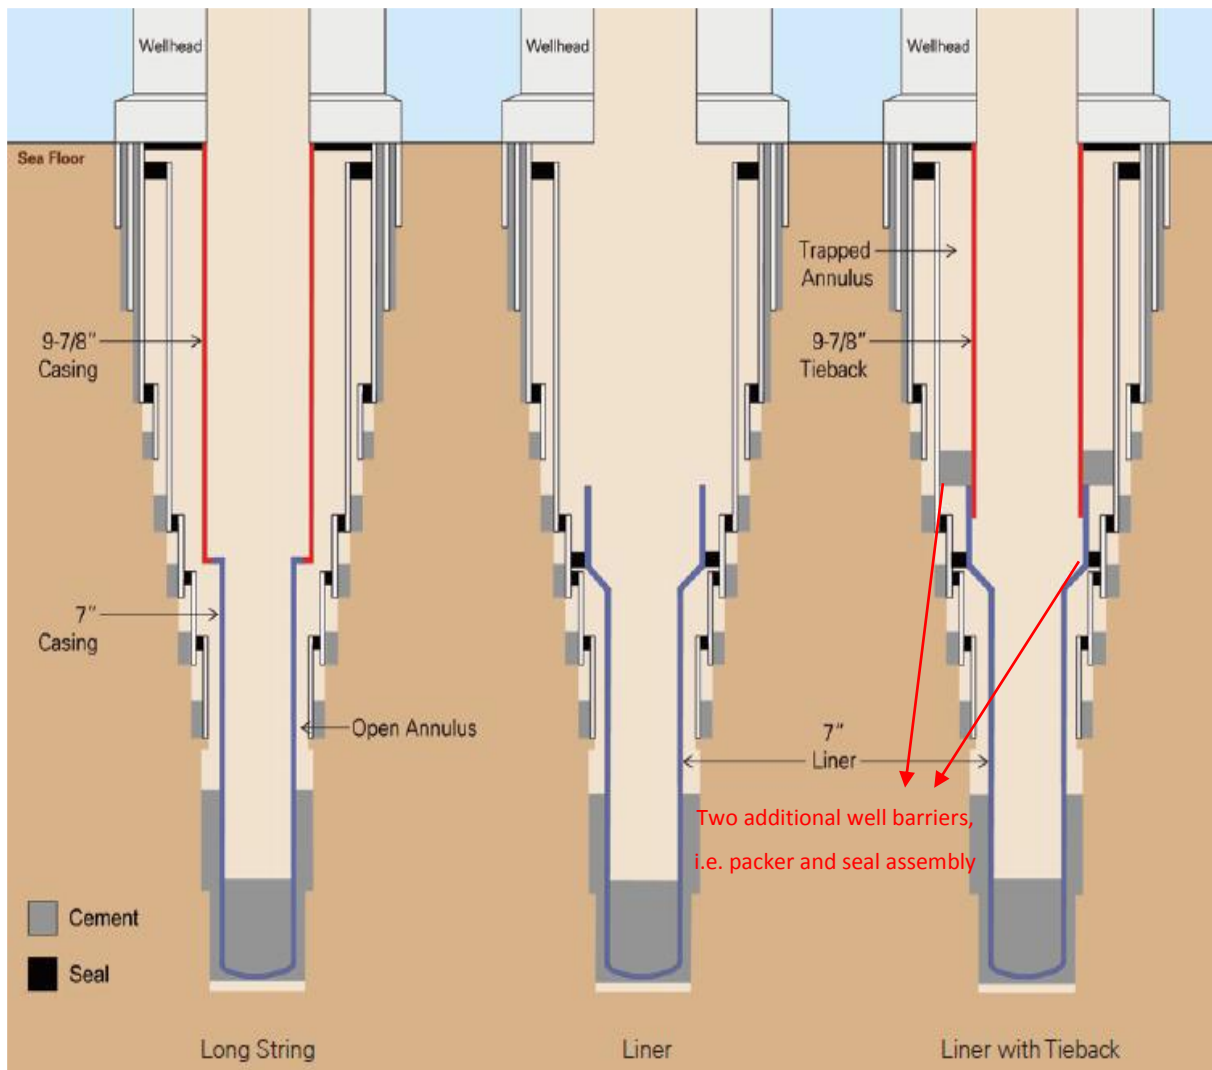
Figure 15-Long string, Liner and Liner with Tieback<sup>18</sup>

A liner tie back string is expensive and although it provides two additional well barrier (i.e. the liner has to be sealed to the previous 9 7/8" casing by a packer as well a seal assembly at the tie back junction, figure 15) to hydrocarbon flow path, it has risks w.r.t mechanical integrity failure at the tie back junction, increased annular pressure build-up due to fluid expansion by heat transfer during production (the annulus of the 7" liner string is sealed at top by the tie-back seal assembly and casing shoe at the bottom, therefore if there is a the pressure build-up, there are no means to bleed off) [4].

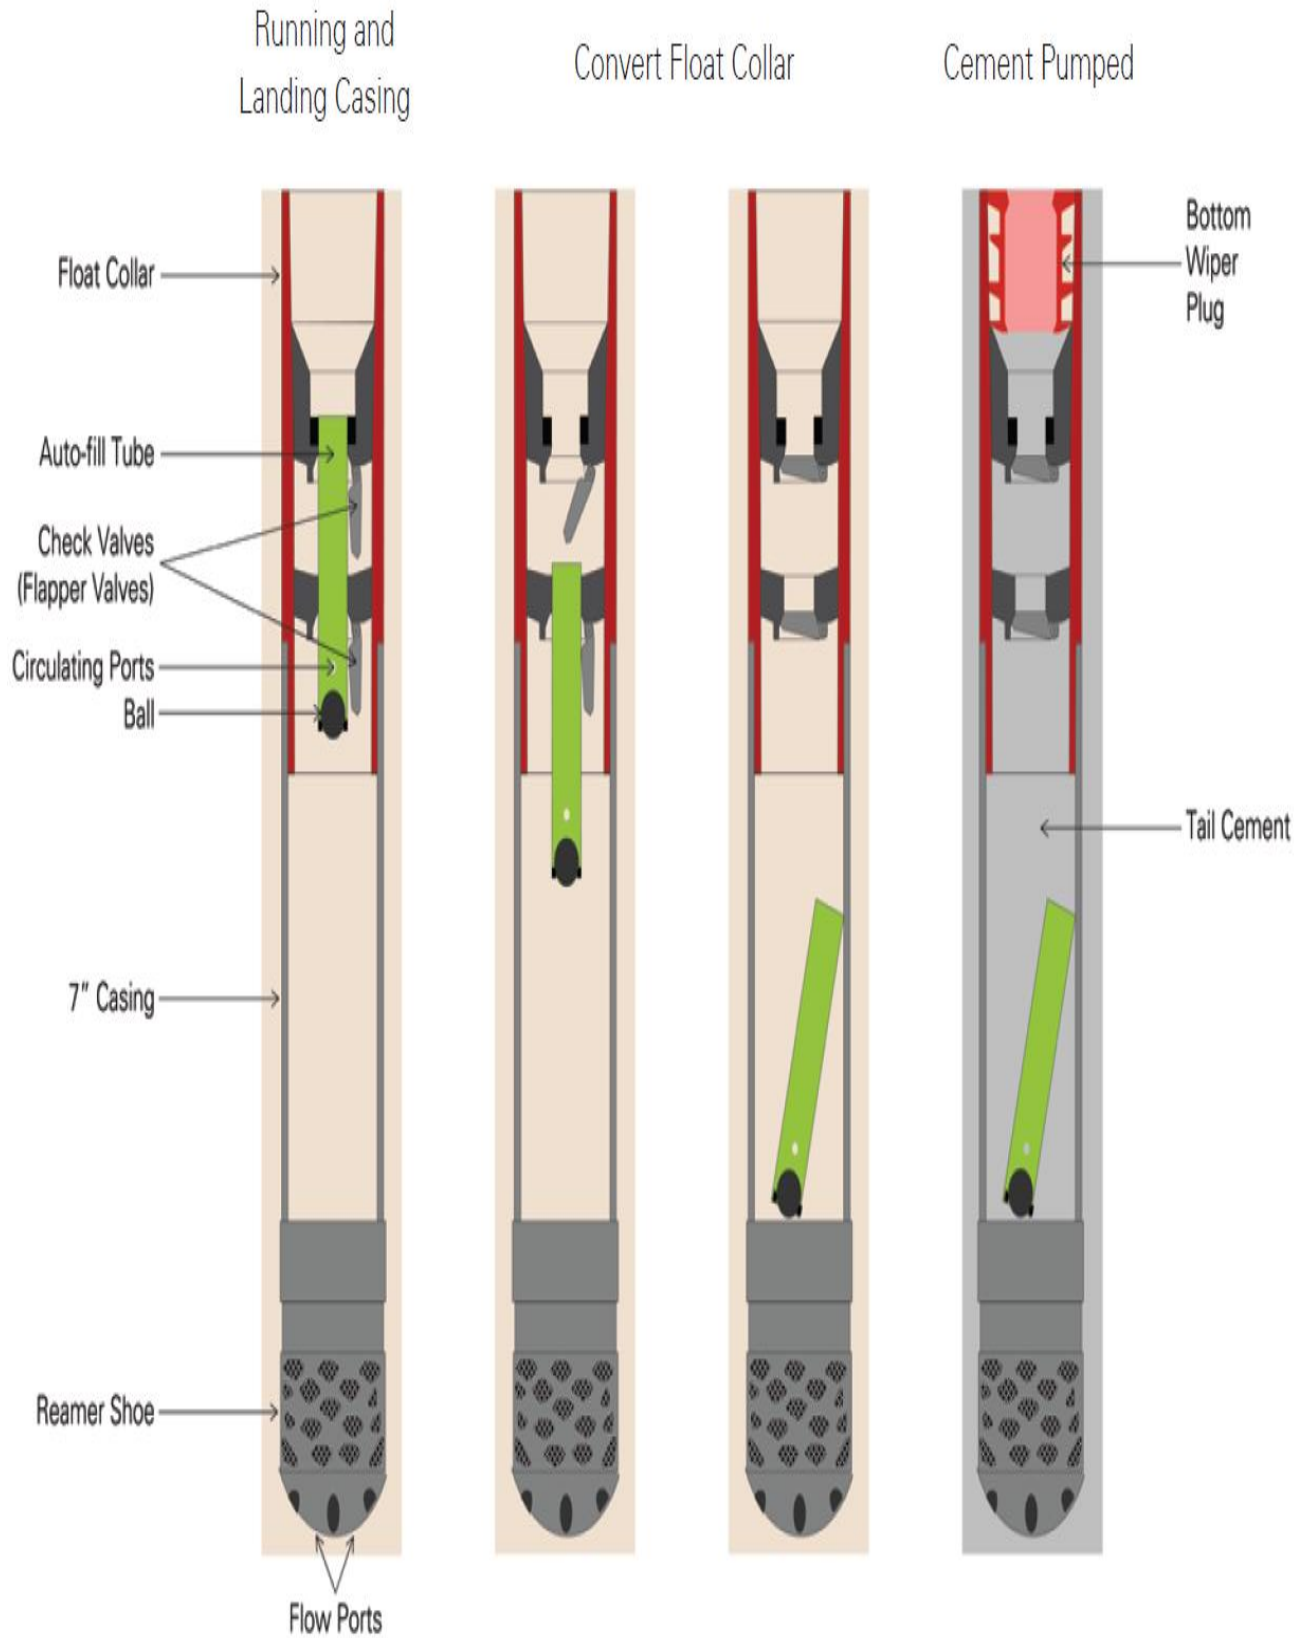
Figure 19-Float Collar conversion<sup>26</sup>.

Float collars are double-check valves on the top of a casing shoe or at the bottom of a casing string, see figure 19. When activated/converted it only allows flow through one direction and stops back-flow. In the Macondo well, BP used a Weatherford Model M45AP (see Appendix D) mid-bore auto-fill float collar[4]. There is an auto fill tube inside the float collars which keeps the two flapper valves held open by default. When the final production casing is run in to the well it results in excess volume (increased ppg) of the casing and therefore the equivalent drilling mud has to be removed/displaced. This is done by displacing the excess volume (increased volume due to running the casing) through the circulating ports in the auto fill tube. Once the casing is run and set, the base oil, spacer and cement mix are pumped in to the casing and up in to the annulus of the liner through flow ports at the bottom

of the casing shoe as shown in figure 19. Once the required Top of Cement (TOC) is reached the casing is pressurized from the rig at an optimal flow rate to convert the float collars (the increasing pressure displaces the auto fill tube into the shoe track<sup>27</sup> below, this closes the flapper valves). In case the float collar does not convert (the auto fill tube is not displaced), the flapper valves are still held open and reverse flow is possible i.e. flow from the annulus of the liner, this reverse flow could be cement or drilling mud or even hydrocarbons in case the cement is contaminated and/or did not set in place.

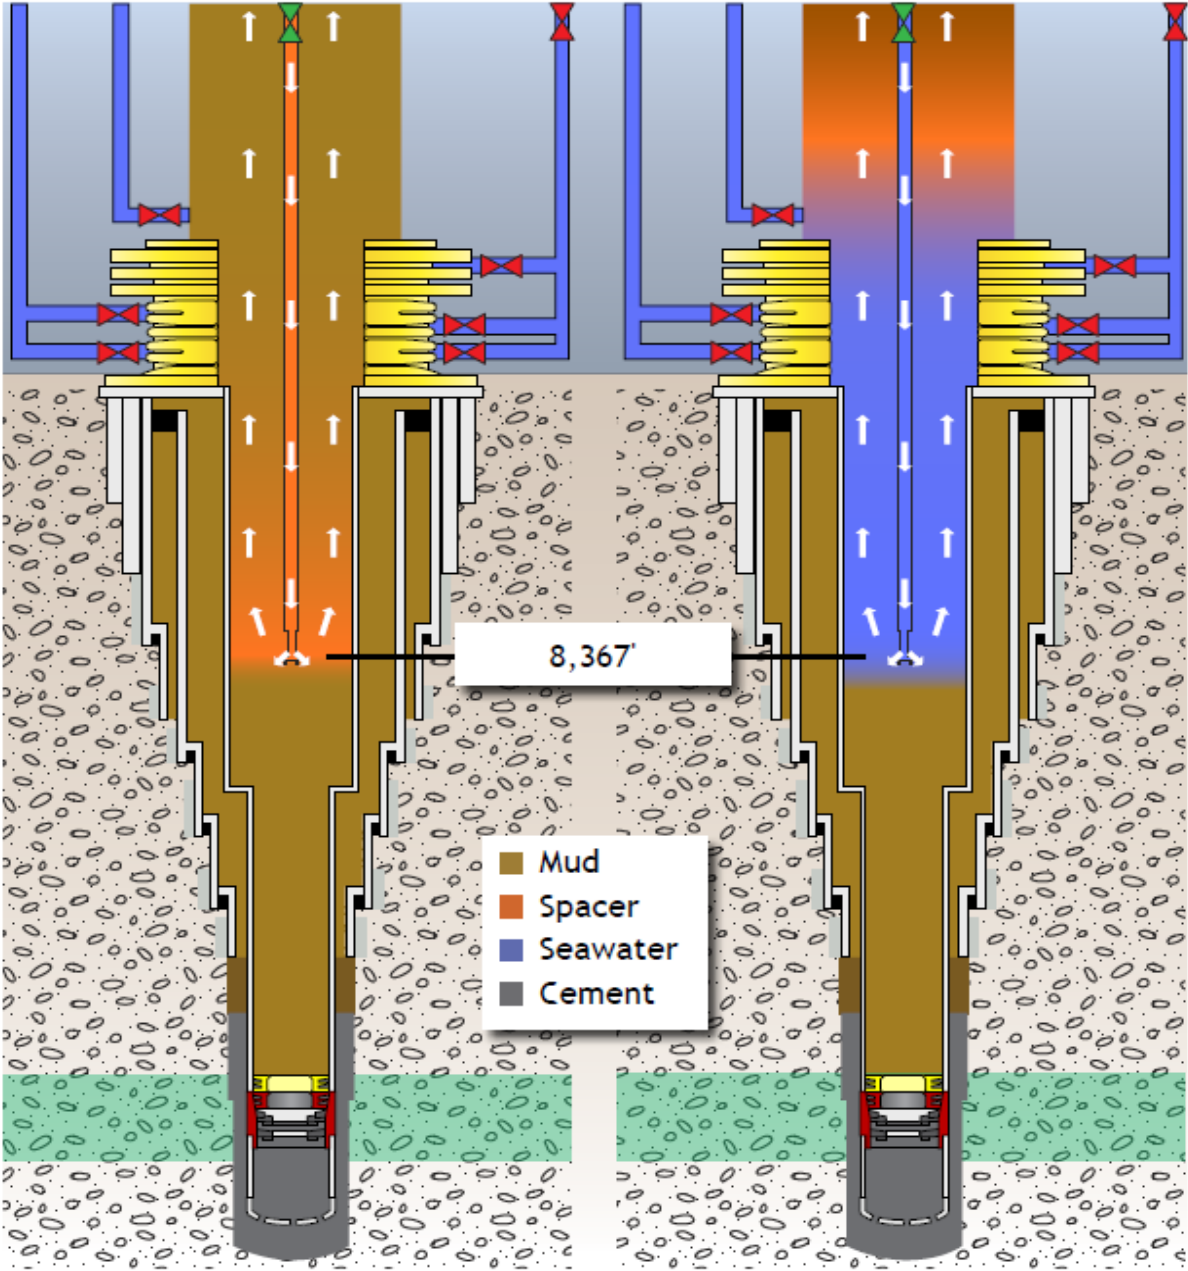
Figure 23-Negative Pressure Test<sup>32</sup>

To conduct the negative pressure test see figure (23), first BP closes and runs the drill pipe to 8367ft followed by pumping of spacer and seawater through the drill pipe, the sea water displaces the heavier drilling mud. There are choke, kill and boost lines accelerates the pumping of seawater and removes drilling mud faster, see figure (24). Once this is accomplished it is followed by closing off the annular preventer in the BOP (choke, boost and kill line are also closed). This is very crucial to note, since the annular preventer removes the hydrostatic pressure of the column of drilling mud and spacer in the riser (5037ft above the mud line).

The first negative pressure test in Macondo showed a sign of problem, after initial bleed off, the pressure in the well could never be brought towards zero i.e. the drill pipe pressure stayed at 260psi and also returned water to the rig. Following this, the rig crew shut the drill pipe valve and observed 1262psi, first negative test failed[5]. See figure 25.

Meanwhile, the rig crew noticed falling spacer level in the riser so dedicated to close the annular preventer tight and perform the second negative test, during the second test the drill pipe pressure was bled to 0psi but the drill pipe returned around 15 barrels of fluid, unusually large volume, following the bleed-off the drill pipe was shut in again only to see the pressure shot up to 773psi, the second negative pressure testing failed[5].

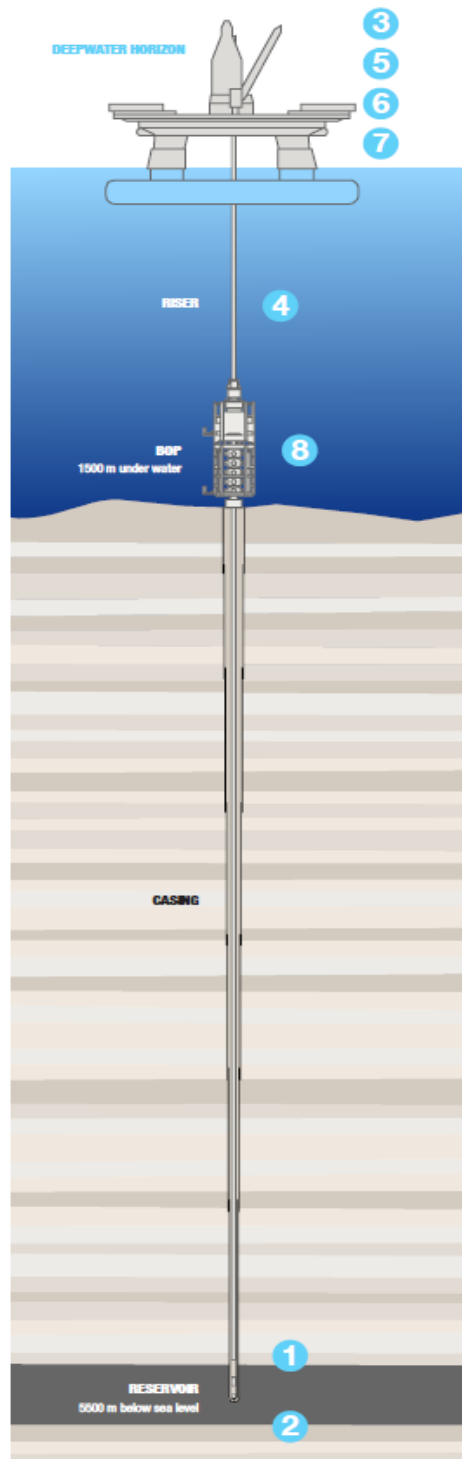
### Macondo Blowout Main technical causes

#### Well integrity was not established or failed
