MASTER'S THESIS

Study program/ Specialization: Mechanical and Structural Engineering and Materials Science	Autumn semester, 2014 Open
Writer: Martin Ask

(Writer's signature)
Faculty supervisor: Gerhard Ersdal (UiS) External supervisor(s): Narve Oma (Ptil), Kai Heine Sirevaag (Solvang)	
Thesis title: Ageing of ships, LPG tankers	
Credits (ECTS): 30	
Key words: Ageing, ship, LPG, tanker, corrosion, fatigue, buckling, coating, maintenance, ballast tank	Pages: 14 + 141 + enclosure: 37 Stavanger, 15.01.2015 Date/year

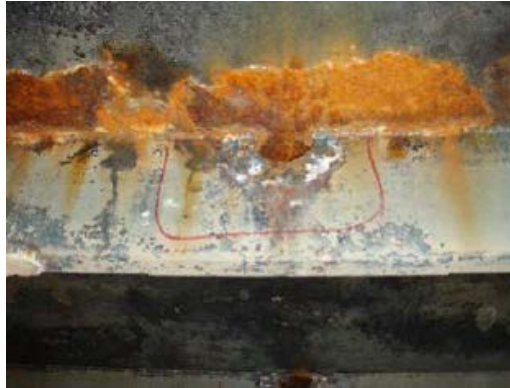
Picture 41 Edge corrosion on drain hole (Clipper Skagen 2009)

In the wing ballast tanks number 22, 24 and 25 a lot of the drain holes in deck longitudinal were found with edge corrosion. See picture 41.

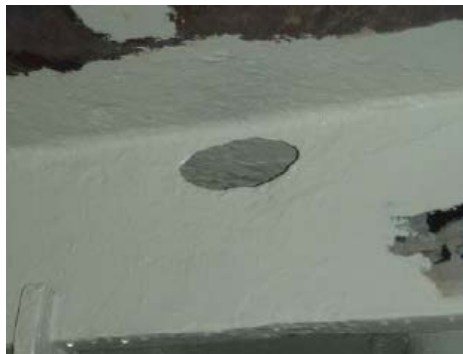
Picture 42 Maintained drain hole (Clipper Skagen 2009)

Some of the drain holes were maintained before CAP inspection, but the edge corrosion wastage was too much to pass the inspection. See picture 42.

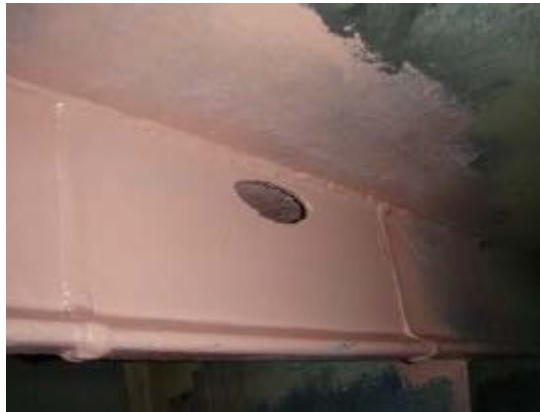
Picture 44 Renewed drain hole after coating (Clipper Skagen 2009)

After insert was fitted, coating was applied. See picture 44. From the picture it looks like the coating are applied in a too tin coat.

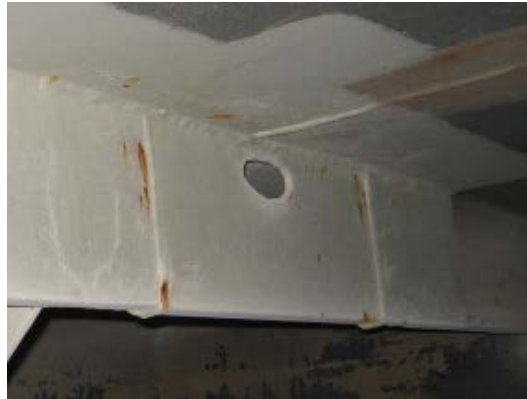
Picture 48 Drain hole one year after renewal (Clipper Skagen 2010)

One year after steel renewal, corrosion starts to appear in the renewed areas. Especially on and around welds, and also on the sharp edges in the drain hole itself. See picture 48.

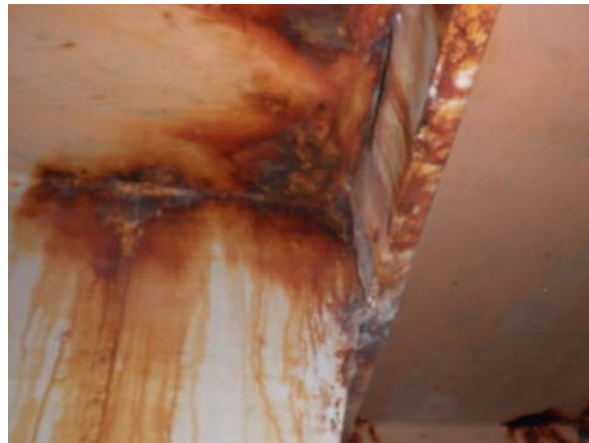
Picture 51 Corrosion near a welded insert (Ask 2014a)

Corrosion near welding after steel replacement. See picture 51. This is probably caused because of the original coating near the new welded insert has been damaged by the heat of the welding process.

Only five years after steel replacement substantial corrosion are found in replaced drain holes and near welds done in connection with steel replacement.

During dry docking in 2009 much steel renewal in top of the wing tanks were necessary due to corrosion. When inspected in Gibraltar 2014, much corrosion was found on and nearby the renewed steel from 2009. The corrosion on the renewed steel sections is mainly caused by poor coating application. The coating thickness also seems to be too thin. Substantial corrosion was found nearby new steel inserts. This corrosion is probably caused due to coating breakdown due to the heat from welding nearby. A larger area around the welds should be grit blasted and recoated.

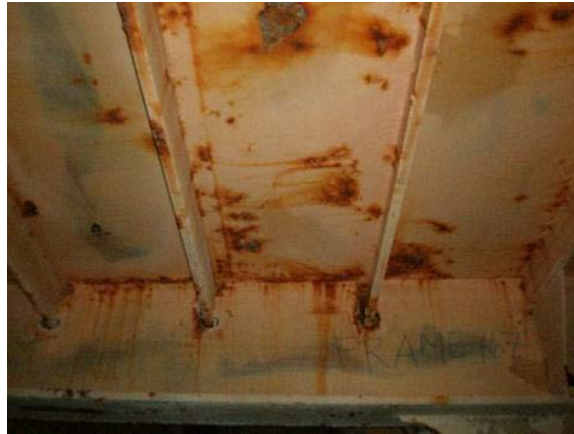
Picture 52 Before grit blasting and recoating (Clipper Skagen 2012)

Due to fair/poor coating condition in wing ballast tanks number 16 and 17, (See picture 52) they were grit blasted and recoated during dry docking in 2012. The coating used was Hempadur Quattro by Hempel.

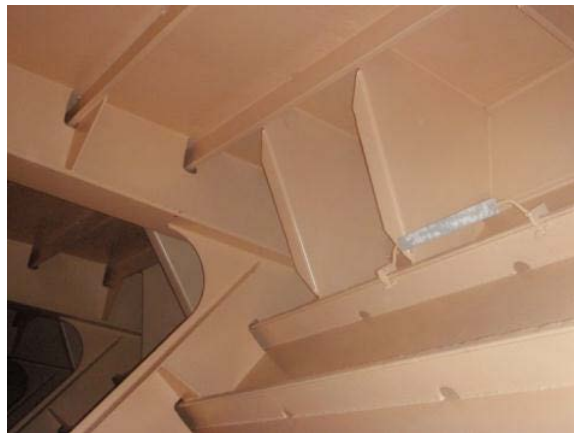
Picture 53 After grit blasting and recoating (Clipper Skagen 2012)

After recoating, the coating condition in both tanks were very good. See picture 53.

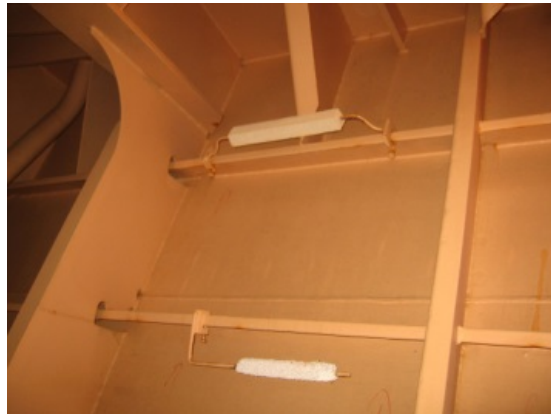
Picture 54 One year after recoating (Clipper Skagen 2013c)

Coating in good condition one year after recoating. See picture 54.

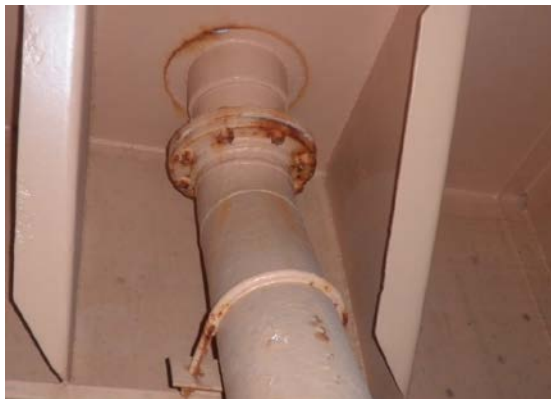
Picture 55 Two years after recoating (Ask 2014a)

Crevice corrosion was found around bolts/nuts on flange and pipe clamp. See picture 55.

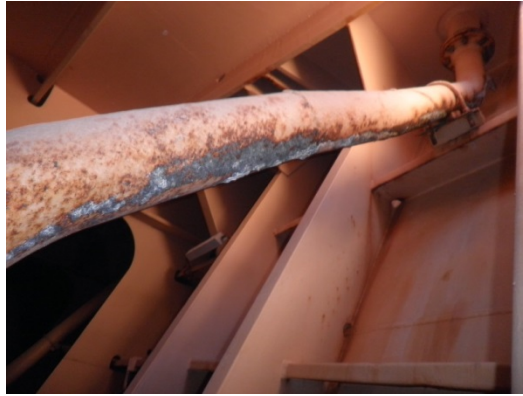
Picture 56 Two years after recoating (Ask 2014a)

The backside of a water pipe inside the tank was found with much corrosion. See picture 56. This is probably caused because of problem with access for the grit blaster and/or carelessness by the grit blaster operator.

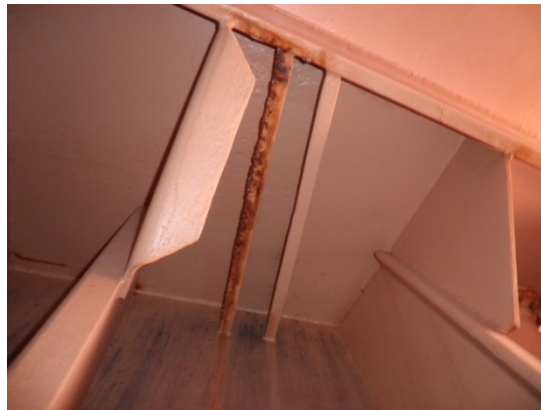
Picture 57 Two years after recoating (Ask 2014a)

In the top of the ballast tank edge corrosion was present on a cross bracing. Probably caused by poor access and/or carelessness when grit blasting. See picture 57.

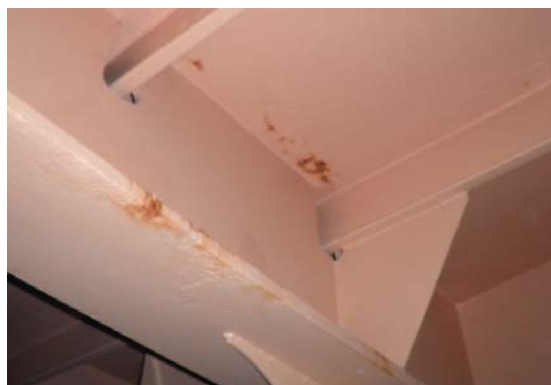
Picture 58 Two years after recoating (Ask 2014a)

Edge corrosion on beam, and grooving/pitting corrosion was found in the in tank top. See picture 58.

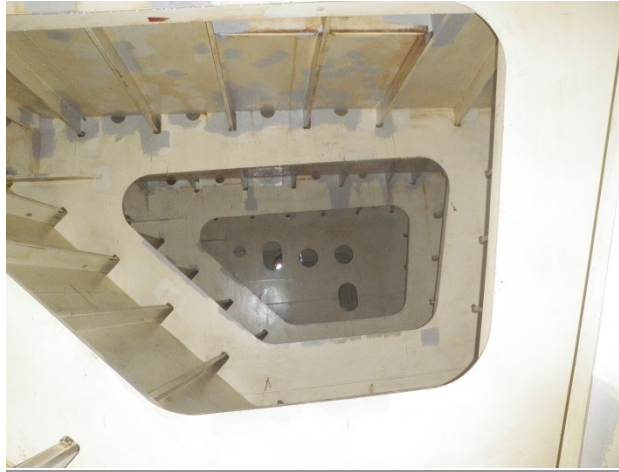
Picture 60 General condition wing ballast tank (Clipper Harald 2012a)

A lot of minor coating maintenance done in the tank earlier, especially in the top deck plating. See picture 60 and 61.

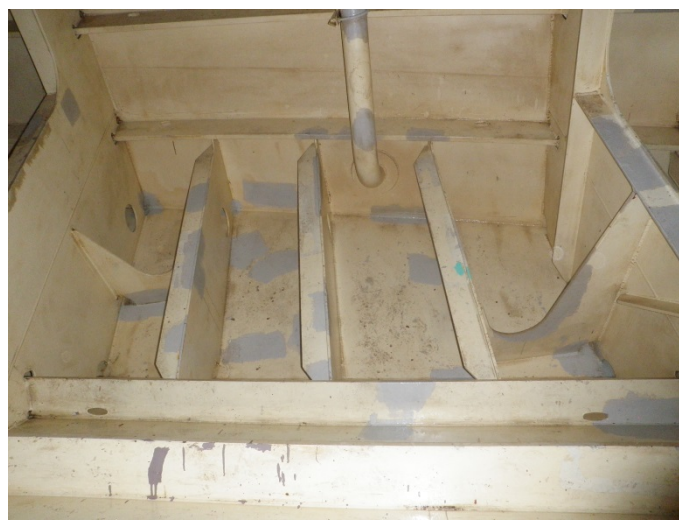
Picture 62 Bottom (Clipper Harald 2012a)

Some coating maintenance is also done in the bottom of the ballast tank. See picture 62.

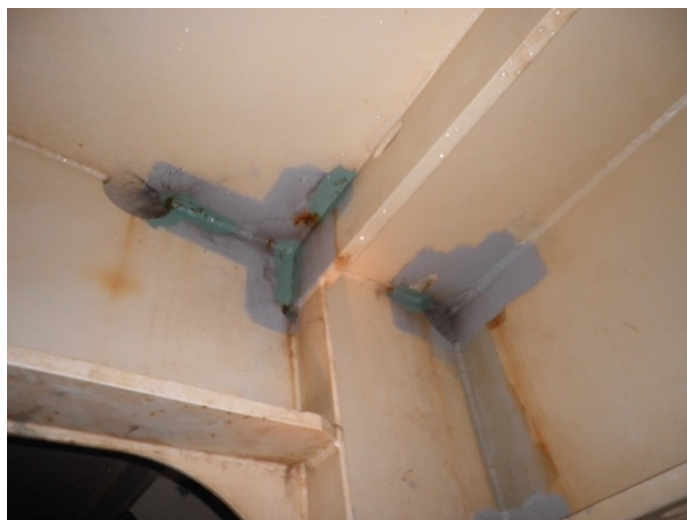
Picture 66 Deckhead (Ask 2014b)

All the tanks were in general good condition with minor rust spots. Corrosion on earlier maintained areas was found. See picture 65, 66 and 67.

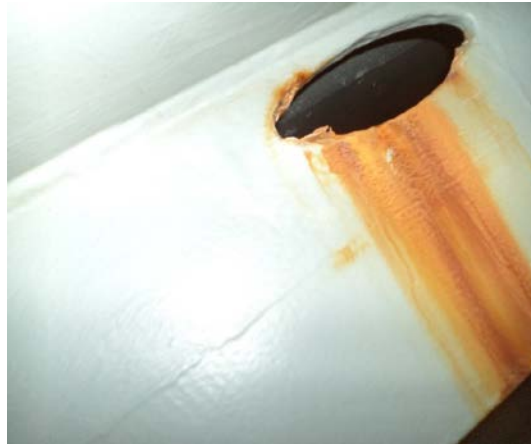
Picture 74 Drainhole in longitudinal (Clipper Mars 2012)

Corrosion in the top of the tank was found in drain holes in longitudinals. See picture 74. Maintenance scheduled to be done in the best time opportunity

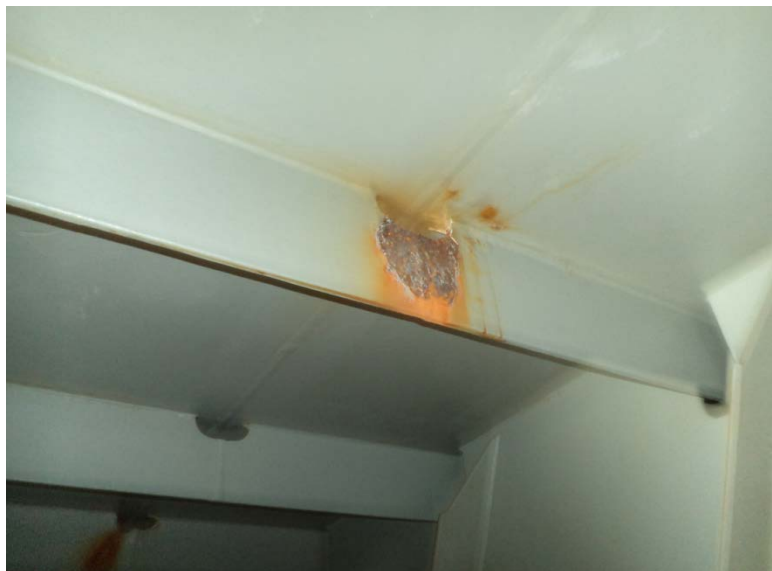
Picture 79 Drain holes in the deckhead (Clipper Mars 2014)

The tank are in generally good condition , but with corrosion around drain holes in longitudinal. See picture 78 and 79.

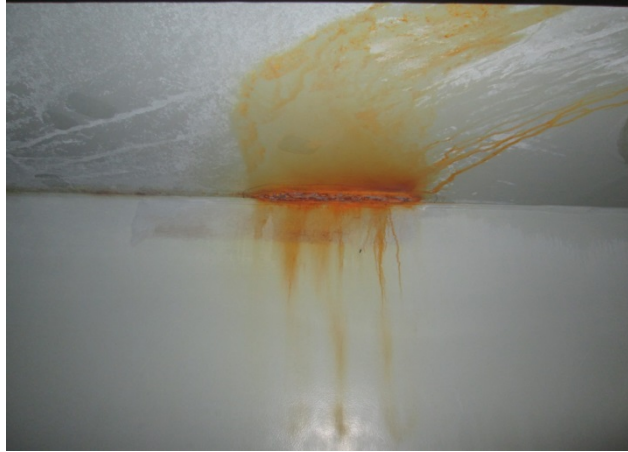
Picture 81 Deckhead after welding (Clipper Posh 2014)

Spot rust found in tank top deck head. It was treated and painted at same day. Spot rust probably caused by welding on the outside of deck plating. See picture 81.

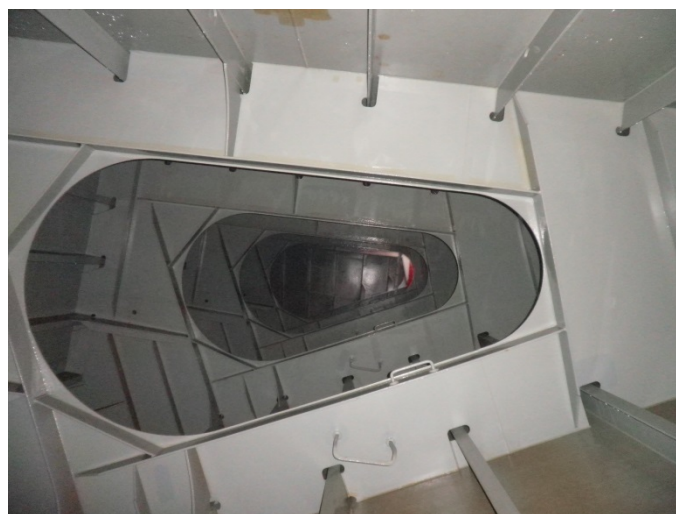
Picture 87 General condition of wing ballast tanks (Ask 2014c)

The overall condition of the tanks inspected was good (As they should be on a one year old ship). See picture 87.

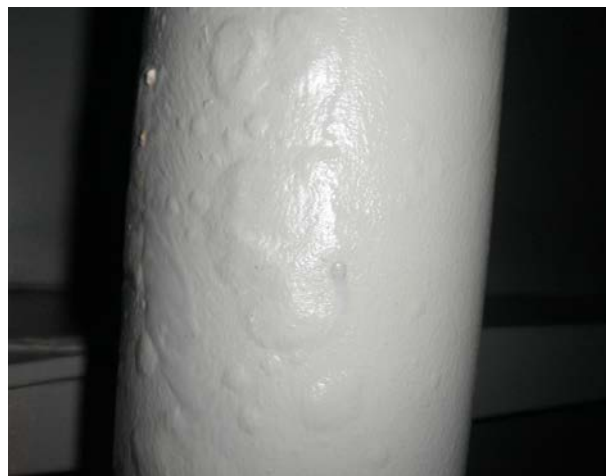
Picture 92 Blisters on a ballast water pipe (Ask 2014c)

It was also found blisters on a ballast water pipe going through the wing ballast tank. See picture 92.

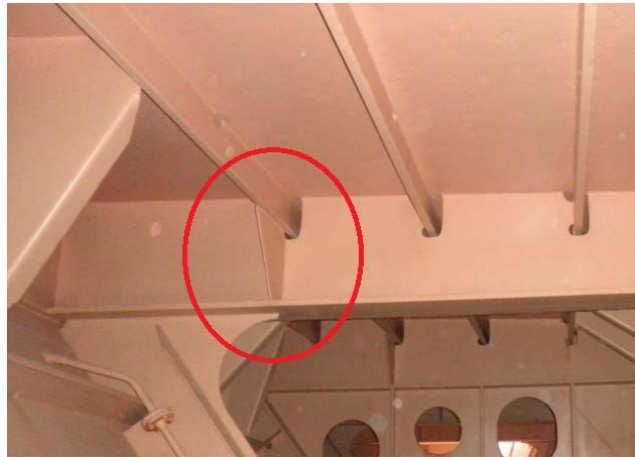
Picture 93 Stiffener support in top of wing ballast tank (Skagen 2014)

In this first fatigue calculation, a spot known to have problems with corrosion and cracks are selected. A stiffener support. See picture 93.
