Universitetet
i Stavanger

MASTER'S THESIS

Study program / Specialization: Offshore Technology: Marine & Subsea	Spring semester, 2016 <input type="checkbox"/> Open / Restricted Access
Writer: Jon Henrik S. Johnsen
Faculty supervisor: Jonas Odland External supervisor:	
Thesis title: Loss of Integrity on Mooring Systems – Causes and Consequences	
Credits (ECTS): 30	
Key words: Station Keeping Offshore Mooring System Mooring System Incidents Risks Connected With Mooring Systems	Pages: + enclosure: Stavanger, June 13 th 2016

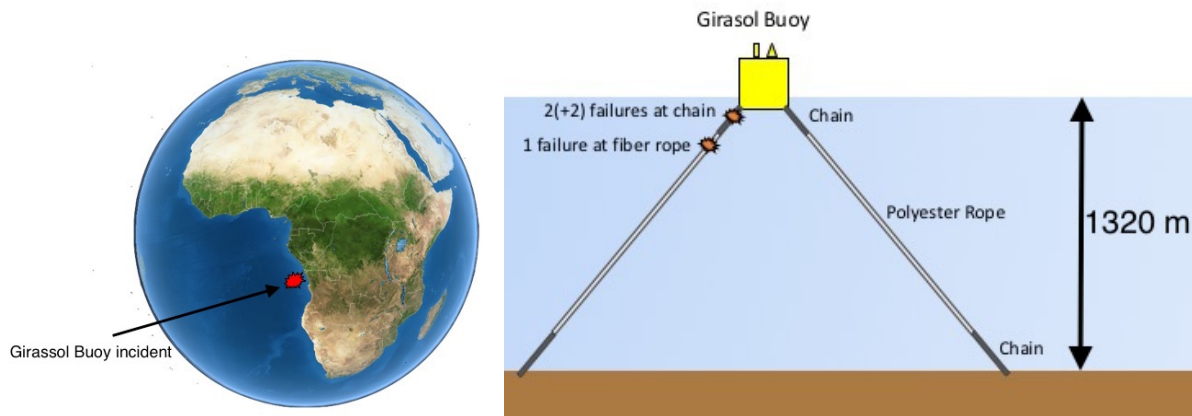
Figure 4-2: Figure showing Girassol Buoy failure locations.

The Girassol incident was a highly unexpected occurrence, happening within a year after installation completion. The incident started with failure in one line at the 5th link from the chain stopper. This was rapidly followed by another failure in the same mooring group (3x3 groups), at exactly the same chain link, the 5th from chain stopper. With these two lines gone, the force became too large to handle for the last remaining line in the same group, resulting in a third failure. Although it would seem that the 5th link was the location experiencing the largest forces, the third and last line in this group failed at the polyester rope segment [23]. With this deviation it is reasonable to assume that the polyester rope got inflicted by a cut or something similar during installation, thus weakening it to some degree. Once these lines were lost, contingency measures were instated. However, not to a sufficient degree, which resulted in two additional failures occurring over time. Luckily this happened to an offloading buoy, and therefore didn't cause any rupture in risers nor did it drift off to cause potential collisions.

Although the deviation with the polyester rope is important, it isn't what is essential in this complete system failure. Inspection of the failed chain links revealed cracks in the metal, indicating fatigue damage. This should not occur this early in the field life, as the lines were designed for permanent installation according to API RP2SK with a designed fatigue life time of 60 years and more (3x designed life) [24]. The probable reason this

failure occurred still, is because of out of plane bending (OPB). With the locking of the chain links at the exit point of the buoy, interlink friction caused a bending moment in the following link that could freely move. This added bending stress was not accounted for in design, and it lead to larger cyclic stresses in the chain than what was assumed to be caused by the environmental loadings. This increased loading caused a massive reduction in fatigue life of the chain link, and ended up with an early cracking of the metal and thus a reduced stress resistance.

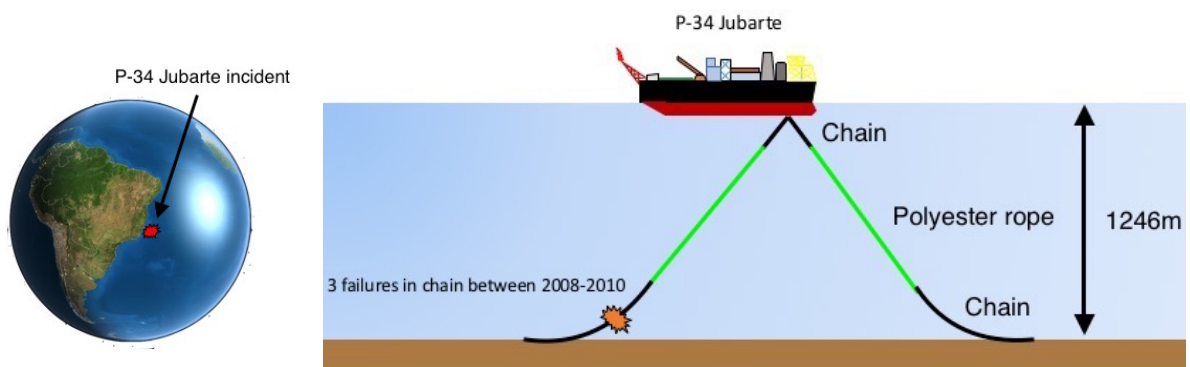
Figure 4-9: Illustration of system failure on P-34 Jubarte FPSO in the Jubarte field.
