Experimental assessment of cracked tubular joints repaired with crack-deflecting holes and weld-toe grinding

S Riise, M Atteya, O Mikkelsen and G Ersdal *

Faculty of Science and Technology, University of Stavanger, Norway

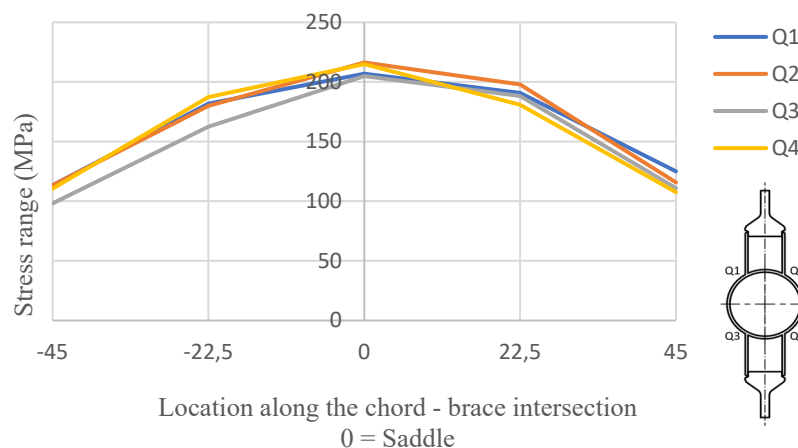
3.2.1. Stress Distribution. The stress distribution in the intact specimen was recorded as the pre-crack testing commenced and as expected for DT joints subjected to axial load the highest strain range was found in the saddle position. Furthermore, it can be seen in Figure 6 that the stress range is gradually decreasing towards the crown. It is also apparent in Figure 6 that stress ranges in all four quadrants are quite similar and symmetric around the saddle. This indicates symmetrically placed strain gauges and a lower probability of significant eccentricities in the specimen or test setup.

Figure 6. Stress range distribution at strain gauge closest to weld along chord-brace intersection ($\Delta P = 40$ kN)

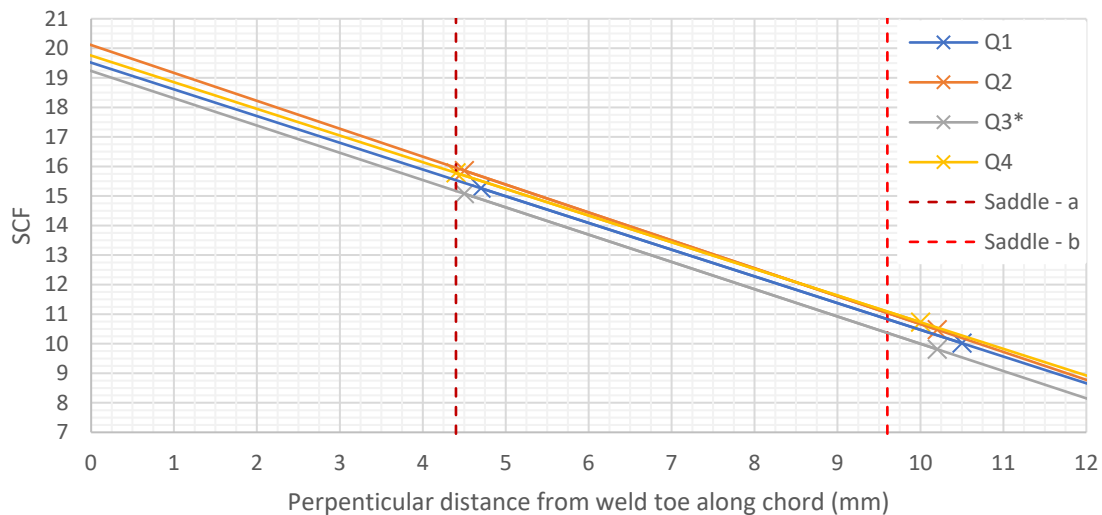
3.2.2. SCF Calculation. In the pre-cracking phase, the stress concentration factors in the four saddle positions in the intact specimen were calculated based on the recorded HSS. The maximum SCF recorded under an axial load range of 40 kN was 20.45 located in Q2 and the average SCF of the four saddle positions was 19.89. Figure 7 below shows the SCF in the four quadrants. Furthermore, it shows the measured location of the strain gauges at a perpendicular distance from the weld toe along the chord surface and the ideal SG location when using linear extrapolation according to DNV is marked with the red dashed lines. Note that the SG positioned in saddle-b (in Figure 7) at Q3 was not measured after installation. Hence, the average SG placement in saddle-b from the other three quadrants is plotted.

Figure 7. SCF at the four quadrants from the experimental work, with $\Delta P = 40$ kN.

*The SG positioned in saddle-b at Q3 was not measured after installation. Hence, the average SG placement in saddle-b from the other three quadrants is plotted.

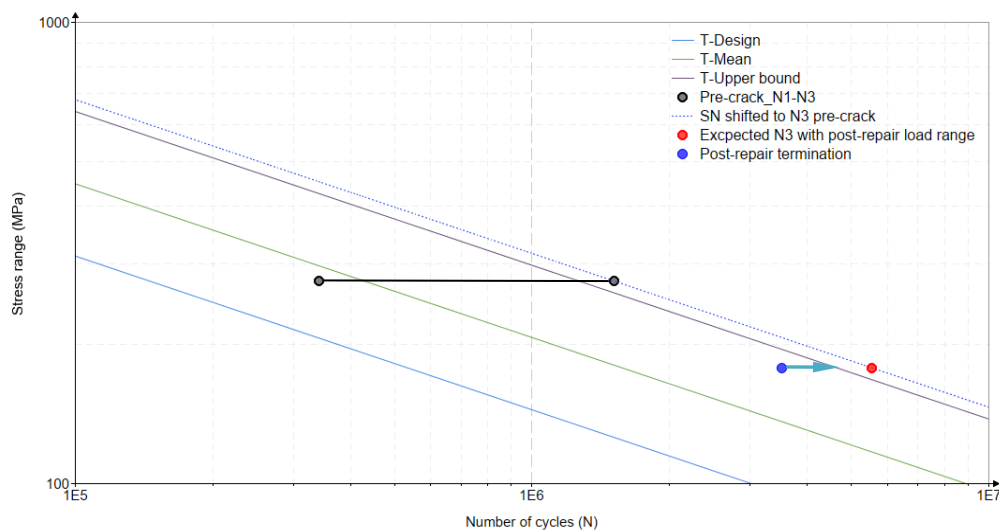
The specimen was subjected to a lower cyclic stress range in the post-repair phase than in the pre-cracking phase. Therefore, a direct comparison to the pre-crack fatigue endurance would not be possible. Nevertheless, the cycle count to reach N3 under the post-repair stress range was estimated by shifting the SN curve to the N3 result from the pre-cracking phase, as shown in Figure 10. Subsequently, from this shifted S-N curve, the projected cycle count to achieve N3 under the stress range employed in the post-repair phase could be derived. Eventually, this enabled comparing the number of cycles in the post-repair phase and the estimated number of cycles to N3. The procedure employed to calculate dR is summarised as follows:

1. Pre-crack result ($\Delta P = 40\text{kN}$):
 - a. $\sigma_{\text{nom}}(14.16 \text{ MPa}) \cdot \text{SCF}(19.4) = \text{HSSr}(274.7 \text{ MPa})$
 - b. Number of cycles to N3 = 1 515 000
2. Shifting the SN curve to N3 from the pre-crack phase:
 - a. New $\log(a) = 13.50$
 - b. $m = 3$
3. Estimate of the Number of cycles to N3 under post-repair load ($\Delta P = 27\text{kN}$):
 - a. $\sigma_{\text{nom}}(9.19 \text{ MPa}) \cdot \text{SCF}(19.4) = \text{HSSr}(178.24 \text{ MPa})$
 - b. Estimated number of cycles to N3 = $10^{\log(a) - m \cdot \log(\Delta\sigma)} = 5\,546\,000$
4. Number of cycles in the post-repair phase ($\Delta P = 27\text{kN}$):
 - a. Number of cycles to run out = 3 515 000
5. Calculating $dR = 3\,515\,000 / 5\,546\,000 = \underline{63\%}$

Figure 10. Standard SN curve and SN curve shifted to pre-crack result

The dR ratio of 63% derived from the approach employed in this section is about 100% higher than the greatest dR number for similar specimens tested without repair. Consequently, the conclusion can be drawn that drilling crack-deflecting holes combined with weld-toe grinding has successfully increased fatigue endurance. It should also be emphasised that N4 has not been reached under these loading conditions, but it was decided to stop the testing due to time limitations and that sufficient data

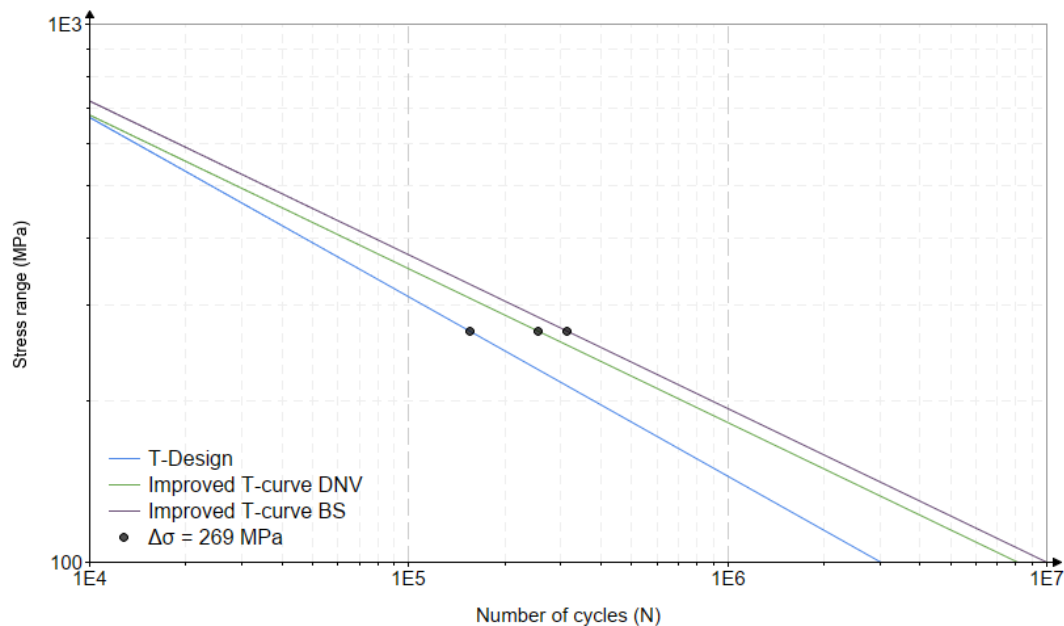
Both DNV-RP-C203 and BS 7608 provide an improved SN curve for welded connection subjected to weld toe grinding, as presented in Figure 11. By comparing the number of cycles from the design T curve with the improved SN curves, it is possible to derive an improvement factor of the weld toe grinding from DNV and BS for the given stress range of 269 MPa.

Figure 11. Improved SN curve from weld-toe grinding

It is evident from these considerations that the weld-toe grinding successfully increased the specimen's fatigue endurance. The number of cycles in the first attempt of the post-repair testing exceeded the number of cycles expected according to DNV when improved with weld toe grinding.
