Study program/ Specialization:  Offshore Technology / Marin and Subsea Technology	Spring semester, 2011  Restricted Access
Writer: Keramat Mohammadi	..... (Writer's signature)
Faculty supervisor: Ove Tobias Gudmestad  External supervisor(s): Per Nystrøm (IKM Ocean Design)	
Title of thesis:  Repair methods for damaged pipeline beyond diving depth.	
Credits (ECTS): 30	
Key words:  Deepwater, Pipeline, Repair, Diverless, Clamp , Coupling	Pages: 90  + enclosure: 7 (+1 CD)  Stavanger, 14.06/2011 Date/year

# Repair methods for damaged pipeline beyond diving depth

Master Thesis / Marine and Subsea Technology

Keramat Mohammadi  
Spring 2011

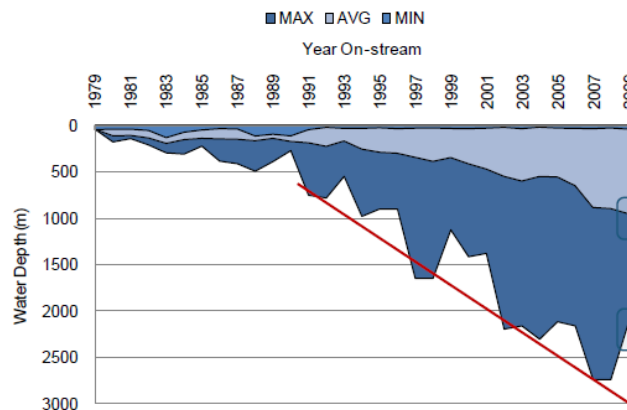
Figure 1-1. Subsea Wells On-stream and Water Depth Trends (Source: Infield Systems)

The exploration for new hydrocarbon resources is being extended to the areas that urge new technologies or methods of development and operation. The frontier fields are in the depth of 3000 meters as of 2010 (Figure 1-1). The deepest subsea well is at depth of 2,934 meter in US GoM in Shell's Tobago field where the average depth of the field is 950 meter (Callanan, 2010).

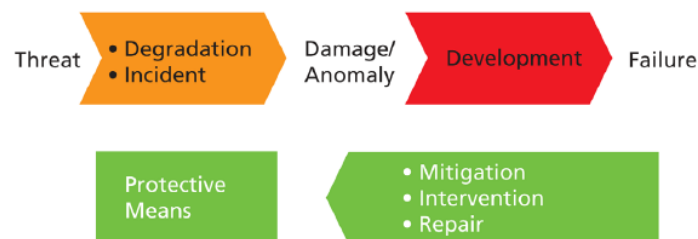
Figure 1-2. From Threat to Failure extension (left to right) and the activities to reduce the likelihood or/and consequence of such extension

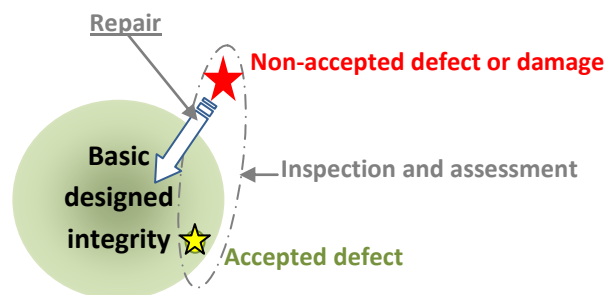
Figure 1-3. The repair brings the system integrity back to the original range of design.

Although the design covers and foresees the probable loads during different phases, the possibility to have any surprise always exists, depending on safety factor. Due to human-side limitations (abilities and cost) and nature-side capabilities, the asset operators should be alerting of threats and prepare the contingencies as responsive as possible (Figure 1-3).

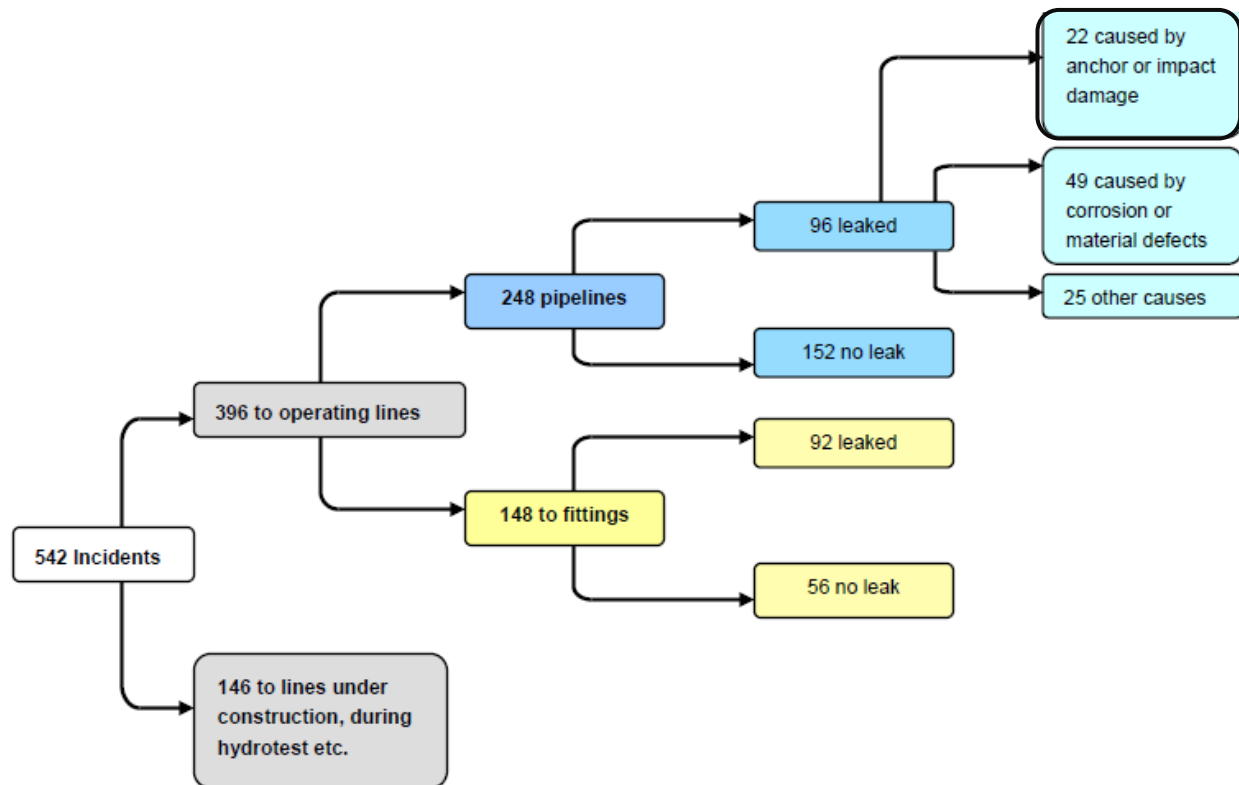
Figure 1-5. Damage report summary shows the distribution of damage type and causes [source: PARLOC 2001].

CODAM (pipeline damages- Damages and incidents, Petroleumstilsynet Norway) and PARLOC (The update and loss of containment data for offshore pipelines, HSE UK) are two references for the North Sea cases. Figure 1-5 illustrate the summary of the PARLOC2001 report. From the figure, about 40 percent of pipeline incidents lead to leakage. This report divides the incidents for pipelines and fittings separately since the survey focuses on the containment leakages due to incidents. The report also tabulates the data for different size of diameters. The tables show that in the most cases the small sized pipelines (< 10”) are exposed to the risk of incidents. Trawl impact and corrosion are the main causes of incidents (PARLOC2001, table 4.2). Weld defect is being reported as the main cause for the larger sized pipelines. PARLOC does not list the incidents based on water depths which is the interest of this thesis.

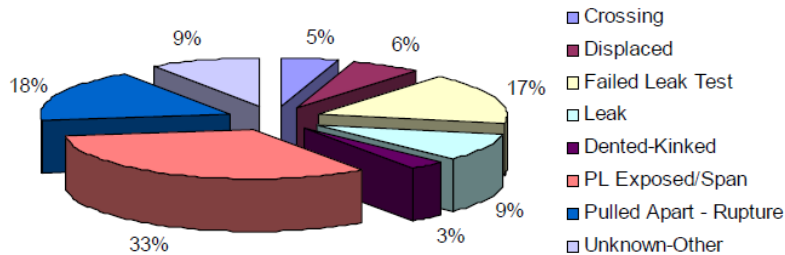
Figure 1-7. Damage categories contribution for both Hurricanes-Katrina and Rita.

survey gives a sensible overlook of pipeline system robustness against the overloading cases. The pipelines being damaged due to storms direct or indirect effects; the platform end displacement; the construction anchor drag and so on. Figure 1-6 illustrates the pipelines which were being affected by both Hurricanes Katrina and Rita (in red). The different categories of damages are shown in Figure 1-7.

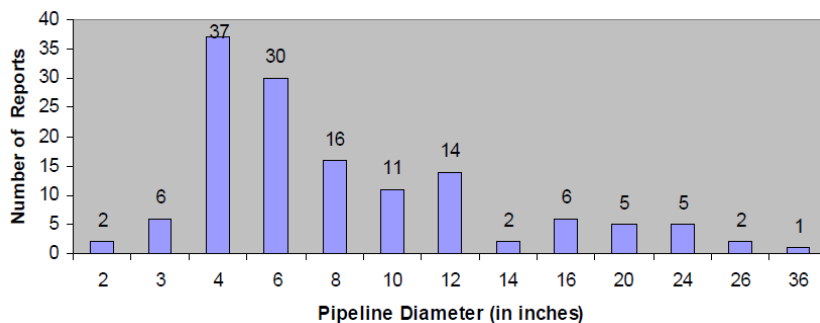
Figure 1-8. Damage diameter size distribution

The report results for the Hurricanes damages, refer most of damages to the small size pipelines, as illustrated in below graph.

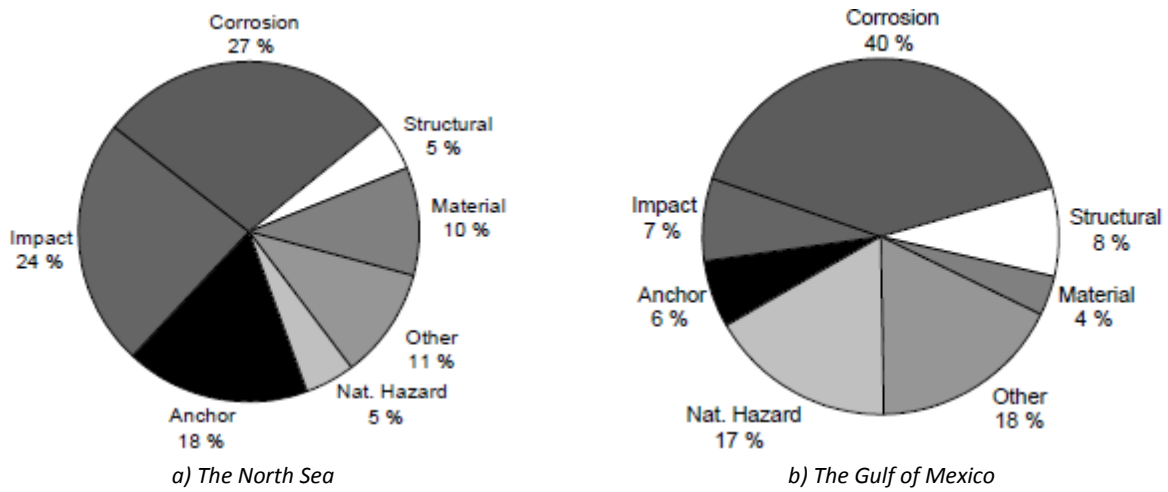
a) The North Sea b) The Gulf of Mexico  
 Figure 1-9. All reported incidents in percentage for a) North Sea and b) the Gulf of Mexico  
 [Reference DNV-RP-F116 Appendix A]

Studying the incident reports for North Sea and Gulf of Mexico for the incidents with and without the leakage (Figure 1-9) shows that the corrosion (internal and external) is the most important cause of damage for both areas. The second important cause is the anchor and impact damage and natural hazard (Hurricanes) for the North Sea and Gulf of Mexico, respectively.

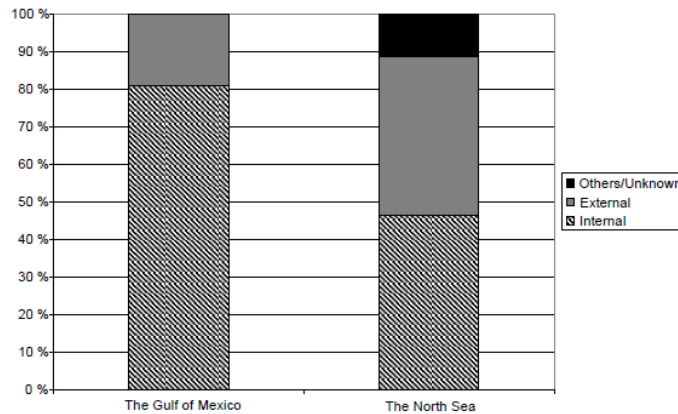
Figure 1-10 Distribution of different types of corrosion damages without leakages  
 [Reference DNV-RP-F116 Appendix A]

Figure 1-10 shows the distribution of the corrosion types for both NS and GoM.

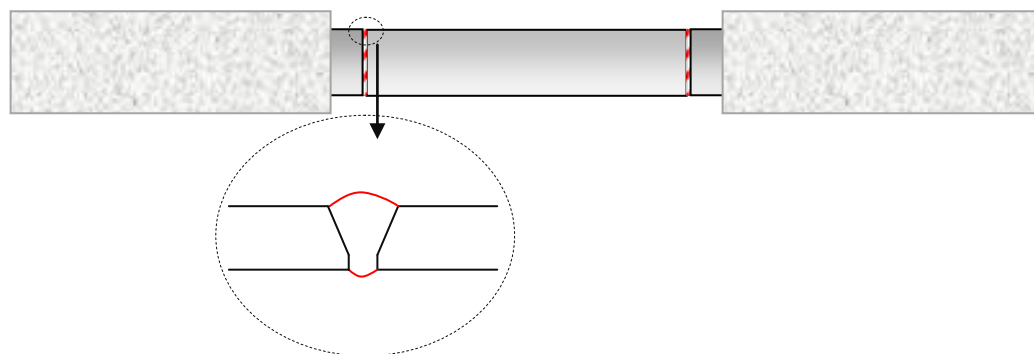
Figure 2-2. Welding the new piece of pipe to the main pipe line.

The new pipe piece is aligned with the pipe end that has been cut and prepared according to welding specification procedures. Normally the new piece has the same size and thickness; hence the welding is of butt type (Figure 2-2). Welding can be performed on the surface or in a subsea dry habitat (diver assisted- or remotely operated-).

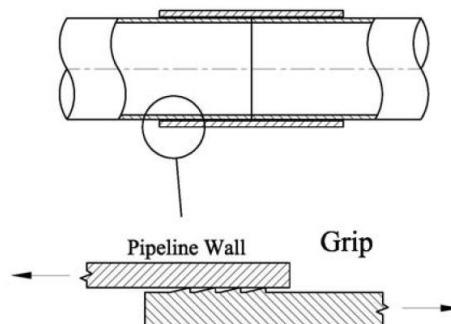
Figure 2-5. A sleeve with the surface profile providing the gripping forces.

- Gripping wedge: the coupling internal profile provide the gripping force in friction shape (Figure 2-5). Reference can be made to the gripping mechanism in clamps of DW RUPE (section section 7) patented by Stress Subsea (Figures 7-3 & 7-4).

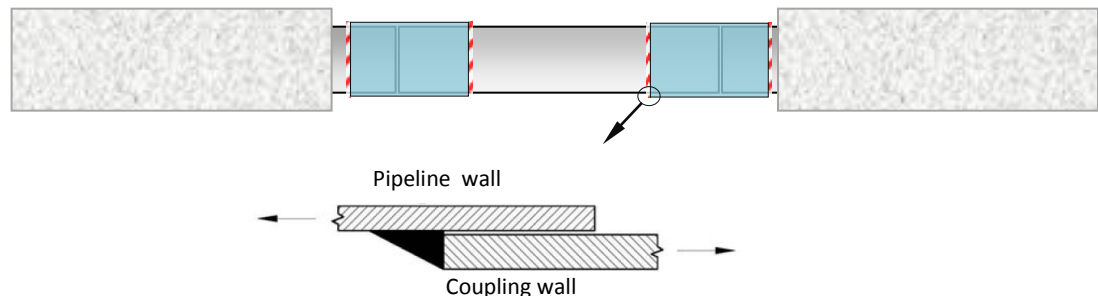
Figure 2-8. The repair spool is integrated to the main line by a pair of welded sleeves.

- Welding: a sleeve coupling is welded to the main pipeline and the spool wall. The weld can prepare the anchorage force as well as the sealing (Figure 2-8).

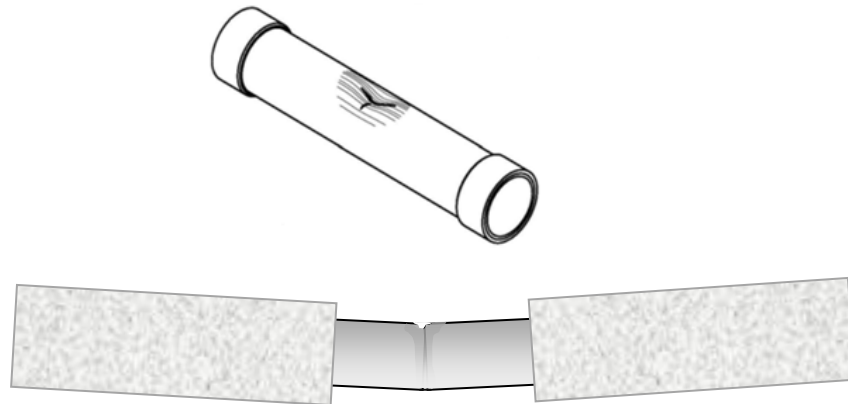
*Figure 2-10. Local minor damage in pipe that can be repairable temporarily or permanently. The defect can be dent, buckle or even a corrosion pinhole.*

In some cases, the damage is classified as tolerable (short affected length or non-progressive defect) through the pipeline defect assessment process and there is no need to cut the pipe (Figure 2-10). For those cases, clamps can compensate the weakened integrity. Depending on the defect type (leaking or dent/gouge), the clamp can be acting as a pressure vessel either as a structural support. The main duty of the clamp is to increase the structural strength of the line at the damage point and/or prepare facilities to seal any possible leakage in the future. The clamps can be designed as the temporary solutions as well as permanent ones.

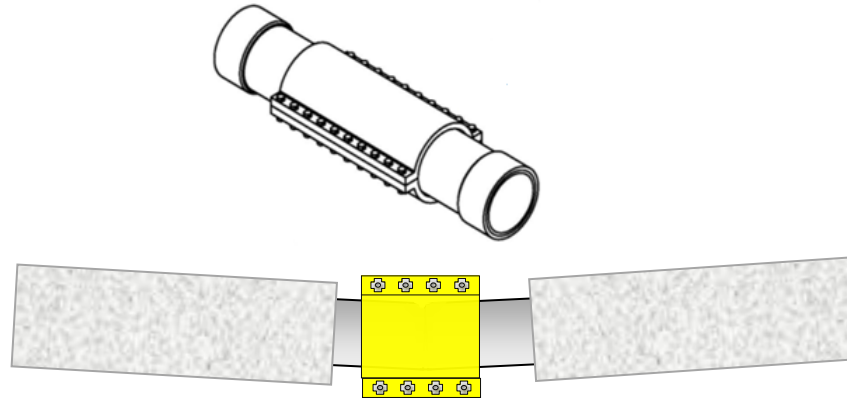
Figure 2-12. The clamp half-shelves are bolted together and squeezed around the pipe at the damaged location.

- bolted  
The bolting increases the hoop strength and also the normal reaction force is contributing to the friction force against the axial loads (Figure 2-12).

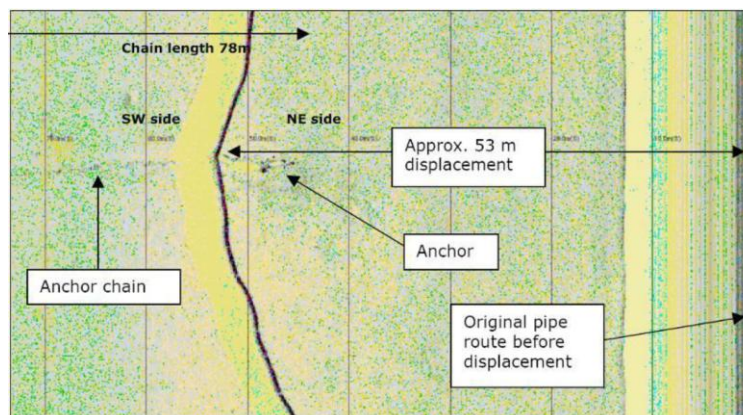
Figure 3-1. The pipe was found 53 meter out of its position, buckled.

During a routine external inspection by a ROV, a serious buckle was discovered. A 10-ton anchor of an unknown vessel hit and dragged the pipeline 53 meter out of its initial position at a depth of 210 meter (Figure 3-1). The anchor was found just nearby the damage point, with the anchor chain connected and underneath the pipe which means that before the chain broke, the line was pulled off the seabed about 30 meter (calculated by simulation, based on the pulling force and the found position). Such pulling force made a sharp dent in the pipe body (17 degree) and also dragged the nearest expansion curves out of position.

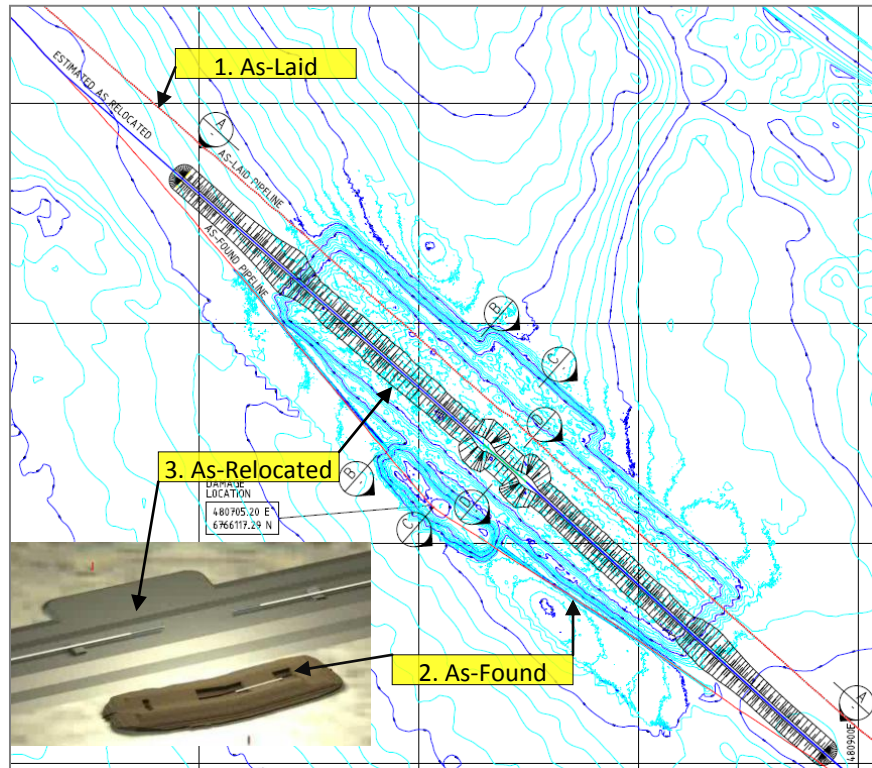
Figure 3-2. Kvitebjørn pipeline repair area. As-laid, As-found and As-relocated arrangement and also post-repair rock dump. [Ref.: 1601921-IKM-Y-RE-0001 - D111-IK-P192-F-RE-010]

After positioning the lines, frames were deployed to lift the line ends off the seabed and the final cutting on both ends was performed. The concrete coating and the seam weld had to be removed. A 25-m long spool was fabricated and brought to site in order to replace the damaged section and connected the pipeline cut ends. The spool was connected to the main line by mechanical connectors. After the connection the integrated pipe was laid on the sea bottom (Figure 3-2). The line was tested prior to re-commissioning.

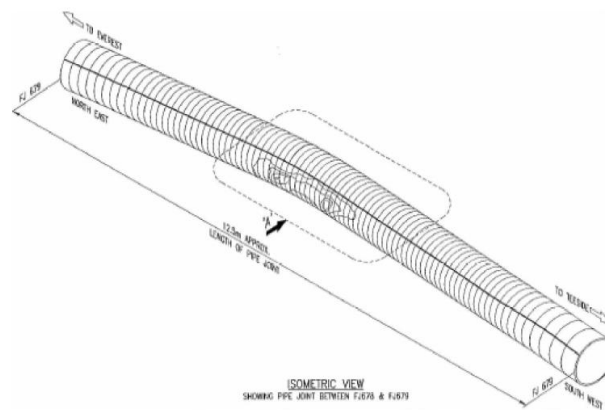
Figure 4-1. deformed shape of pipe after anchor hitting. The anchor flukes caused two dent either side of point with maximum curvature. [Source: IPC2008-64480]

Further detailed mapping, showed the existence of two dented points extending from 8 o'clock up to around 10 o'clock (looking along the line from Teesside end), with the maximum depth of 31mm. the dents covered the seam weld in its upper tail (Figures 4-1 & 4-2).

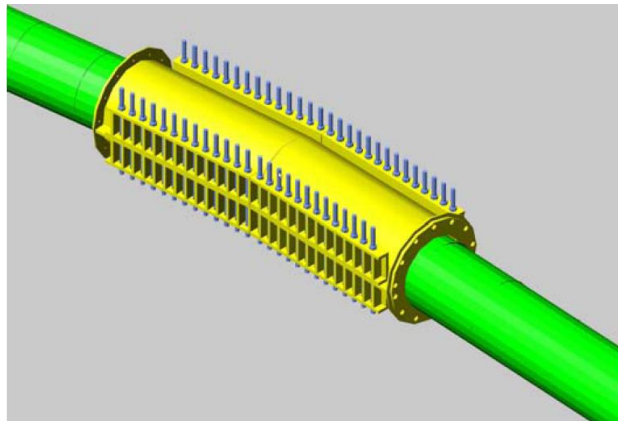
Figure 4-3. Grouted clamp [Source: IPC2008-64480].

The decision was made to support the damaged section of the pipe structurally. For this purpose, a grouted steel clamp was designed (Figure 4-3). It provided high rigidity and prevents the radial movement over the dented pipe under the pressure cycling. The cement grouting filled the annulus between the pipe and the clamp half-shells.

The sleeve length was 4.2 m with a 6.5 degree mitered elbow in the middle. The clamp was installed by divers and the grouting was done following the bolt tightening.

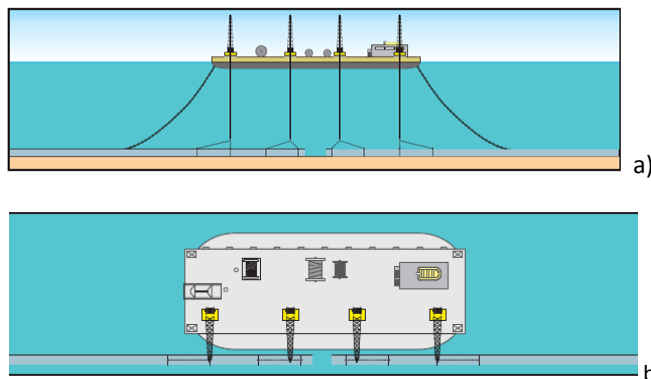
Figure 5-1. Upon cutting off the damaged section of pipe, the vessel with lifting capacity is in place and the riggings are connected to the pipe ends.

A construction vessel with enough davit capacity comes in position over the pipe such that both free-ended lines can be handled by the davits (or any other lifting tool). Divers assist to connect rigging lines to the pipes (figure 5-1). Once the connections are done, the lines are lifted off the sea bottom up to the surface, where the construction deck is facilitated to do repair related tasks: detail inspection, cutting, pipe end preparation (beveling, machining), alignment, etc. (Figures 5-2 & 5-3).

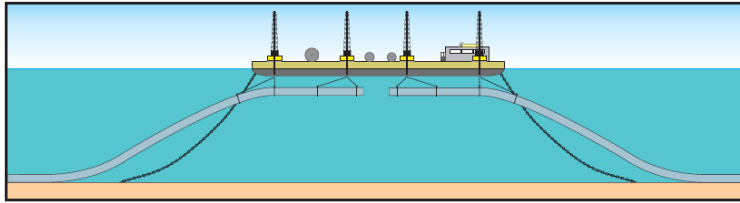
Figure 5-2. The pipe ends are lifted off the seabed, using the lifting davit or cranes. It can also be done one after the other when welding flange is the case.

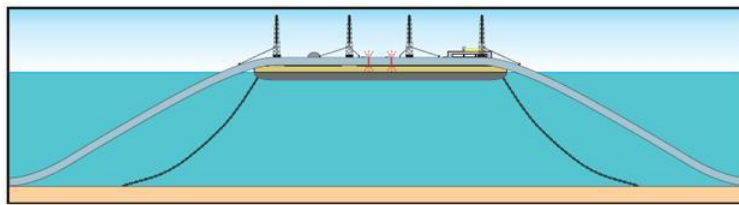
a)

A new piece of sound pipe (spool) is welded to the recovered ends on the construction deck. In some cases, when lifting both ends is not possible or the damaged section is long or because of any other reason, a flange is welded to the pipe end. It is done for both sides in two separate go, then a flanged spool will be fabricated and installed in between.

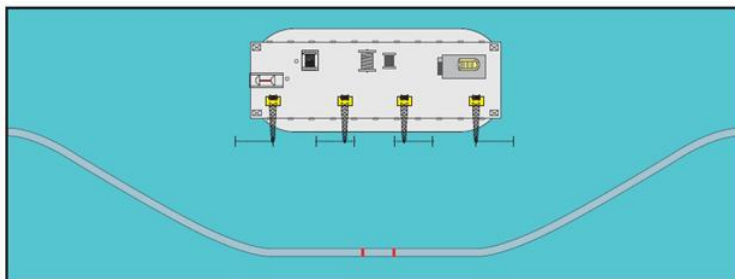
Figure 5-4. The repaired pipe is laid back on the seabed. Due to possible change in length the pipe might be off the original route.

Following the welding, the quality of weld is examined by NDT methods before laying back the repaired line on the seabed. The line configuration may be changed slightly due to accommodating an extra length of spool piece (figure 5-4). In case that the flange connection be the solution, the flanged lines are laid on sea bed and the “closing” spool will be deployed and installed in between by diver assistance. Upon the pipeline repair and securing in place, generally a hydrostatic test will be performed to check the integrity prior to decommissioning the line.

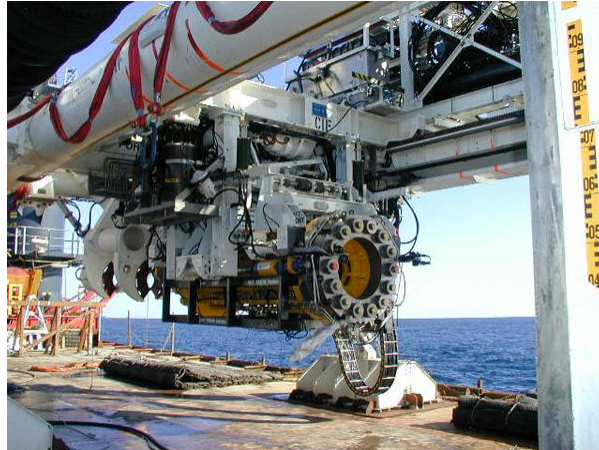
Figure 6-3 shows the CIF with CCM carrying a Morgrip coupling.

Figure 6-3. CIF with a Morgrip carried by CCM (source: Hydratight)

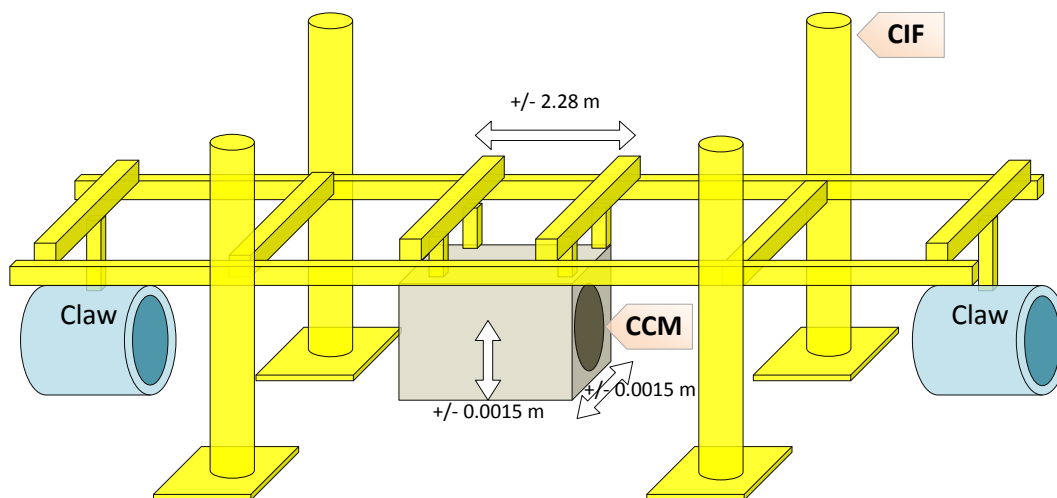
CCM is an integrated module with the CIF to carry and control the alignment of the Morgrip coupling. The CCM and CIF are designed such that the CCM with the coupling can travel along the pipeline axis. This traveling capacity is 4,56 meter (+/- 2.28 m). The vertical movement can be in range of +/- 1.5 mm and maximum transverse movement is of +/-1.5 mm (figure 6-4).

Figure 6-4. CIF and CCM 3D arrangement.

Figures 6-4 & 6-5 show the schematic view of the systems. The claws and the coupling frame jaws are parted-circles and encircle the pipe body by hydraulic pistons those are activated by ROV or remote control from the surface.

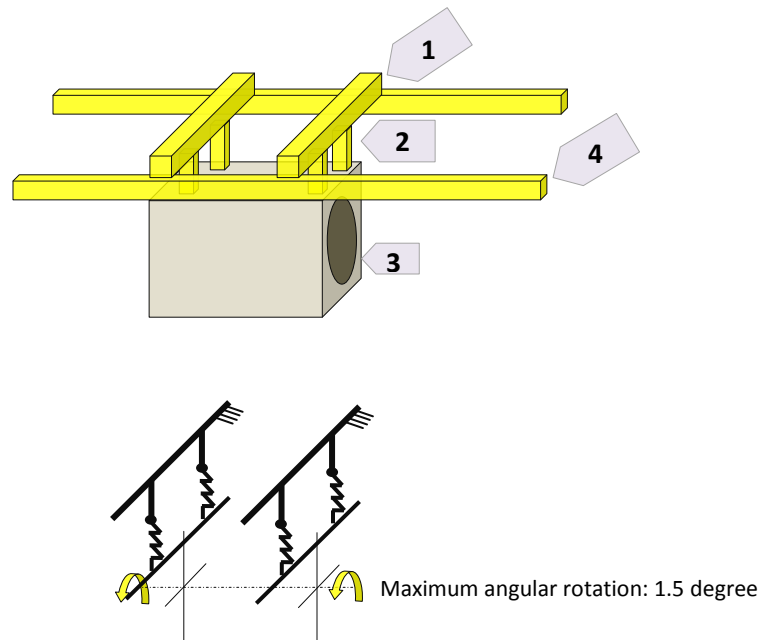
1. Carrier Frame
2. Suspension Frame
3. Coupling Frame
4. Carrier Railway System
5. Cable & Piping System

Figure 6-5. Coupling Carrier Module (CCM). The compliancy of the module structure provides the angular and transversal motions.

The coupling frame (#3) is suspended from the carrier frame (#1) via a suspension system (#2) that has a compliant mode to prepare coupling radial and angular flexibility (Norman, 1997)(Figure 6-5). The carrier frame itself can travel along the pipeline axis over a railway system (#4) and bogie flanged wheels. Two rack and pinion drives connected to two geared hydraulic motors supply the driving forces for the carrier system. There is a wire anchor on the carrier beam that enables operator to use ROV to pull the frame in an emergency case. The hydraulic and electric connections between the PCM (Power& Control Module) are through hoses and cables via a drag chain on one side of the CIF.

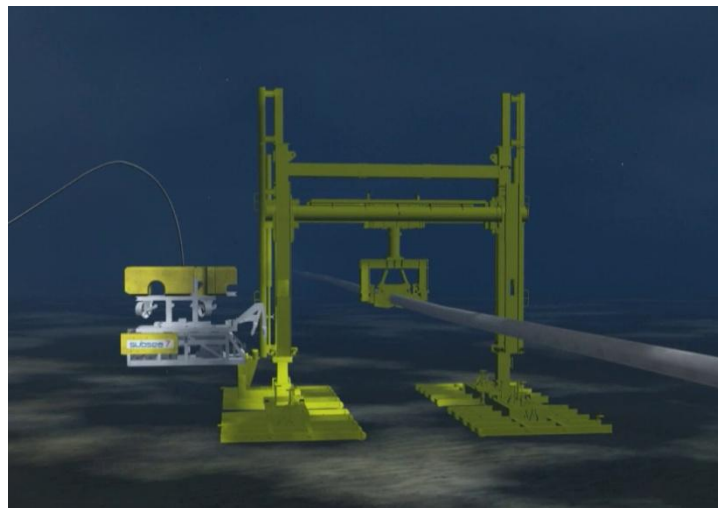
Two lifting frames ease the pipeline end handling during the repair operation. H-frames are located at a certain distance from pipe ends and lift the pipe off the seabed by hydraulic-jaw claw. The claw is connected to a frame that can move vertically once the ROV operates it. The force from the pipe weight transferred to the ground through the frame legs and the mud-mat plates (Figure 6-6).

*Figure 6-6. H-frame (source:Subsea7)*

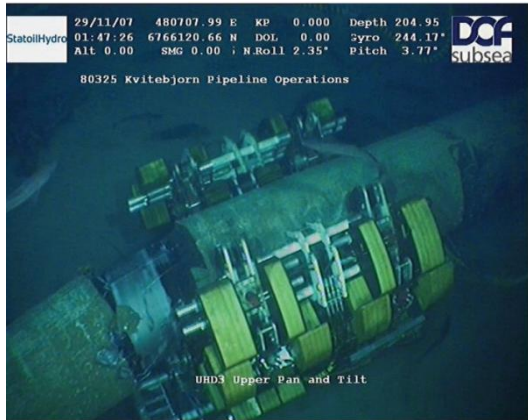
CRU works based on high pressure water jet cutting of the concrete coating over the pipe. Once the concrete coat is removed in large pieces, the concrete re-bars are cut by the ROV cutting tools and afterward the residual concrete over the pipe surface is removed.

Figure 6-7. Coating Removal unit (CRU) to remove concrete coating. (Sources: Statoil)

Further to above subsystems, there are some ancillary units that support the repair operation. The main ancillary units are the Coating Removal Unit (CRU) (figure 6-7) and the Weld Seam Removal Unit (WSRU) (Gjertveit, Berge and Opheim, 2010). These units are carried by ROVs and normally there is no need to have a frame (Figure 6-8).

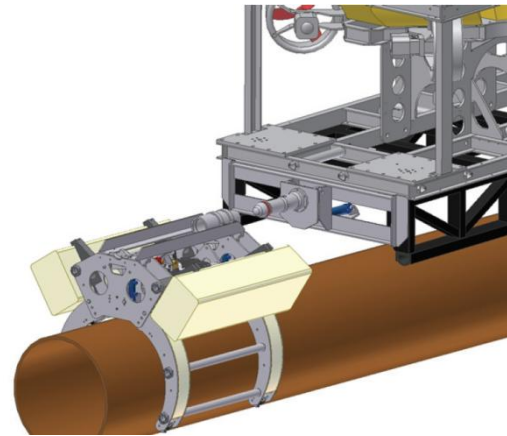
The WSRU is supposed to remove the longitudinal weld cap over the pipe surface. A diamond disc is used to remove the cap. However the newly manufactured seam-weld pipes have seam line with very smooth caps.

Figure 6-8. ROV carries the WSRU (Sources: OTC20814)

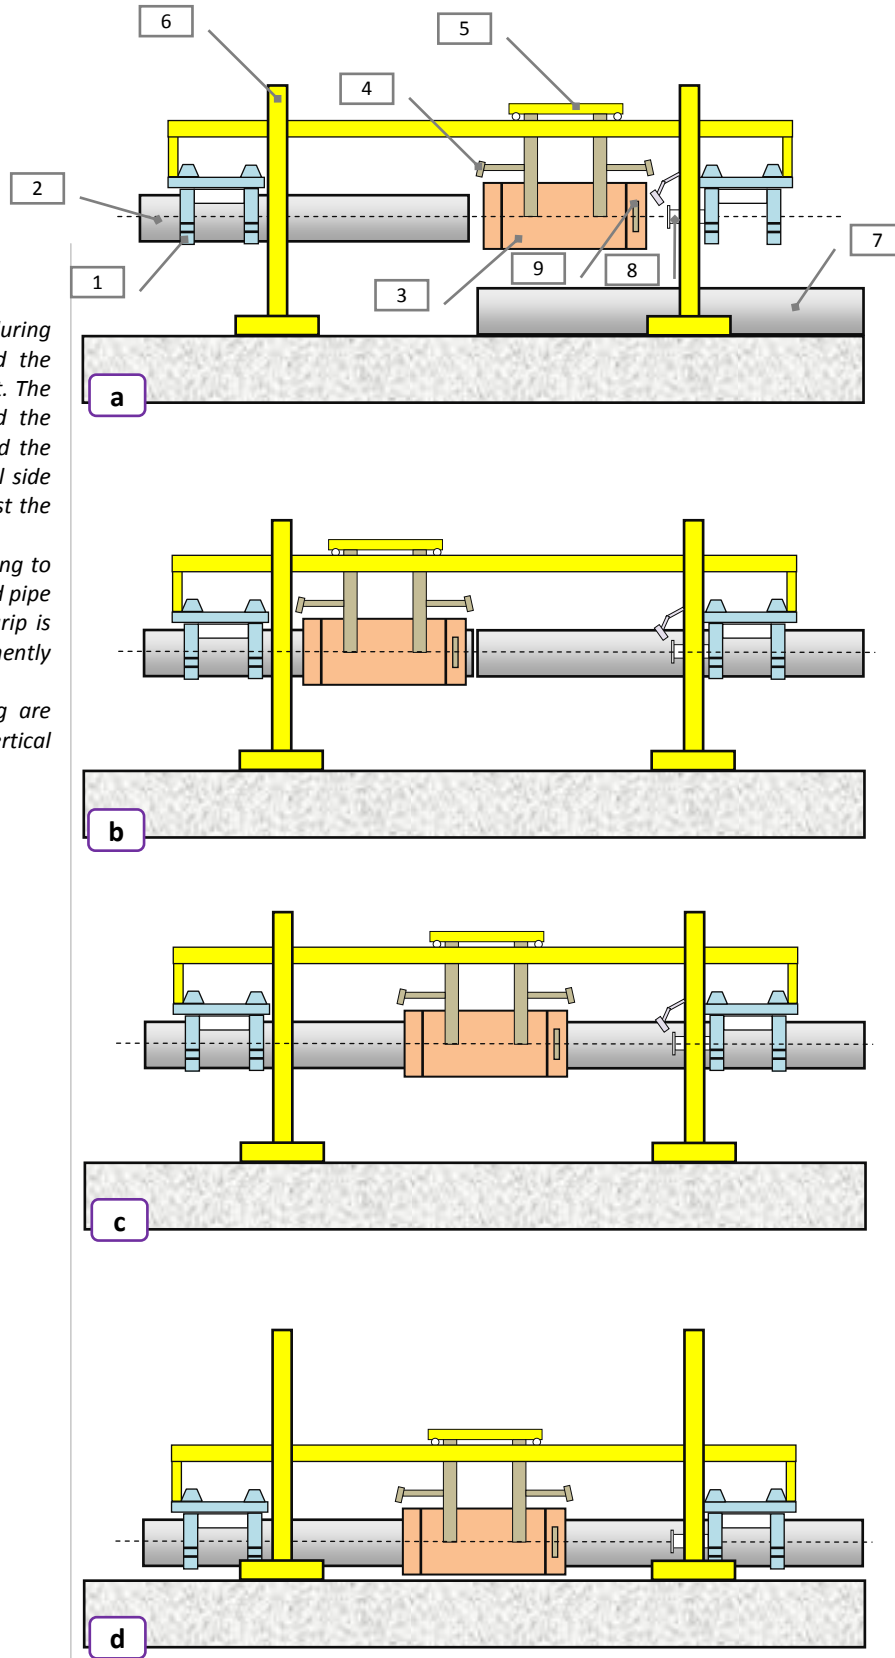
Figure 6-10. CIF actions during coupling installation. CCM and the coupling are shifted to the right. The line side pipe is lifted (a) and the CCM moves toward and around the lifted pipe to the left. The spool side pipe is lifted and aligned against the line side pipe end (b).

The CCM transverses the coupling to the right and around the aligned pipe of the spool side (c). The Morgrip is then activated and the permanently locked.

Figure 6-9 illustrates the main steps of the procedure in more details, where the pipe ends are being mated and the mechanical coupling is engaged and locked and finally the pipe is lowered and laid on the seabed. In order to monitor the sensitive alignment operation, some cameras and laser technology are being employed. Figure 6-10 shows the close up view of the coupling installation steps using the CIF.

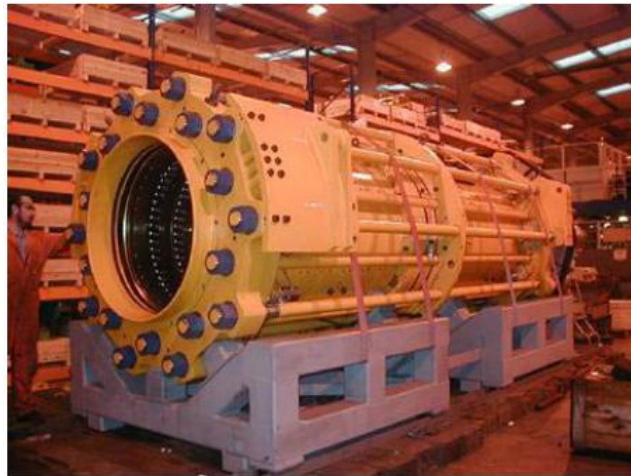
The Morgrip coupling is being the core of the PRS, since diver-assisted welding methods are facing the serious challenges for the deep waters. The Morgrip technology is owned by Hydratight and developed for the depths beyond diver access (Figure 6-11).

Figure 6-11. Morgrip connector (source: Hydratight)

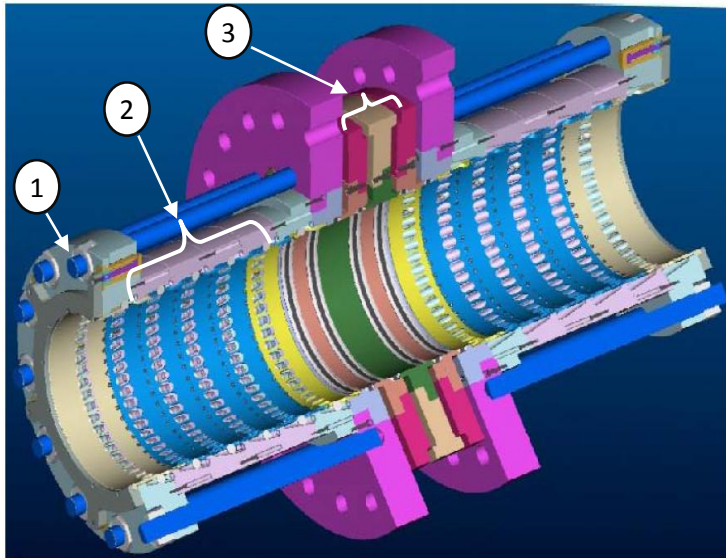
Figure 6-12 shows the schematic view of a typical Morgrip coupling. The number of ball rows may change for each case, depend on design parameters.

Figure 6-12. the Morgrip different parts:  
 1. mechanical locking  
 2. gripping rows  
 3. sealings

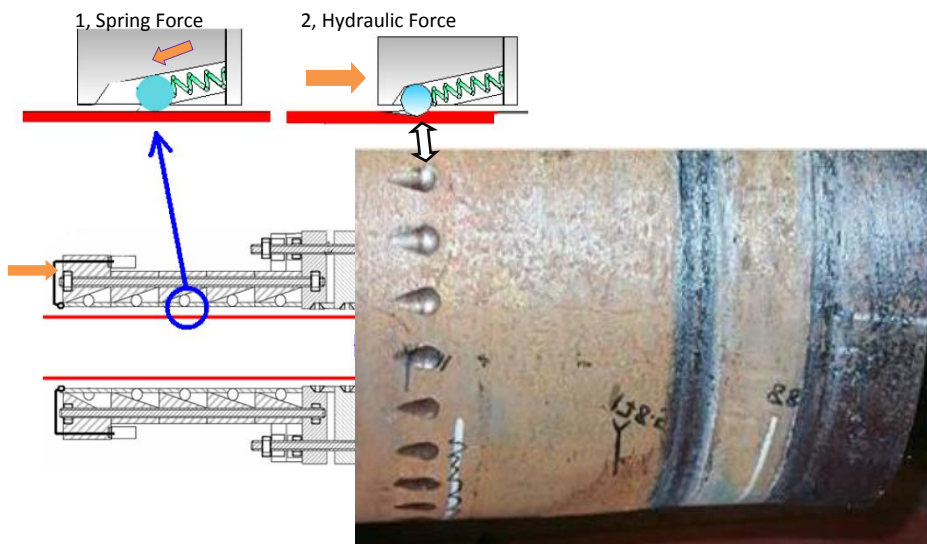
The gripping is supplied by several rows of steel balls that are spring loaded and during activation the ball segments are pushed toward the pipe's external surface (Figure 6-13). The material of ball is of grade BS 535A99 that is bearing steel with high surface hardness. The balls are positioned in a tapered housing that is locked by pins in a passive state. Springs are released just prior to hydraulic activation by removing the locking pins. Once the balls contact the pipe surface, the hydraulic pushing force causes swaging effect and provides a grip that compensate the pipe strength regardless the gripping force from the sealing system.

Figure 6-13. Gripping system in Morgrip coupling. The balls indent the pipe metal and are trapped in.

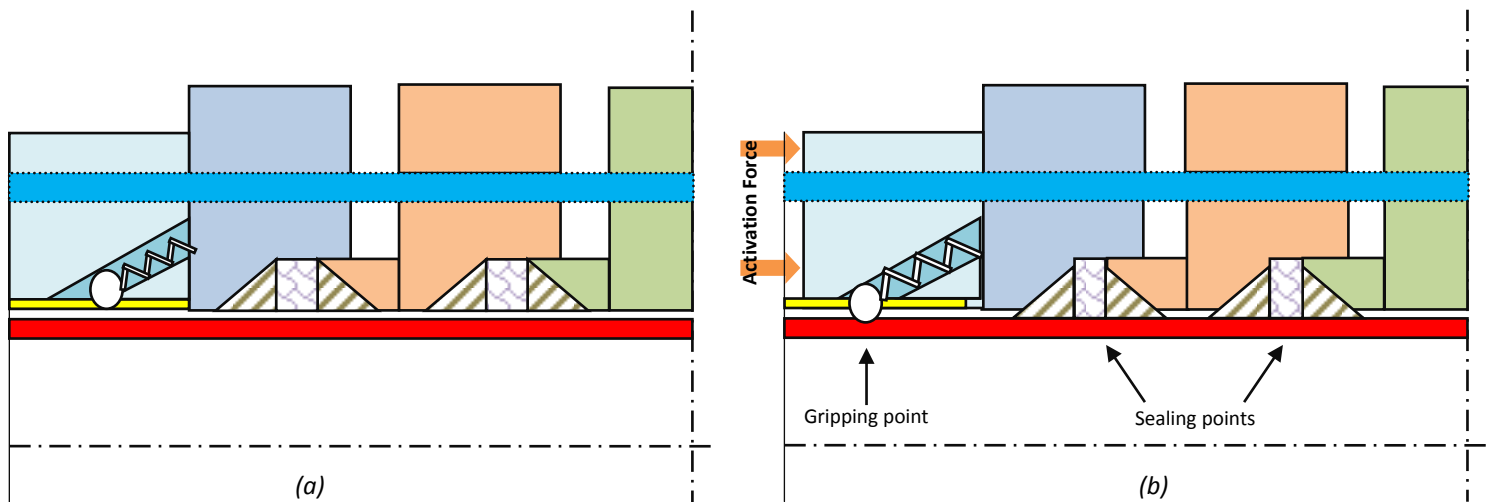
A twin sealing system provides the sealing against the leakage from the damaged pipe. The seal is a Metal-Graphite-Metal sandwich that is compressed onto the pipe and resulting in the radial sealing. In the Morgrip design, the sealing is engaged at the same time as the balls swage into the pipe in one-run activation.

Figure 6-14. Morgrip activation mechanism. Gripping ball rows are locked by ball cages (yellow part) before activation (a). The hydraulic activation force and the spring restoring force activate both sealing and gripping mechanism (b).

The graphite filler energizes the metal rings and the metal rings provide the limiting support to avoid longitudinal extrusion of the graphite ring in order to have more radial packing. The double series of the sealing rings on each side of the coupling increases the reliability of the sealing system. The test is conducted by injecting seawater into the annulus space between two sealant rings.

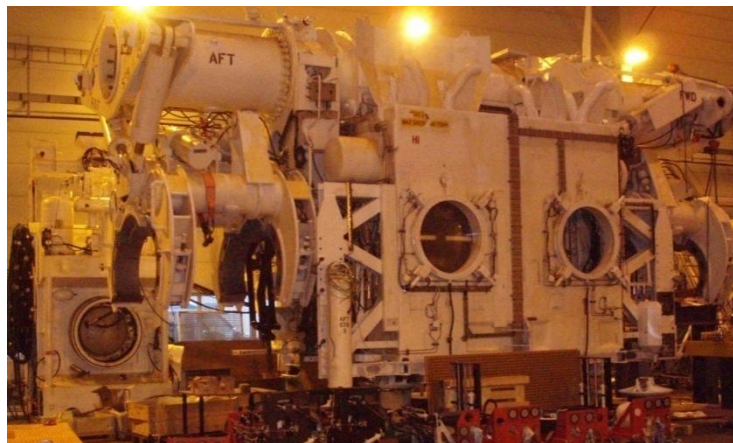
For diver-assisted welding, the habitat is accessible for divers (Figure 6-15). Divers can re fill the welding consumable drums, check the welding operation and detect any stop in welding operation and fix it or report it to the surface. In fact the dry habitat provides a working room similar to normal working atmosphere on the surface except that the pressure is high in order to overcome the hydro-static pressure.

*Figure 6-15. Dry habitat with the diver access and assistance (courtesy of Statoil).*

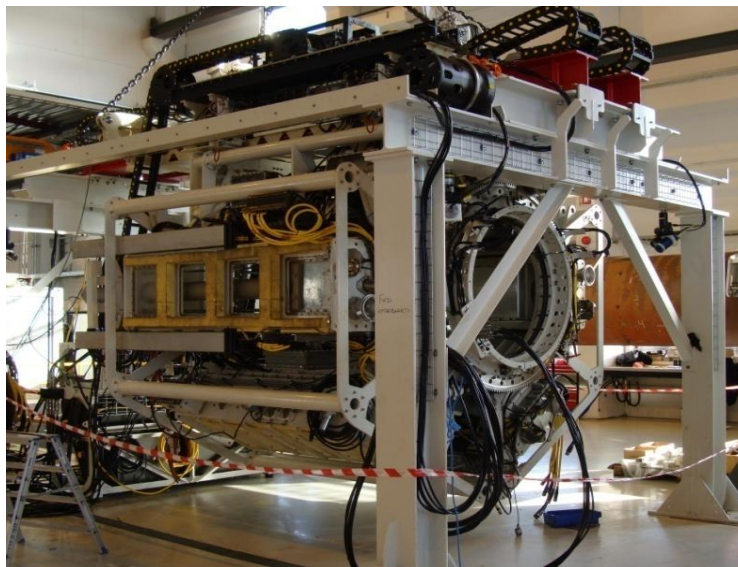
Remotely operated welding is the main part of the DEEP PRS program in Statoil. A feasibility study to extend the remotely operated welding down to 4000 meter water depth is ongoing. The MIG (Metal Inert Gas) welding for depth of 2500 meter is experienced. The TIG (Tungsten Inert Gas) is proven to be efficient only for depths up to 1000 meter. The welding can be butt-welding where the new piece of pipe is beveled and aligned with the pipe (Figure 2-2) or fillet weld where a sleeve pipe is to connect the pipe spool to the main line (Figure 2-8). The butt-to-butt closure has limitation on the alignment that shall be very precise while the fillet weld does not need very accurate alignment of pipes. Weld examination is a challenge for fillet type of welding. The ongoing plan in Statoil PRS is based on the sleeved joint with fillet weld. The application of butt weld type of connection is under study as a R&D project in SINTEF. Figures 6-16 and 6-17 show the Remotely Operated Welding Tool (ROWT). A camera is mounted inside the tool over the welding torch. It provides the ability to monitor the welding operation from the surface.

Figure 6-16. ROWT: Remotely Operated Welding Tool (courtesy of Statoil).

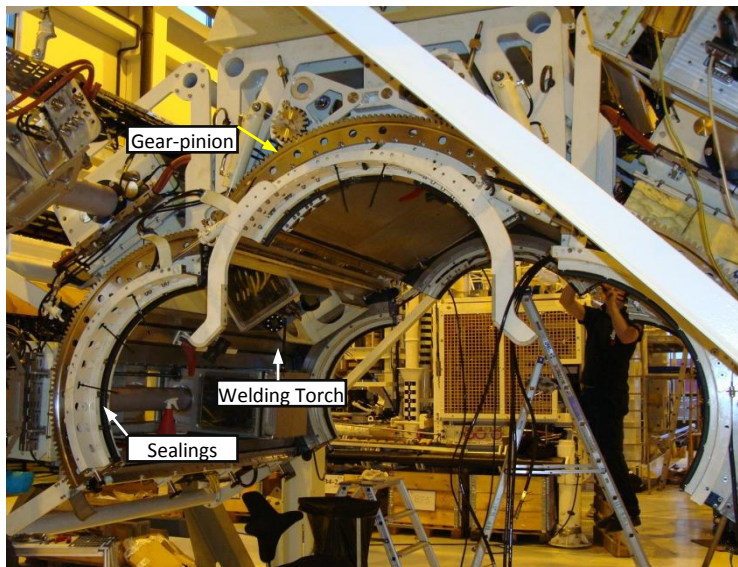
Figure 6-17. ROWT, three surrounding parts provide the room for dry welding (courtesy of Statoil).

A gear-pinion mechanism rotates the whole chamber while the welding travels (Figure 6-17).

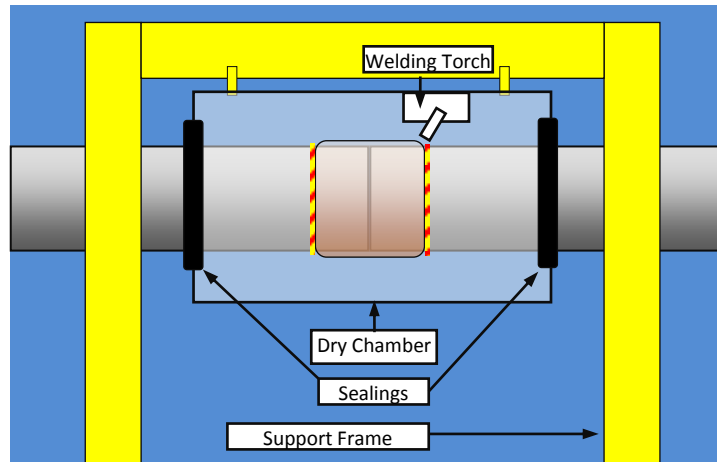
A sealing mechanism should be in place all the time during welding to keep the welding space dry (Figure 6-18).

*Figure 6-18. ROWT, dewatered and dried space for welding is necessary before start welding. Purging is done by inert gases.*

For the sleeve type of connection: it contains two internal environmental seals each side to prevent water seeping back into the welding zone. In addition it is a blower nozzle to help blowing away any surface water in the gap. Since the humidity affects the weld quality, it shall be monitored all the time. The humidity level shall be controlled to be below 300 ppm which is the welding specification. For the butt-weld type of connection: a specific design of smart plug can be utilized for aligning and the back sealing.

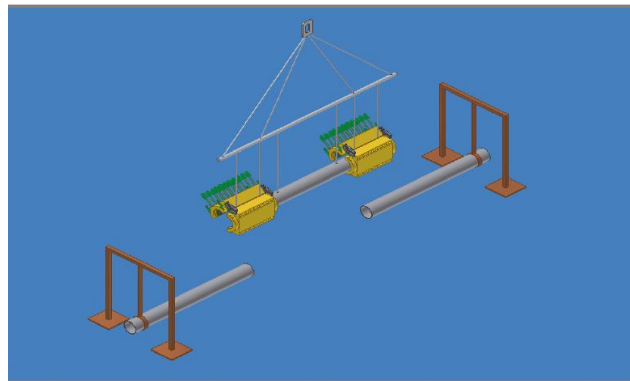
As a result of a JIP (Joint Industry Project), an emergency repair contingency method has been developed to respond to the repair jobs in water depths from 300 meters to 3,000 meters in the US Gulf of Mexico. The program is split into two categories, the pipeline and the flow line repair. The main idea is to employ full structural clamps (as connectors) and a spool piece (Figure 7-1). Using the clamp and avoiding the “slip on” connectors reduces the risk of damage with the elastomer seals that might be due to rough cut end of pipes.

Figure 7-1. Clamped spool piece installation (source: OTC19207).

The initial plan was based on employing a set of split clamps and spool-piece. Figure 7-3 shows the arrangement for the clamps and spool pipe. The structural split clamps are fixed to the spool and are deployed using spreader bar while the clamps are opened with hinges (Figures 7-1 & 7-2).

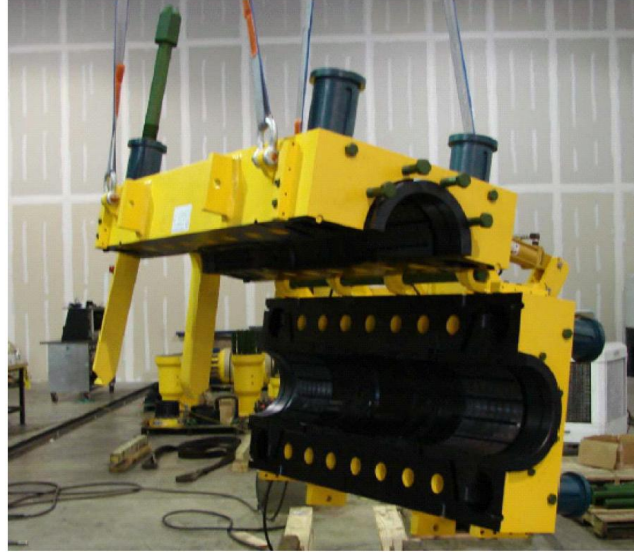
Figure 7-2. Opened clamp (source: OTC19207).

The test of the split clamps showed that the clamp can accommodate the nominal pipe diameter plus 1.5% ovality in the pipe with the efficient sealing and gripping (Ayers et al, 2008). Tolerances are a matter of challenges for clamp designs. Tests may reveal mismatches if the tolerances are not considered during design.

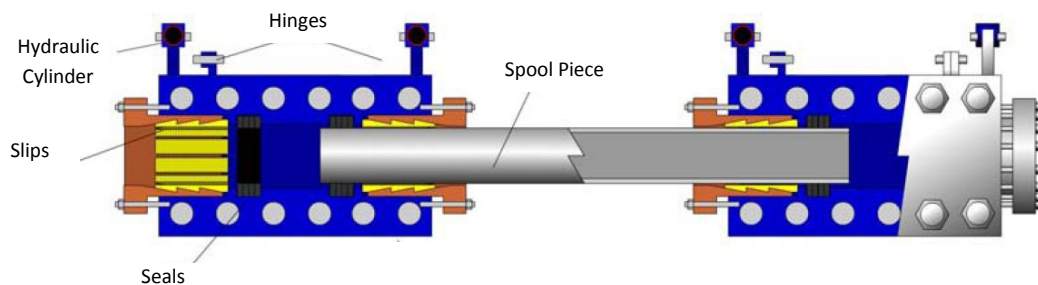
Figure 7-3. The clamped spool (source: Stress subsea, Inc).

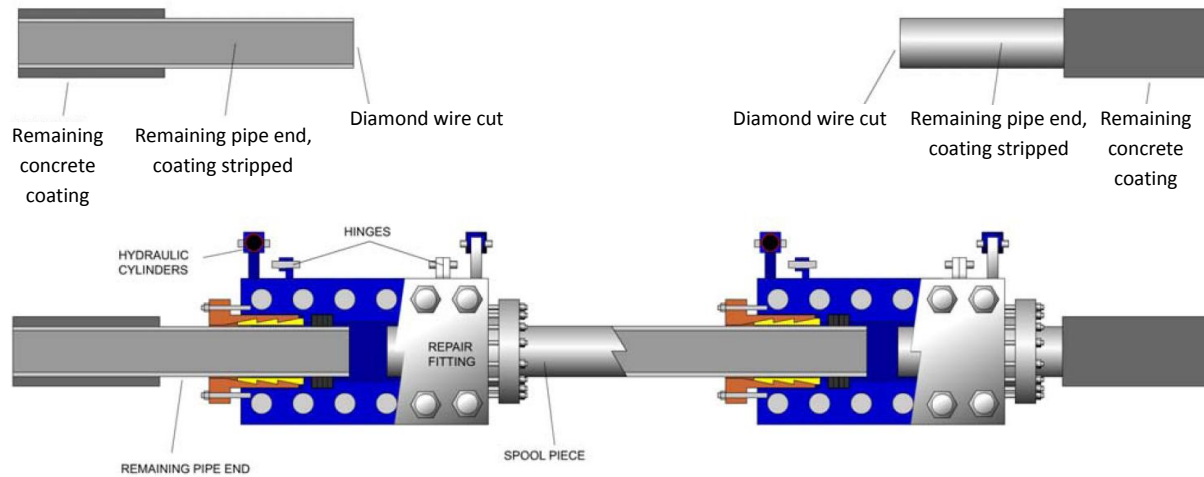
The pipe ends are already cut and prepared for the final alignment and spool connection (Figure 7-4). Hydraulic cylinders are placed on the clamps. The clamp halves are closed and bolted once they are in final position. The cross sectioned part of the clamp shows the gripping system engaged the pipe outer diameter.

Figure 7-4. The clamped spool installed and the pipe ends are connected (source: Stress subsea, Inc).

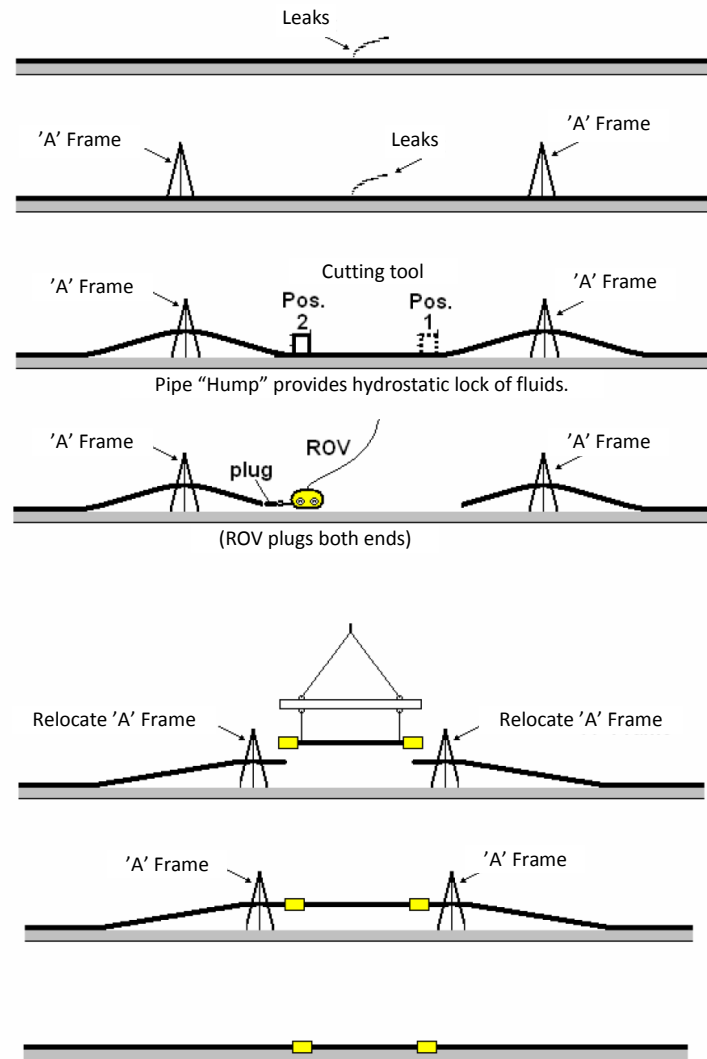
The schematic of the typical repair sequence is illustrated in Figure 7-5.

- to deploy A-frames at either sides of the damaged location, lift the pipe from two points,
- to cut the damaged suction off the pipe,
- (using the ROV) to insert the pump-able plugs into the cut-end of the pipes,
- to lower the clamped spool down to the pipe ends,
- to engage and activate the clamps with the pipe ends,
- to lay down the fixed pipe on the seabed,
- to recover the tools and frames to the surface,

Figure 7-5. Installation sequence (Source: OTC17772).

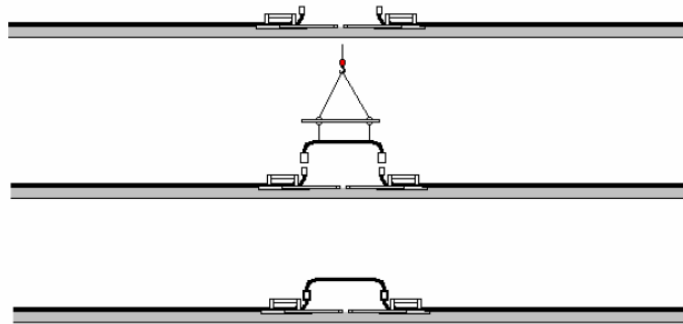
Once the same task is done for the other pipe end, and the pipes are laid back to the sea bottom, a pipe spool similar to the tie-in jumpers is deployed and complete the connection of line (Figure 7-7).

Figure 7-7. A jumper-type connector pipe completes the line (Source: OTC 19207).

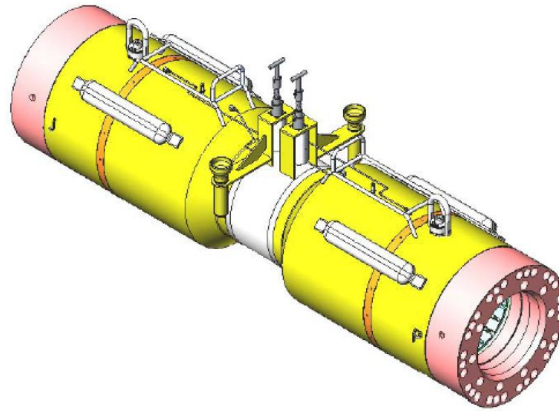
The connector is made of two Grip and Seal connectors that are welded together. The design is proposed by Oil States Industries, Inc. (Ayers et. al, 2008). Shell is one of the main clients for this design. The system is shown below (Figure 7-8).

Figure 7-8. Dual Grip and Seal Connector (Source: OTC 19207).
