Study program/ Specialization:  Offshore Technology / Marin and Subsea Technology	Spring semester, 2011  Restricted Access
Writer: Keramat Mohammadi	..... (Writer's signature)
Faculty supervisor: Ove Tobias Gudmestad  External supervisor(s): Per Nystrøm (IKM Ocean Design)	
Title of thesis:  Repair methods for damaged pipeline beyond diving depth.	
Credits (ECTS): 30	
Key words:  Deepwater, Pipeline, Repair, Diverless, Clamp , Coupling	Pages: 90  + enclosure: 7 (+1 CD)  Stavanger, 14.06/2011 Date/year

# Repair methods for damaged pipeline beyond diving depth

Master Thesis / Marine and Subsea Technology

Keramat Mohammadi  
Spring 2011

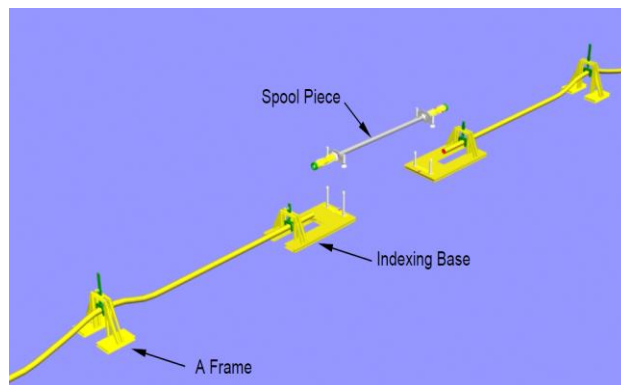
The installation method differs from the clamp type alternative. The connector erection and skidding is based over an indexing base (Figure 7-9). The connectors are primarily mounted on the replacing spool and are deployed at the installation location on seabed, where the lifting frames and indexing bases lift the pipe ends and make them ready for spool installation. Once the stabbing guides on the indexing base bring the spool into the right position, the index guides slide the connectors toward the pipe ends and the connectors locking system will be activated (Figure 7-10).

Figure 7-9. In-Line Connection System Profile (Source: OTC 19207).

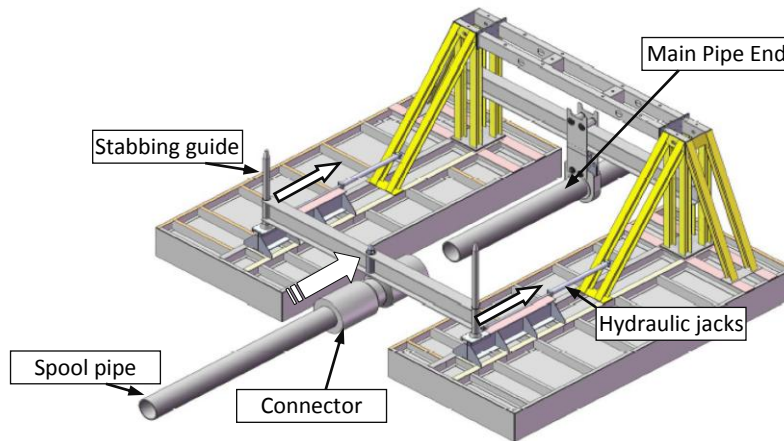
Figure 7-10. Indexing Base (Source: OTC 19207).

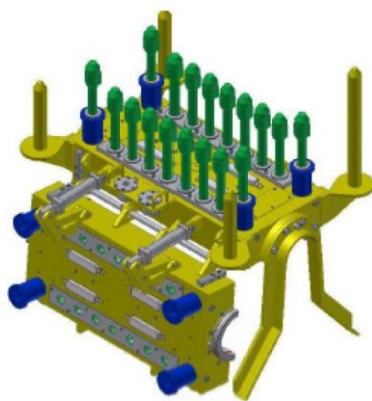
a). Clamp Size : 10-16 inch (Quality Connector System, Inc.)

Figure 7-11. Structural Leak Clamps (Source: OTC 19207).

On the small size clamps (Quality Connector System, Inc. design, Figure 7-11 a) there is a guide for the time of installation to piggyback the clamp over the line where it leaks. The bolts are tightened by subsea hammers.

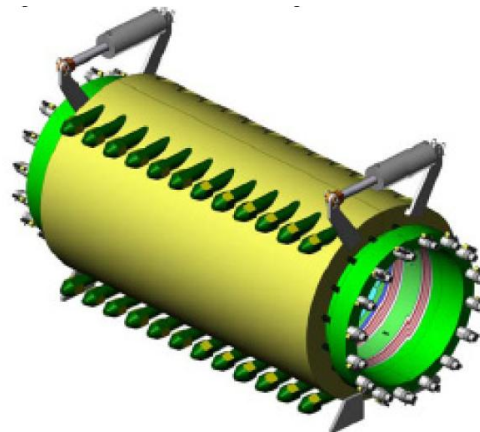
b). Clamp Size : 18-24 inch (Oil states Industries, Inc.)

For the bigger size clamps (Oil States Industries design, Figure 7-11 b), the installation force is achieved by hydraulic jacks and for permanent locking, bolts will be tightened after the final installation.

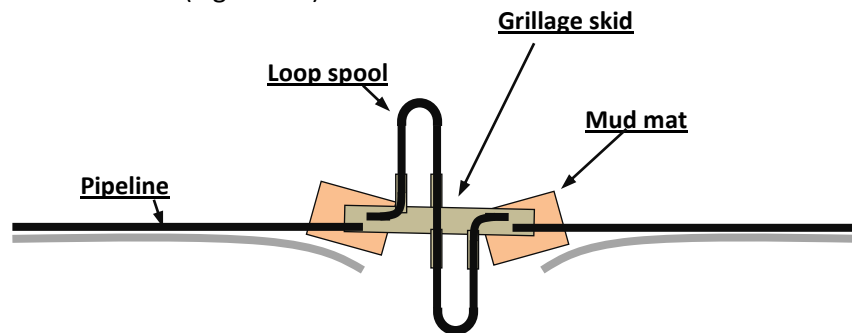
The method is almost as same as the Statoil PRS. The main difference is the tools for the connector installation which is done by the CIF in the Statoil system. Subsea7 designed a grillage skid that is put on top of two pieces of mud-mat (Figure 8-1).

Figure 8-1. Subsea7 repair system (top view). The damage pipe is replaced by a loop.

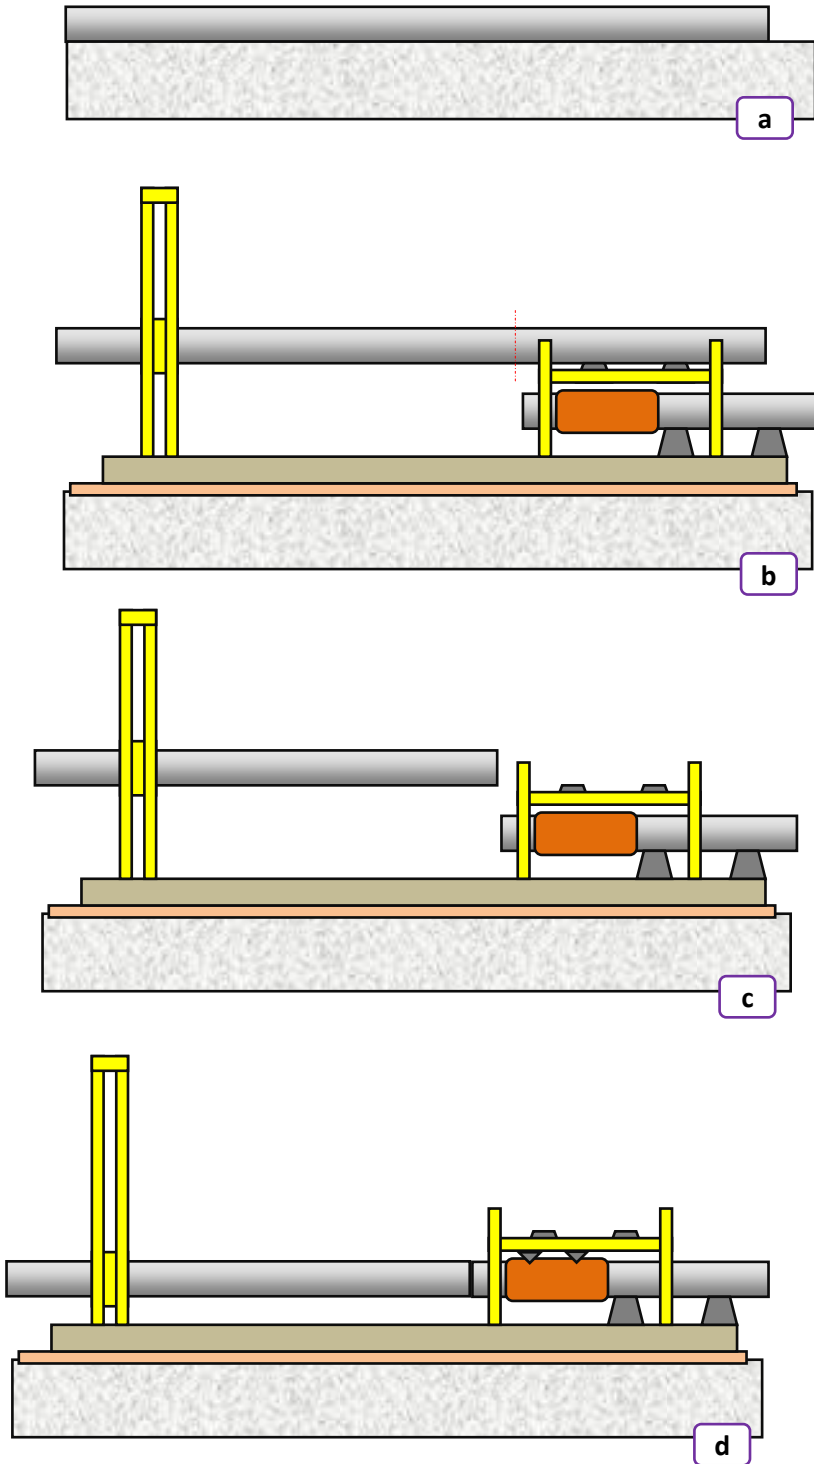
Figure 8-2. Subsea7 technology for TOTAL Girassol pipeline repair.

- a) The damaged pipe is already cut and the ready
- b) The grillage skid and the connector installation tool with the loop and connector itself are deployed on the seabed and the pipeline end is lifted and placed on top of the connector installation tool. After measuring the pipeline end is cut to precise length.
- c) The extra length is cut.
- d) The handling frame lower the pipeline end and using alignment frame, the two pipe faces are mated.

The operation is shown in Figure 8-2.

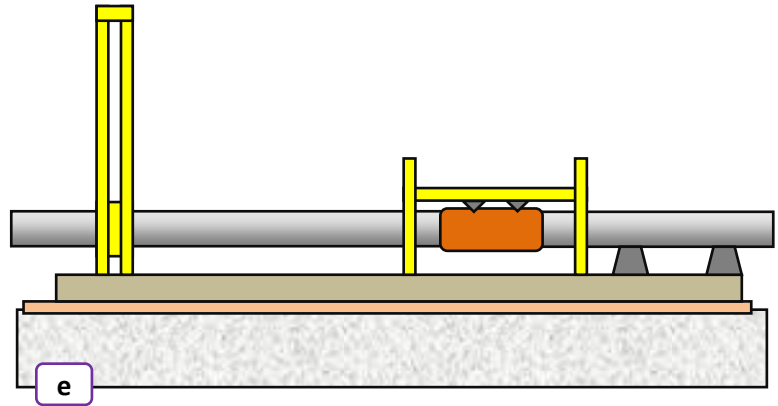
e

- e) The connector and the connector installation tool is moved to the installation place.
- f) The connector is activated and the installation tool and the handling frame are removed upon the pipeline is laid on seabed or support.

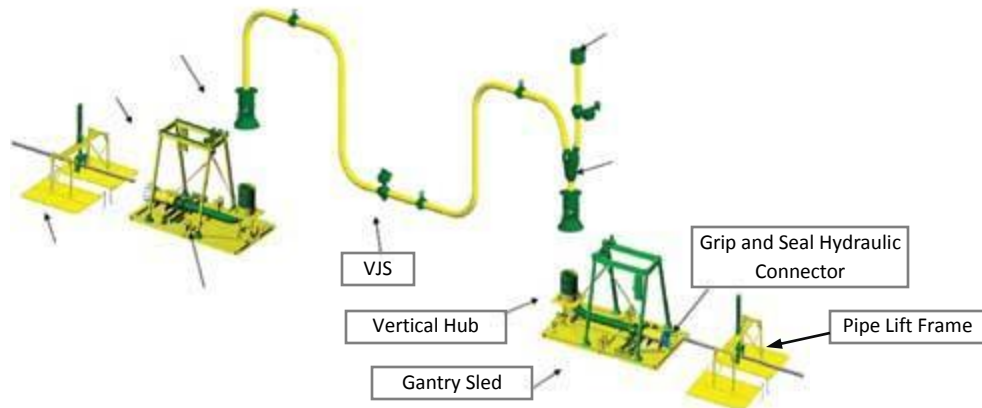
Figure 9-1 shows the general arrangement of VJS and the other components involved in on-bottom repair system.

Figure 9-1. Vertical Jumper Spool (VJS) Installation (Source: Offshore Magazine).

The PLF is to lift the pipe off the seabed and to provide access to the pipe end for the repair operations (Figure 9-1). It can lift the pipe in the vertical and lateral directions. It also allows the pipe rotation. The PLF functions are manipulated by the ROV hydraulically. Foldable mud mat eases the subsea lowering and retrieval (Figure 9-6).

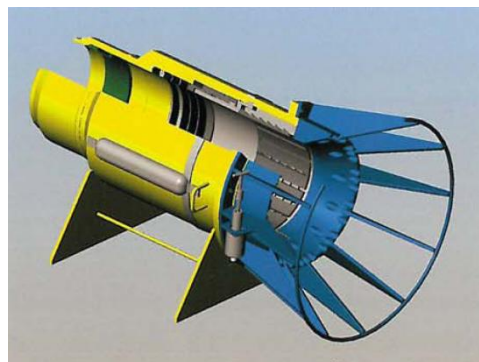
It connects an elbow (with a hub at the other end) to the pipeline end and provides a structural connection joint. It is assembled into the gantry sled (Figure 9-3) and it will be installed remotely by ROV when the pipeline end is prepared. The gripping mechanism is using a wedge-shaped slip segments inside the body (Oil States website, 2011). The gripping shall support the tension (from internal pressure and externally exerted tension) and compression (from thermal longitudinal expansion) loads. The dual-grip design provides support for both tension and compression loads. The sealing consists of two stacks of elastomer packers with an annulus space in between which makes the pressure-test possible upon the connector setting and installation (Oil States website, 2011). This is provided in dual arrangement in order to verify the joint integrity (Martin, Killeen and Chandler, 2004). The axial compression strains packers radially against the pipe outer diameter.

Figure 9-2. Grip and Seal Hydraulic Connector (GSHC) (Source: Oil States Website).

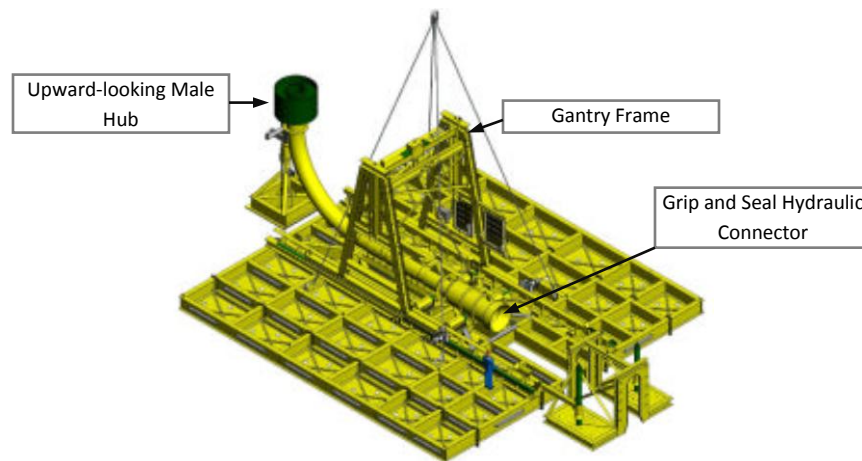
This is a supporting structure to install the elbow to the pipeline end (Figure 9-3). The GSHC is mounted on one end of the elbow (toward the pipe) and an upward-looking male hub is welded to the other end (toward the VJS). The Gantry Sled acts like a bridge crane and with conjunction of an alignment guide frame slides the GSHC-elbow-hub assembly over the pipe end. Hydraulic power is used for the movements. An ROV supplies the hydraulic power and controls the actions. Once the connector and pipe end are aligned, ROV actuates the GSHC to connect to pipeline.

Figure 9-3. Gantry Sled (Source: OTC 16635).

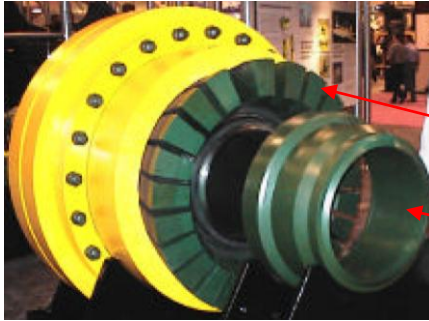
Figure 9-4 shows the collet connector (the green segmented part). It provides a female fitting against the male hub from the elbow. Figure 9-5 shows the after-connection arrangement.

Figure 9-4. Collet connector (Source: OTC 16635)

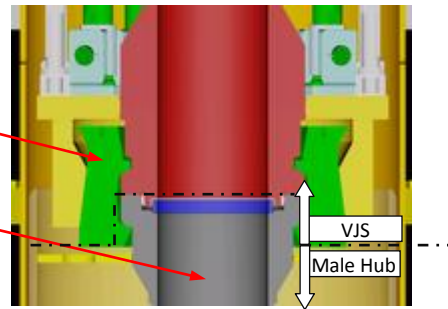
Figure 9-5. Collet connector after connection to upward-looking male hub (Source: Oil States)

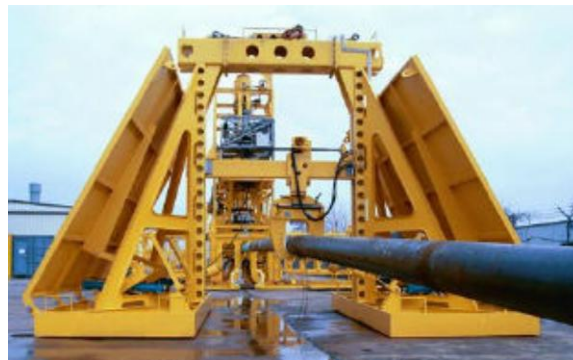
Figure 9-6. Pipe Lifting Frame (OTC 16635).

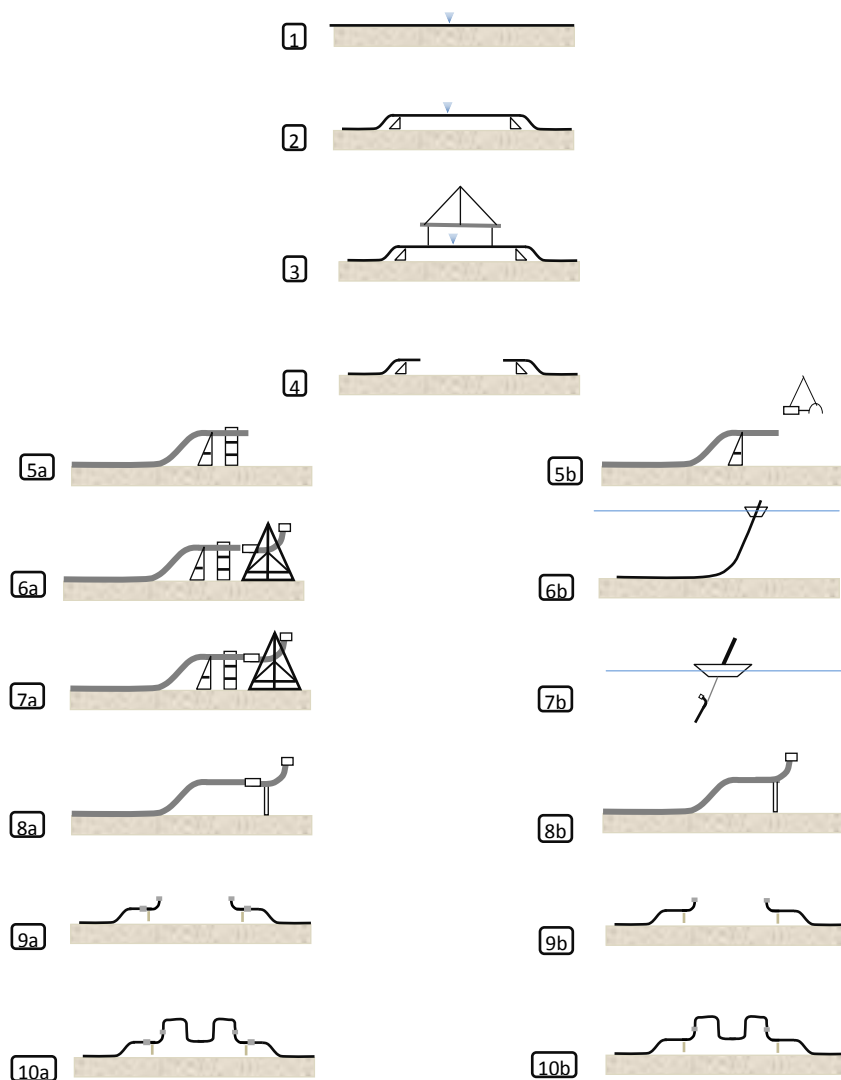
Figure 9-7 illustrates the steps for both the clamp and on-bottom repair methods.

Figure 9-7. Operational steps for on-bottom and Surface-Lift repair methods (Step 1-10a and 1-10b respectively).

Steps one to three in Figure 9-7 show the above procedure.

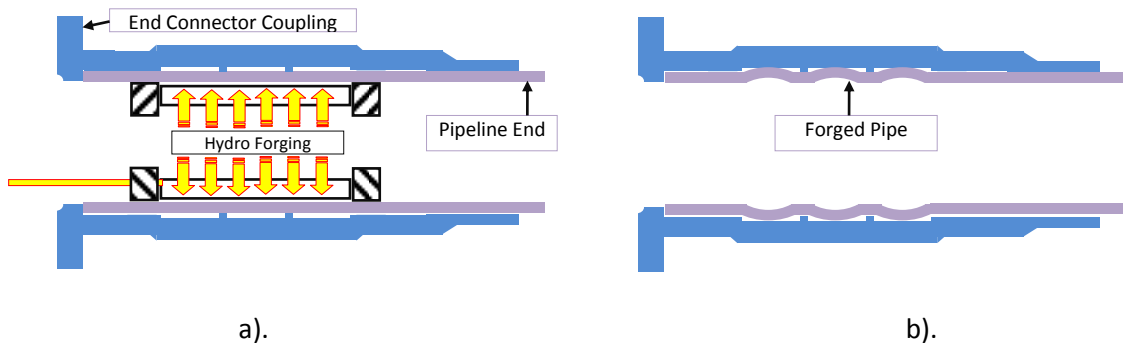
In the replacement type of repair, the focus is on a forged locking mechanism (metal to metal) (Figure 2-6). For this type of repair, there is a forging tool and a coupling device called the end connector. The first one is a tool to install the latter. The forging tool strains the pipe body onto the end connector wall permanently by using a hydraulic expansion force (Figure 10-1).

Figure 10-1. Forging the pipe wall on the end connector. The forging tool expands the pipe inside the pre-machined wall of end connector (a). The forged pipe and the coupling are integrated (b).

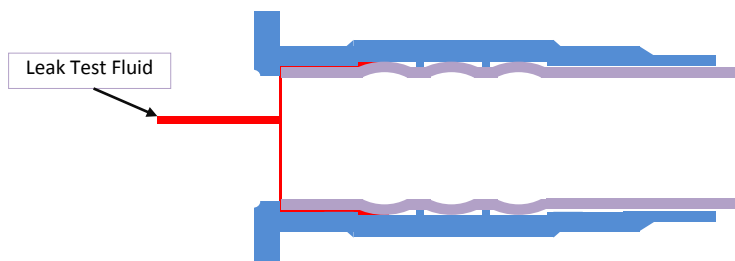
Figure 10-2. Leak test of the annulus space between the pipe and end connector.

The plastically deformed pipe (with a very high strain value) provides the sealing (Giuliano Malatesta, Brandi and Spinelli, 2008) as well as the gripping mechanism in conjunction with machined grooves on the internal side of end connector piece (high friction effect). Once the forging is completed, the annulus between the forged pipe and the end connector is leak-tested (Figure 10-2) (Eni Website, 2011).

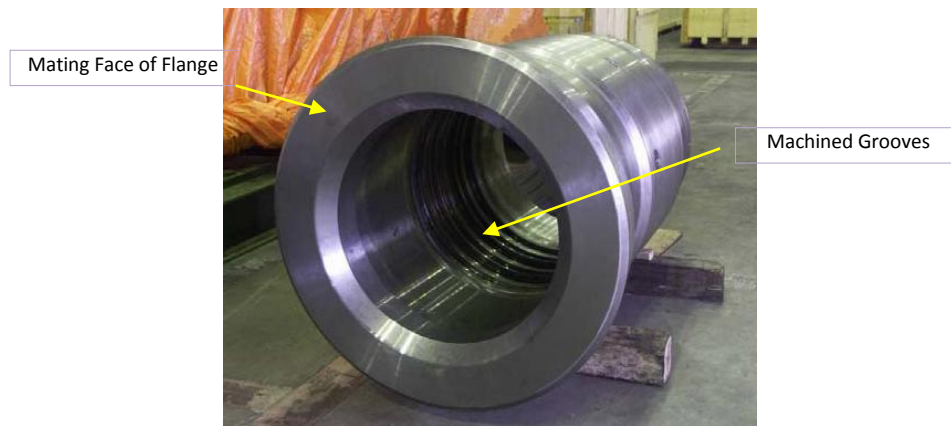
Figure 10-3 shows an end connector that is ready for installation. The end connector design shall be such that it resists the same kind and size loading as the pipeline itself. The connector wall shall be in its elastic range and this prepares circumferential stress around the pipe and improves the sealing (Giuliano Malatesta, Brandi and Spinelli, 2008).

Figure 10-3. End Connector (Source: ISOPE 2009).

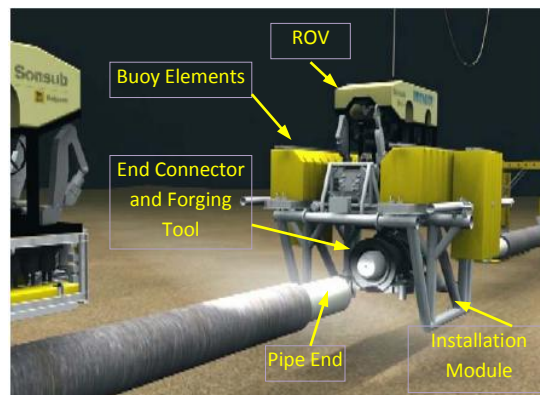
For each case and size, stress analysis and tests shall be conducted. The end connector is fixed in place and installed by a module that can be handled by ROV easily due to built-in buoyancy elements (Figure 10-4).

Figure 10-4. End Connector Installation (Source: ISOPE 2009).

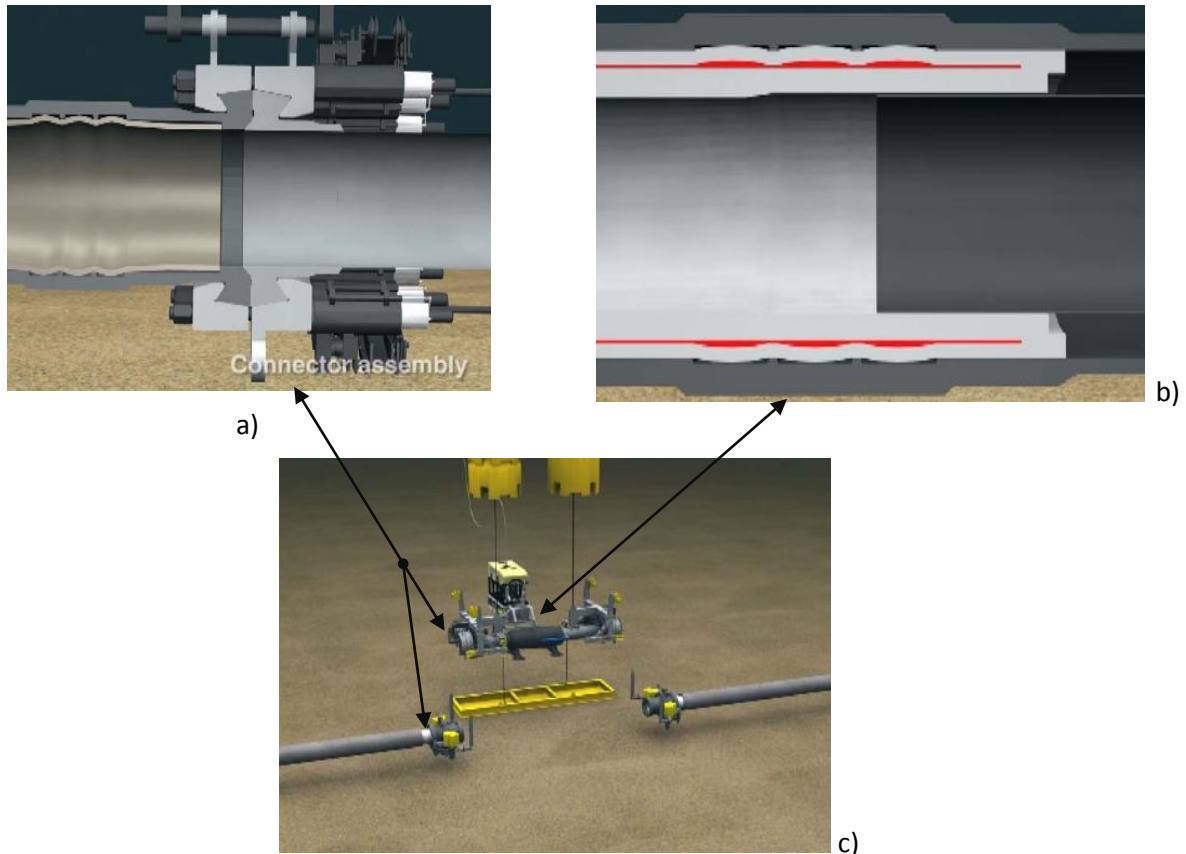
spool side are pushed together in a clamp type surrounding jaw that is tightened hydraulically (Figure 10-5 a). Due to uncertainty in the precise distance between the two pipe ends (spool length), the spool will have an elongation in the mid point. Once in place and adjusted to the required length, the spool is locked by a cold forging system similar to that of the end connectors (Figure 10-5 b&c).

Figure 10-5. Spool Installation (Source: ISOPE 2009).

- a) The Flange connection between pipe end and spool
- b) Spool piece central forging (red color shows the pressurizing water into the forging chambers)
- c) Spool installation, utilizing the surface-bottom and local guides

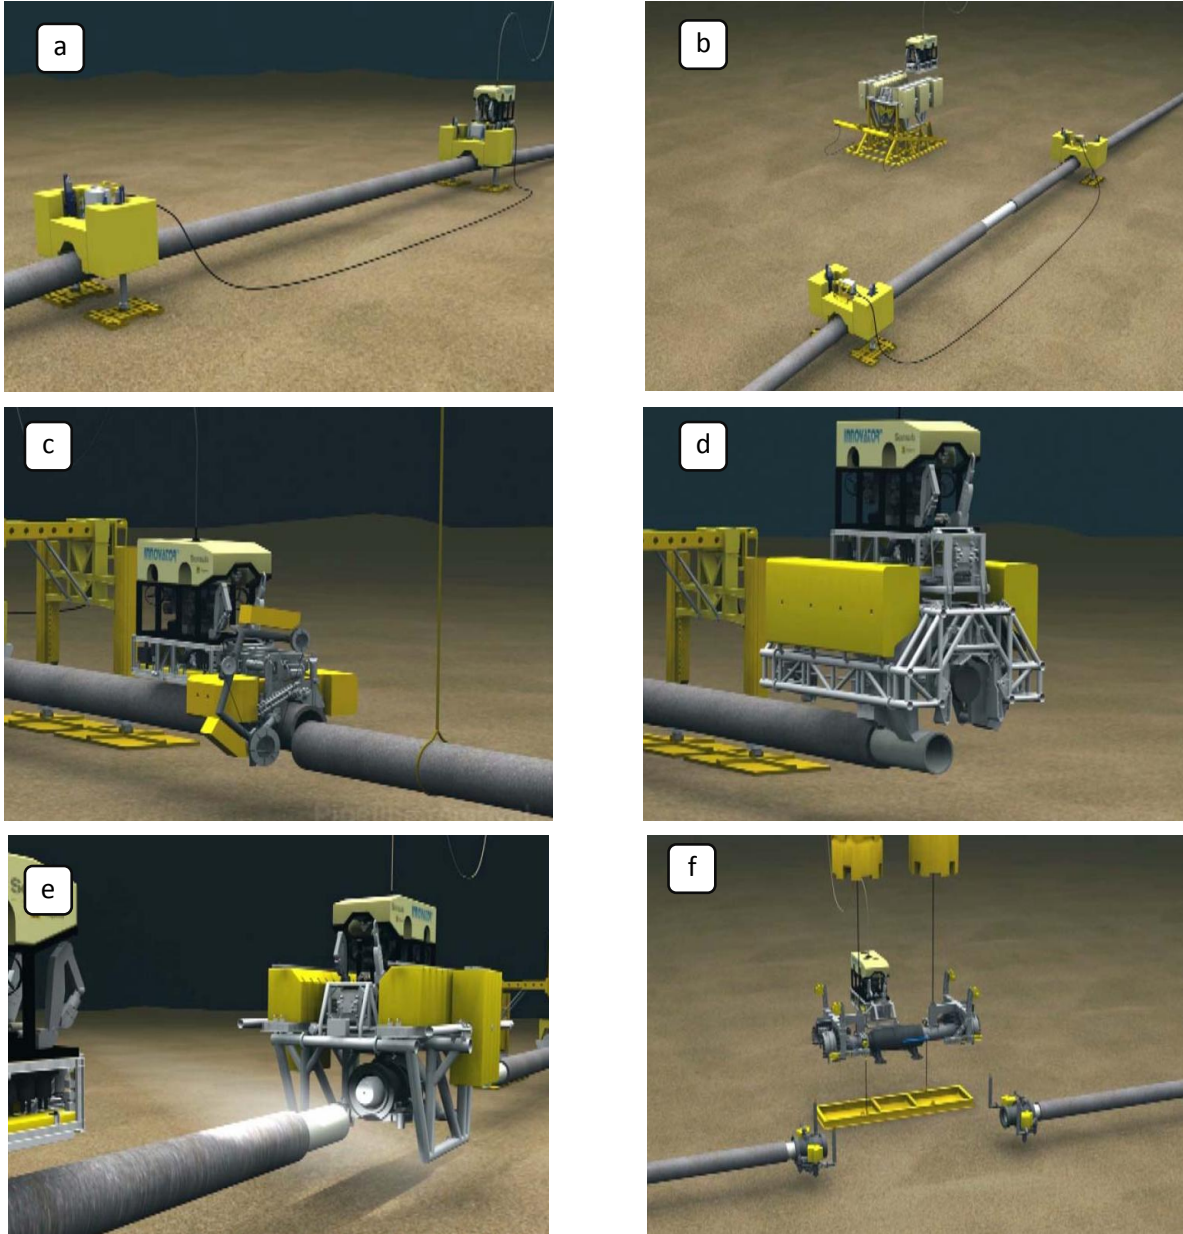
Figure 10-6. Eni/Saipem SiRCoS repair operation steps (Source: ISOPE Paper by Spinelli and Sergio Fabbri)

- a. Pipe Lifting*
- b. Concrete and Coating Removal*
- c. Pipe Cutting*
- d. Pipe End Coating Removal and preparation*
- e. End Connector Installation*
- f. Spool Installation*

The overall view of the operation is illustrated in Figure 10-6 pictures. All photos are taken from the ISOPE paper by Spinelli and Sergio Fabbri (2009).

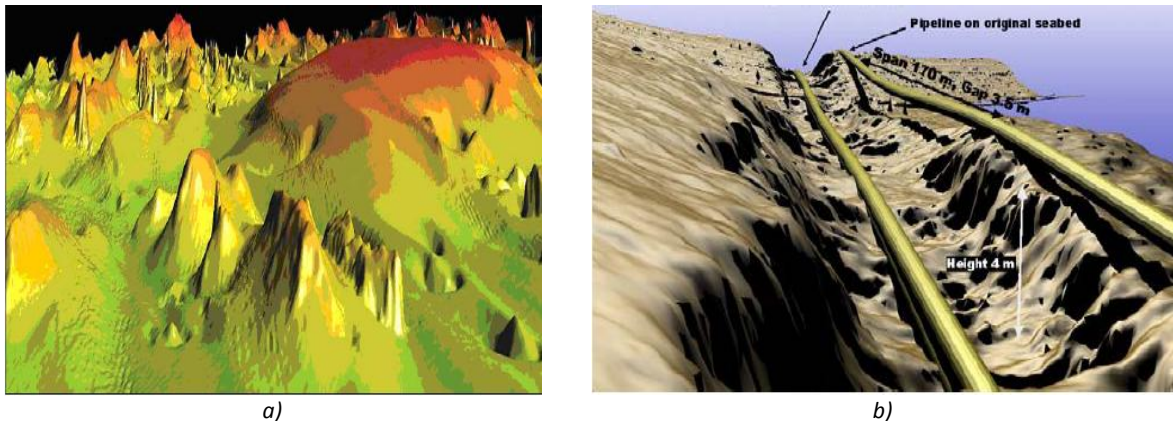
Figure 11-1. Ormen Lange seabed profile. Very uneven seabed (a) urges steep pipeline route (b) even after seabed preparation (Source: OTC-18967).

The systems and methods are for flat seabed or a very limited inclination (e.g. Statoil PRS standard specification tolerates 5 degree inclination and up to 30 degree in some very limited pipeline sections). This is very challenging for a repair operation and currently the main methodology is to replace the entire section and do the tie-ins in locations where the seabed is easier to operate at. Uneven seabed is common for deep water pipelines and in some areas it is very steep, reference is made to Ormen Lange pipeline route where it passes across steep hills (30 degree) (Eklund, Høgmoen and Paulsen, 2007). Figure 11-1 illustrates Ormen Lange seabed profile that is challenging for repair as well as for installation.

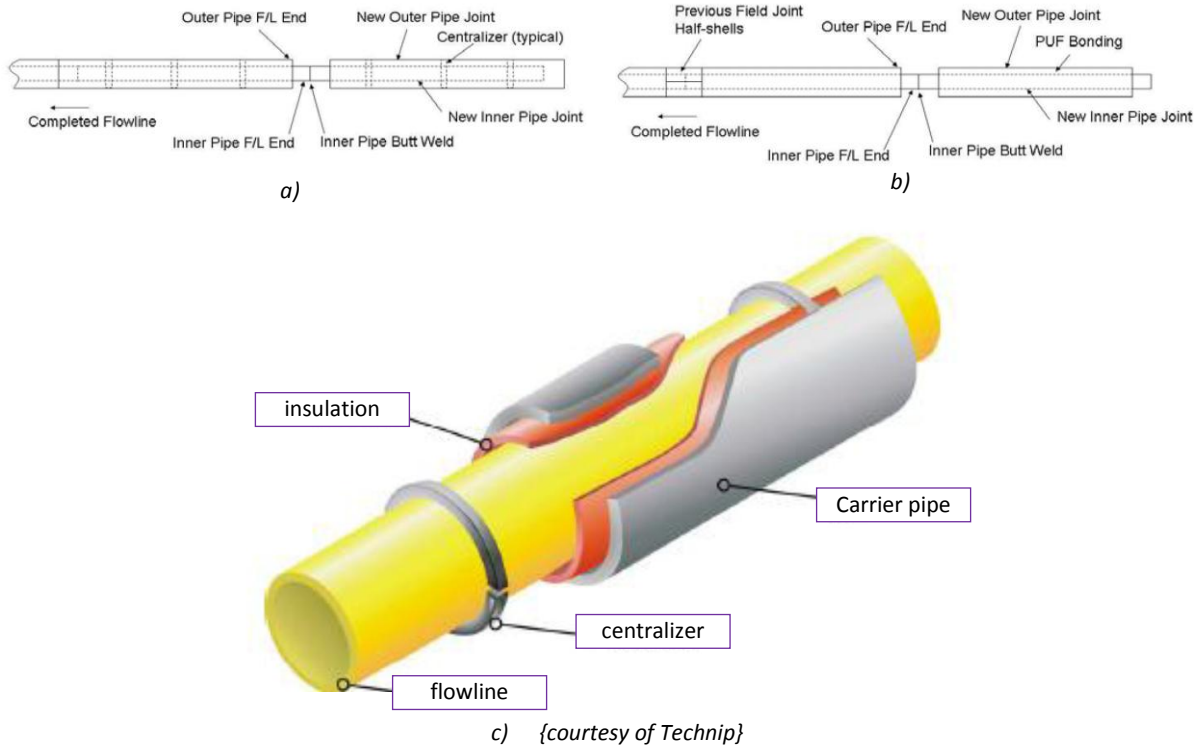
PIP is a common and complex design to satisfy the flow assurance requirement of a deep water flowlines by preparing housing for high performance and thick insulations (O'Grady, Bakkenes, Lang and Connaire, 2008). Figure 11-3 shows two major types of PIP assembly: sliding assembly and bonded assembly.

Figure 11-3. Pipe-In-Pipe assemblies: Sliding PIP (a) and Bonded PIP (b). (Source: OTC-18063)

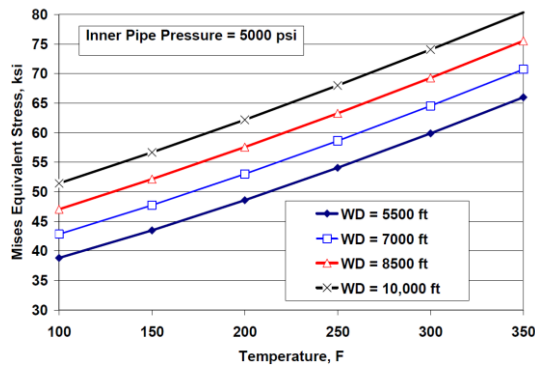
This type of line is exposed to different failure risks. Further to normal risks that can happen for any line, axial buckling risk is also present, particularly when the water depth is increased and the operating temperature is higher and there is no pre-tensioning in the line (related to bonded assembly type) (Harrison and McCarron, 2006). Figure 11-4 shows how the stress is higher for pipeline with higher temperature in deeper water.

Figure 11-4. Effect of water depth combined with operating temperature on inner pipe stress at a certain inner pressure (Source: OTC-18063).

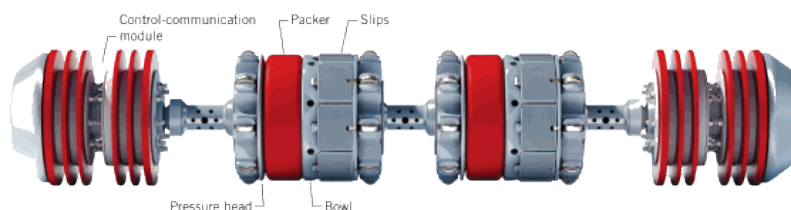
a).

There is a possibility to send a remotely operated isolation plug into a pipeline and plug the line at any arbitrary point. TD Williamson present a technology solution called SmartPlug® that is claimed to provide “tetherless, through-wall remote-controlled pipeline pressure isolation services” (TDW website, 2011) (Figure 11-5).

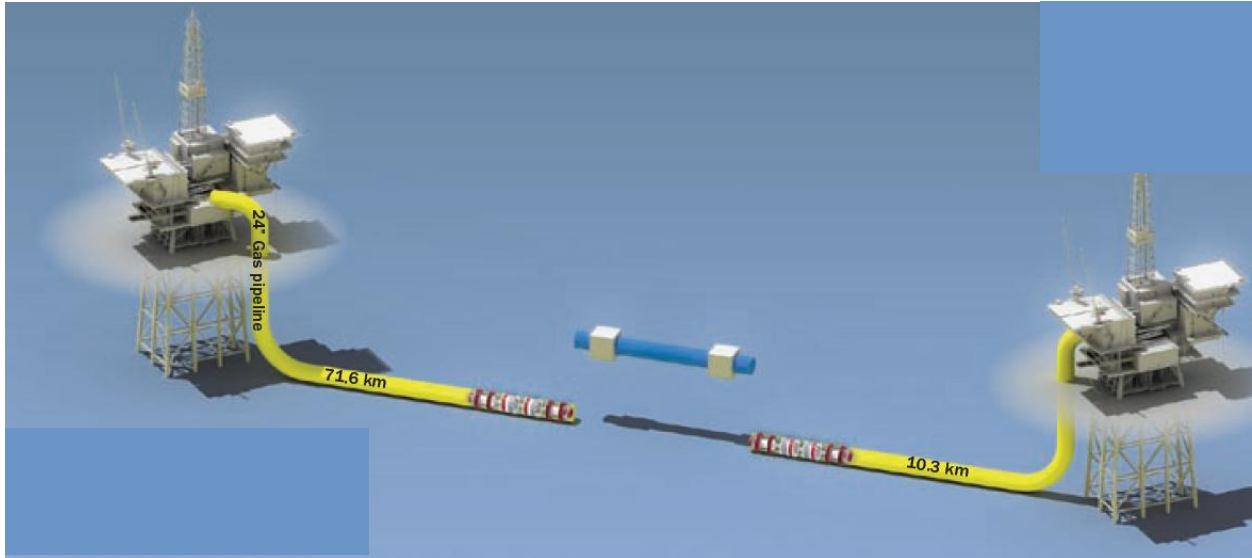
b).

Figure 11-5. Pipeline Isolation. Smart Plug (a), schematic representation of midline replacement on pipeline at operating pressure (b) (Source: PSI).

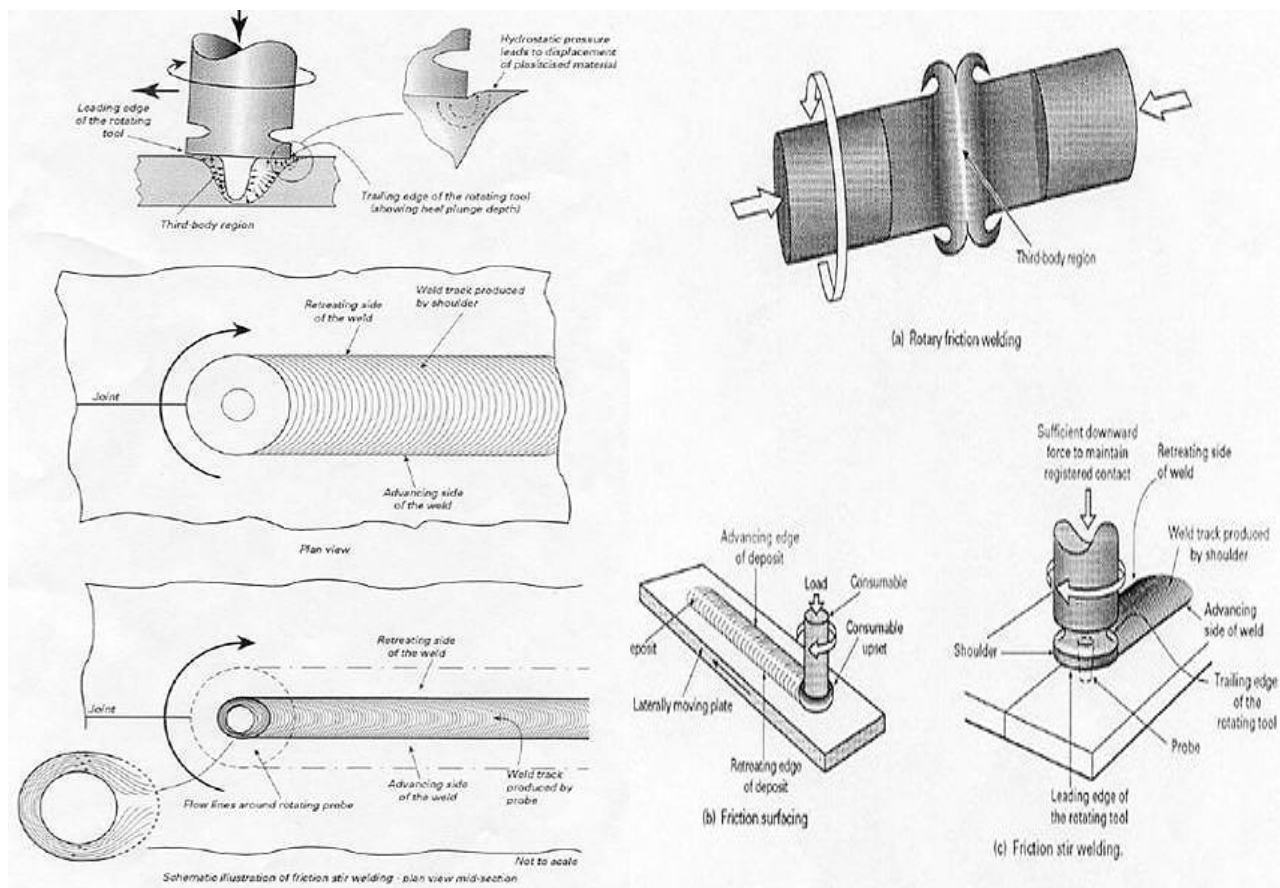
Figure 11-6. Solid phase weld (Source: Key to Metals website)

There might be the possibility to use wet welding (solid phase welding) as sealing barrier with combination of mechanical connectors. The solid phase welding is defined as the method in which the weld is achieved by using heat and pressure without fusion. It is also called “friction stir” weld. It is based on friction heat that is obtainable by using a hard rotating tool on the welding surface (Figure 11-6). Since the weld quality is sensitive to the water depth and the wet operation is limited to depth in order of few tens of meters (Richardson, Woodward and Billingham , 2002), solid phase (wet) welding can be used in shallow (diver-assisted) operations.

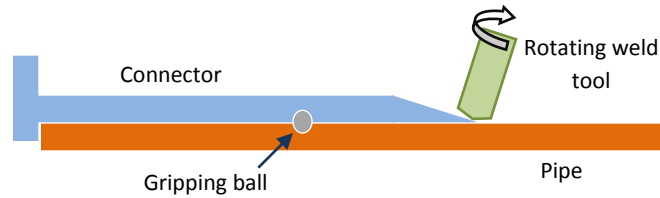
Figure 11-7. Solid phase welding, schematic for repair application.

Figure 11-7 shows schematically, the possibility to employ wet welding as a solution for sealing uncertainties in mechanical connectors.

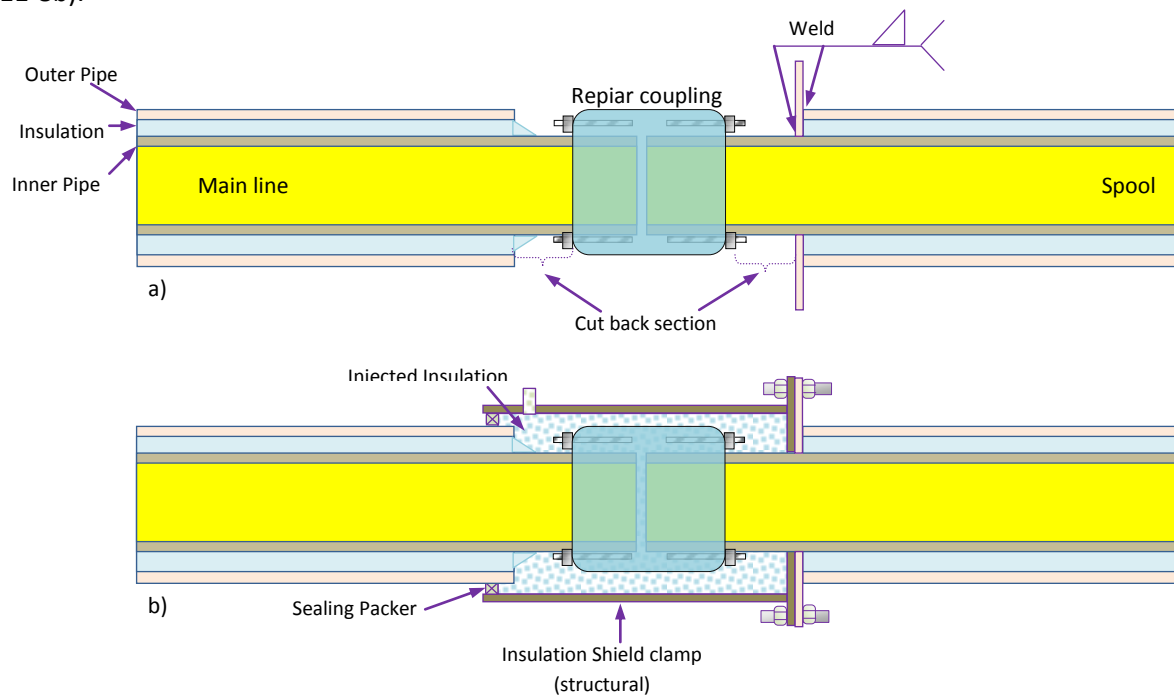
Figure 11-8. Pipe-In-Pipe (PIP) repair proposal. The insulation shield clamp is placed on the pipe after fixing the repair coupling and prior to insulation injection.

If a PIP gets damaged and it is required to replace it, the common methods can be implemented for the main (inner) pipe. The main difference refers to the outer pipe and the annulus insulation compensation. If replacing the damage part is the case, the whole system will be replaced, including the inner and outer pipes plus the annulus material. The outer materials will be cut-back at the cutting points in order to have enough space for the spool connections (Figure 11-8a). Once the spooled PIP is connected to the main line, insulation and the outer shield shall be compensated at the connection points and nearby areas. At the bare sections, structural clamps can be deployed and installed (Figure 11-8b).

Insulation packing can be done by injecting water-based insulation into the installed clamp. The clamp will seal the insulation and be integrated to the main outer pipe from one side and connected to the shield that is used for connector insulation purpose from the other end.

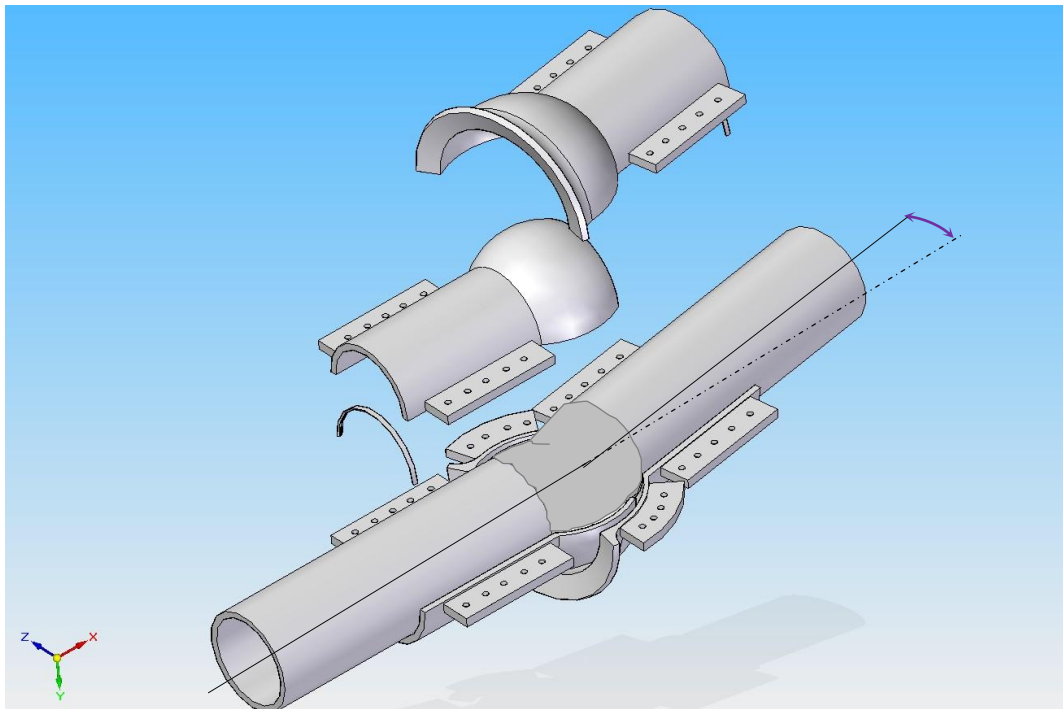
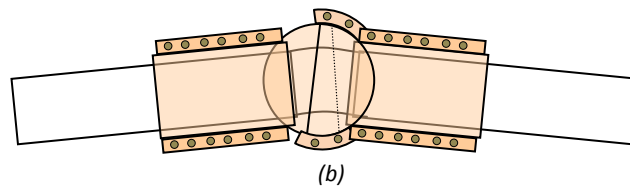
(a)(modeled by Solid Edge program-UiS License)

(b)

Figure 11-9. Angled-Clamp. Four main half-pipes (a), the installed arrangement around an angled pipe (b).

The angled-clamp comprises four main parts (half-pipes) (Figure 11-9). In fact it is a combination of two straight clamps that are connected via a ball joint arrangement. The radial and longitudinal sealing is similar to typical clamps for the straight parts. For the ball joint section, once all parts are assembled together around the pipe, an activation mechanism (similar to the Morgrip one) energizes the sealing and packs the annulus between two shelves of ball joint (Figure 11-10).

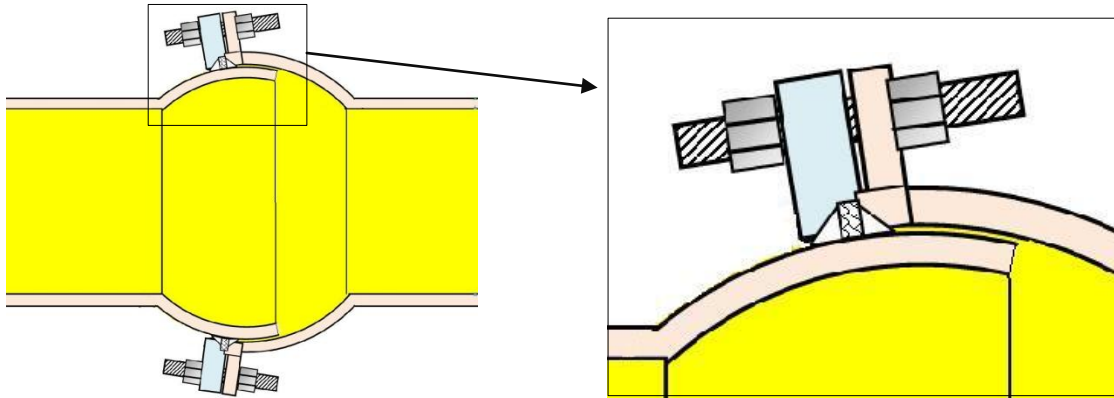
Figure 11-10. Angled-Clamp sealing mechanism. It can be doubled and with gripping ball rows (not shown here).

A ball or wedge gripping mechanism can also be utilized to accommodate the longitudinal loads and displacement. The sealing and gripping mechanism can be in multiplied rows, depending on the geometry and space.

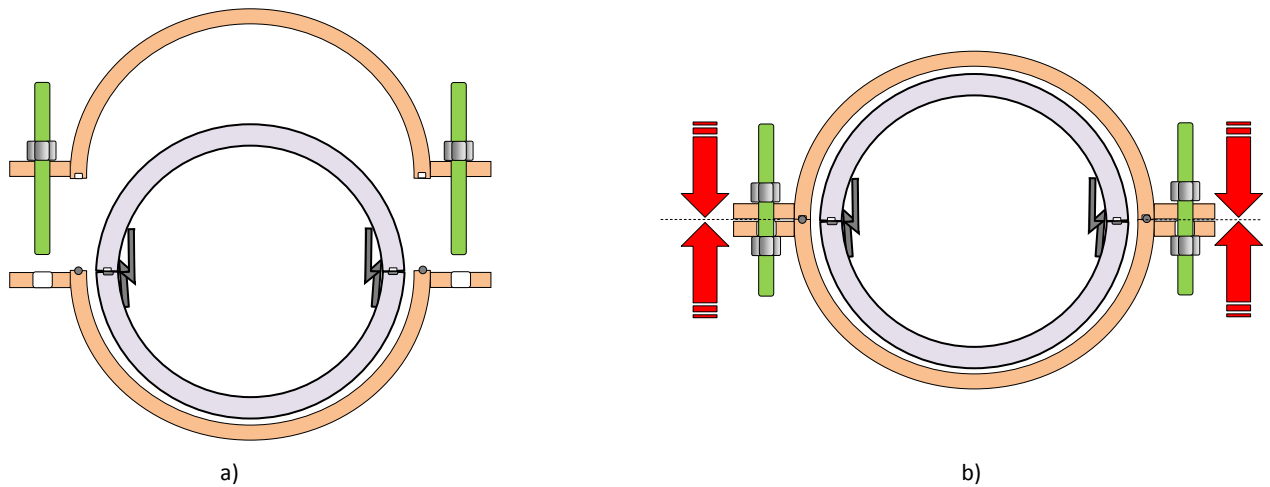
Figure 11-12. Clamp installation at ball joint cross section-outer parts.

For the installation, the inner parts are first clamped together around the pipe. The outer parts -that surround the pipe at the straight section and the inner parts at the ball section- complete the clamping and assembling (Figure 11-12). The longitudinal and radial sealing is engaged while clamping and tightening.

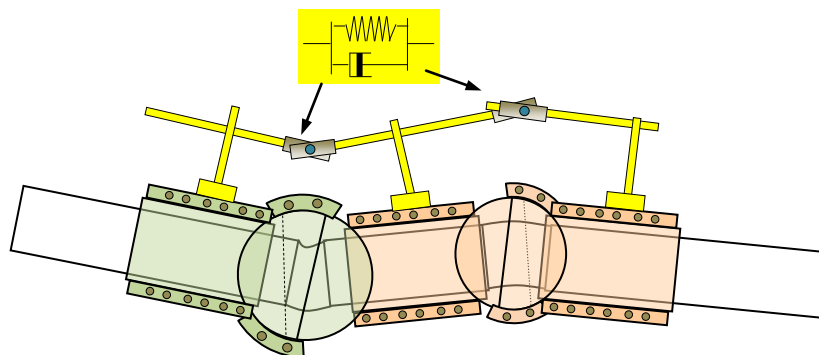
Figure 11-13. Combination of angled-Clamps with different ball joint sizes.

A structural fixture with calculated stiffness and damping shall be designed in order to limit the angular movement of the clamp sections after installation (Figure 11-13).

The angled clamp can be modular and for a certain pipe dimension, there can be several sizes of joint balls in order to cover different geometries of deformation. The modular design enables the operator to have the flexibility versus different damage scenarios. Figure 11-13 illustrates a modular application of the angled clamp.

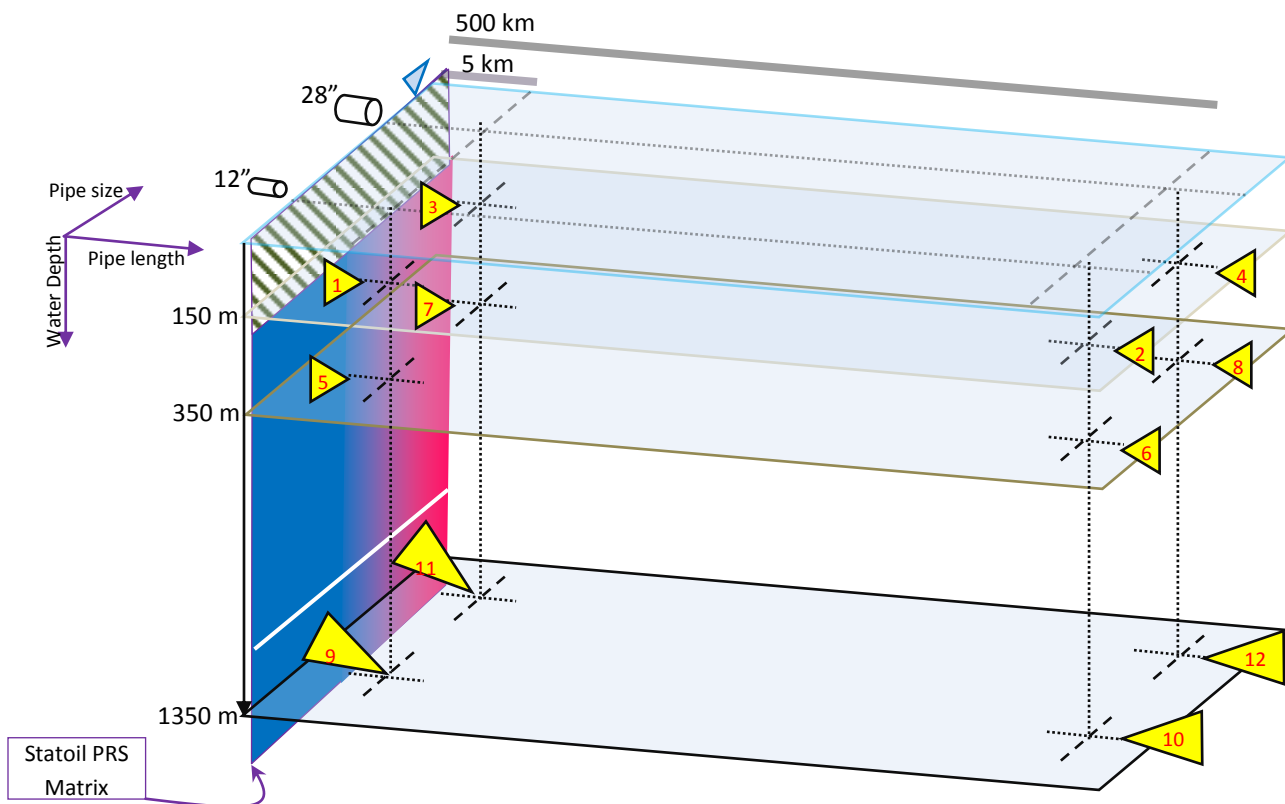
Figure 12-2 different cases for different water depth, pipe sizes and pipe lengths.

Figure 12-2 shows the schematics of the cases defined above.

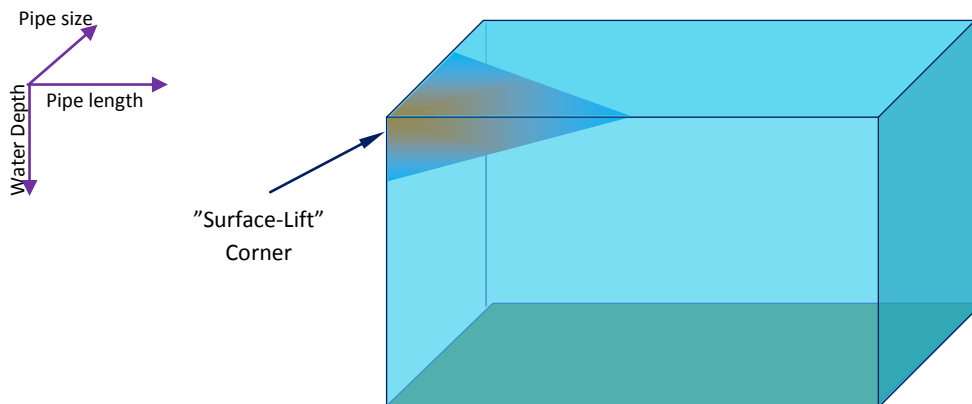
*Figure 12-3 General illustration of cases where the above-water repair or surface lift can be the solution. The feature of the matrix is corresponding to matrix in Figure 12-2.*

*Note:* Generally the small size pipe in shallow water can be lifted to the surface. A shorter length of pipe makes the operation more practical. It is shown in Figure 12-3 as “surface-lift” corner.

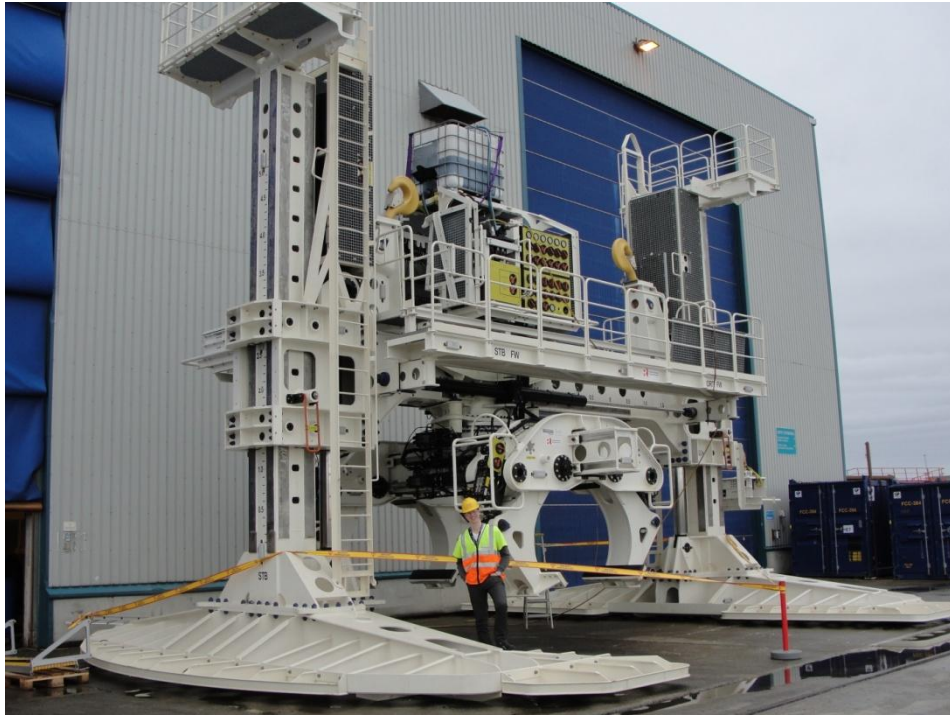
*Figure A-1. PRS Lifting (H-) Frame*

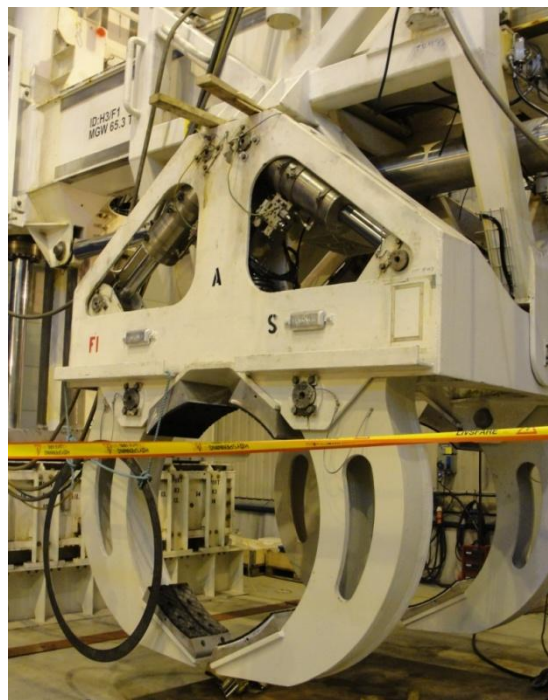
*Figure A-2. PRS Lifting Claw*
