Study program/ Specialization:  Offshore Technology / Marin and Subsea Technology	Spring semester, 2011  Restricted Access
Writer: Keramat Mohammadi	..... (Writer's signature)
Faculty supervisor: Ove Tobias Gudmestad  External supervisor(s): Per Nystrøm (IKM Ocean Design)	
Title of thesis:  Repair methods for damaged pipeline beyond diving depth.	
Credits (ECTS): 30	
Key words:  Deepwater, Pipeline, Repair, Diverless, Clamp , Coupling	Pages: 90  + enclosure: 7 (+1 CD)  Stavanger, 14.06/2011 Date/year

# Repair methods for damaged pipeline beyond diving depth

Master Thesis / Marine and Subsea Technology

Keramat Mohammadi  
Spring 2011

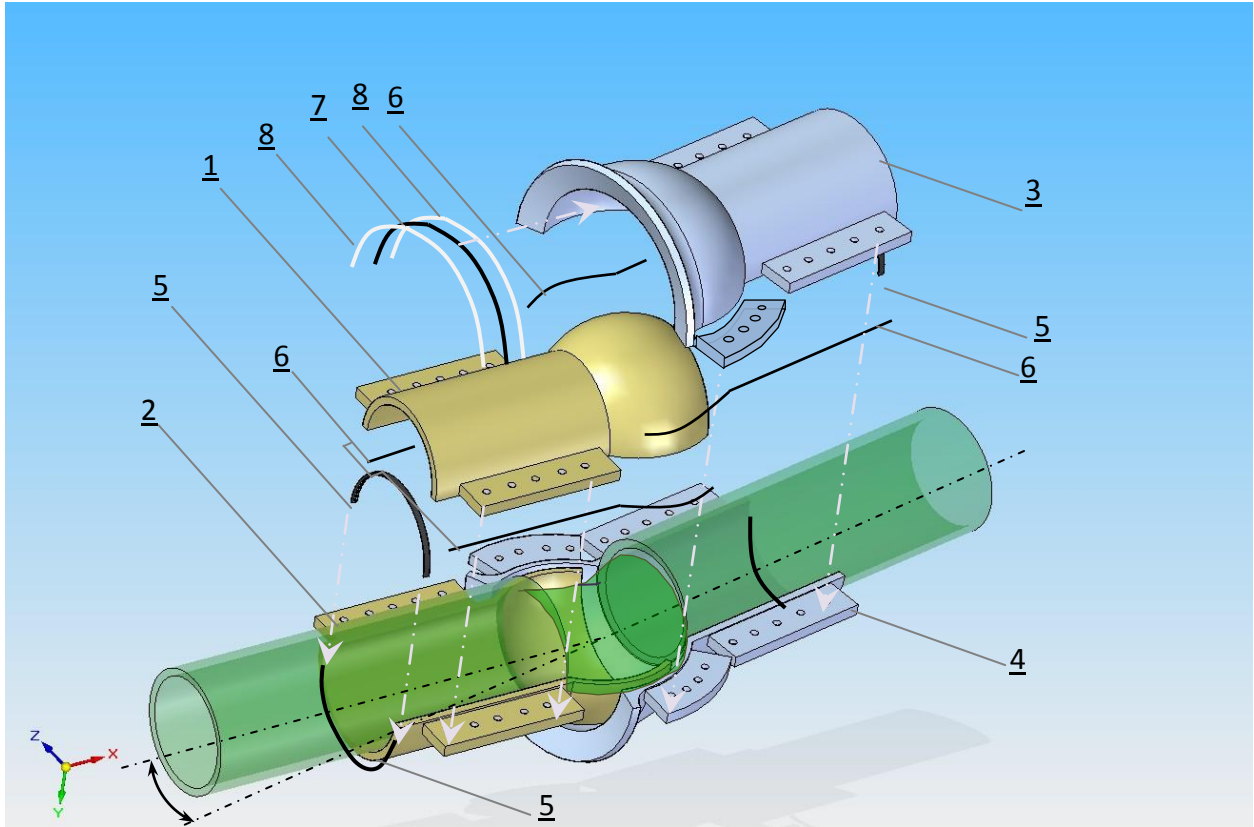
Figure 1. Angled Clamp composition.

In the following is given a description of an Angled Clamp that can solve the damage problem within the angled pipe. With reference to Figure 1, the clamp comprises four main parts (1,2,3 and 4). Each part itself comprises a half-pipe and a partial hemisphere that are welded together.

Sealing is provided through elastic material (elastomer) for radial and hoop directions in each part (items 1 to 4). The hoop tightening (clamping) is achieved by bolting mechanism for the outer clamp (items 3 and 4). For the inner clamp (items 1 and 2) the hoop tightening is done by bolting mechanism in the straight section and two wedge-shape buckles (male-female elastic wedges- items 10 and 11) (or a collet connector) provide the internal clamping at either side of the joint (Figure 4 ).

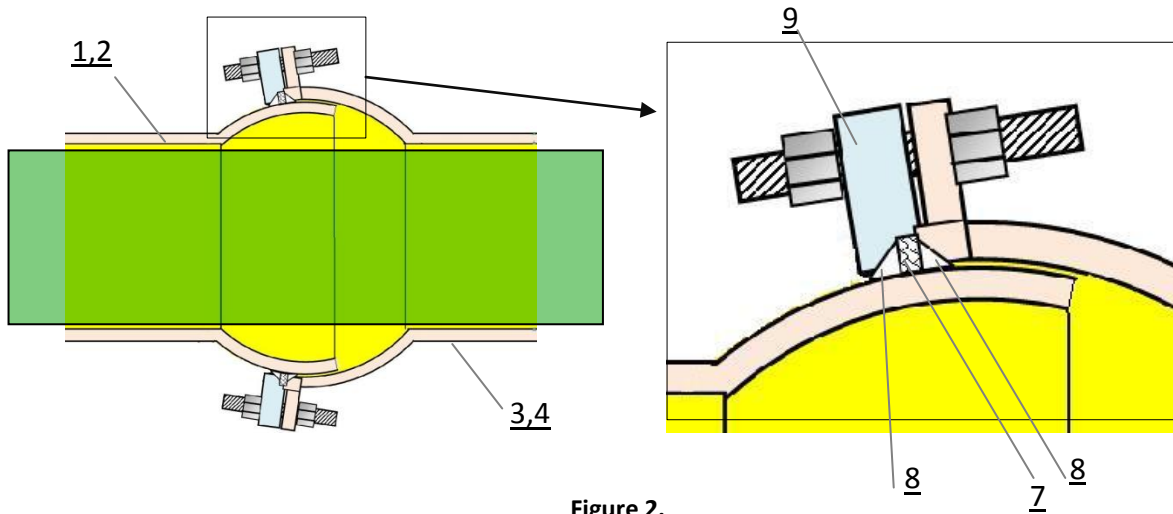
Figure 2. Angled-Clamp sealing mechanism. It can be doubled and a gripping ball rows (not shown here) can also be considered.

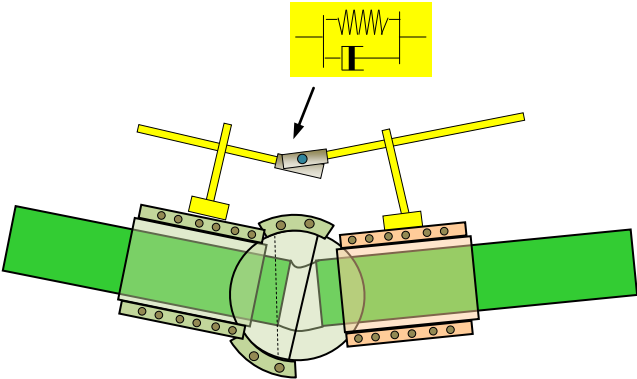
Figure 3. Structural support of clamp.
