MASTER'S THESIS

Evaluation of Ballast Failures during operations of Semi-submersible rigs

Ballast failures, buoyancy loss, stability

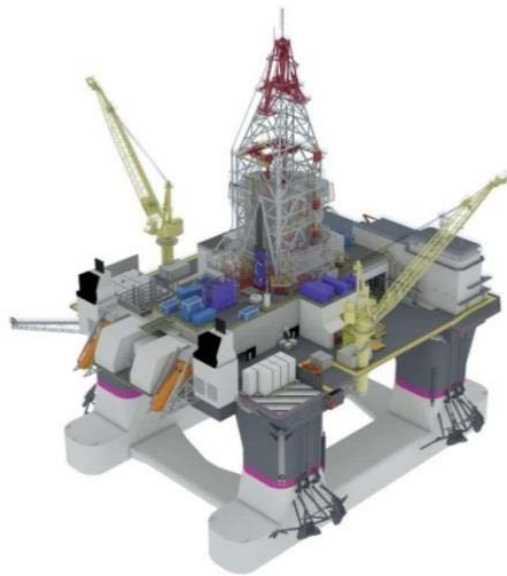
Figure 2-1: A semi-submersible rig. Source: ABB, n.d

Figure 2-1 presents a semi-submersible rig consisting of several systems. The topside is situated above the columns and is made up of living quarters, drilling derrick, drilling deck and operation equipment. The columns are usually made up of four or eight legs. These columns support the top side and provides adequate air gap between the deck and the water. Also, the columns are used for ballasting, as well as store bulk loads including fuel and drilling mud. The number of legs the column has is dependent on the required variable deck load capacity and stability. The units are usually designed with either a ring pontoon or two pontoons, which connects the columns. The pontoon provides the rig with the required buoyancy (Sharma et al., 2010). The hull is used for storing fuel, mud and ballast water. A brace is usually used to fortify the columns and pontoons to enhance the unit's structural integrity.

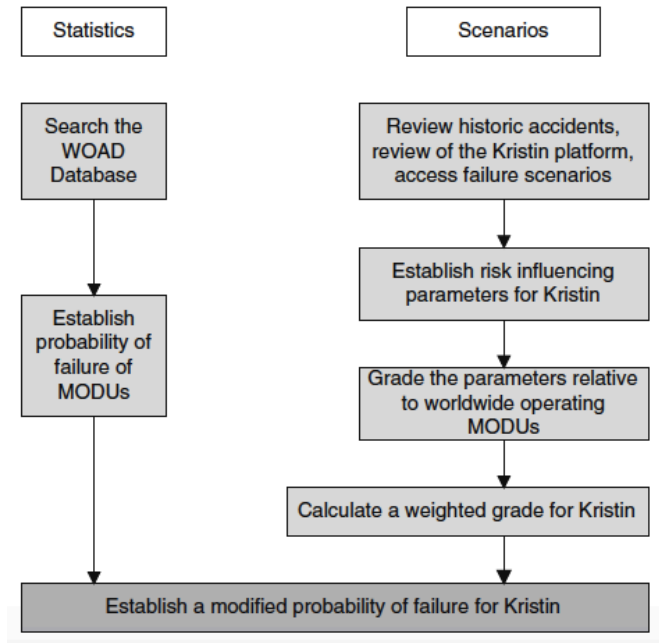
Figure 2-2: Failure frequency assessment approach based on gross errors. Source: Lotsberg et al. (2004); Vinnem (2013)

Lotsberg et al., (2004) adopted an alternative to approach the QRA. This approach presented in figure 2-2 was used in the Kristin field. Comparing to the traditional QRA approaches, this approach is somewhat of an improvement (Vinnem, 2013). It involves using historical data to establish probability of failure of platforms, establishing risk influencing parameters and calculating a weighted grade on the operating parameters of the platform. However, the drawback of this approach is its inability to identify risk reducing measures and the associating risk of the risk reducing measures (Vinnem, 2013).

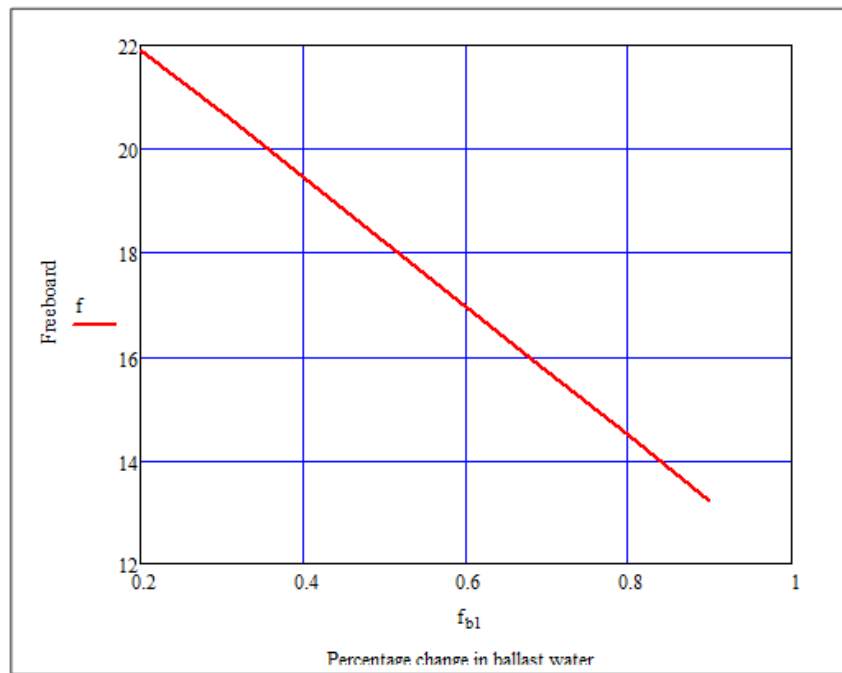
Figure 5-10: Variation of freeboard with change in percentage of ballast water

Figure 5-10 presents the relationship between freeboard and varying ballast water of a semi-submersible during operations. The initial freeboard when the two pontoons were filled with 90% of ballast water was 13.2 m. However, when there was further 10% reduction on one of the pontoons the freeboard changed from 13.2m to 14.46m. In the case where the ballast water was reduced to about half of its mass, there is 3.725 m increase of freeboard. This is expected, as there is a reduction in weight. It is important to note that the freeboard discussed here, is the freeboard at the middle of the semi-submersible. The minimum freeboard criteria for a semi-submersible is 1.50 (DNV, 2013). This means that the freeboard of the semi-submersible is met in all cases of ballast water variation.

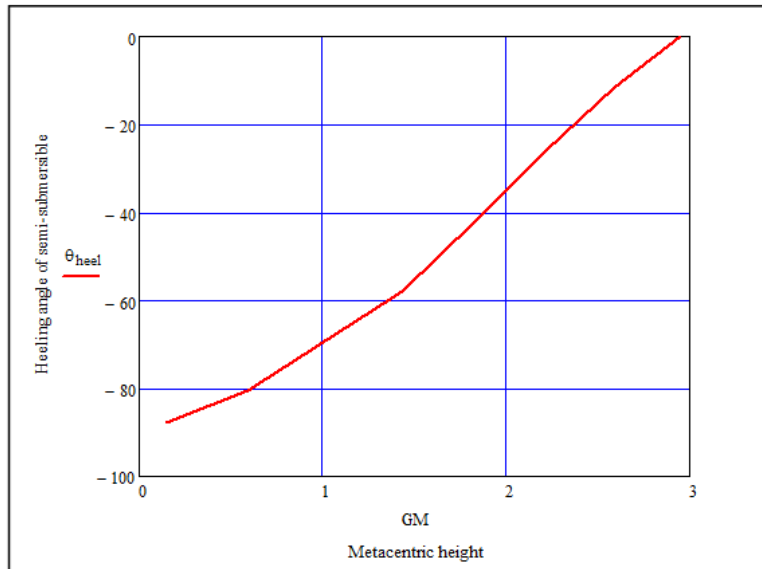
Figure 5-11: Variation of metacentric height for different percentages of ballast water

The intact stability was 2.95 m when both pontoons were filled with 90% ballast water. However, when there was further 10% (i.e., 80% ballast water) reduction on one pontoons, the intact stability reduced to 2.59m, which is about a 0.51 m reduction. This is presented in figure 5-11. According to regulations, the minimum allowable metacentric height is 1m. This means that in all scenarios where water ballast is varied, the criteria for the metacentric height is met, but for reduced mass of 30%.

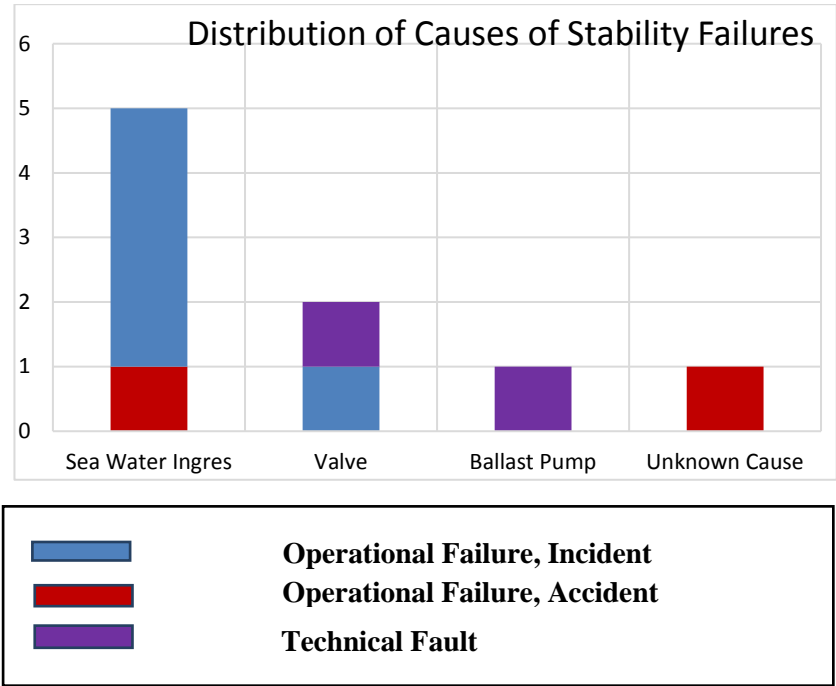
Figure 7-1: Distribution of causes of stability failures

A more detailed information about some semi-submersibles and its dimensions is given in chapter 4. Five out of the nine incidents/accidents, were caused by uncontrolled water ingress. This is in line with the conclusion by Tinmannsvik et al. (2011) who noted that uncontrolled water ingress is the main common cause of accidents and incidents. On the other hand, a similar study carried out by Vinnem et al., (2006) concluded that valve failures are the main cause category for incidents and accidents. This discrepancy may be due to the fact that in most cases where ballast valve failure is not the initiating cause of an event, however it seen to be among the casual factors on the incident chain. It is further observed that seven out of nine incidents/accidents occurred due to human error. These accidents could have been prevented if the human interface (i.e., designers, operators and organization) had followed

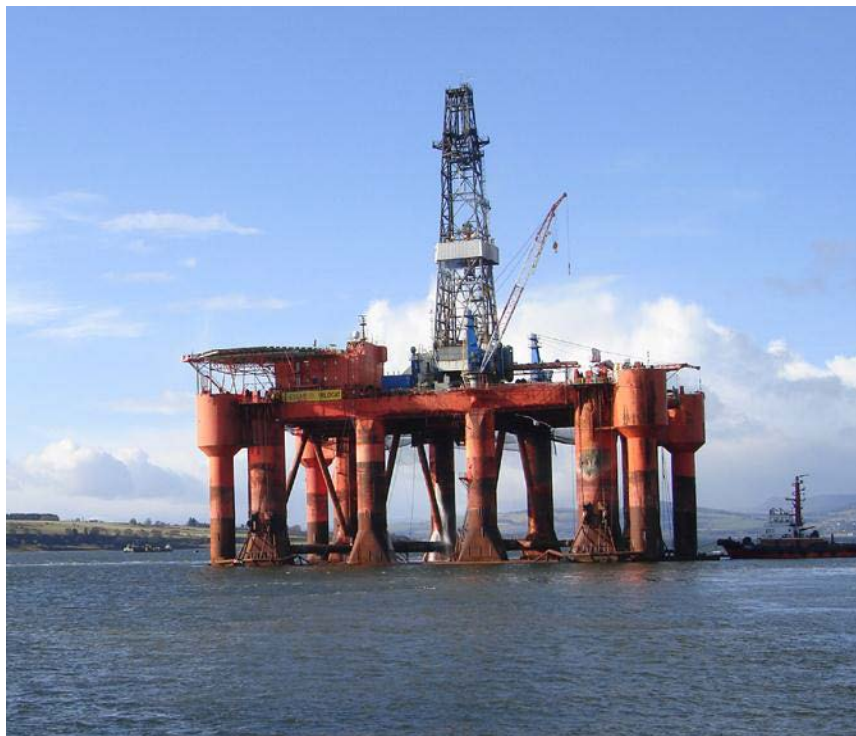
Figure A- 2; Essar Wildcat. A 2nd generation Aker H-3 submersible developed in 1977. Source; Kaiser et al., (2013)

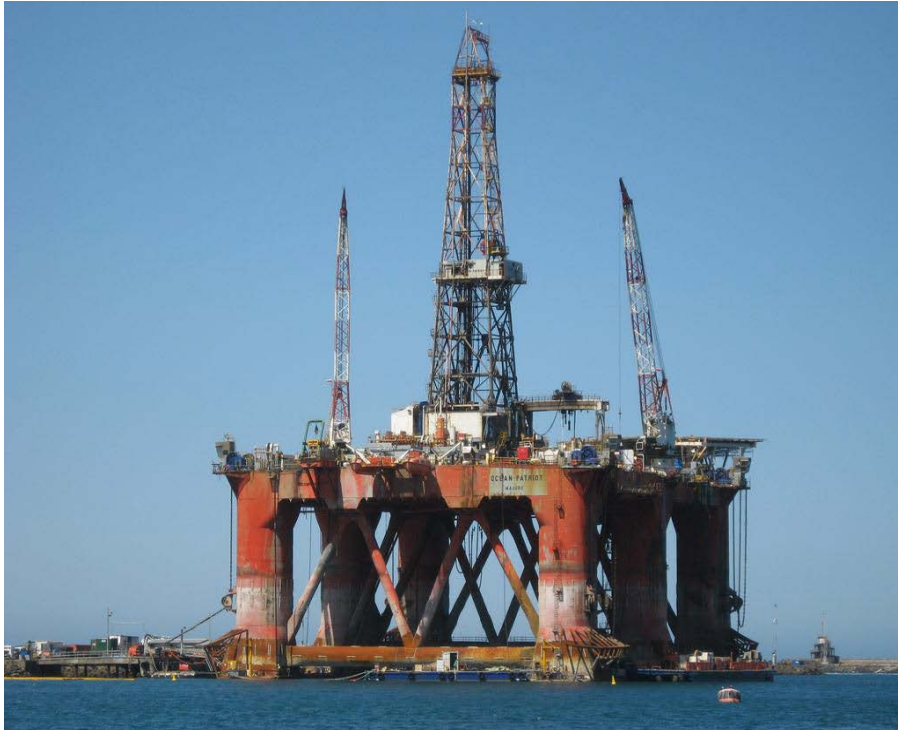
Figure A- 3: Ocean Patriot, a 3rd generation Bingo 3000 semisubmersible, built in 1983. Source; Kaiser et al., (2013)

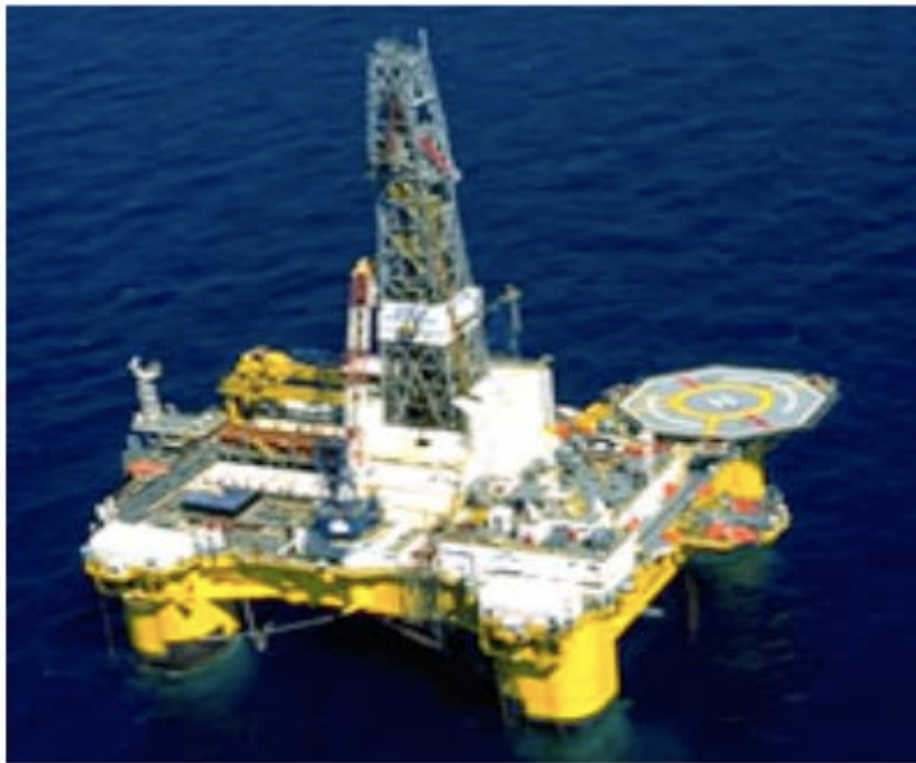
Figure A- 4; Transocean Richardson, a 4th generation semi-submersible, built in 1988/1991. Source; Deepwater, (n.d ,a)

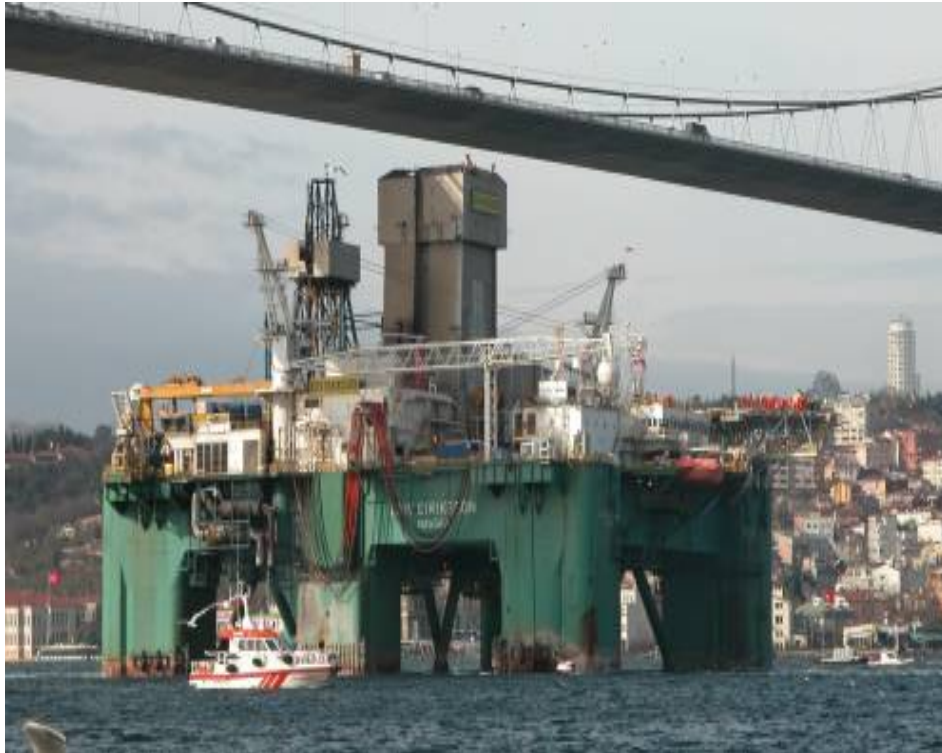
Figure A- 5; Leiv Eirikssen, a 5th generation semisubmersible, built in 2001. Source; Ocean Rig (n.d)

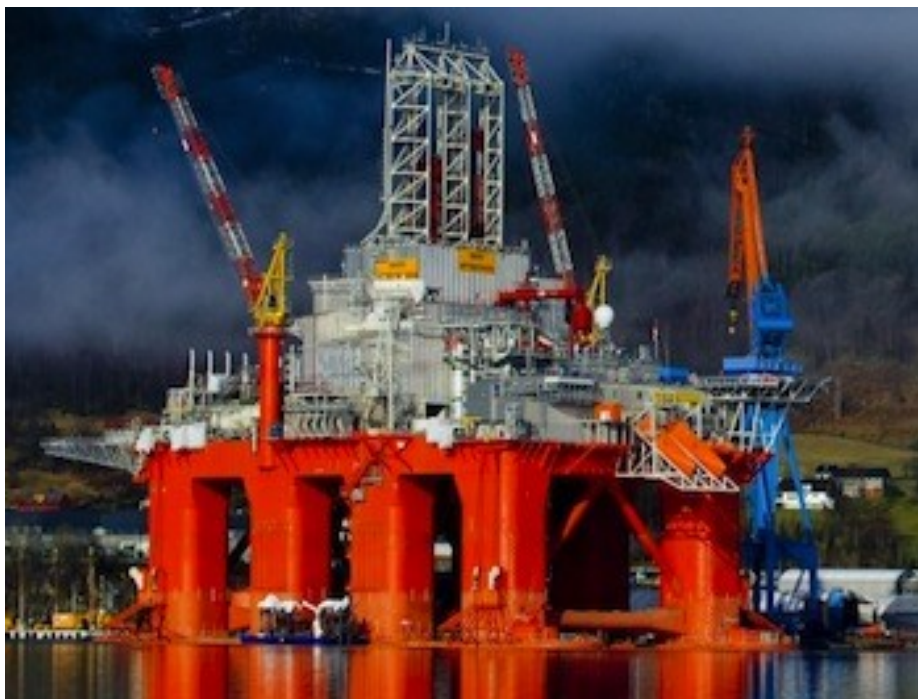
Figure A- 6; Transocean Spitsbergen a 6th generation semisubmersible Aker H-6e Semi-submersible , built in 2009. Source; Deepwater, (n.d ,b)
